ENVIRONMENTAL MONITORING & AUDIT MONTHLY REPORT

March 2018

Contract Name : Castle Peak Road Trunk Sewer and Tuen Mun Village Sewerage (Sewage Pumping Station at Lok Chui Street near Castle Peak Villas)

Contract No. : DC/2014/01

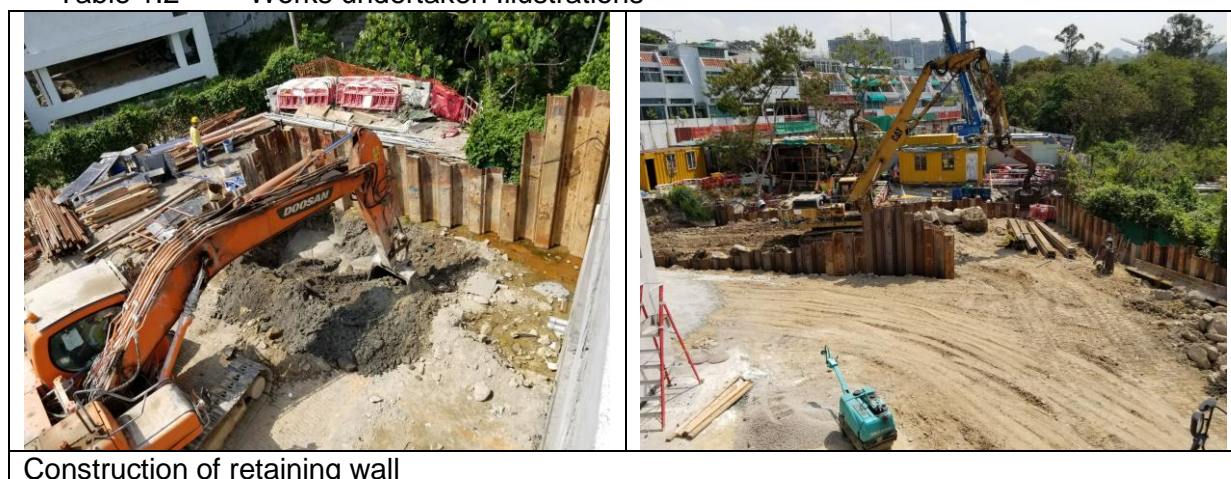
Table 1.2 Works undertaken Illustrations

- Construction of retaining wall

1.4.2 Illustrations of works undertaken during the reporting period are shown in **Table 1.2**:
