ENVIRONMENTAL MONITORING & AUDIT MONTHLY REPORT

July 2018

Contract Name : Castle Peak Road Trunk Sewer and Tuen Mun Village Sewerage (Sewage Pumping Station at Lok Chui Street near Castle Peak Villas)

Report No. : 0367/15/ED/1078

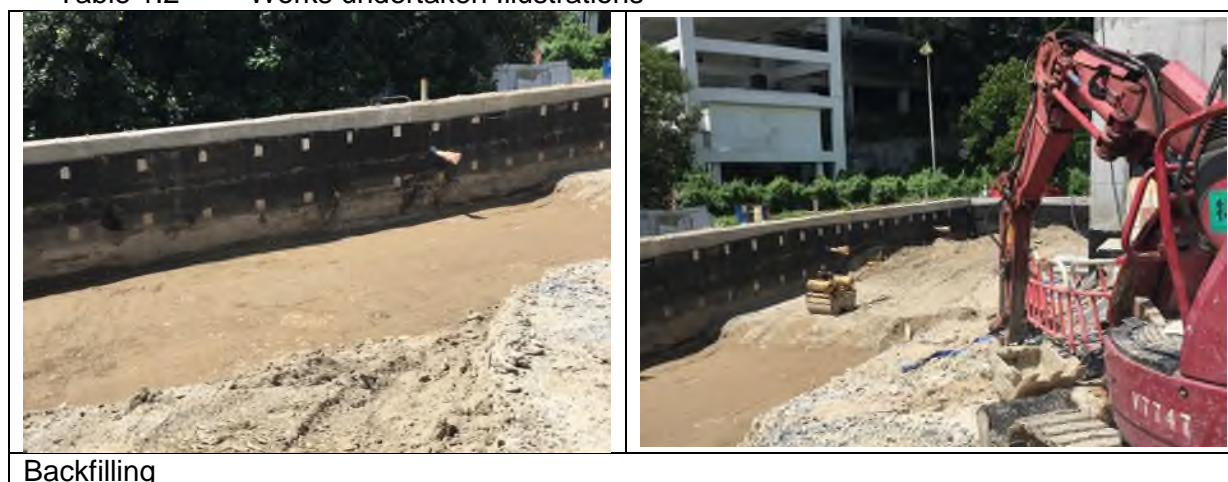
Table 1.2 Works undertaken Illustrations

- Backfilling

1.4.2 Illustrations of works undertaken during the reporting period are shown in **Table 1.2**:
