ENVIRONMENTAL MONITORING & AUDIT MONTHLY REPORT

August 2018

- Client : SANG HING - KULY JOINT VENTURE
- Contract Name : Castle Peak Road Trunk Sewer and Tuen Mun Village Sewerage (Sewage Pumping Station at Lok Chui Street near Castle Peak Villas)
- Contract No. : DC/2014/01
- EP No. : EP-068/2000/A
- Title of Project : Sewage Pumping Stations at Tai Lam Chung Tsuen Luen On San Tsuen, Tai Lam Valley and Lok Chui Street near Castle Peak Villas under the scope of "Tuen Mun Sewerage -Eastern Coastal Sewerage Extension"
- **Report No.** : 0367/15/ED/1097

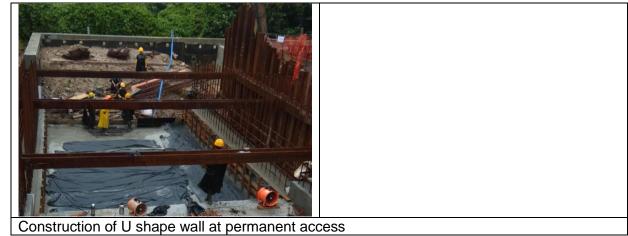
- 1.4.1 During this reporting period, the principal work activities within the site included:
 - Construction of U shape wall at permanent access
- 1.4.2 Illustrations of works undertaken during the reporting period are shown in **Table 1.2**:

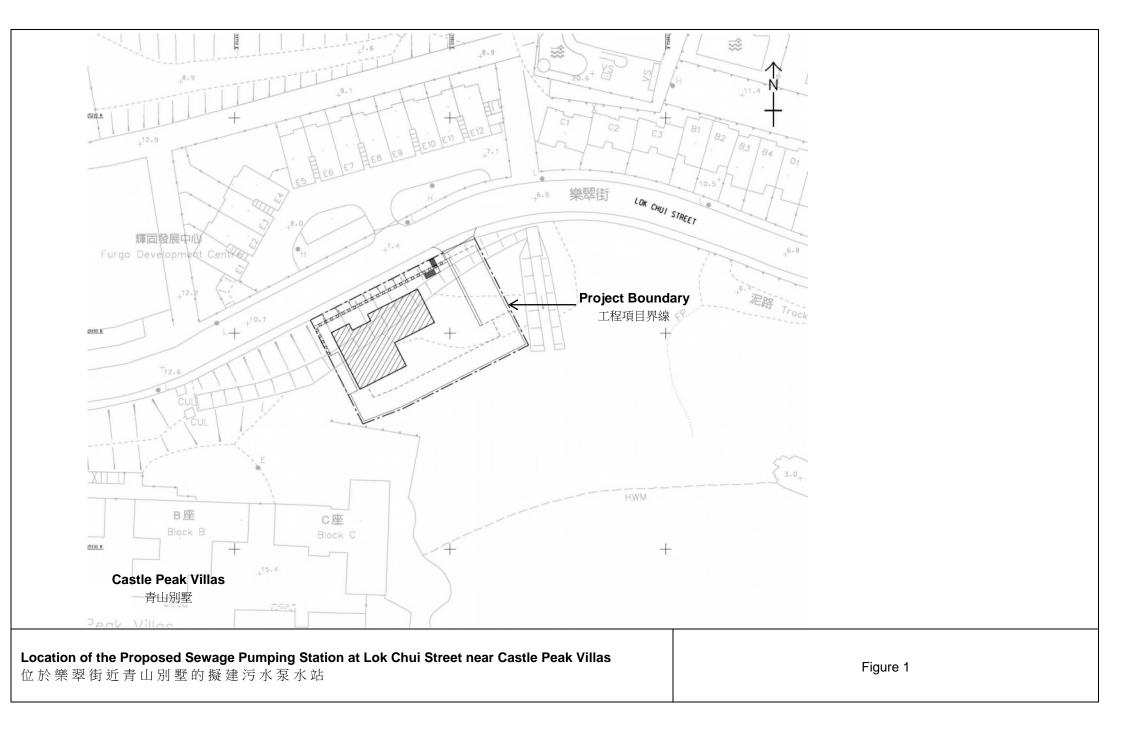
Figure 1

- 1.1.1 Contract No. DC/2014/01 Castle Peak Road Trunk Sewer and Tuen Mun Village Sewerage ("the Project") includes the construction of a sewage pumping station at Lok Chui Street near Castle Peak Villas as shown in **Figure 1**.

Project General Layout

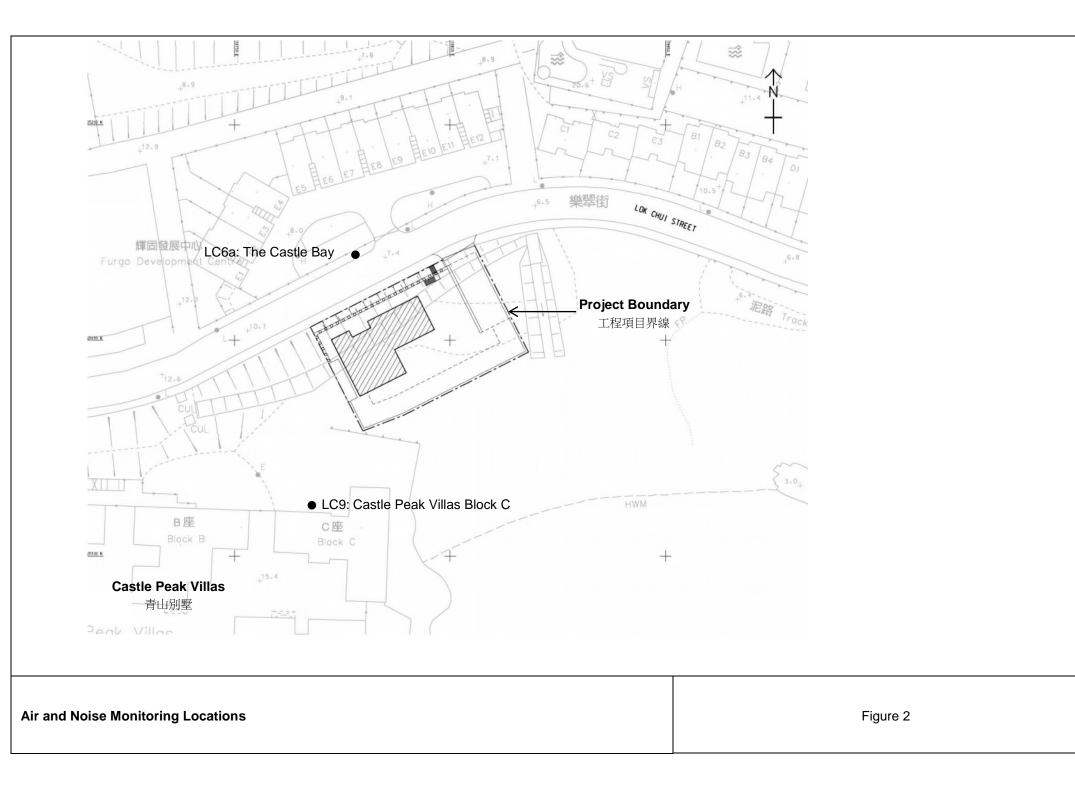
Figure 2

2.4.1 In accordance with the updated EM&A Manual, two designated air quality monitoring stations, LC6a and LC9 are selected for the Project Area of constructing a sewage pumping station at Lok Chui Street near Castle Peak Villas as they are the representative air sensitive receivers located near to the Project site. All designated air quality monitoring stations listed in the updated EM&A Manual and the air quality monitoring stations are shown in **Table 2.3** and the monitoring locations are shown in **Figure 2**.

Air and Noise Monitoring Locations

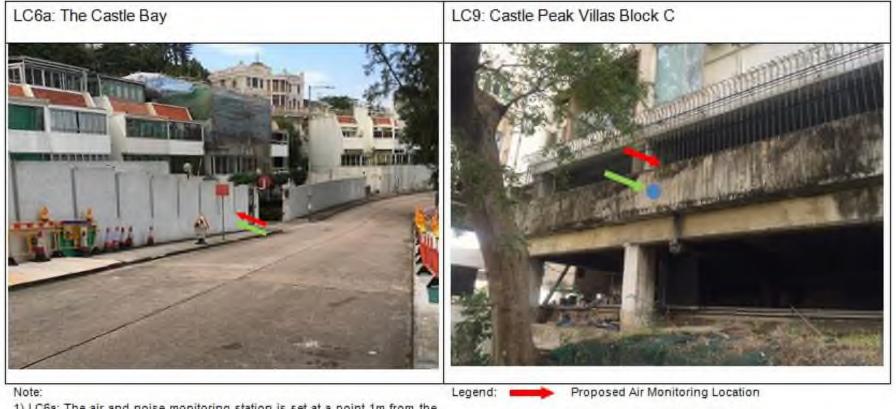
LC6a: The air and noise monitoring station is set at a point 1m from the exterior of the sensitive receiver fence wall, and set at a position 1.2m above ground. Facade measurement will be carried out for noise monitoring.

2) LC9: The air monitoring station is set at the top of parapet wall of sensitive receivers building and the noise monitoring station is set at a point 1m from the exterior of the sensitive receivers building façade and set at a position 5m above the ground.
