ENVIRONMENTAL MONITORING & AUDIT MONTHLY REPORT

November 2018

Contract Name : Castle Peak Road Trunk Sewer and Tuen Mun Village Sewerage (Sewage Pumping Station at Lok Chui Street near Castle Peak Villas)

Contract No. : DC/2014/01

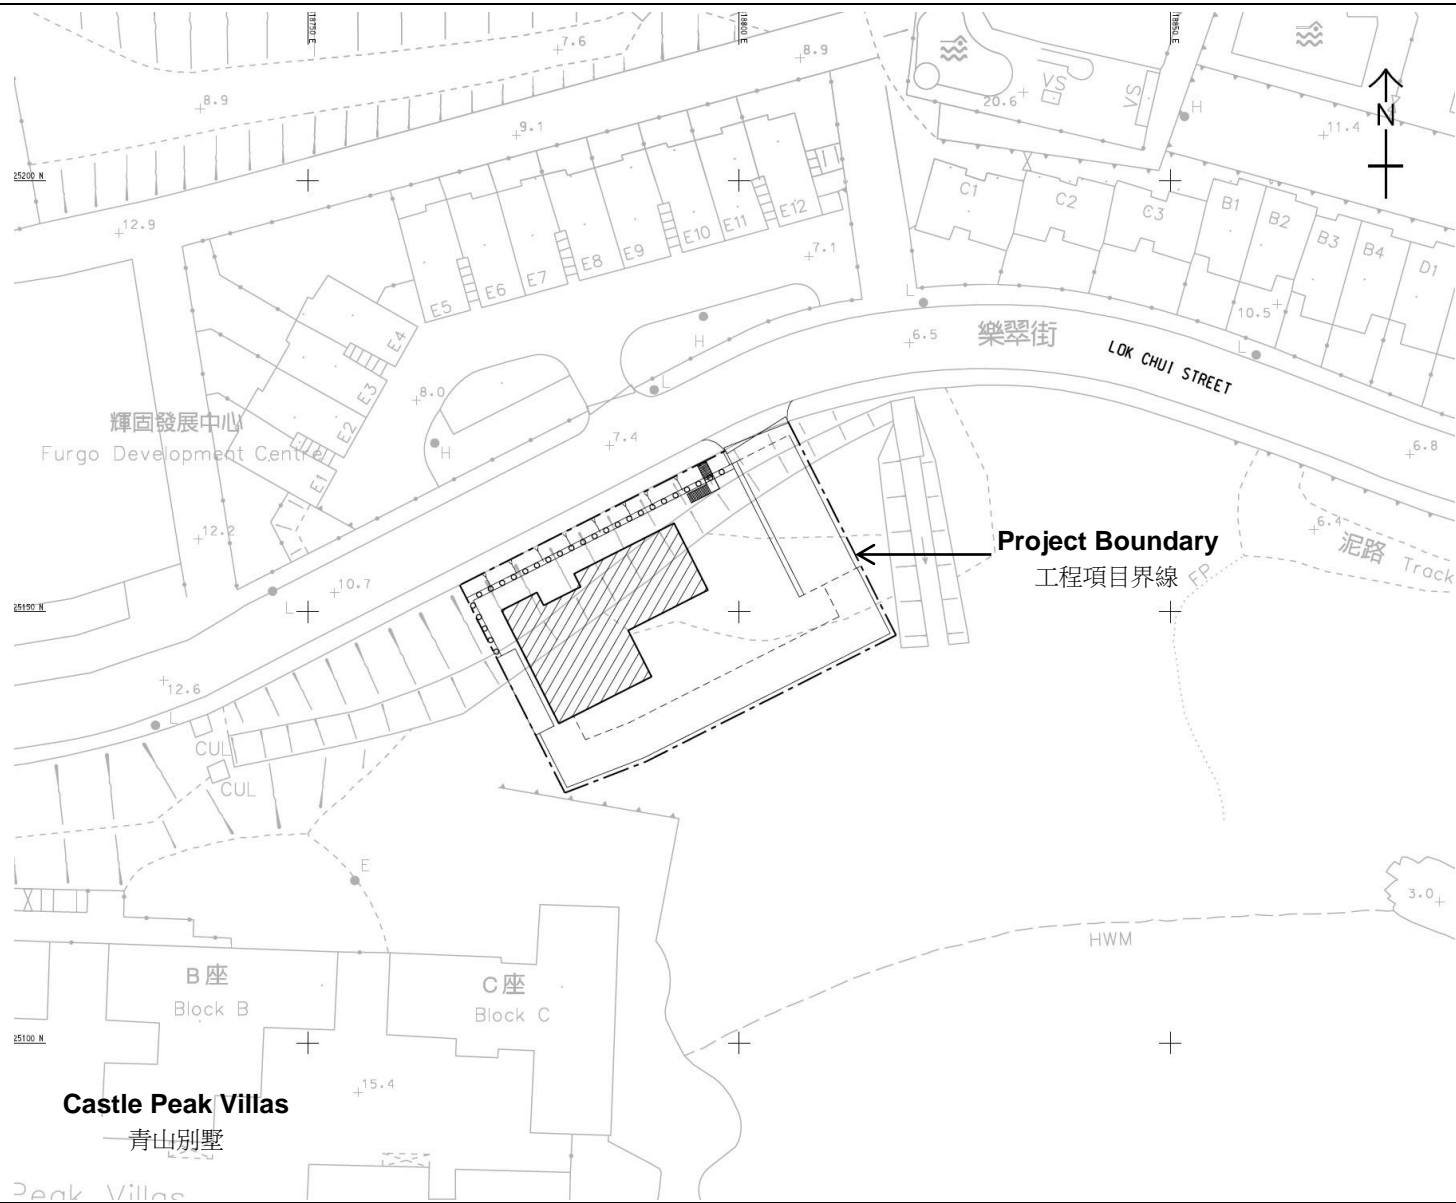
Figure 1

Project General Layout

Location of the Proposed Sewage Pumping Station at Lok Chui Street near Castle Peak Villas
 位於樂翠街近青山別墅的擬建污水泵水站

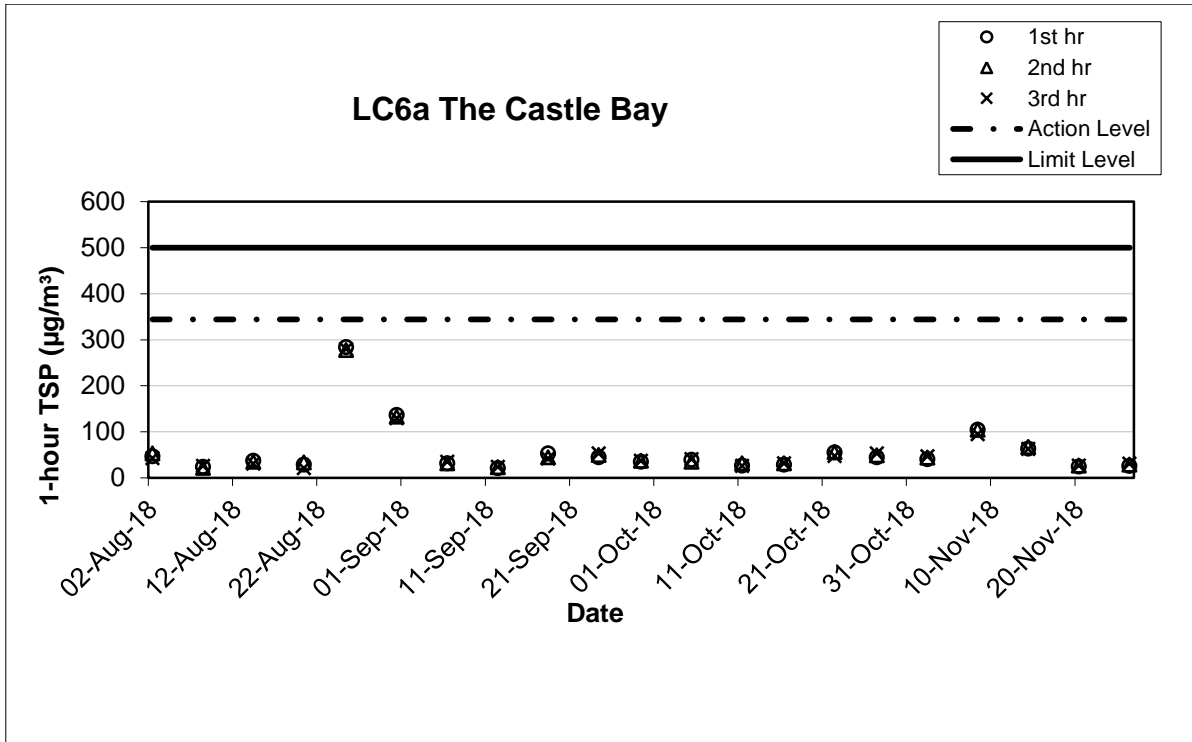
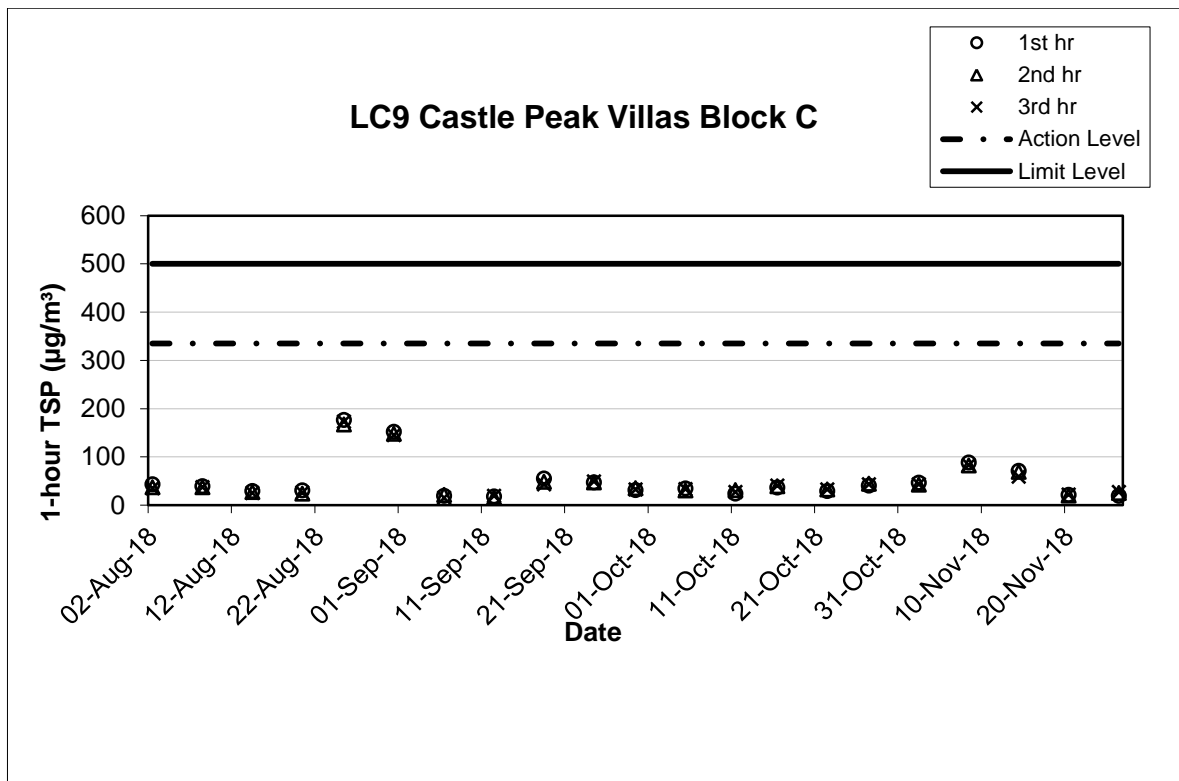
LC9 Castle Peak Villas Block C

1-hour TSP ($\mu\text{g}/\text{m}^3$)					
Date	Start Time	1st hr	2nd hr	3rd hr	Weather
02-Nov-18	13:10	46	42	43	Sunny
08-Nov-18	13:45	88	82	83	Fine
14-Nov-18	08:36	71	69	59	Fine
20-Nov-18	14:17	21	20	22	Fine
26-Nov-18	13:27	19	25	27	Fine
	Average	48			
	Max	88			
	Min	19
