ENVIRONMENTAL MONITORING & AUDIT MONTHLY REPORT

December 2018

Contract Name : Castle Peak Road Trunk Sewer and Tuen Mun Village Sewerage (Sewage Pumping Station at Lok Chui Street near Castle Peak Villas)

Report No. : 0367/15/ED/1145A

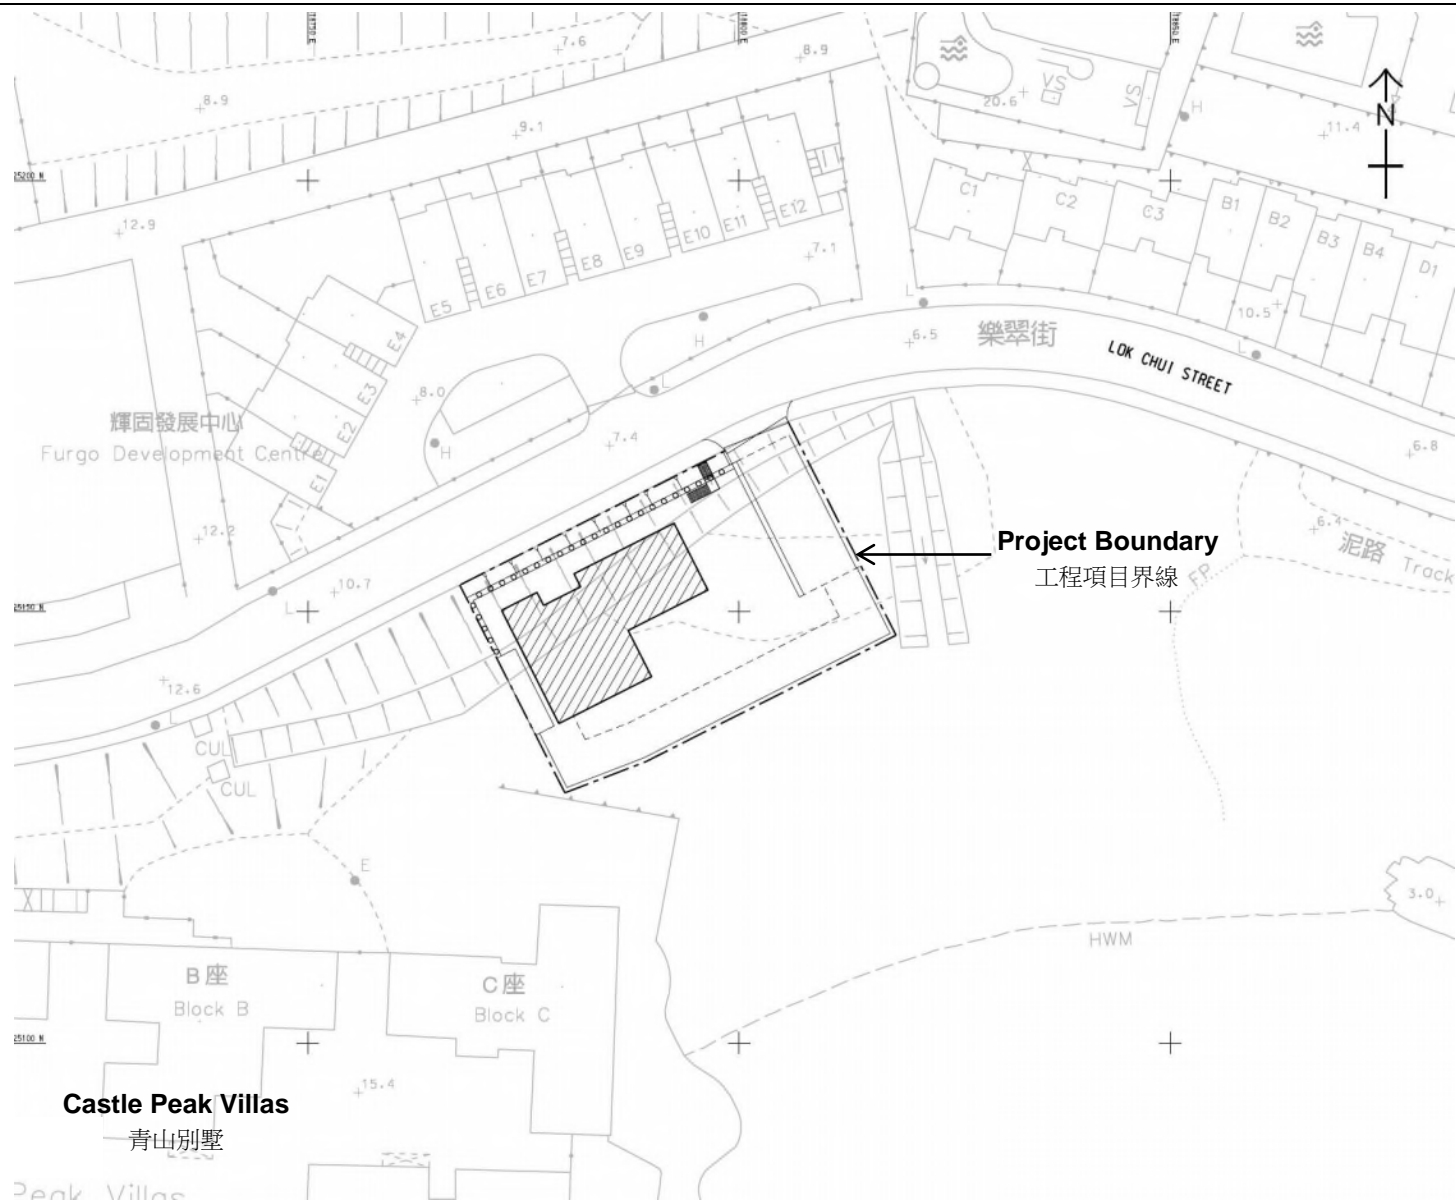
Figure 1

Project General Layout

Location of the Proposed Sewage Pumping Station at Lok Chui Street near Castle Peak Villas
 位於樂翠街近青山別墅的擬建污水泵水站

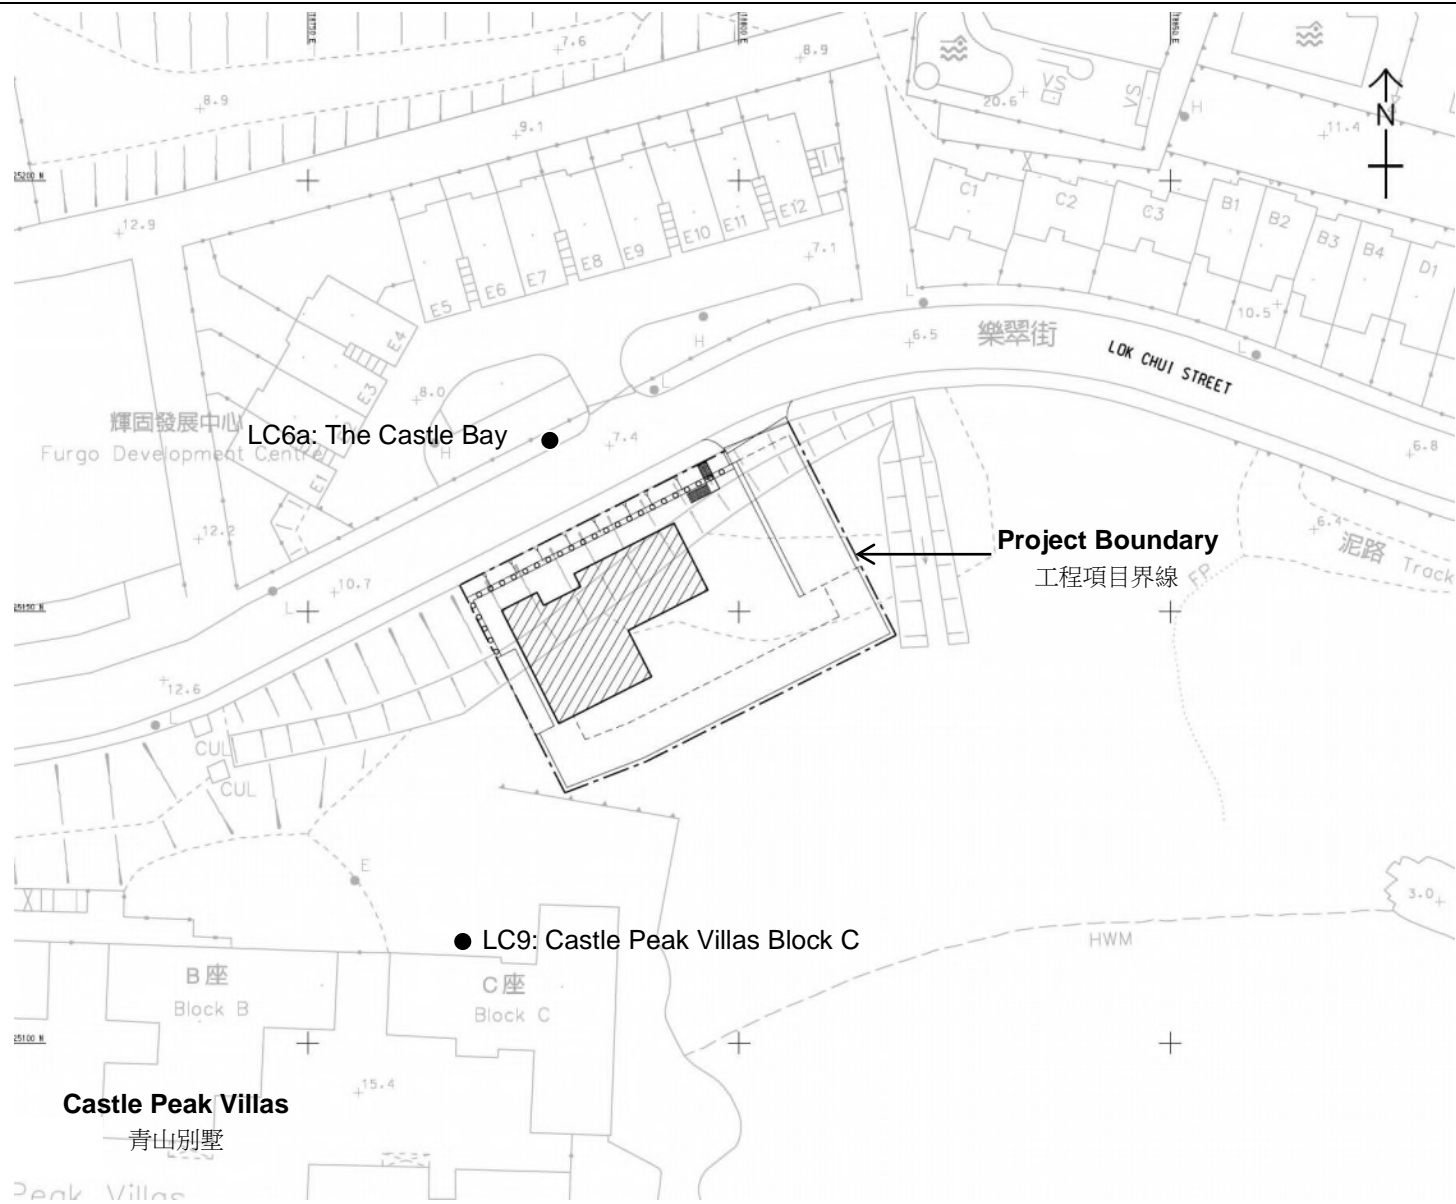
Figure 2

2.4.1 In accordance with the updated EM&A Manual, two designated air quality monitoring stations, LC6a and LC9 are selected for the Project Area of constructing a sewage pumping station at Lok Chui Street near Castle Peak Villas as they are the representative air sensitive receivers located near to the Project site. All designated air quality monitoring stations listed in the updated EM&A Manual and the air quality monitoring stations are shown in **Table 2.3** and the monitoring locations are shown in **Figure 2**.

3.4.1 Noise monitoring were conducted at two designated monitoring stations as described in **Table 3.3** and the monitoring locations are shown in **Figure 2**.

Air and Noise Monitoring Locations

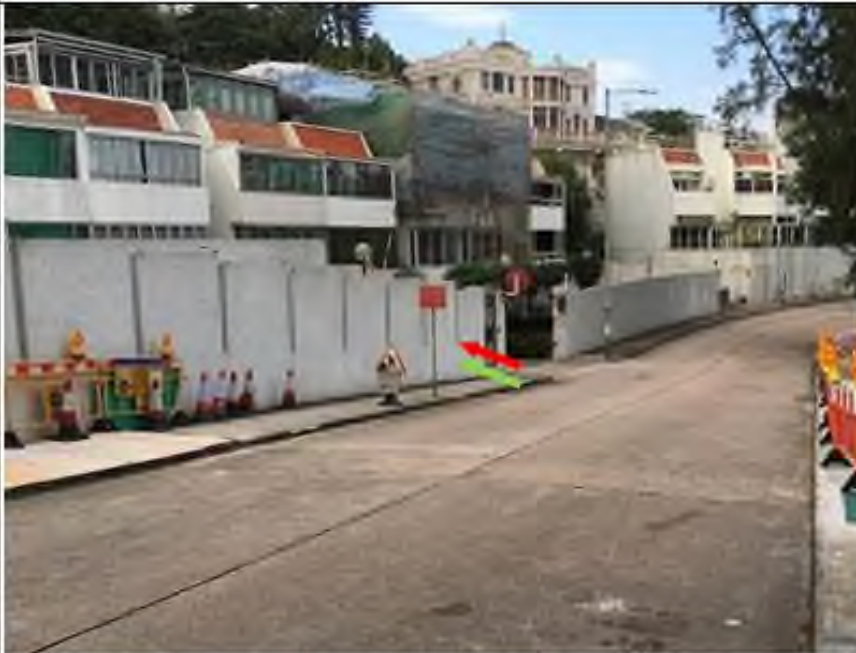
LC6a: The Castle Bay

- 1) LC6a: The air and noise monitoring station is set at a point 1m from the exterior of the sensitive receiver fence wall, and set at a position 1.2m above ground. Façade measurement will be carried out for noise monitoring.
- 2) LC9: The air monitoring station is set at the top of parapet wall of sensitive receivers building and the noise monitoring station is set at a point 1m from the exterior of the sensitive receivers building façade and set at a position 5m above the ground.

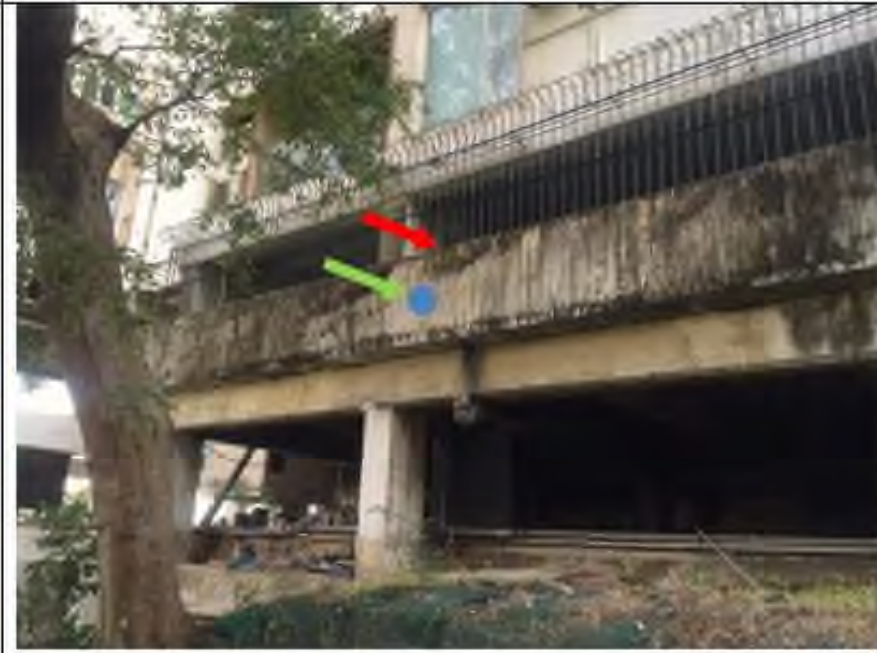
LC9: Castle Peak Villas Block C
