ENVIRONMENTAL MONITORING & AUDIT MONTHLY REPORT

May 2019

Contract Name : Castle Peak Road Trunk Sewer and Tuen Mun Village Sewerage (Sewage Pumping Station at Lok Chui Street near Castle Peak Villas)

Title of Project : Sewage Pumping Stations at Tai Lam Chung Tsuen Luen On San Tsuen, Tai Lam Valley and Lok Chui Street near Castle Peak Villas under the scope of “Tuen Mun Sewerage – Eastern Coastal Sewerage Extension”

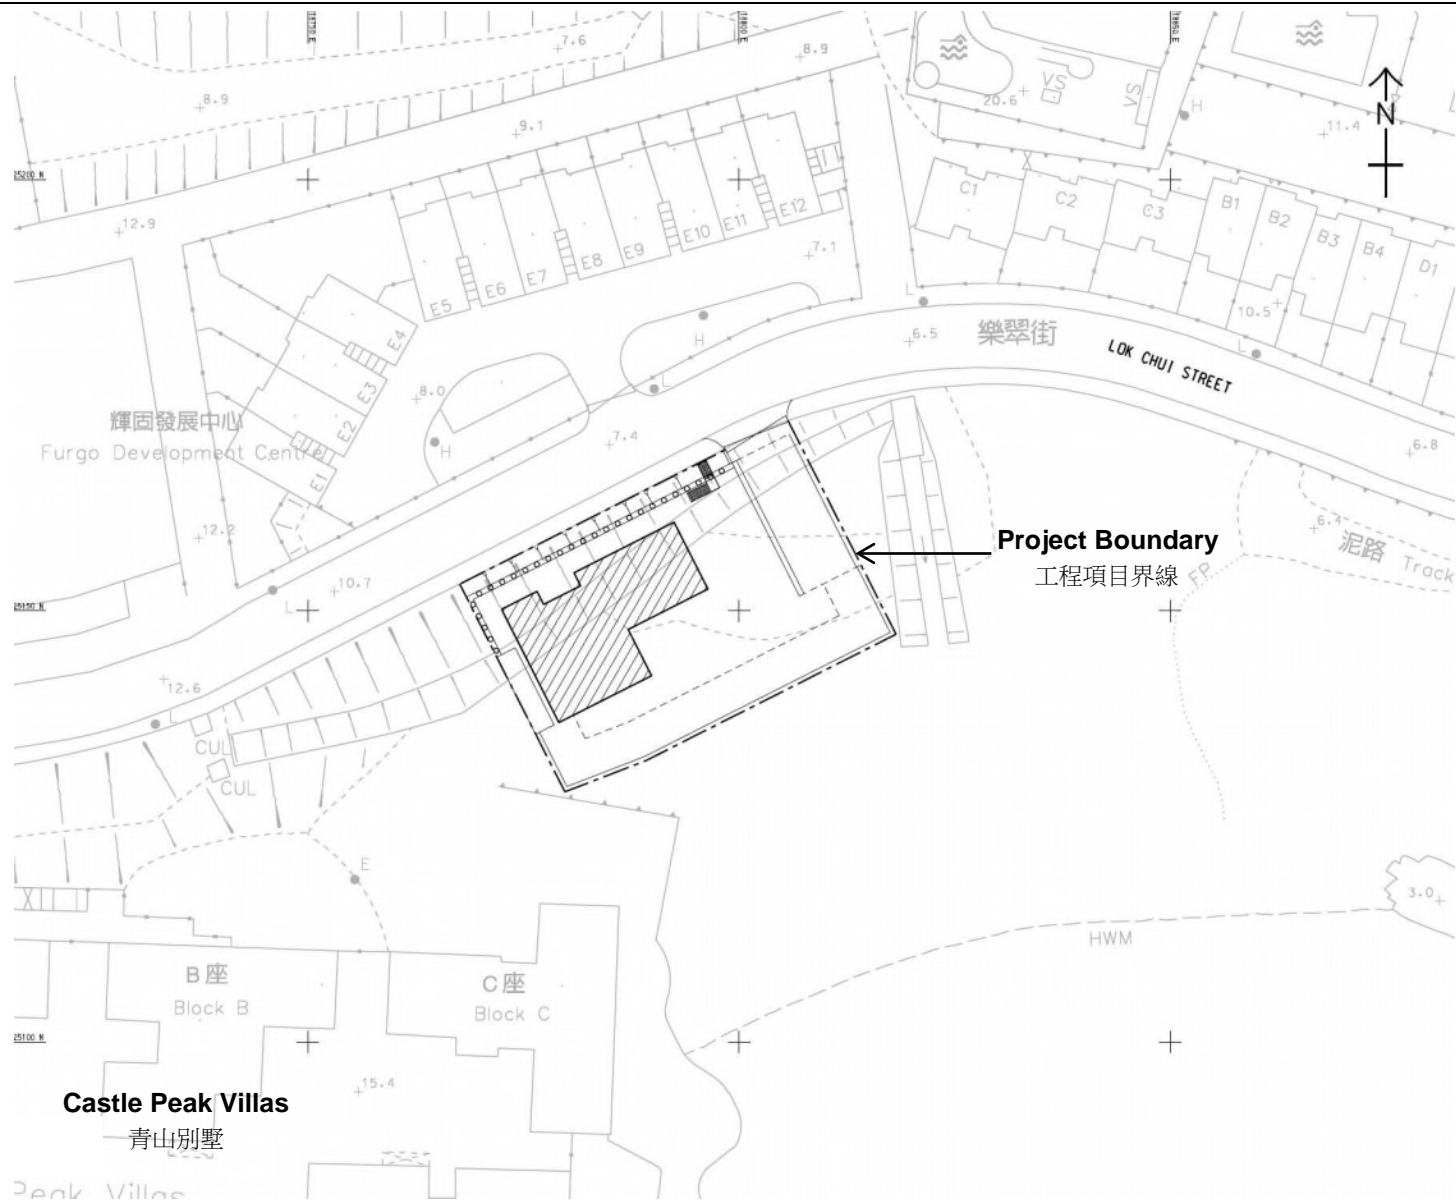
Figure 1

Project General Layout

Location of the Proposed Sewage Pumping Station at Lok Chui Street near Castle Peak Villas
 位於樂翠街近青山別墅的擬建污水泵水站

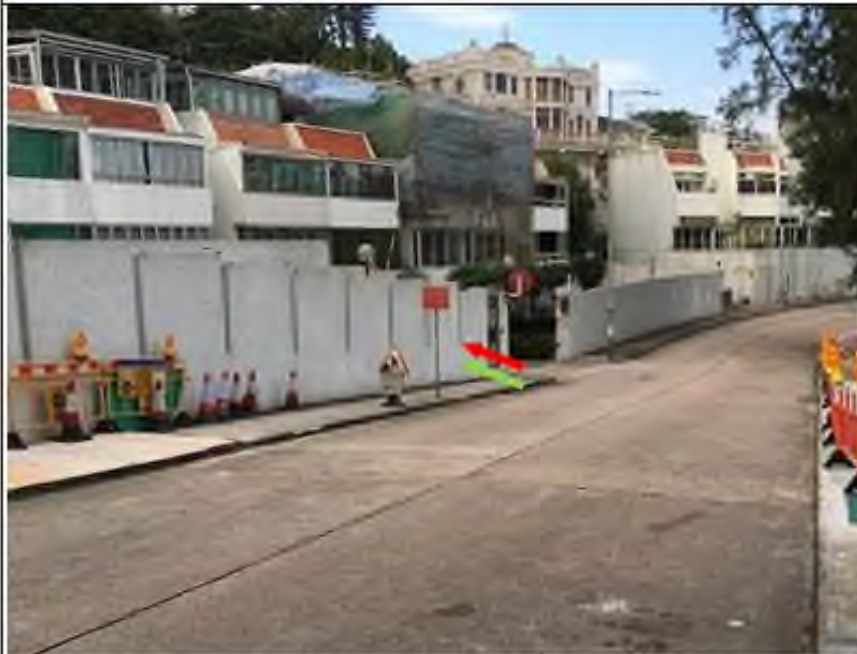
LC6a: The Castle Bay

1) LC6a: The air and noise monitoring station is set at a point 1m from the exterior of the sensitive receiver fence wall, and set at a position 1.2m above ground. Façade measurement will be carried out for noise monitoring.

- Monitoring Stations:
 - LC6a: The monitoring station was set at a point 1m from the exterior of the sensitive receiver fence wall and set at a position 1.2m above the ground. Façade measurement is carried out for noise monitoring.

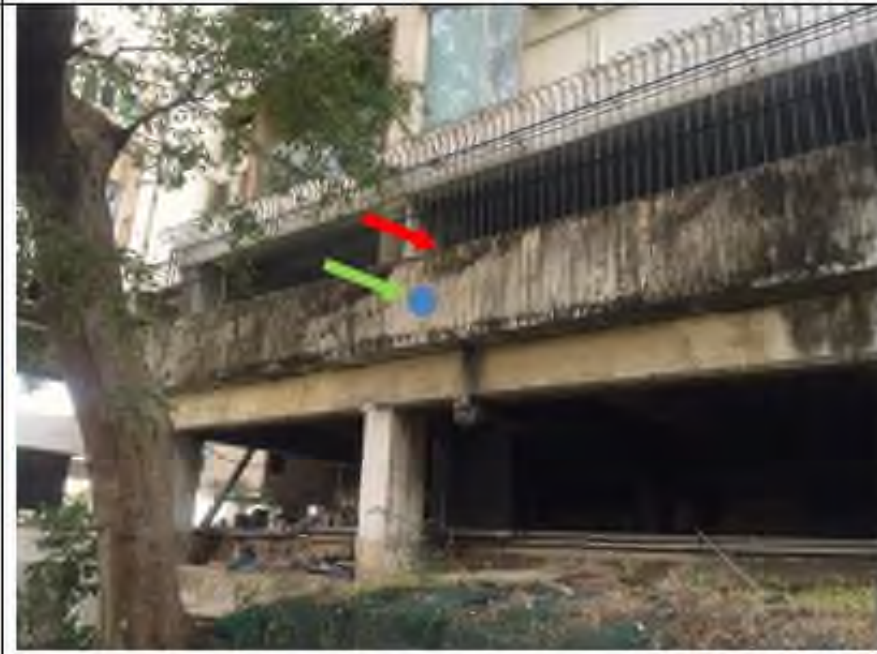
LC9: Castle Peak Villas Block C

- LC9: The monitoring station was set at the top of parapet wall of sensitive receivers building and the noise monitoring station is set at a point 1m from the exterior of the sensitive receivers building façade and set at a position 5m above the ground.
