ENVIRONMENTAL MONITORING & AUDIT MONTHLY REPORT

July 2019

Contract Name : Castle Peak Road Trunk Sewer and Tuen Mun Village Sewerage (Sewage Pumping Station at Lok Chui Street near Castle Peak Villas)

Report No. : 0367/15/ED/1202

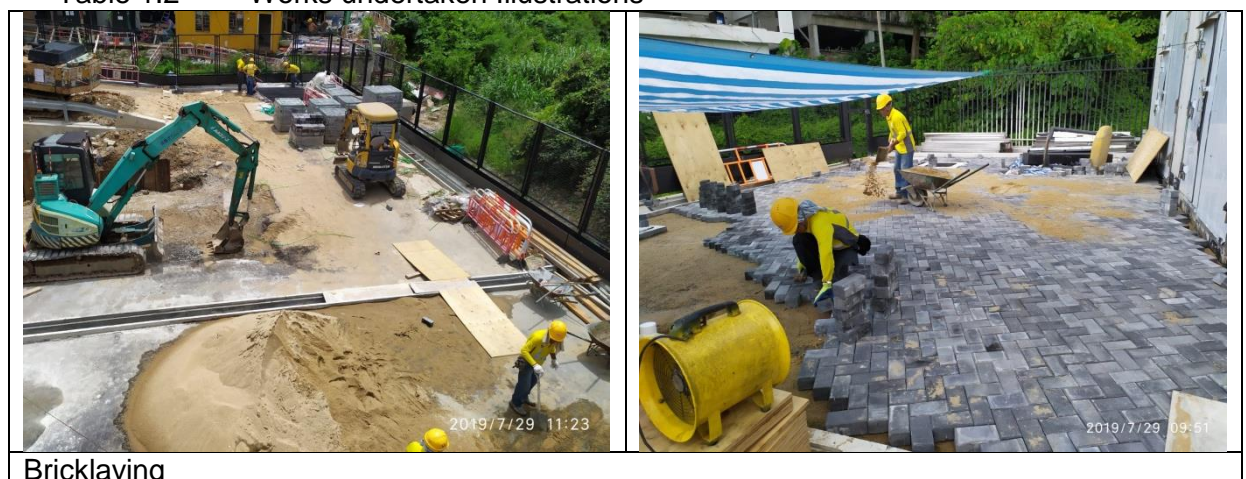
Table 1.2 Works undertaken Illustrations

1.4.1 During this reporting period, the principal work activities within the site included:

- Bricklaying

1.4.2 Illustrations of works undertaken during the reporting period are shown in **Table 1.2**:
