ENVIRONMENTAL MONITORING & AUDIT MONTHLY REPORT

August 2019

Contract Name : Castle Peak Road Trunk Sewer and Tuen Mun Village Sewerage (Sewage Pumping Station at Lok Chui Street near Castle Peak Villas)

Report No. : 0367/15/ED/1206

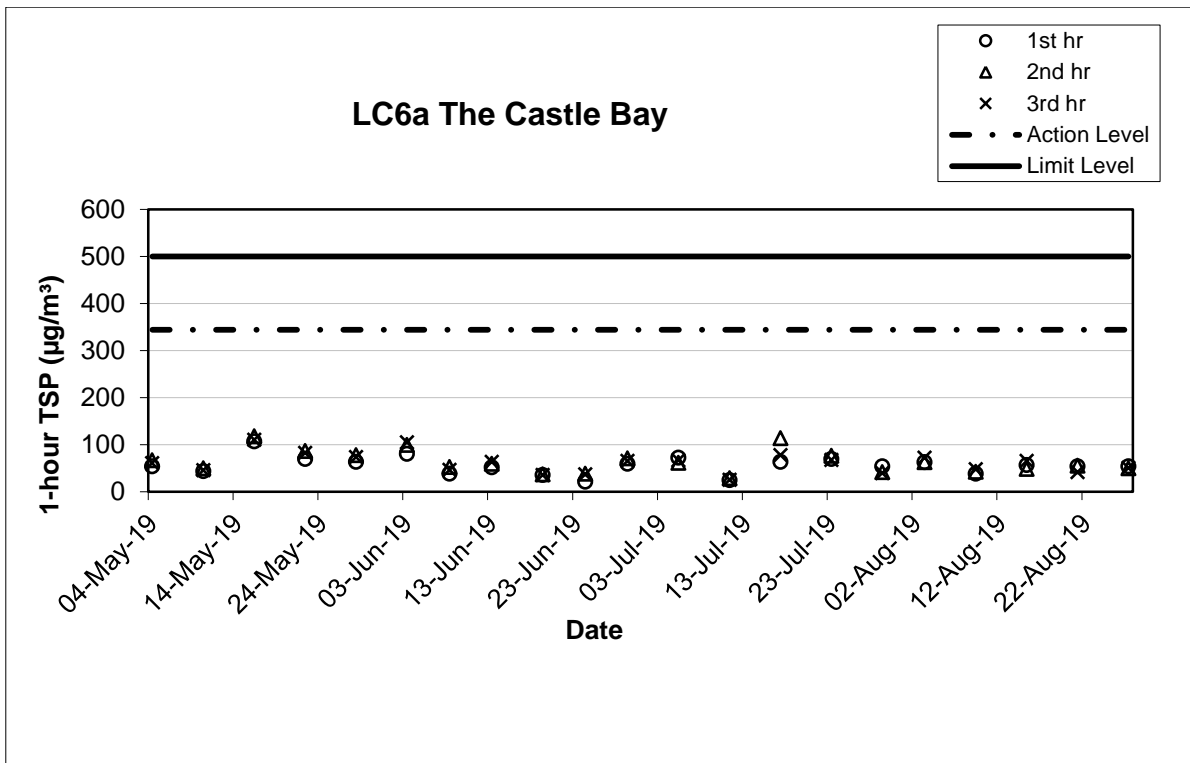
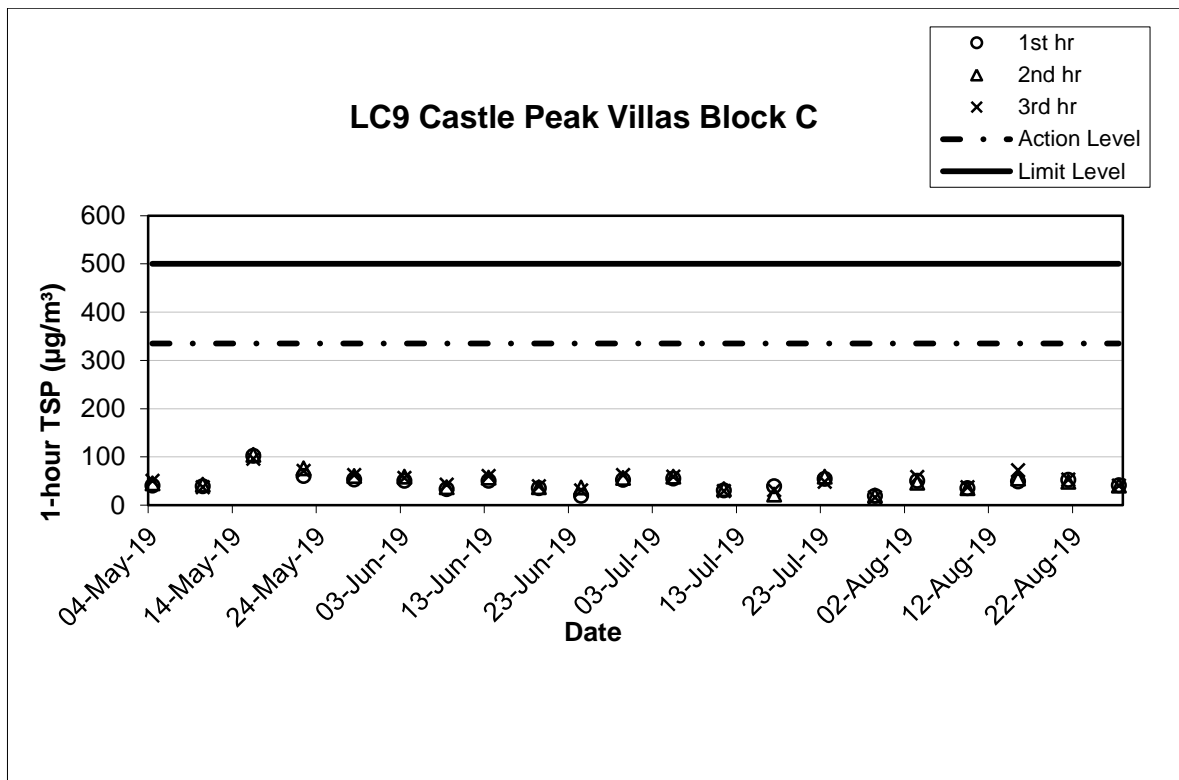
1-hour TSP ($\mu\text{g}/\text{m}^3$)					
Date	Start Time	1st hr	2nd hr	3rd hr	Weather
03-Aug-19	08:35	50	46	58	Cloudy
09-Aug-19	08:30	35	35	37	Fine
15-Aug-19	08:35	49	55	72	Fine
21-Aug-19	13:50	52	48	53	Fine
27-Aug-19	09:40	41	40	40	Fine
	Average	47			
	Max	72			
	Min	35

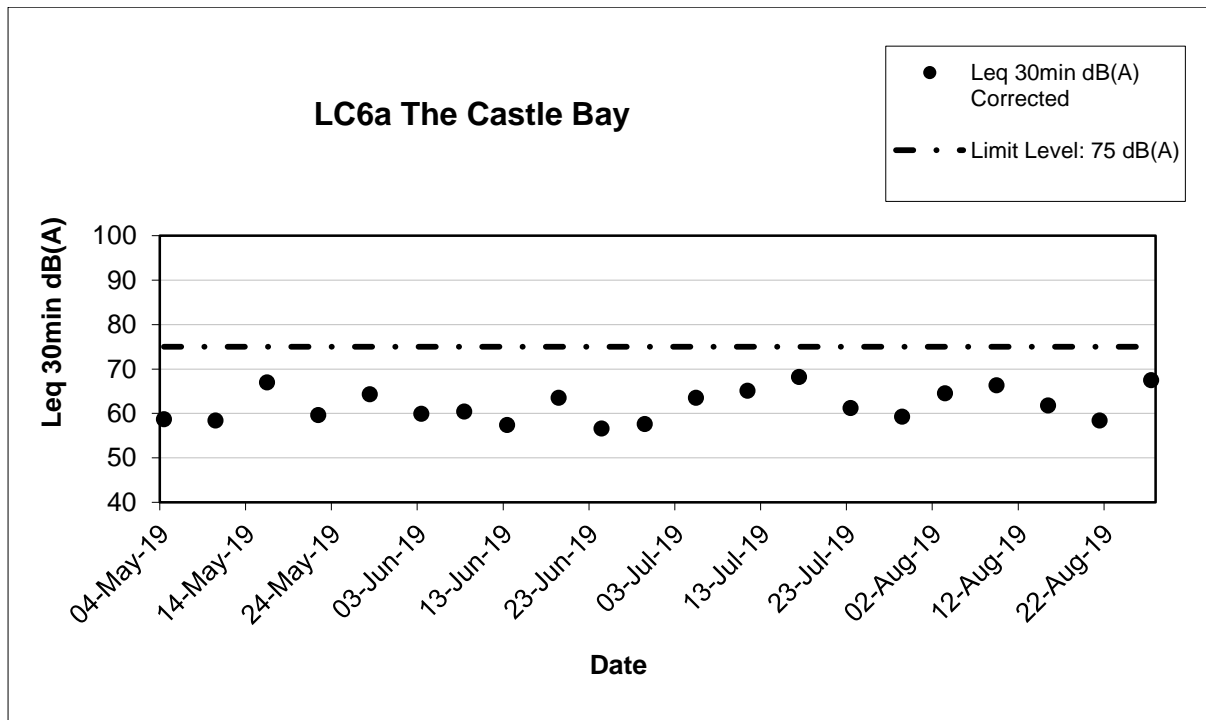
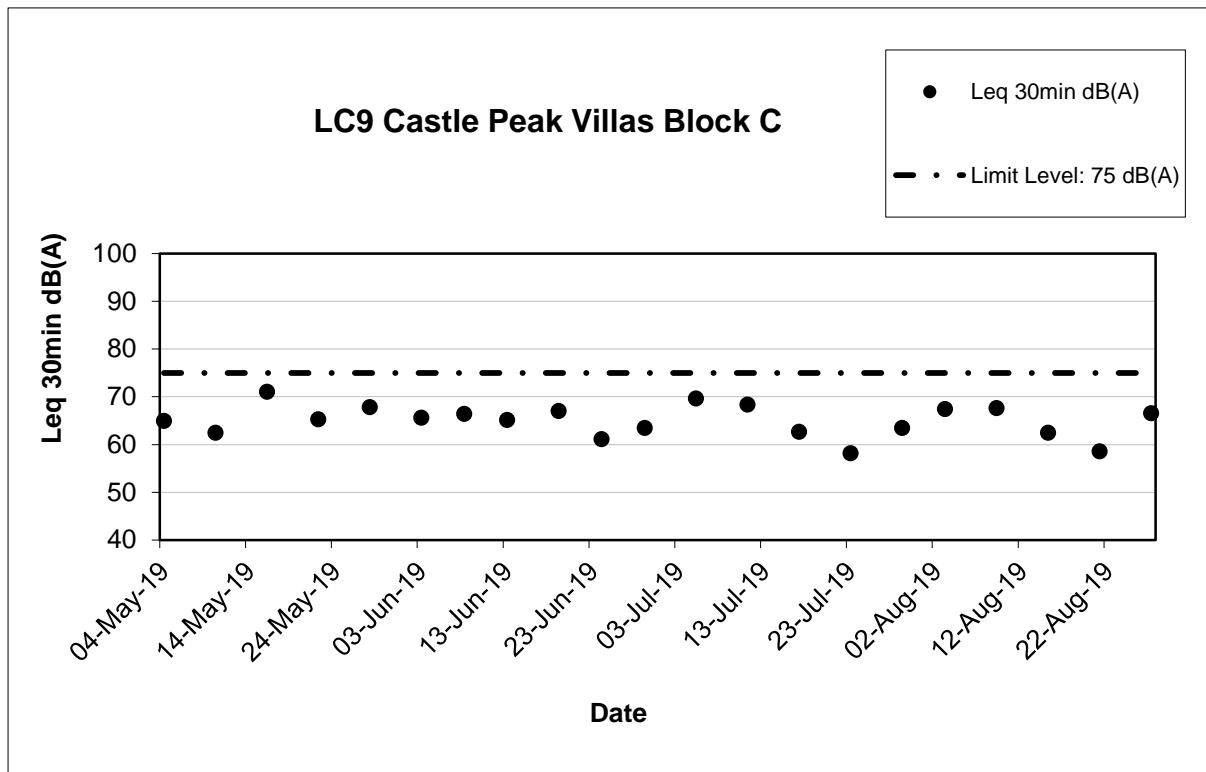
Date	Start Time	L _{eq} 30min dB(A)	Corrected L _{eq} 30min dB(A)	L ₉₀ dB(A)	L ₁₀ dB(A)	Weather
03-Aug-19	09:45	67	N.A	64	71	Cloudy
09-Aug-19	08:32	68	N.A	63	69	Fine
15-Aug-19	08:32	62	N.A	60	68	Fine
21-Aug-19	14:52	59	N.A	57	61	Fine
27-Aug-19	09:43	67	N.A	61	69	Fine
