ENVIRONMENTAL MONITORING & AUDIT MONTHLY REPORT

September 2019

Contract Name: Castle Peak Road Trunk Sewer and Tuen Mun

Contract No. : DC/2014/01

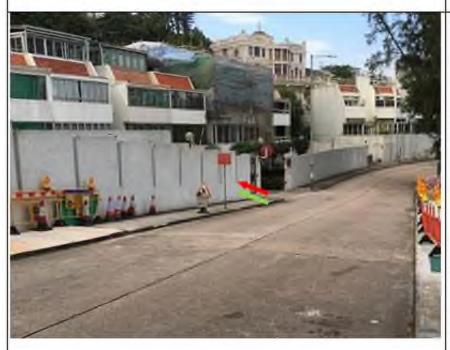
LC6a: The Castle Bay

- LC6a: The air and noise monitoring station is set at a point 1m from the exterior of the sensitive receiver fence wall, and set at a position 1.2m above ground. Façade measurement will be carried out for noise monitoring.
- 2) LC9: The air monitoring station is set at the top of parapet wall of sensitive receivers building and the noise monitoring station is set at a point 1m from the exterior of the sensitive receivers building façade and set at a position 5m above the ground.
