ENVIRONMENTAL MONITORING & AUDIT MONTHLY REPORT

October 2019

Contract Name : Castle Peak Road Trunk Sewer and Tuen Mun Village Sewerage (Sewage Pumping Station at Lok Chui Street near Castle Peak Villas)

Contract No. : DC/2014/01

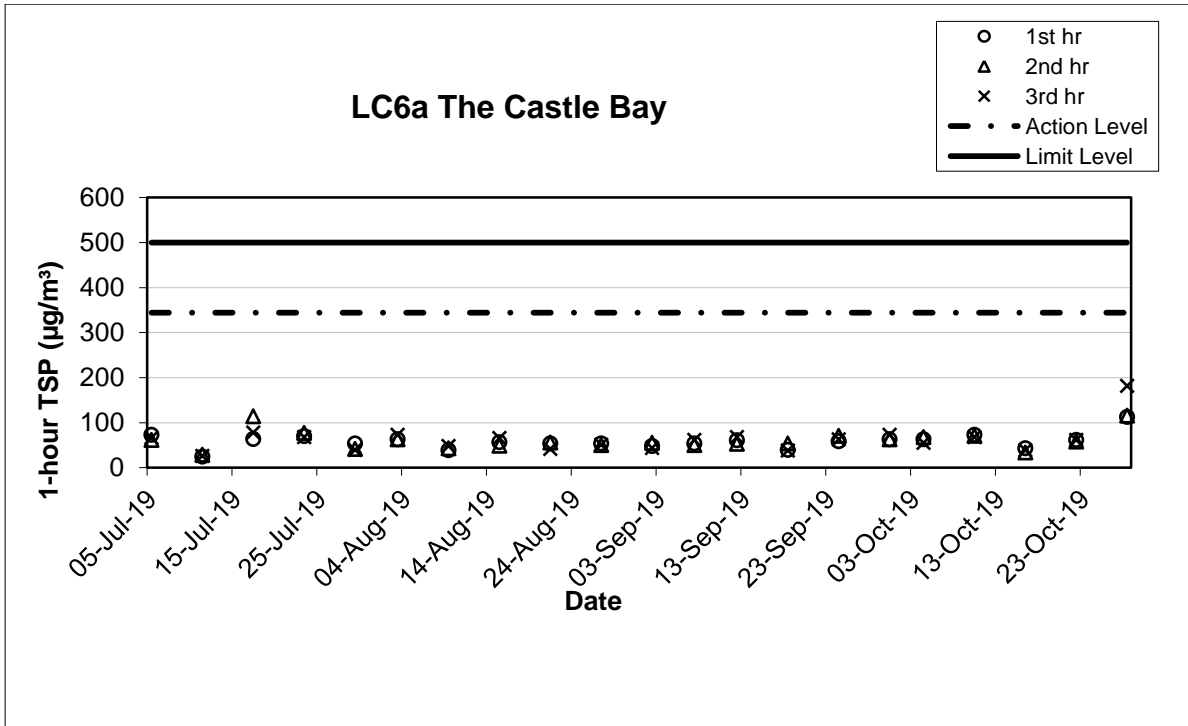
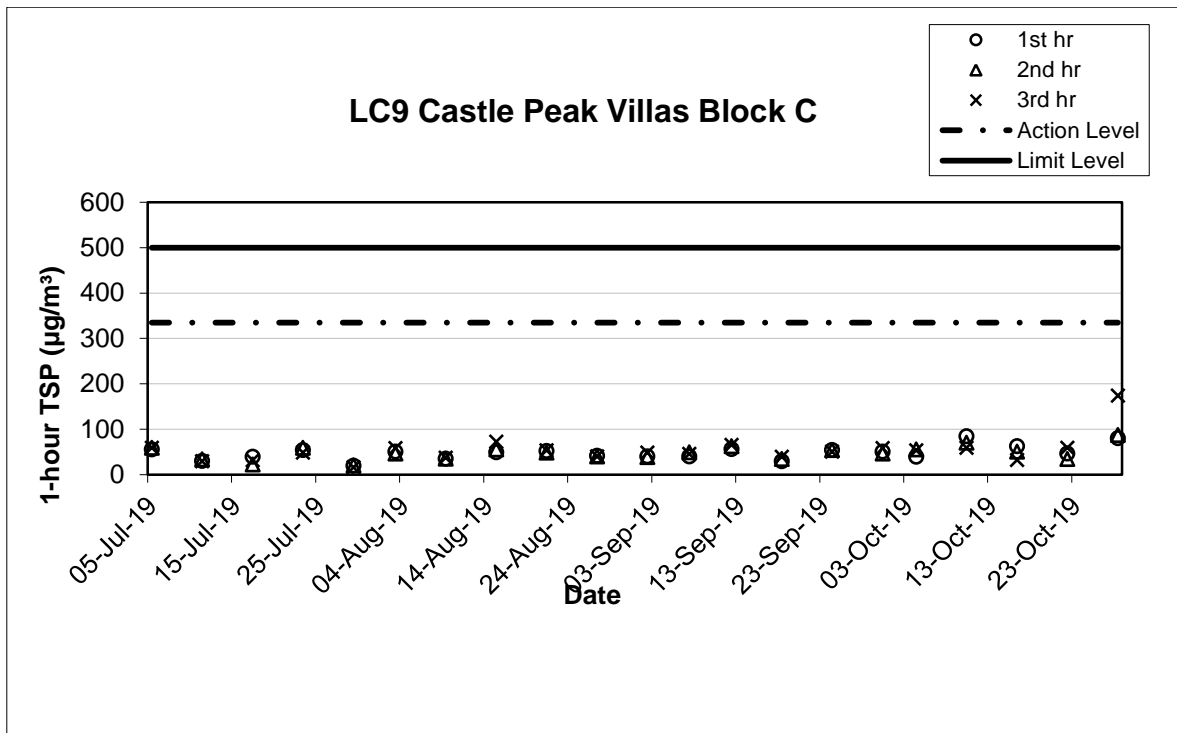
LC9 Castle Peak Villas Block C

1-hour TSP ($\mu\text{g}/\text{m}^3$)					
Date	Start Time	1st hr	2nd hr	3rd hr	Weather
04-Oct-19	08:45	39	55	53	Fine
10-Oct-19	09:30	84	70	59	Fine
16-Oct-19	09:00	62	50	32	Fine
22-Oct-19	09:20	46	34	59	Fine
28-Oct-19	09:12	80	87	174	Fine
	Average	66			
	Max	174			
	Min	32

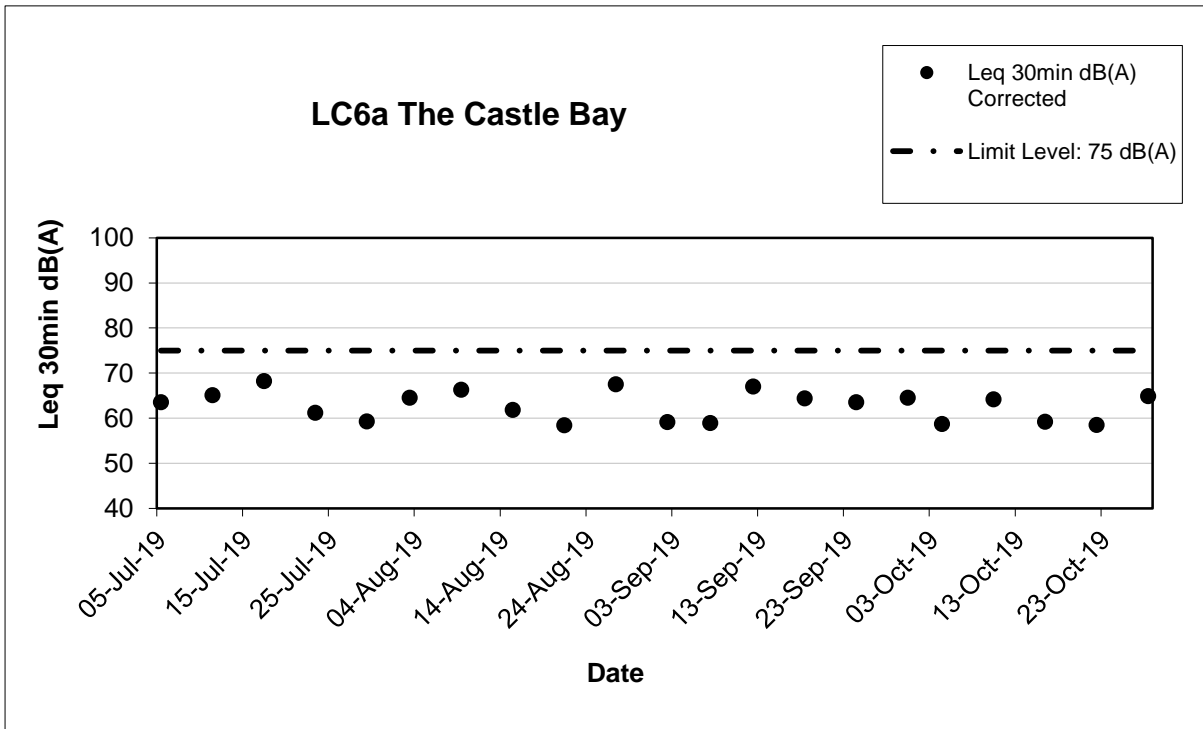
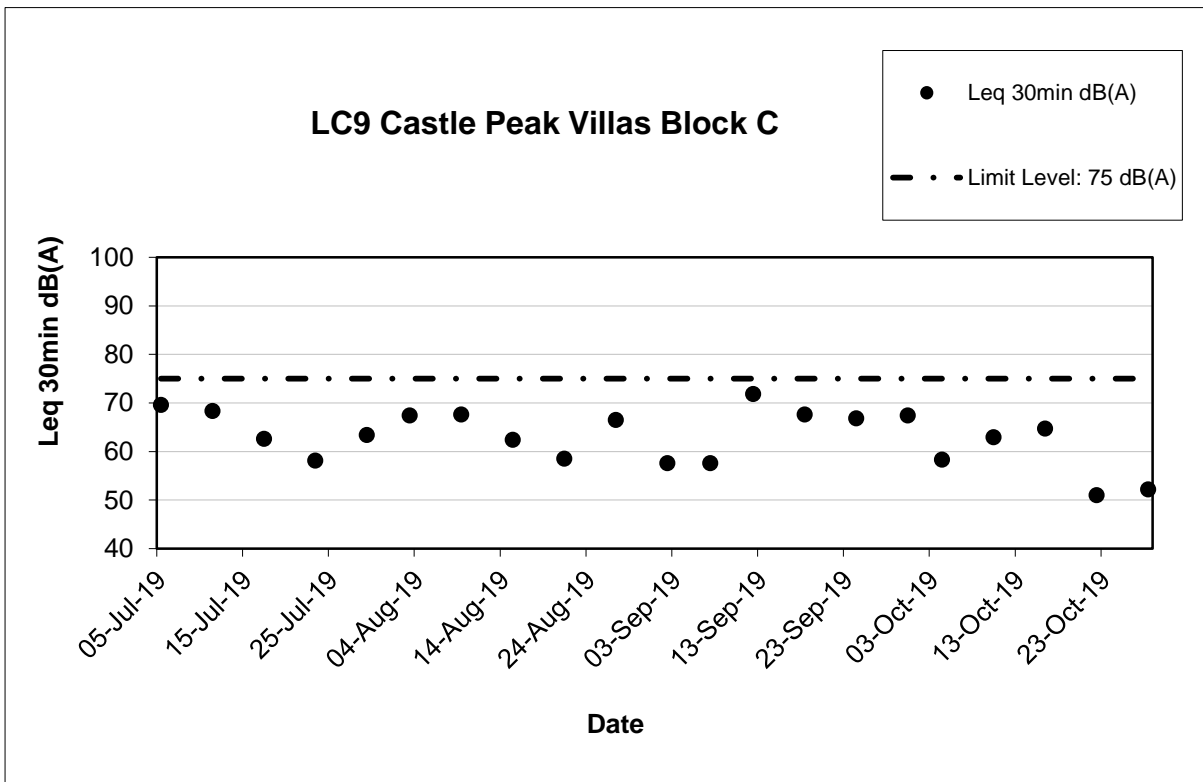
LC9 Castle Peak Villas Block C

Date	Start Time	L _{eq} 30min dB(A)	Corrected L _{eq} 30min dB(A)	L ₉₀ dB(A)	L ₁₀ dB(A)	Weather
04-Oct-19	08:51	58	N.A	56	61	Fine
10-Oct-19	09:59	63	N.A	59	64	Fine
16-Oct-19	09:34	65	N.A	61	68	Fine
22-Oct-19	09:53	51	N.A	49	53	Fine
28-Oct-19	09:42	52	N.A	50	54	Fine
