ENVIRONMENTAL MONITORING & AUDIT MONTHLY REPORT

December 2019

Contract Name : Castle Peak Road Trunk Sewer and Tuen Mun Village Sewerage (Sewage Pumping Station at Lok Chui Street near Castle Peak Villas)

Contract No. : DC/2014/01

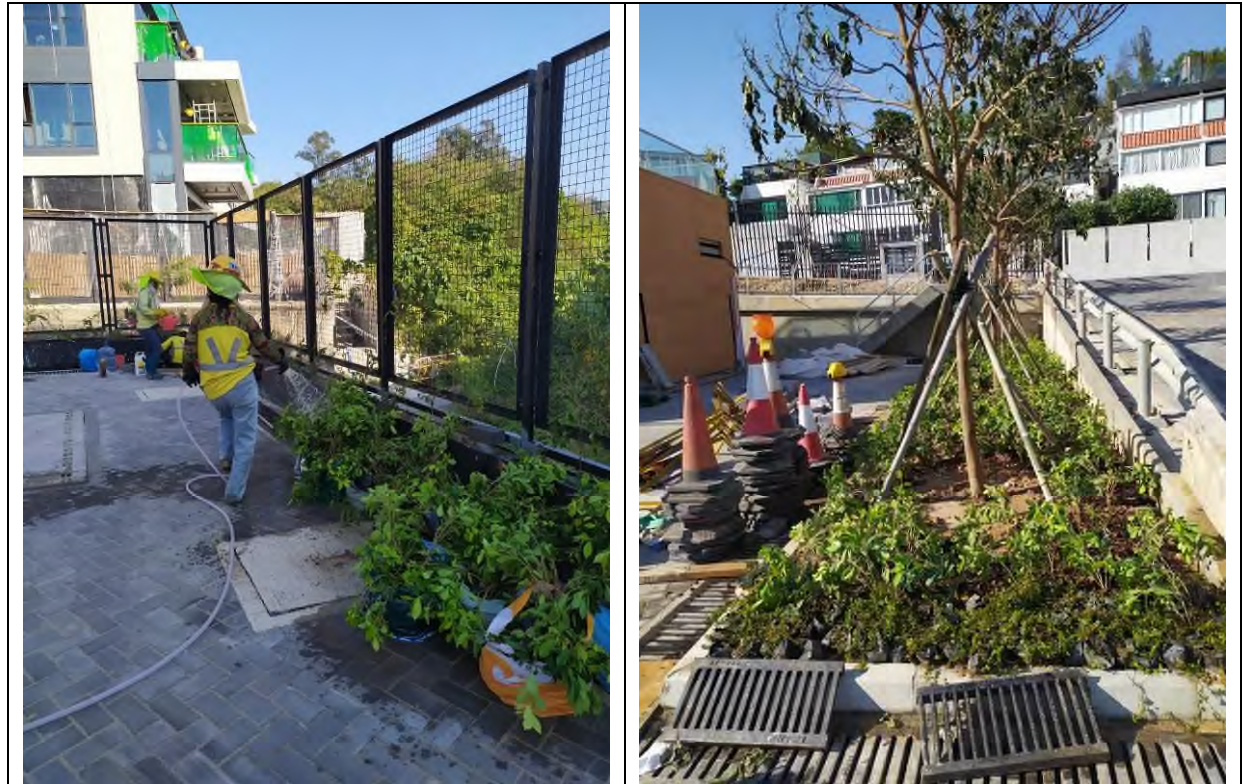
Table 1.2 Works undertaken Illustrations

Landscape works and install irrigation

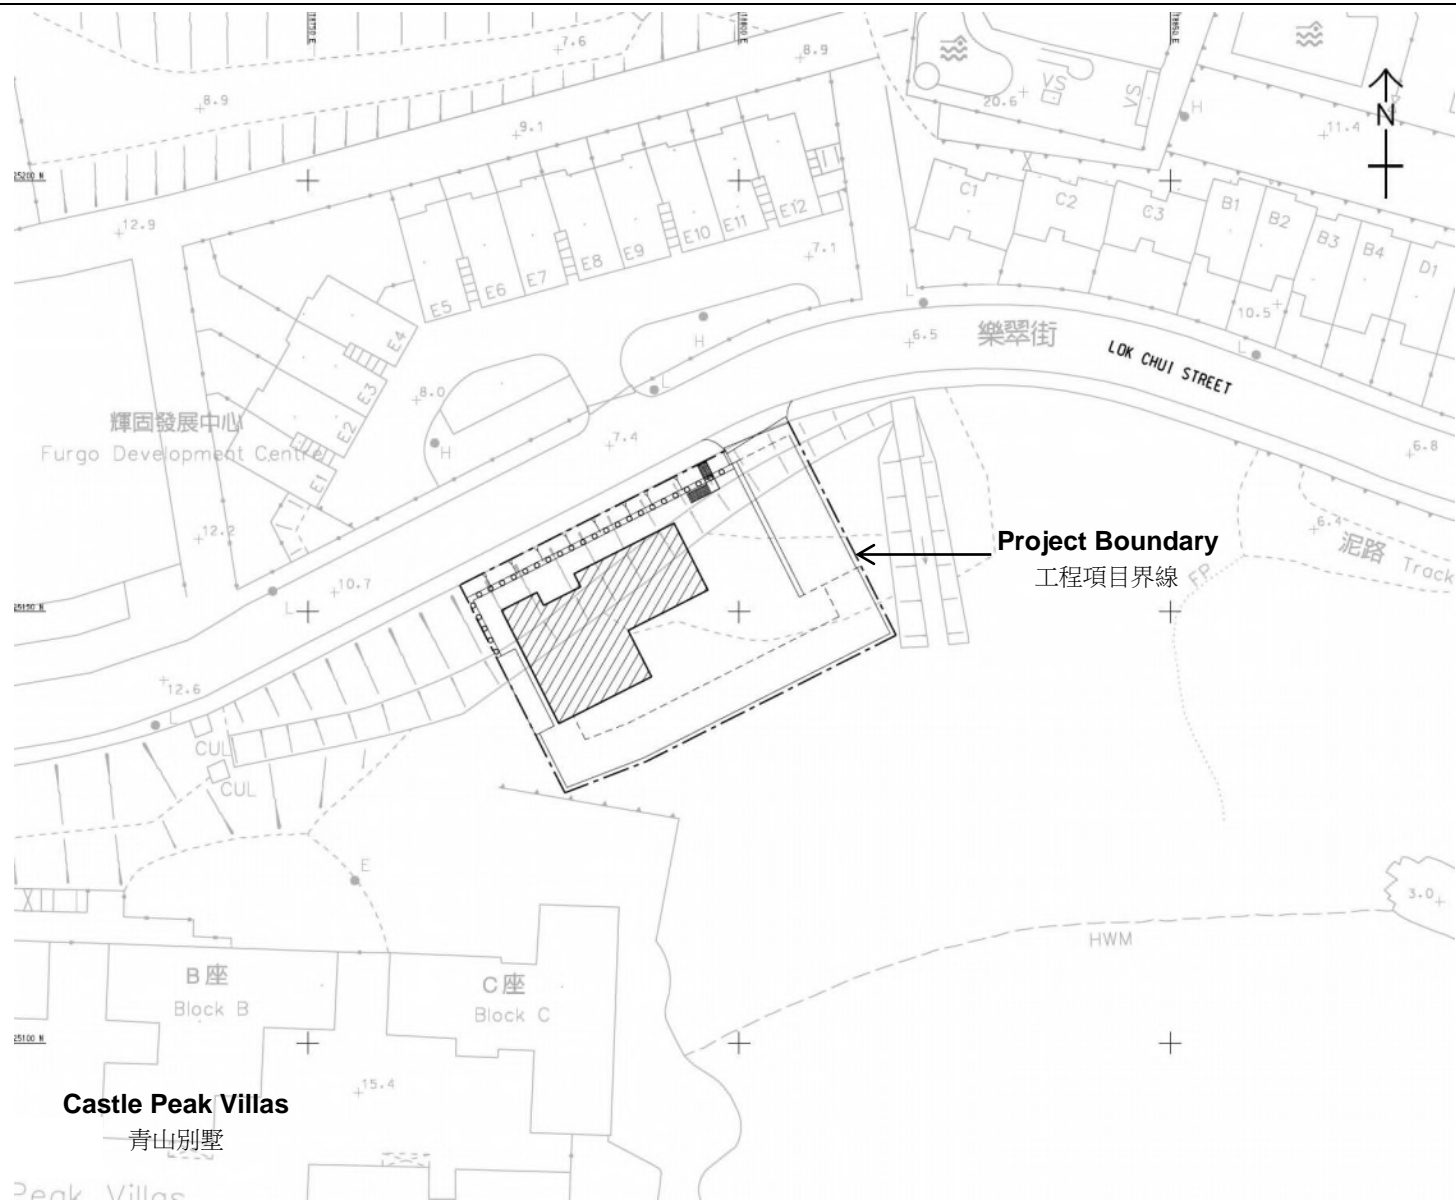
Figure 1

Project General Layout

Location of the Proposed Sewage Pumping Station at Lok Chui Street near Castle Peak Villas
 位於樂翠街近青山別墅的擬建污水泵水站

- 1.1.1 Contract No. DC/2014/01 – Castle Peak Road Trunk Sewer and Tuen Mun Village Sewerage (“the Project”) includes the construction of a sewage pumping station at Lok Chui Street near Castle Peak Villas as shown in **Figure 1**.

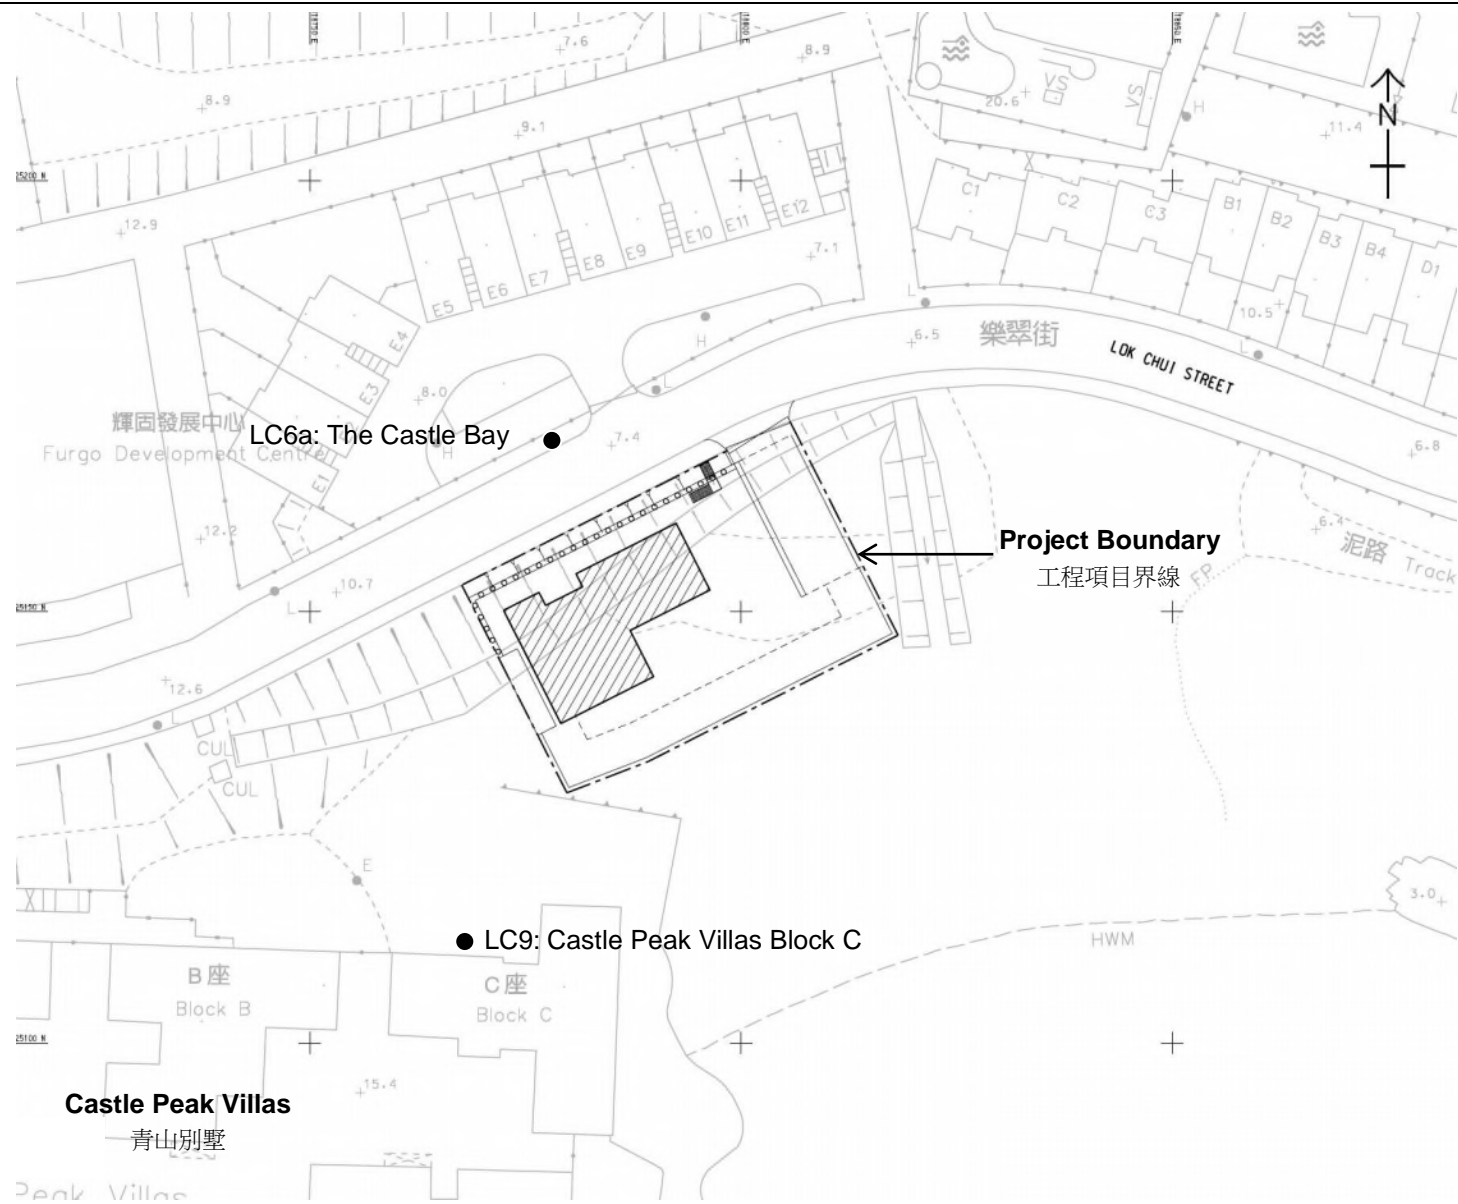
Figure 2

Air and Noise Monitoring Locations

2.4.1 In accordance with the updated EM&A Manual, two designated air quality monitoring stations, LC6a and LC9 are selected for the Project Area of constructing a sewage pumping station at Lok Chui Street near Castle Peak Villas as they are the representative air sensitive receivers located near to the Project site. All designated air quality monitoring stations listed in the updated EM&A Manual and the air quality monitoring stations are shown in **Table 2.3** and the monitoring locations are shown in **Figure 2**.

3.4.1 Noise monitoring were conducted at two designated monitoring stations as described in **Table 3.3** and the monitoring locations are shown in **Figure 2**.
