QUARTERLY ENVIRONMENTAL MONITORING & AUDIT SUMMARY REPORT

March 2016 - May 2016

Contract Name : Castle Peak Road Trunk Sewer and Tuen Mun Village Sewerage (Sewage Pumping Station at Lok Chui Street near Castle Peak Villas)

Contract No. : DC/2014/01

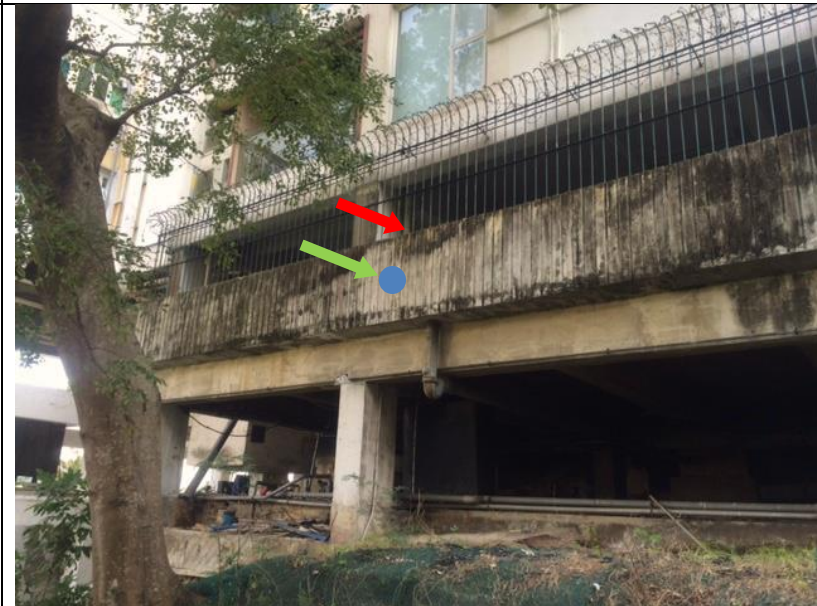
LC9: Castle Peak Villas Block C

2) LC9: The air monitoring station is set at the top of parapet wall of sensitive receivers building and the noise monitoring station is set at a point 1m from the exterior of the sensitive receivers building façade and set at a position 5m above the ground.

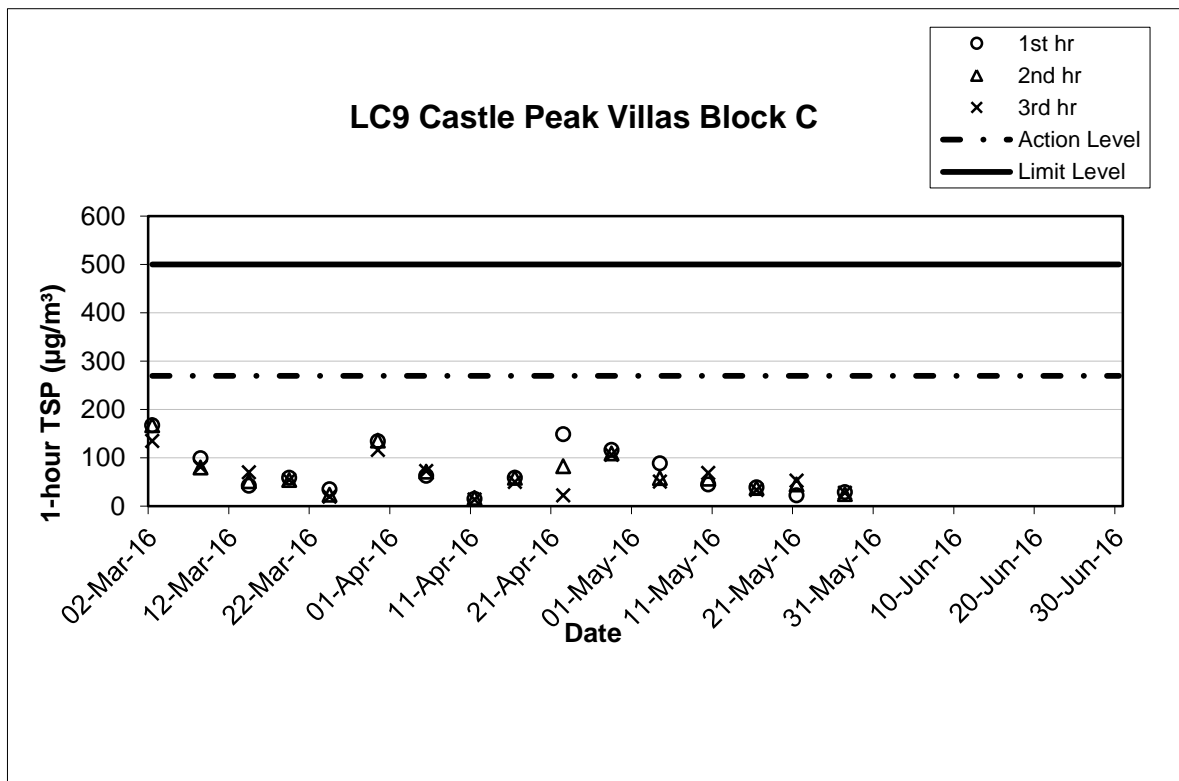
Air Quality Monitoring Data and Graphical Presentations

1-hour TSP ($\mu\text{g}/\text{m}^3$)					
Date	Start Time	1st hr	2nd hr	3rd hr	Weather
02-Mar-16	10:29	139	143	118	Fine
08-Mar-16	13:40	83	66	66	Cloudy
14-Mar-16	09:45	59	68	83	Cloudy
19-Mar-16	09:15	57	60	62	Sunny
24-Mar-16	10:04	54	95	63	Cloudy
30-Mar-16	08:41	120	102	84	Fine
05-Apr-16	09:21	50	47	51	Fine
11-Apr-16	14:14	17	18	24	Cloudy
16-Apr-16	08:36	56	53	48	Fine
22-Apr-16	08:24	146	75	73	Cloudy
28-Apr-16	10:55	88	97	81	Cloudy
04-May-16	08:40	71	42	44	Fine
10-May-16	08:52	63	72	74	Cloudy
16-May-16	09:10	29	36	38	Sunny
21-May-16	08:33	42	51	53	Cloudy
27-May-16	08:30	28	29	27	Cloudy

1-hour TSP ($\mu\text{g}/\text{m}^3$)					
Date	Start Time	1st hr	2nd hr	3rd hr	Weather
02-Mar-16	10:41	168	168	135	Fine
08-Mar-16	13:30	99	80	81	Cloudy
14-Mar-16	09:33	42	52	70	Cloudy
19-Mar-16	09:00	59	54	54	Sunny
24-Mar-16	09:50	35	24	20	Cloudy
30-Mar-16	08:10	134	136	116	Fine
05-Apr-16	09:47	63	71	73	Fine
11-Apr-16	14:25	15	17	14	Cloudy
16-Apr-16	08:53	59	59	50	Fine
22-Apr-16	08:39	149	83	22	Cloudy
28-Apr-16	11:05	116	109	106	Cloudy
04-May-16	08:53	89	59	51	Fine
10-May-16	09:03	45	57	69	Cloudy
16-May-16	09:18	39	38	34	Sunny
21-May-16	08:45	22	45	53	Cloudy
27-May-16	09:15	29	25	28	Cloudy

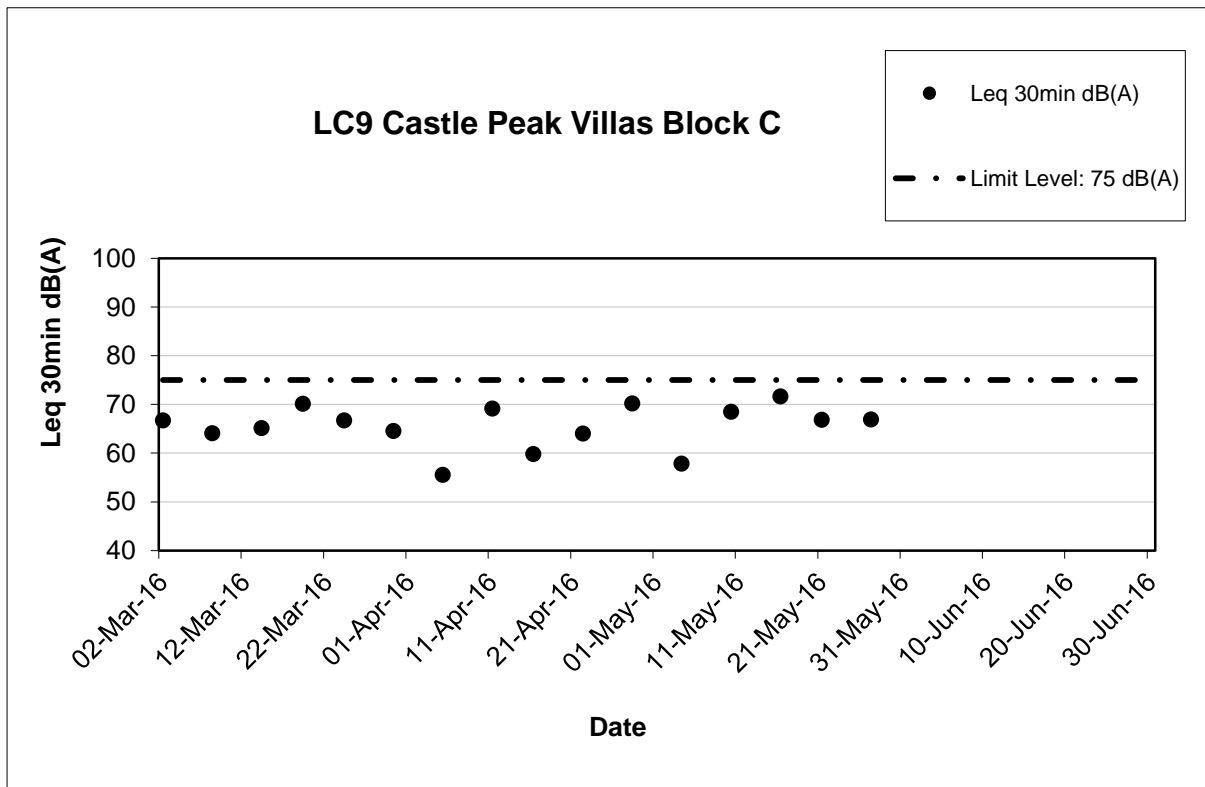
Noise Monitoring Data and Graphical Presentations

Date	Start Time	L _{eq} 30min dB(A)	Corrected Leq 30min dB(A)	L ₉₀ dB(A)	L ₁₀ dB(A)	Weather
02-Mar-16	14:00	66	61	59	67	Fine
08-Mar-16	14:26	69	64	64	70	Cloudy
14-Mar-16	14:20	71	66	67	74	Cloudy
19-Mar-16	09:20	68	63	66	72	Sunny
24-Mar-16	09:17	66	61	61	70	Cloudy
30-Mar-16	08:50	66	61	61	71	Fine
05-Apr-16	13:03	62	57	52	66	Fine
11-Apr-16	14:50	71	66	68	72	Cloudy
16-Apr-16	09:38	64	59	57	66	Fine
22-Apr-16	12:15	63	58	58	64	Cloudy
28-Apr-16	11:43	61	56	51	63	Cloudy
04-May-16	11:33	64	59	51	65	Fine
10-May-16	09:56	63	58	55	64	Cloudy
16-May-16	10:04	71	66	62	73	Sunny
21-May-16	09:46	64	59	59	66	Cloudy
27-May-16	08:30	67	62	60	68	Fine

Date	Start Time	L _{eq} 30min dB(A)	Corrected Leq 30min dB(A)	L ₉₀ dB(A)	L ₁₀ dB(A)	Weather
02-Mar-16	13:24	67	N.A	59	68	Fine
08-Mar-16	13:38	64	N.A	57	70	Cloudy
14-Mar-16	13:45	65	N.A	62	67	Cloudy
19-Mar-16	10:03	70	N.A	68	74	Sunny
24-Mar-16	09:53	67	N.A	61	71	Cloudy
30-Mar-16	08:02	65	N.A	55	67	Fine
05-Apr-16	12:25	56	N.A	52	59	Fine
11-Apr-16	14:18	69	N.A	68	70	Cloudy
16-Apr-16	08:53	60	N.A	54	62	Fine
22-Apr-16	12:56	64	N.A	58	69	Cloudy
28-Apr-16	11:03	70	N.A	69	71	Cloudy
04-May-16	12:10	58	N.A	57	59	Fine
10-May-16	09:07	69	N.A	65	73	Cloudy
16-May-16	09:25	72	N.A	58	74	Sunny
21-May-16	08:58	67	N.A	59	70	Cloudy
27-May-16	09:19	67	N.A	61	71	Cloudy
