## QUARTERLY ENVIRONMENTAL MONITORING & AUDIT SUMMARY REPORT

**June 2016 - August 2016**

**Contract Name** : Castle Peak Road Trunk Sewer and Tuen Mun  
Village Sewerage (Sewage Pumping Station at  
Lok Chui Street near Castle Peak Villas)

**Title of Project** : Sewage Pumping Stations at Tai Lam Chung Tsuen  
Luen On San Tsuen, Tai Lam Valley and Lok Chui Street near  
Castle Peak Villas under the scope of "Tuen Mun Sewerage –  
Eastern Coastal Sewerage Extension"

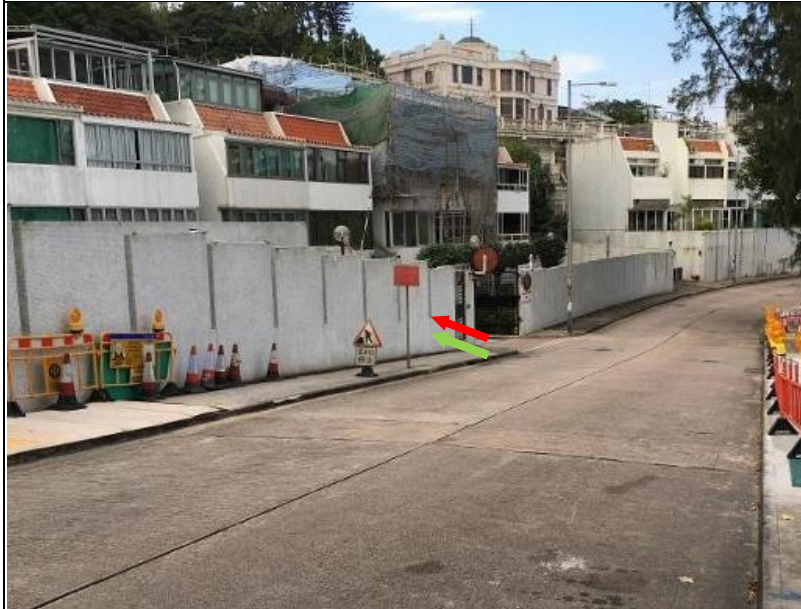
LC6a: The Castle Bay

1) LC6a: The air and noise monitoring station is set at a point 1m from the exterior of the sensitive receiver fence wall, and set at a position 1.2m above ground. Façade measurement will be carried out for noise monitoring.

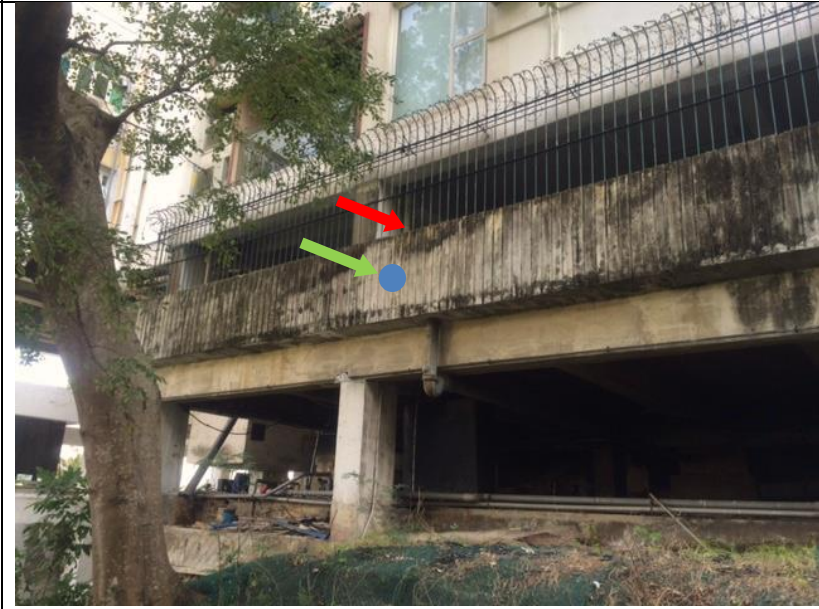
LC9: Castle Peak Villas Block C

2) LC9: The air monitoring station is set at the top of parapet wall of sensitive receivers building and the noise monitoring station is set at a point 1m from the exterior of the sensitive receivers building façade and set at a position 5m above the ground.

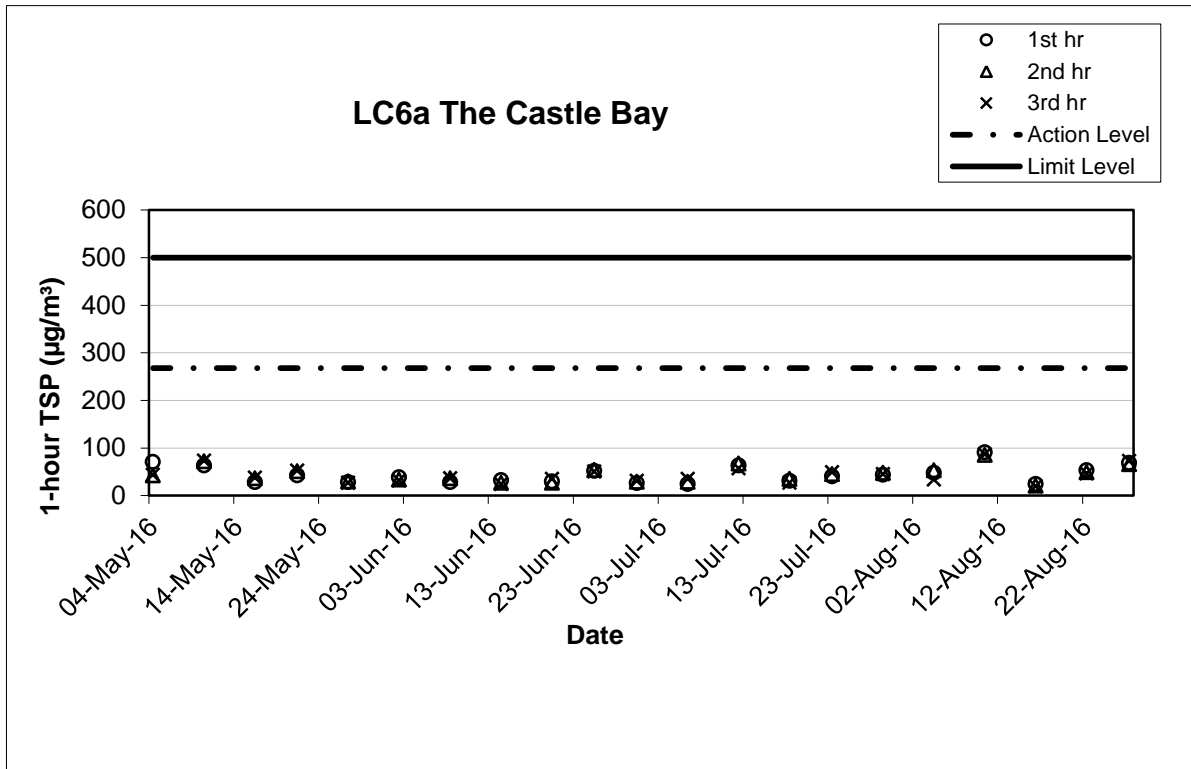
1-hour TSP ( $\mu\text{g}/\text{m}^3$ )					
Date	Start Time	1st hr	2nd hr	3rd hr	Weather
04-May-16	08:40	71	42	44	Fine
10-May-16	08:52	63	72	74	Cloudy
16-May-16	09:10	29	36	38	Sunny
21-May-16	08:33	42	51	53	Cloudy
27-May-16	08:30	28	29	27	Cloudy
02-Jun-16	11:20	38	34	31	Fine
08-Jun-16	08:32	28	36	36	Cloudy
14-Jun-16	09:19	32	27	24	Cloudy
20-Jun-16	08:45	29	27	35	Fine
25-Jun-16	08:54	52	54	50	Fine
30-Jun-16	09:30	26	29	31	Fine
06-Jul-16	08:45	24	29	35	Cloudy
12-Jul-16	08:35	63	68	57	Cloudy
18-Jul-16	08:36	31	35	27	Sunny
23-Jul-16	14:05	41	45	49	Sunny
29-Jul-16	12:37	43	48	45	Fine
04-Aug-16	15:30	48	53	34	Cloudy
10-Aug-16	08:47	91	85	87	Cloudy
16-Aug-16	13:50	24	21	20	Cloudy
22-Aug-16	12:48	53	49	46	Sunny
27-Aug-16	08:46	69	66	73	Fine

1-hour TSP ( $\mu\text{g}/\text{m}^3$ )					
Date	Start Time	1st hr	2nd hr	3rd hr	Weather
04-May-16	08:53	89	59	51	Fine
10-May-16	09:03	45	57	69	Cloudy
16-May-16	09:18	39	38	34	Sunny
21-May-16	08:45	22	45	53	Cloudy
27-May-16	09:15	29	25	28	Cloudy
02-Jun-16	11:40	43	39	38	Fine
08-Jun-16	08:36	17	21	22	Cloudy
14-Jun-16	09:30	45	36	30	Cloudy
20-Jun-16	08:52	48	41	44	Fine
25-Jun-16	09:15	50	59	53	Fine
30-Jun-16	09:15	15	22	24	Fine
06-Jul-16	09:04	27	20	24	Cloudy
12-Jul-16	08:45	56	62	67	Cloudy
18-Jul-16	08:48	34	34	38	Sunny
23-Jul-16	14:17	53	53	50	Sunny
29-Jul-16	12:40	41	45	49	Fine
04-Aug-16	15:34	55	59	48	Cloudy
10-Aug-16	09:02	83	95	85	Cloudy
16-Aug-16	14:10	27	29	29	Cloudy
22-Aug-16	12:57	64	70	70	Sunny
27-Aug-16	09:03	76	67	67	Fine
