## QUARTERLY ENVIRONMENTAL MONITORING & AUDIT SUMMARY REPORT

June 2018 – August 2018

**Contract Name** : Castle Peak Road Trunk Sewer and Tuen Mun Village Sewerage (Sewage Pumping Station at Lok Chui Street near Castle Peak Villas)

**Title of Project** : Sewage Pumping Stations at Tai Lam Chung Tsuen Luen On San Tsuen, Tai Lam Valley and Lok Chui Street near Castle Peak Villas under the scope of “Tuen Mun Sewerage – Eastern Coastal Sewerage Extension”

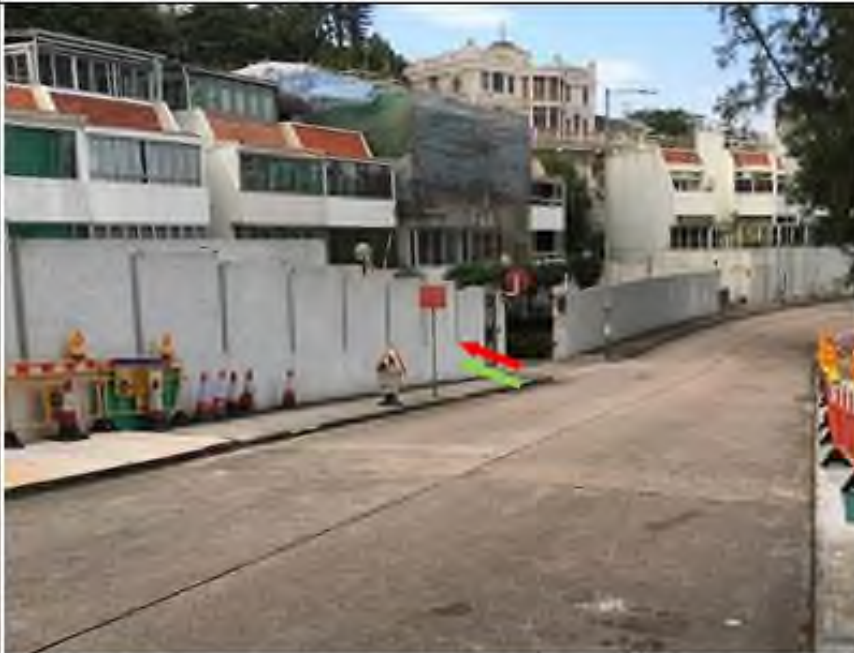
LC6a: The Castle Bay

- 1) LC6a: The air and noise monitoring station is set at a point 1m from the exterior of the sensitive receiver fence wall, and set at a position 1.2m above ground. Façade measurement will be carried out for noise monitoring.
- 2) LC9: The air monitoring station is set at the top of parapet wall of sensitive receivers building and the noise monitoring station is set at a point 1m from the exterior of the sensitive receivers building façade and set at a position 5m above the ground.
