**Agreement No. CE 59/2015 (EP)
Environmental Team for
Tseung Kwan O – Lam Tin Tunnel
Design and Construction**

**Monthly Environmental Monitoring and
Audit Report for December 2016**

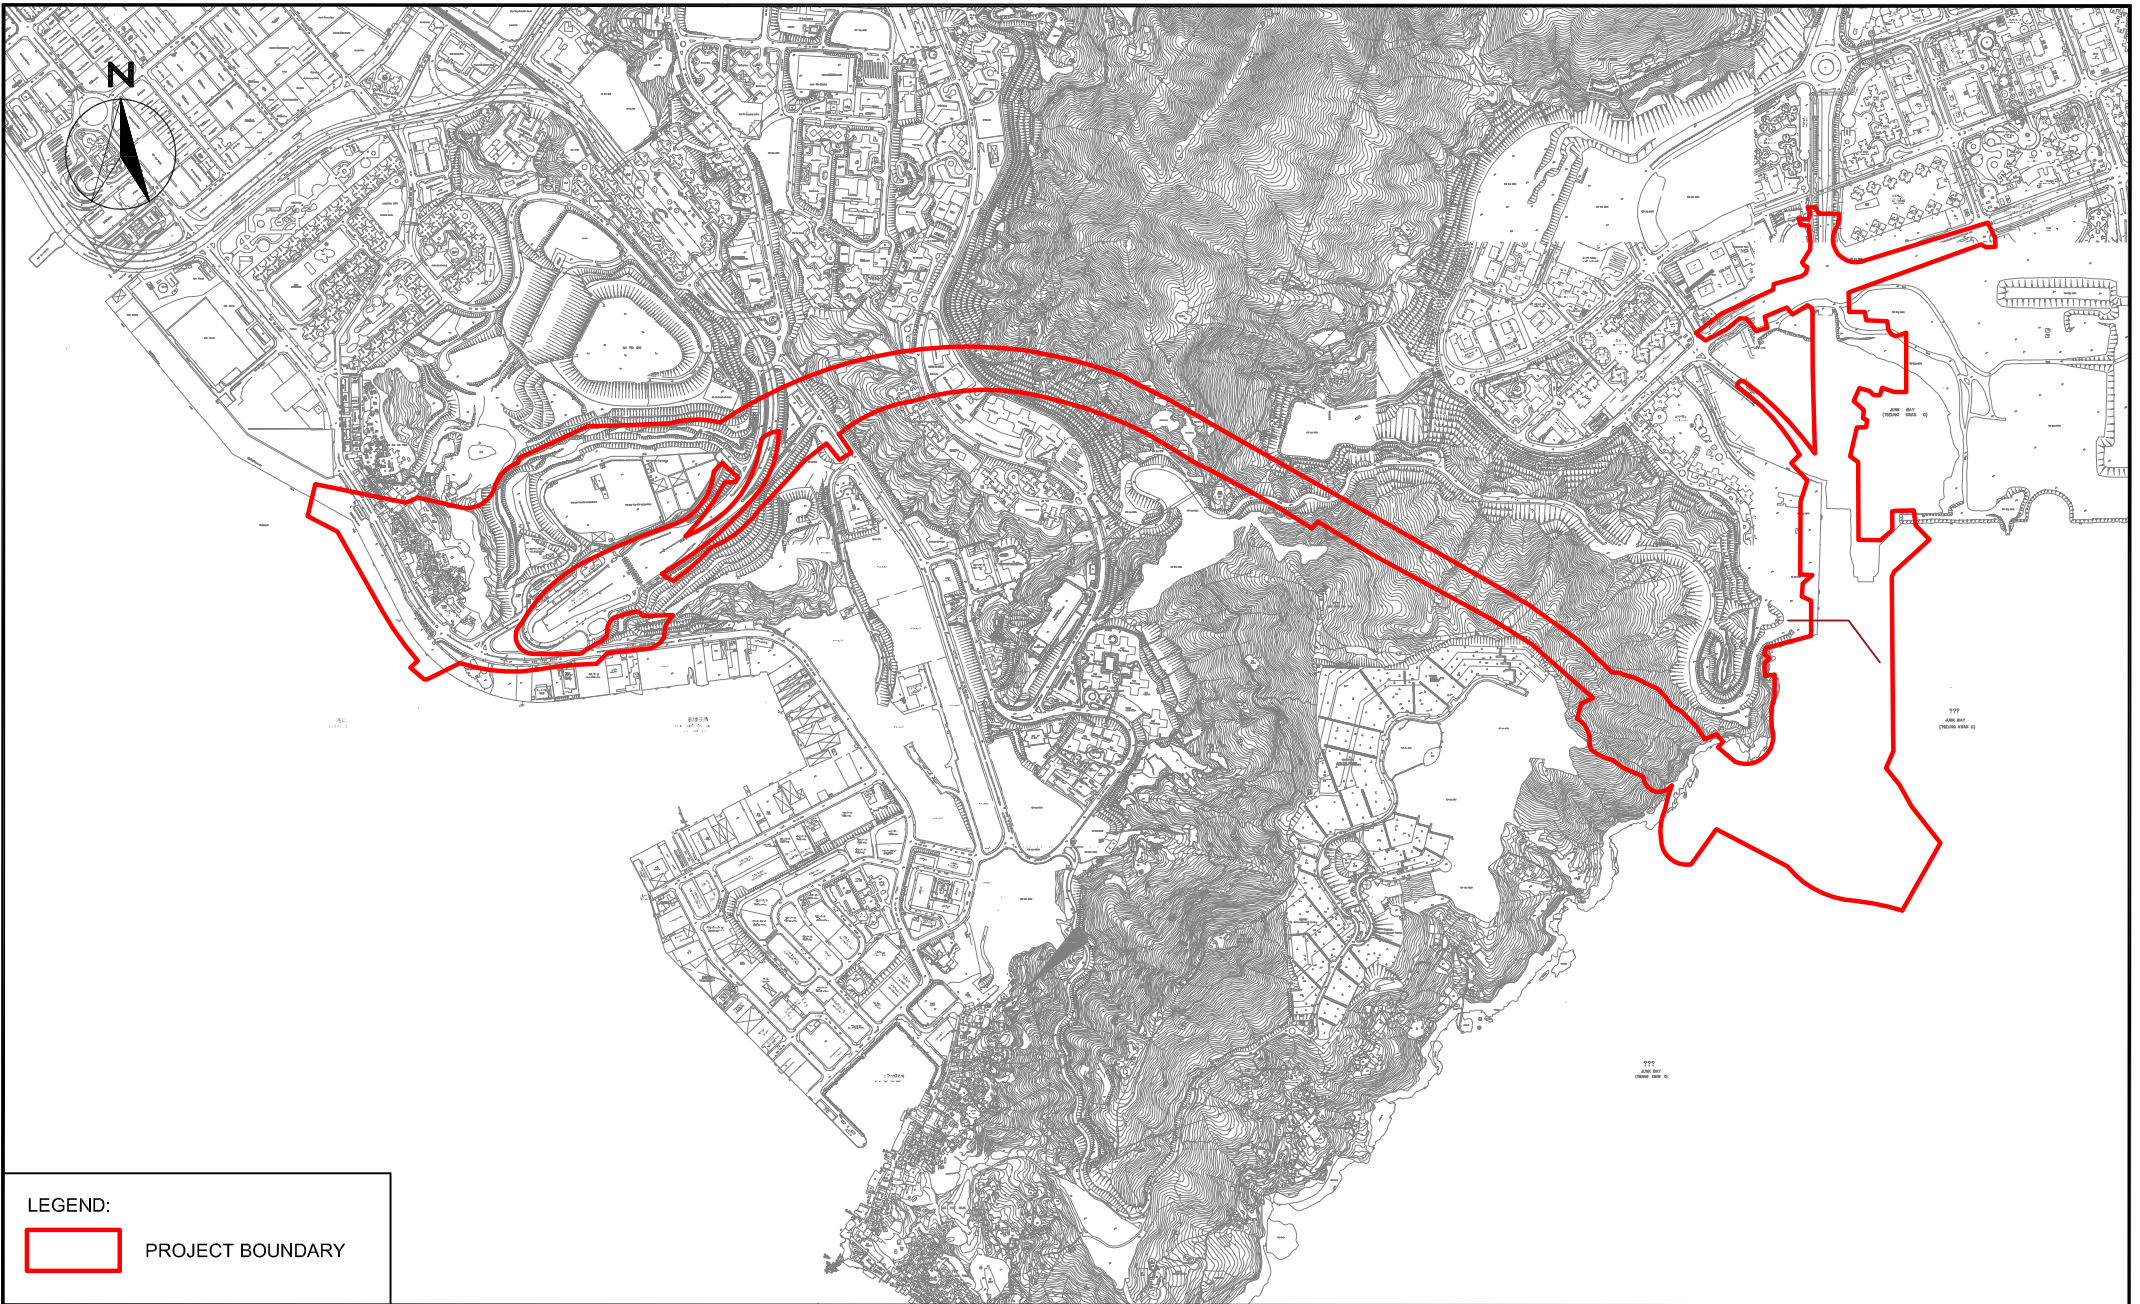
SCALE	1:15000 @ A4	DATE	NOV 2016	
CHECK	JF	DRAWN	JW	
JOB No.	MA16034	FIGURE NO.	1	REV -

- 2.2 At present, the Tseung Kwan O Tunnel is the main connection between Tseung Kwan O (TKO) and other areas in the territory. To cope with the anticipated transport need, the TKO Study recommended the provision of Tseung Kwan O – Lam Tin Tunnel (TKO-LTT) (hereinafter referred to as “the Project”) and Cross Bay Link (CBL) to meet the long-term traffic demand between TKO and the external areas. The site layout plan for the Project is shown in **Figure 1**.

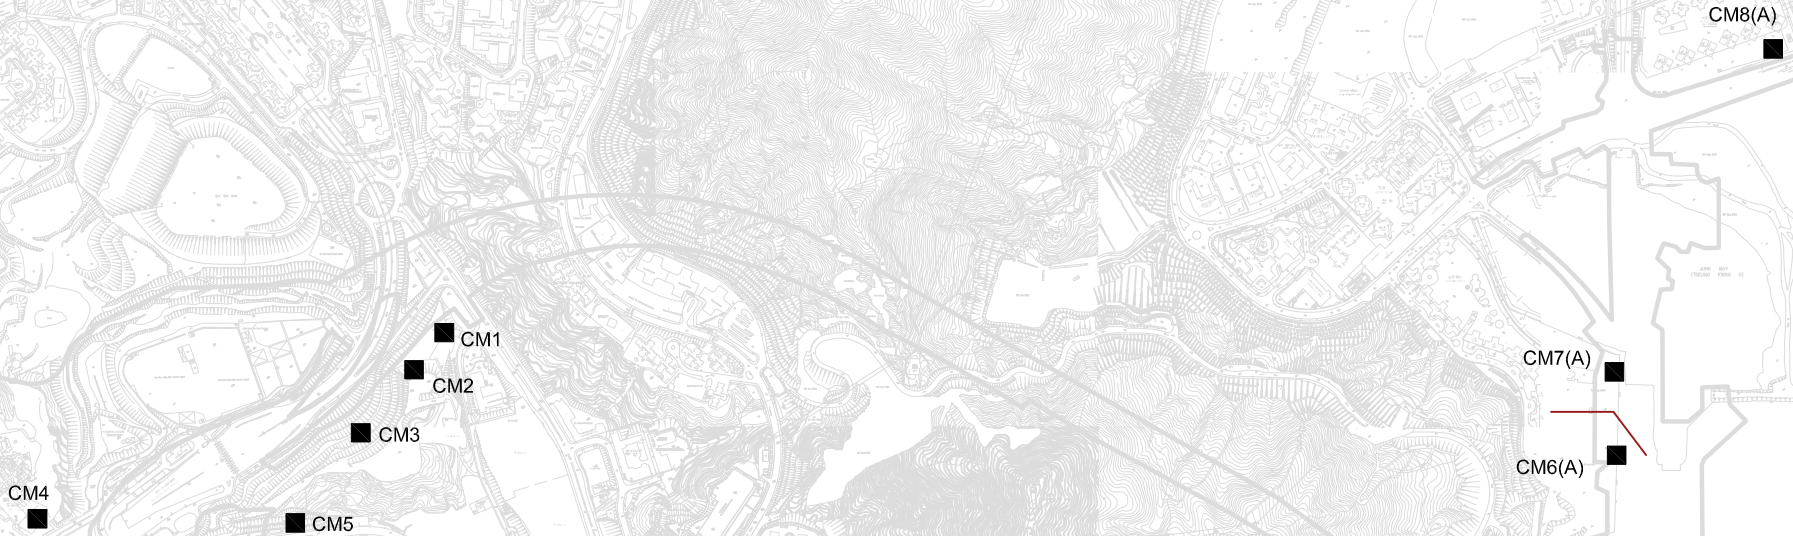
Air Quality Monitoring Stations

- 3.2 Six designated monitoring stations were selected for air quality monitoring programme. **Table 3.1** describes the air quality monitoring locations, which are also depicted in **Figure 2**.

- 3.23 The air temperature, precipitation and the relative humidity data was obtained from Hong Kong Observatory where the wind speed and wind direction were recorded by the installed Wind Anemometer at rooftop of Yau Lai Estate Bik Lai House (41/F). The location is shown in **Figure 2**. This weather information for the reporting month is summarized in **Appendix C**.
- 3.24 The monitoring data and graphical presentations of 1-hour and 24-hour TSP monitoring results are shown in **Appendices E** and **Appendix F** respectively.
- 3.25 The summary of exceedance record in reporting month is shown in **Appendix K**. No exceedance was recorded for the air quality monitoring.
- 3.26 According to our field observations, the major dust source identified at the designated air quality monitoring stations are as follows:
