MTR Corporation Limited

Kwun Tong Line Extension (KTE)

Monthly EM&A Report (March 2016)

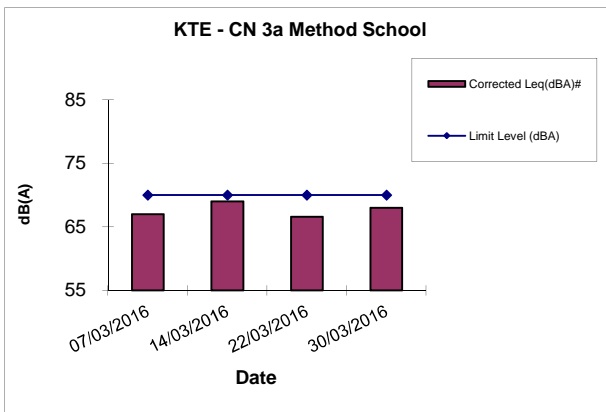
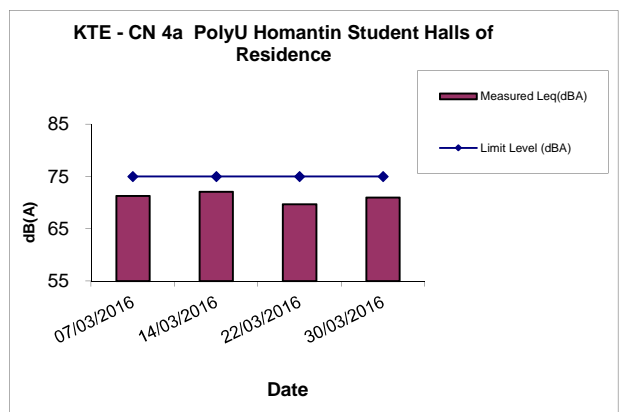
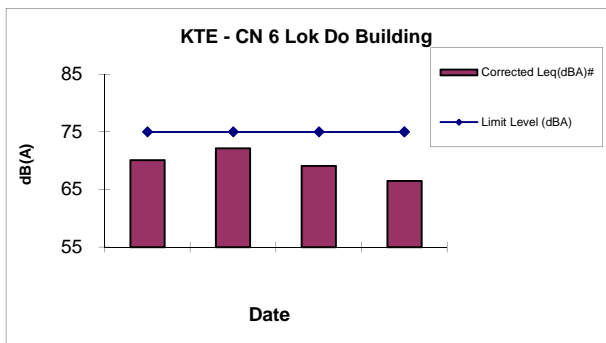
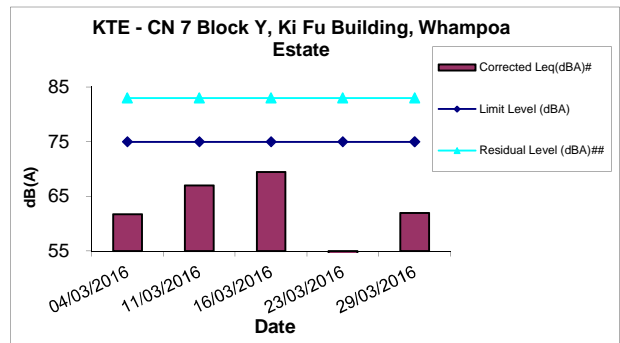
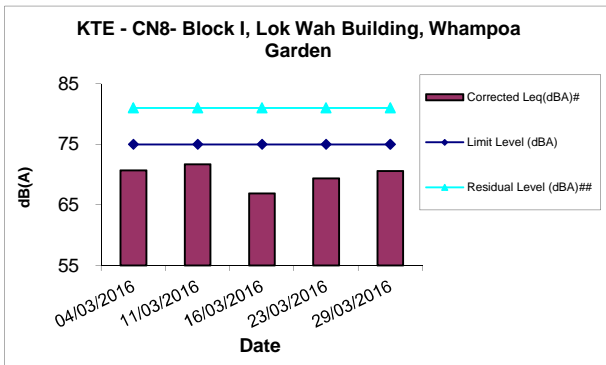
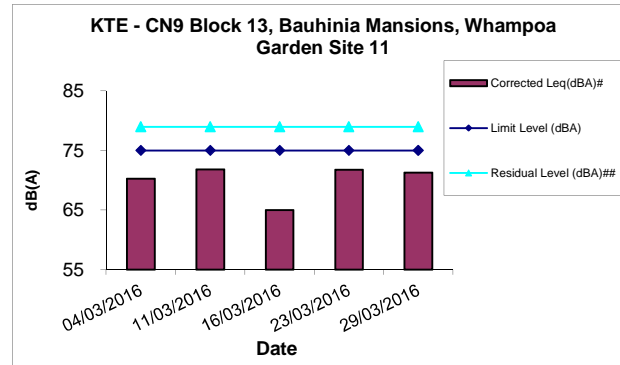
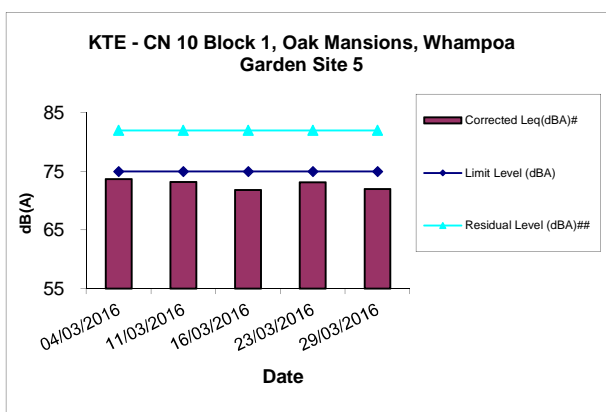
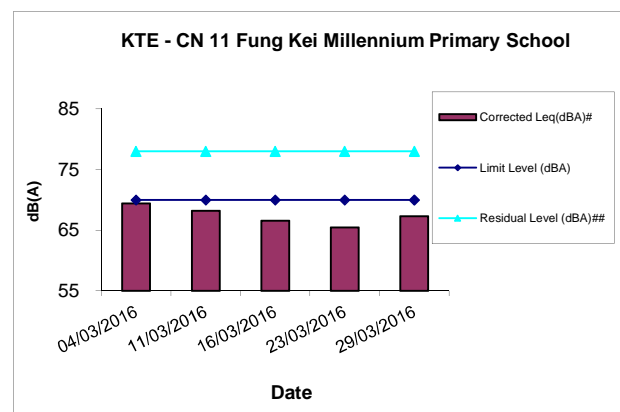
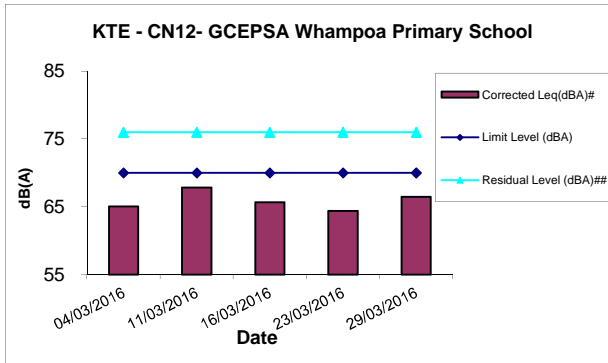
Appendix F - Impact Noise Monitoring Results

As some of the measured Leq is lower than the baseline level, correction against baseline level cannot be applied.
