Kwun Tong Line Extension (KTE)

Monthly EM&A Report (July 2016)

The EM&A programme for the Kwun Tong Line Extension (KTE) Project commenced on 20 June 2011. This is the 61st Monthly Environmental Monitoring and Audit (EM&A) Report for the Project. The Report presents the results of EM&A works and the impact monitoring for the construction works undertaken by respective Contractors during the period of 1 July 2016 to 31 July 2016.

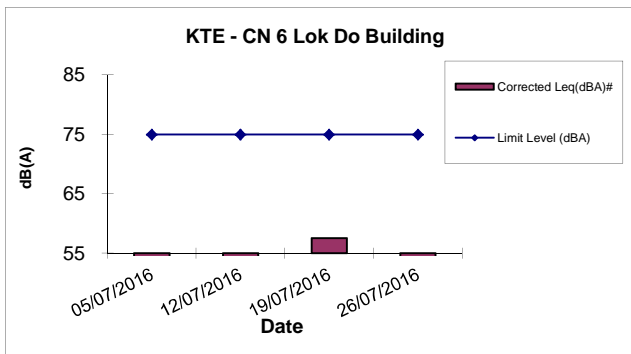
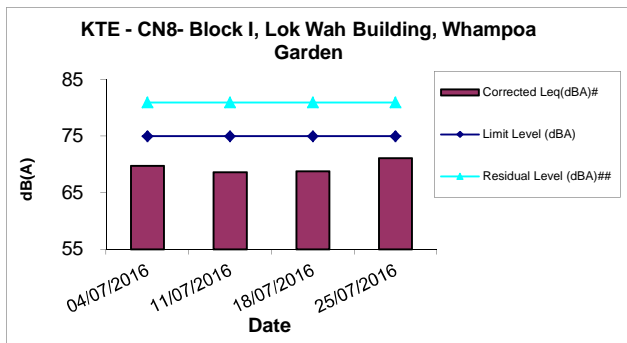
Appendix F - Impact Noise Monitoring Results

As some of the measured Leq is lower than the baseline level, correction against baseline level cannot be applied.
