MTR Corporation Limited

Kwun Tong Line Extension (KTE)

Monthly EM&A Report (October 2016)

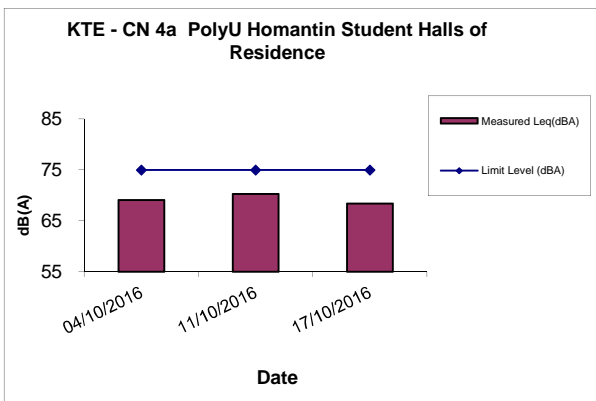
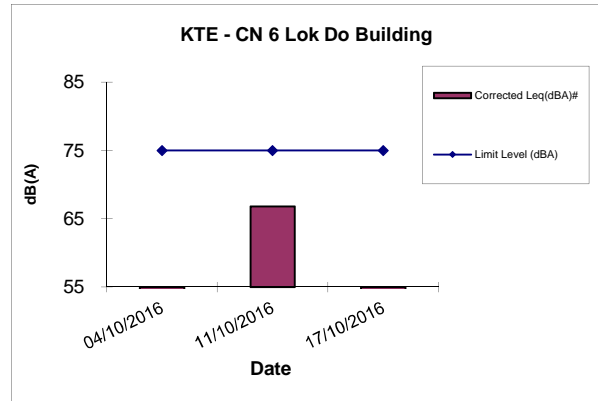
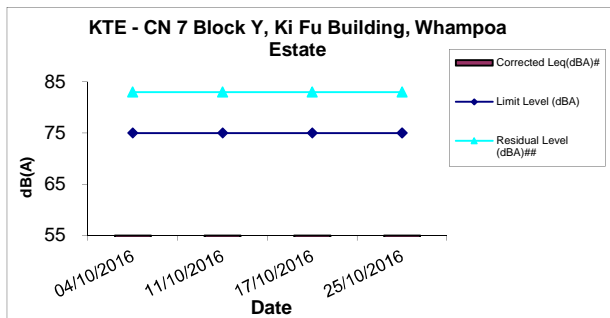
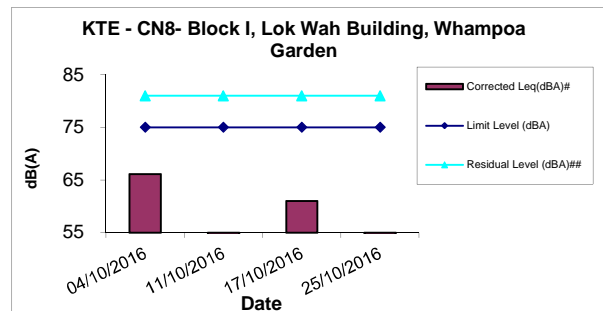
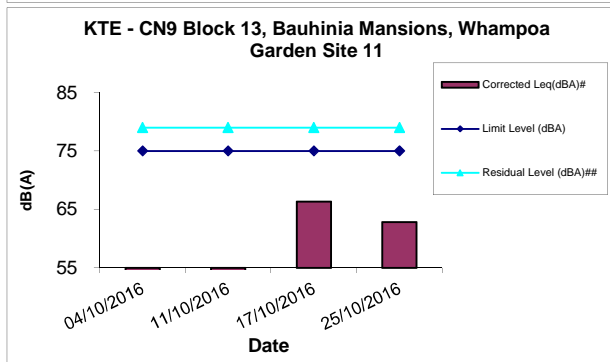
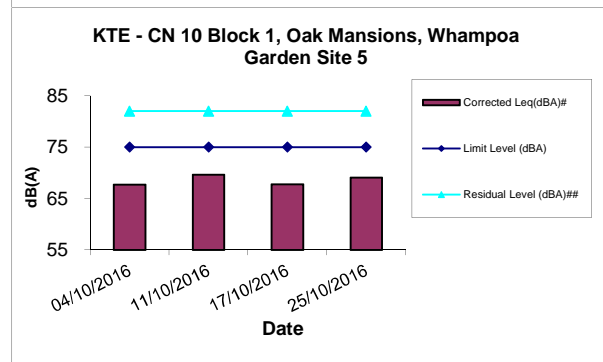
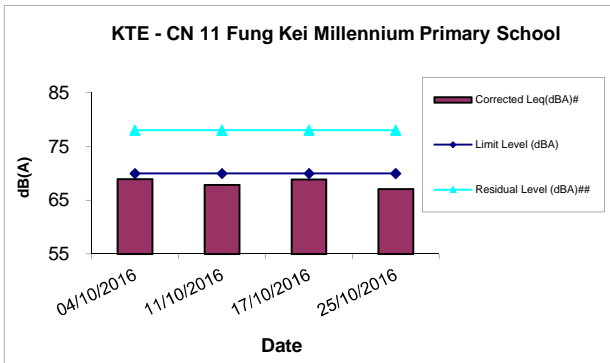
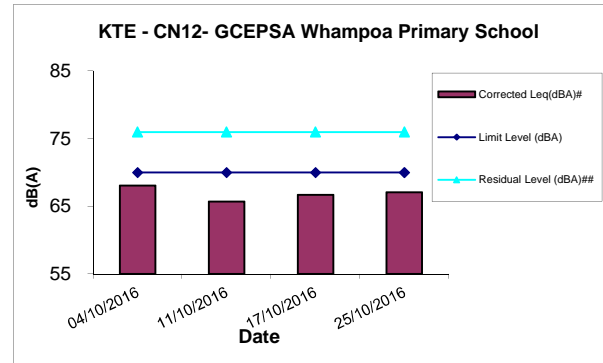
Appendix F - Impact Noise Monitoring Results

As some of the measured Leq is lower than the baseline level, correction against baseline level cannot be applied.
