MTR Corporation Limited

Kwun Tong Line Extension (KTE)

Monthly EM&A Report (May 2017)

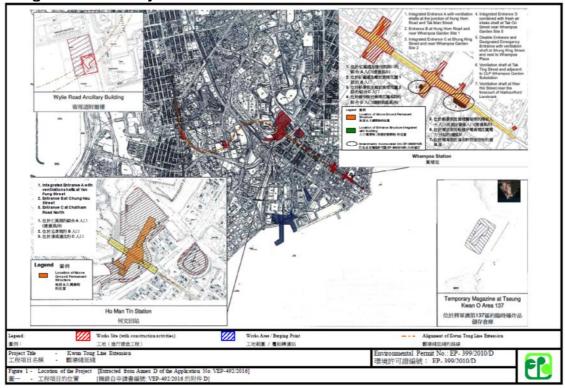
Figure 1. KTE Project Works Area

The KTE Project works sites and areas are summarized in Table 2 below and shown in Appendix A Figure 1. The locations of environmental monitoring stations are indicated in Appendix A Figure 2 and 3. Table 3 shows the details of the active monitoring stations as reported in Sections 3.1 and 3.2.

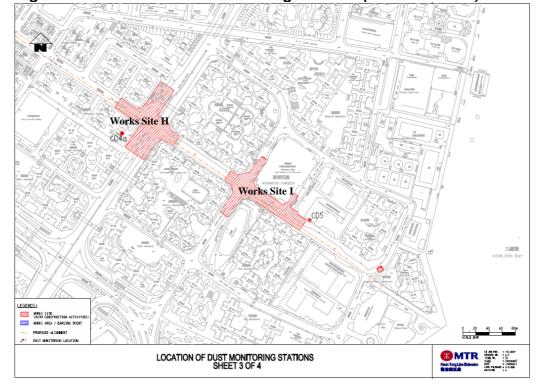
Figure 2. Location of Dust Monitoring Stations (CD4a and CD5)

To examine the construction dust levels, 24-hour TSP monitoring was undertaken according to the EM&A Manual. The dust monitoring locations are shown in the Section 2.2 above.
