**Shatin to Central Link –
Tai Wai to Hung Hom Section and
Mong Kok East to Hung Hom Section**

Monthly EM&A Report No. 42

[Period from 1 to 29 February 2016]

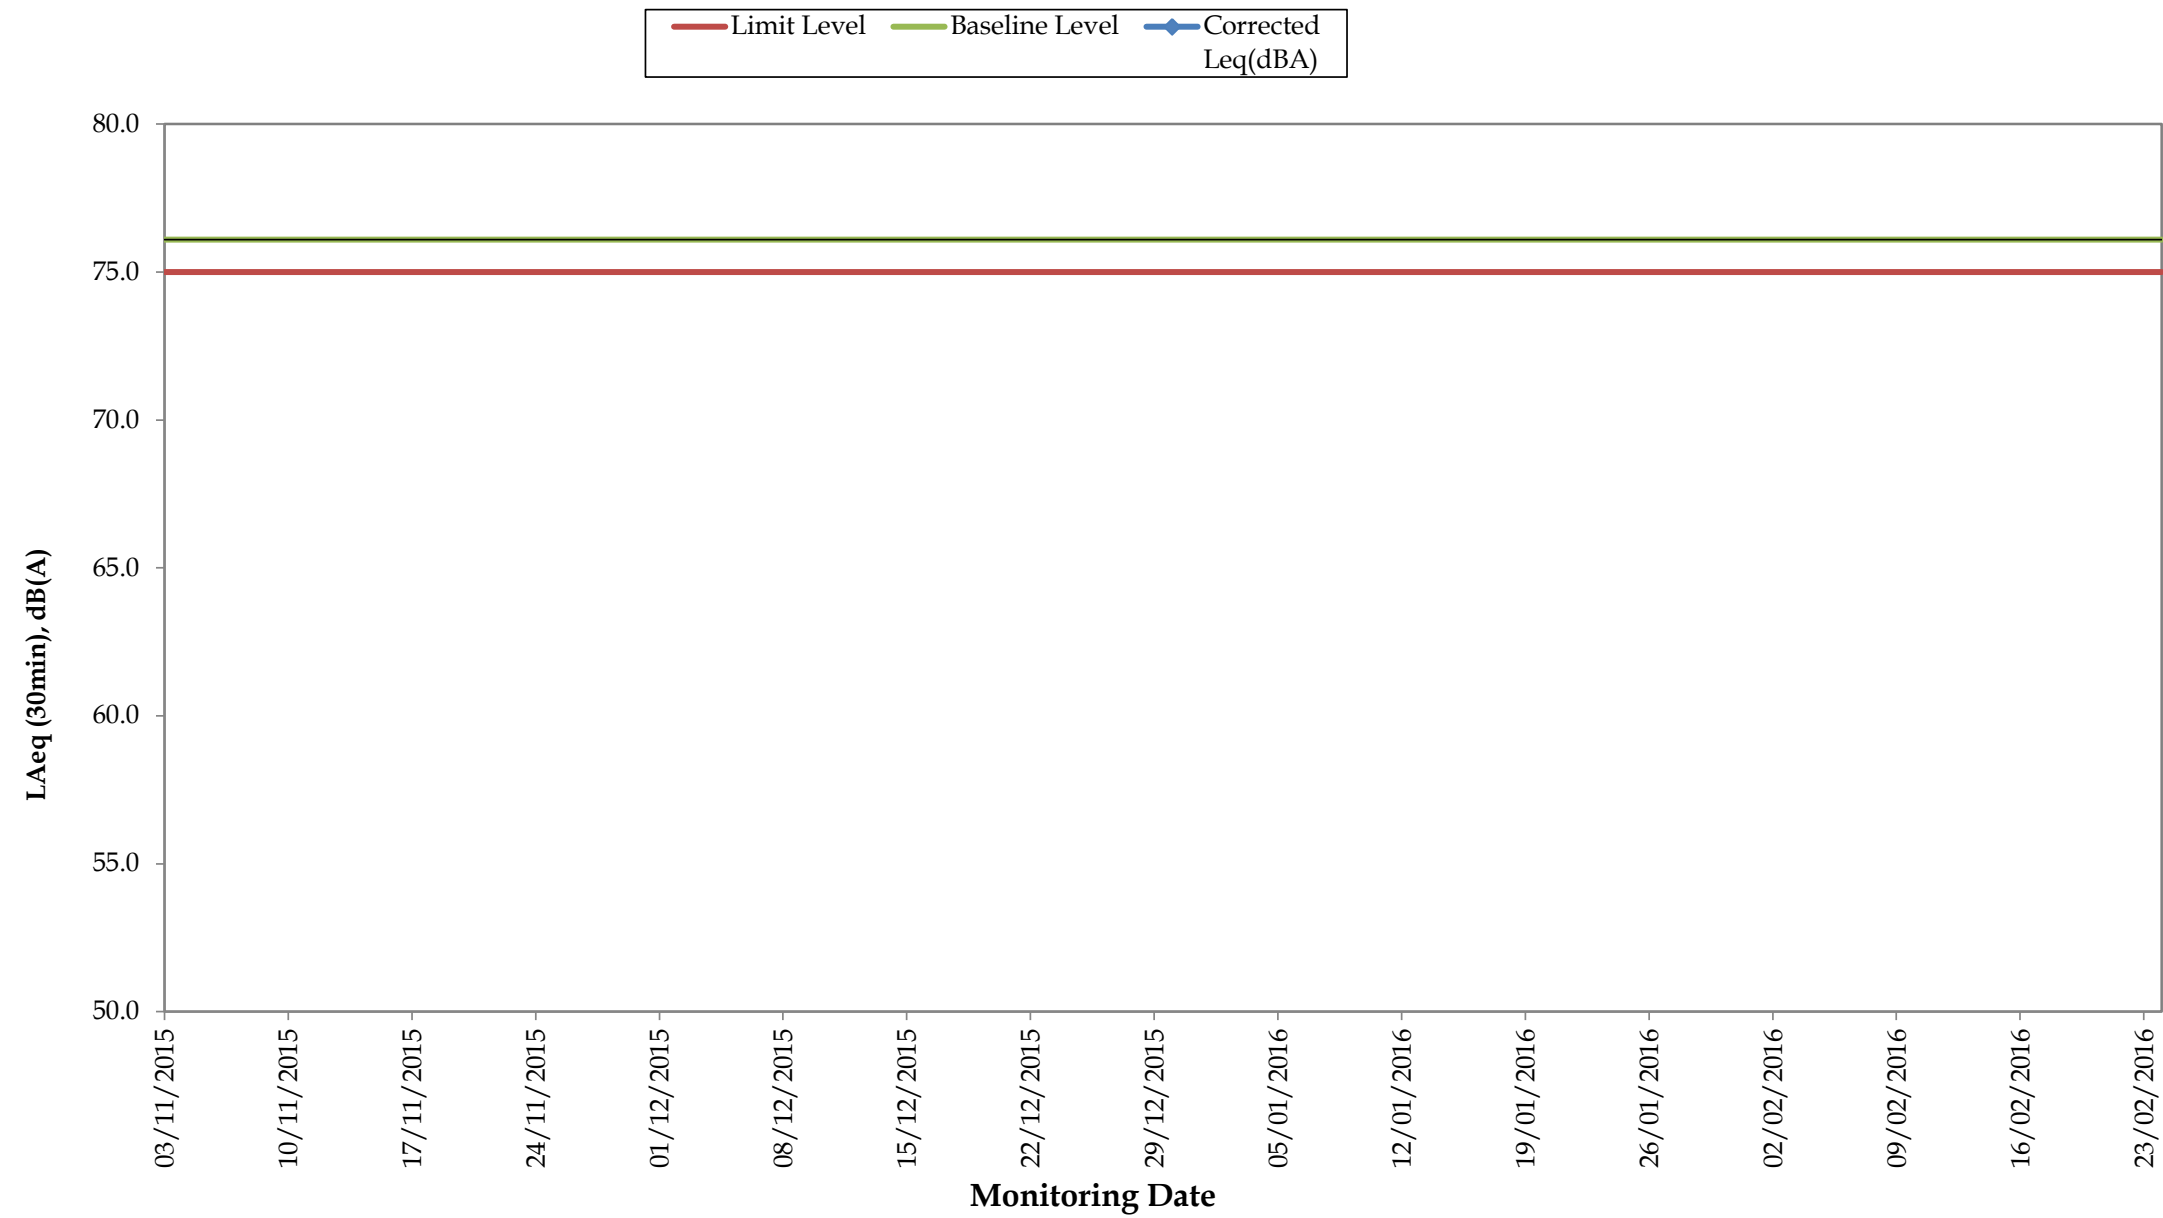
Regular Noise Monitoring Results at NMS-CA-6 (No. 16-23 Nam Kok Road) (LAeq, 30min) for the Past 4 Months

- For those corrected noise levels that are not shown in this graph, the measured noise levels are below baseline level.

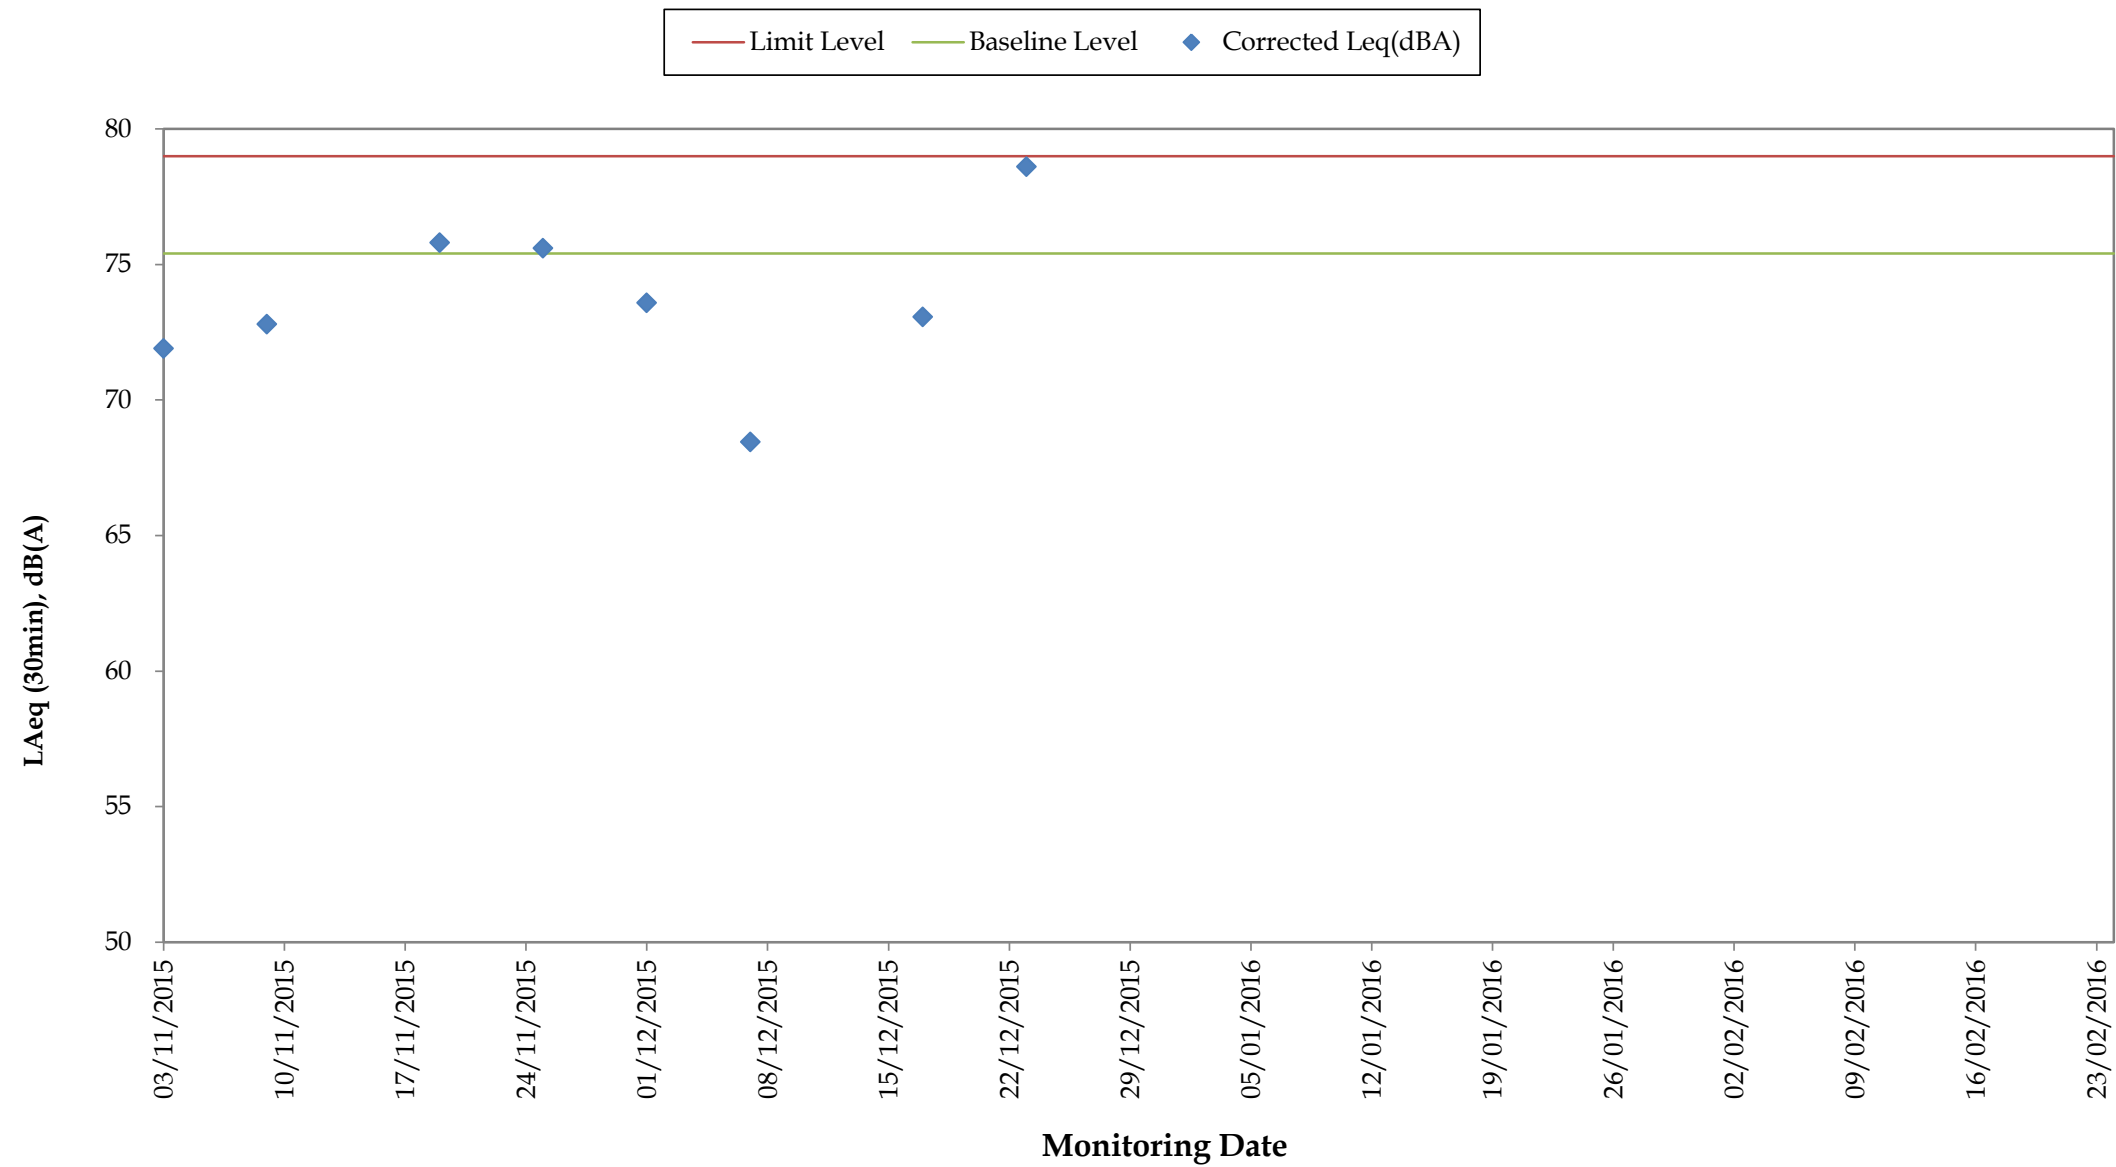
Regular Noise Monitoring Results at NMS-CA- 8 (SKH Good Shepherd Primary School) (LAeq, 30min) for the Past 4 Months

- For those corrected noise levels that are not shown in this graph, the measured noise levels are below baseline level.
- The limit level was updated from 78dB(A) to 79 dB(A) on 22 Aug 2013 as per the latest CNMP and CNMMP.

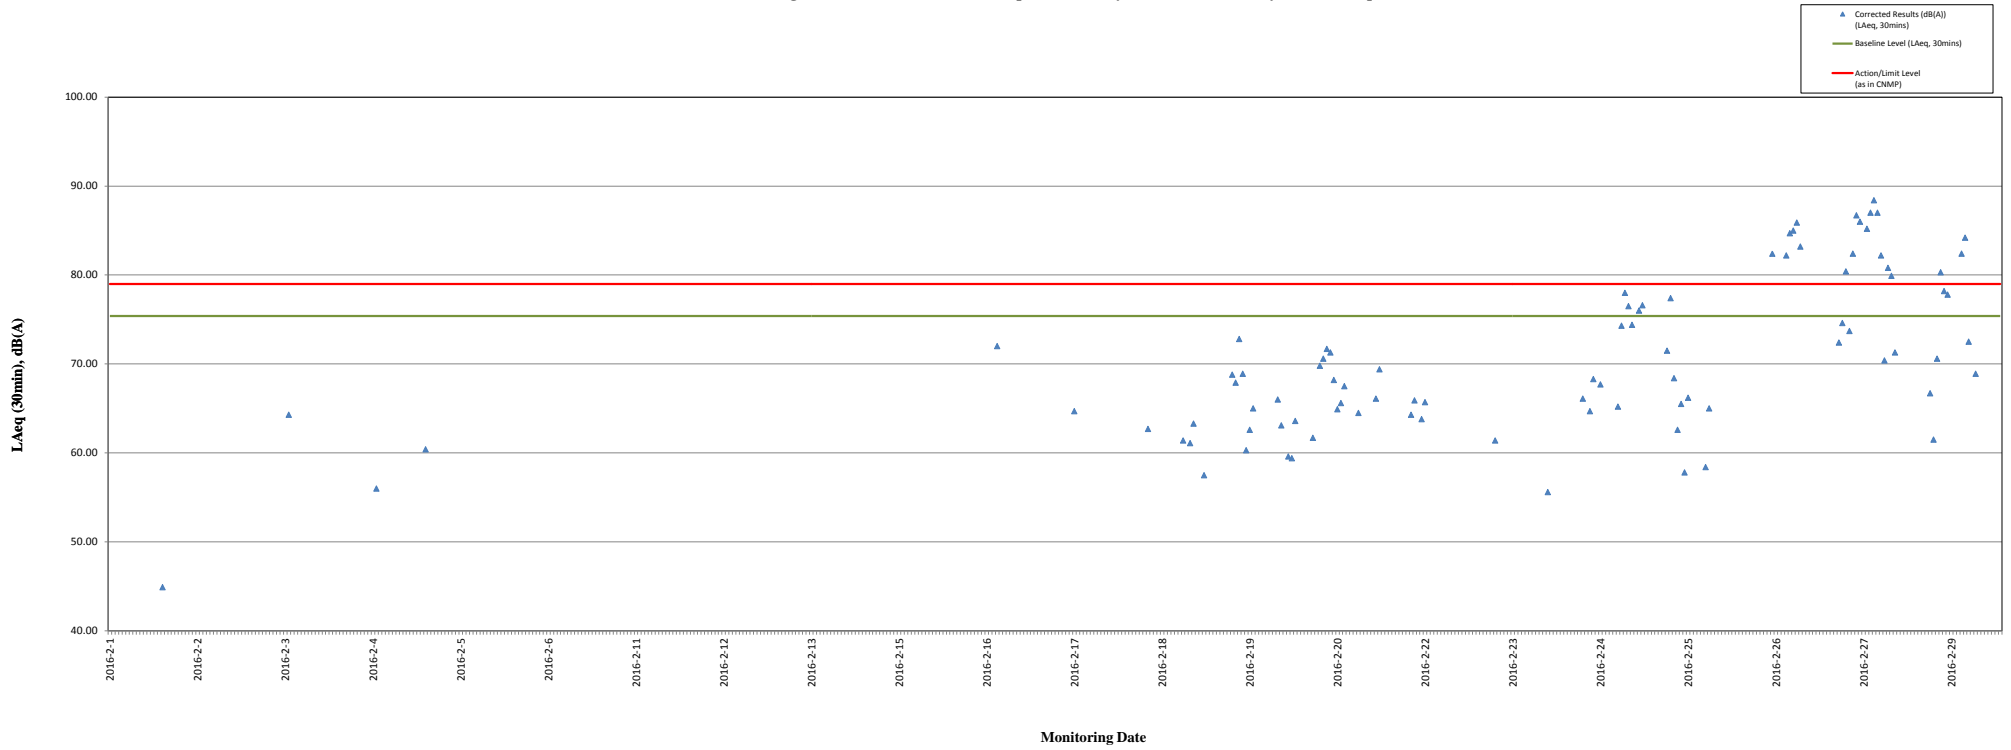
Continuous Noise Monitoring at MTW-16-1(SKH Good Shepherd Primary School) in February 2016- (LAeq, 30min)

Remarks:
 - For those corrected noise levels that are not shown in this graph, the measured noise levels are below baseline level.

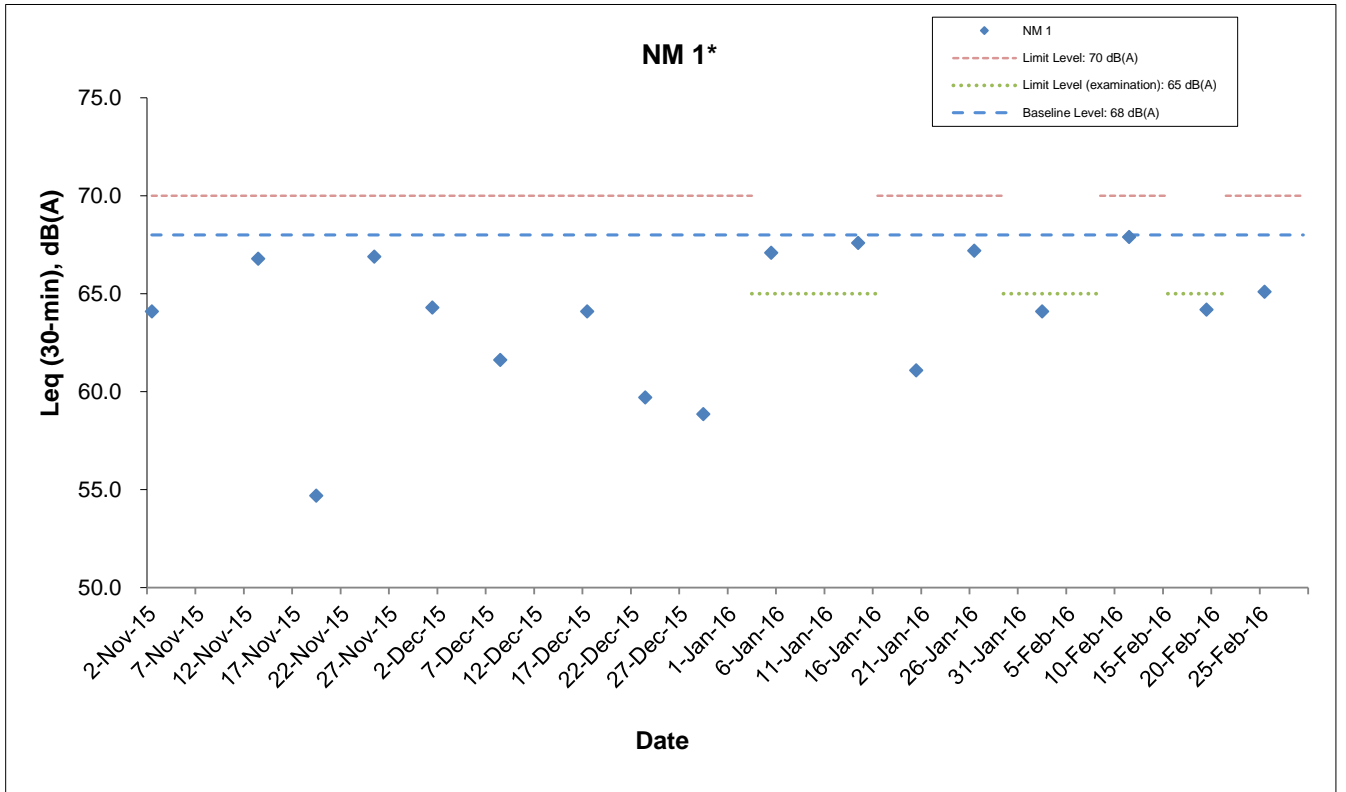
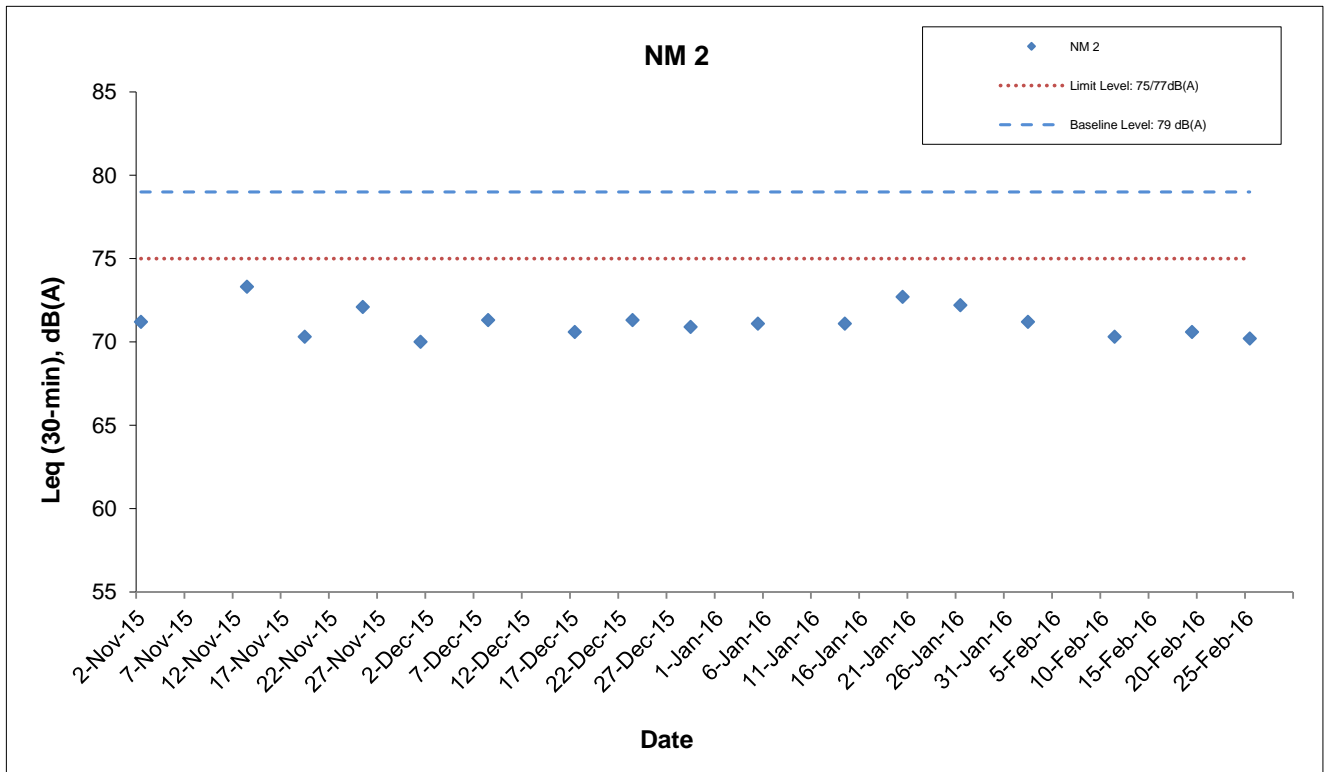
Appendix H Regular Construction Noise Monitoring Results

* - The noise monitoring results of the measurements are higher than the daytime construction noise criterion. However, the results are not considered as exceedance if they are either below the baseline level or below the limit level after deducting the baseline noise level.
