**CONTRACT NO.: HY/2013/02
HONG KONG – ZHUHAI- MACAO BRIDGE
HONG KONG BOUNDARY CROSSING
FACILITIES – INFRASTRUCTURE
WORKS STAGE I
(WESTERN PORTION)
MONTHLY EM&A REPORT
NO. 35
(01 OCTOBER – 31 OCTOBER 2017)**

Report No.: ENA76494

**Contract No. HY/2013/02 – HZMB HKBCF – Infrastructure Works Stage I
(Western Portion)
Monthly Environmental Monitoring & Audit Report for October 2017**

Contract No. HY/2013/02 – Hong Kong – Zhuhai – Macao Bridge
Hong Kong Boundary Crossing Facilities – Infrastructure Works Stage I (Western Portion) Complaint Investigation Report Log No. 015

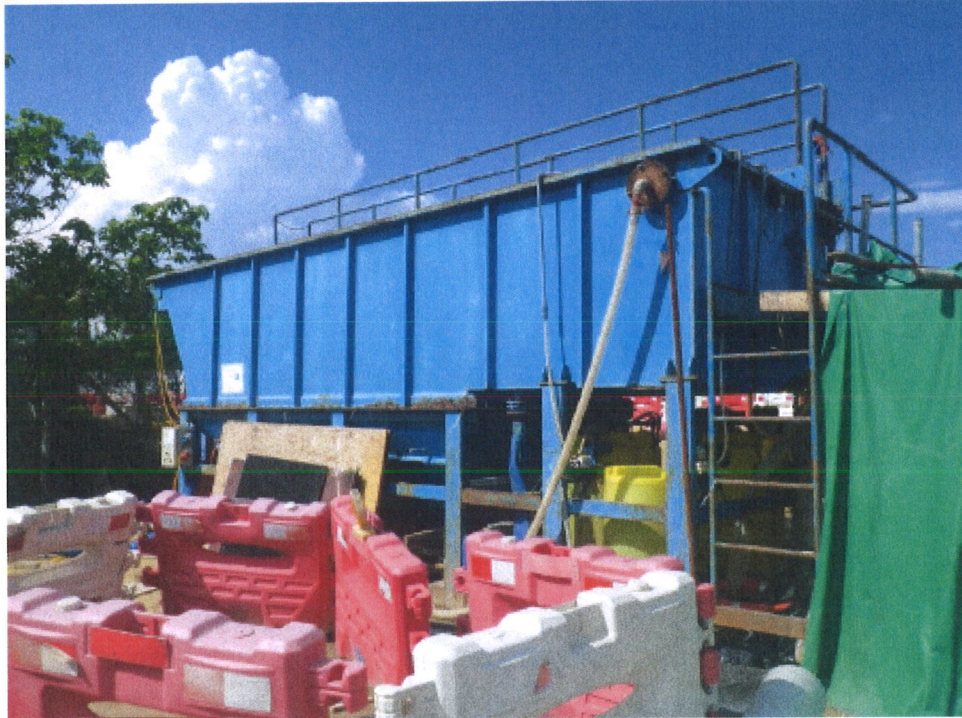
According to the investigation, de-silting pits with geotextile were provided and wastewater was collected by the wetsep for proper treatment prior to disposal. Besides, effluent water sample was sampled for testing the total suspended solids. According to the latest test report with sample sampled on 25 September 2017, the parameter complied with the discharge license requirement. Hence, the complaint was found non-related to Contract No. HY/2013/02. The complaint investigation report (Log No. 015) was provided in **Appendix J**.

Photo 171030_002 – Wetsep

Although this complaint was non-related to Contract No. HY/2013/02, the Contractor of Contract No. HY/2013/02 was reminded to provide appropriate water pollution mitigation measures, such as ensure all construction activities that would deteriorate the water quality was collected by sedimentation tanks or package treatment systems for proper treatment prior to disposal, ensure all silt removal facilities, channels and manholes were maintained and any deposited silt and grit was removed regularly and direct the wheel wash overflow and surface run-off to silt removal facilities before discharging to the storm drain.			
Details of Action(s) Taken by the Contactor of Contract No. HY/2013/02			
<ol style="list-style-type: none"> 1. Collect wastewater by sedimentation tanks or package treatment systems for proper treatment prior to disposal; 2. Ensure all silt removal facilities, channels and manholes were maintained and any deposited silt and grit were removed regularly 3. Direct the wheel wash overflow and surface run-off to silt removal facilities before discharging to the storm drain
