**Re: Agreement No. CE 48/2011 (EP)  
Environmental Project Office for the  
HZMB Hong Kong Link Road, HZMB Hong Kong Boundary Crossing Facilities,  
and Tuen Mun-Chek Lap Kok Link – Investigation**

**Contract No. HY/2013/01 – HZMB HKBCF – Passenger Clearance Building  
Monthly Environmental Monitoring & Audit Report for July 2018**

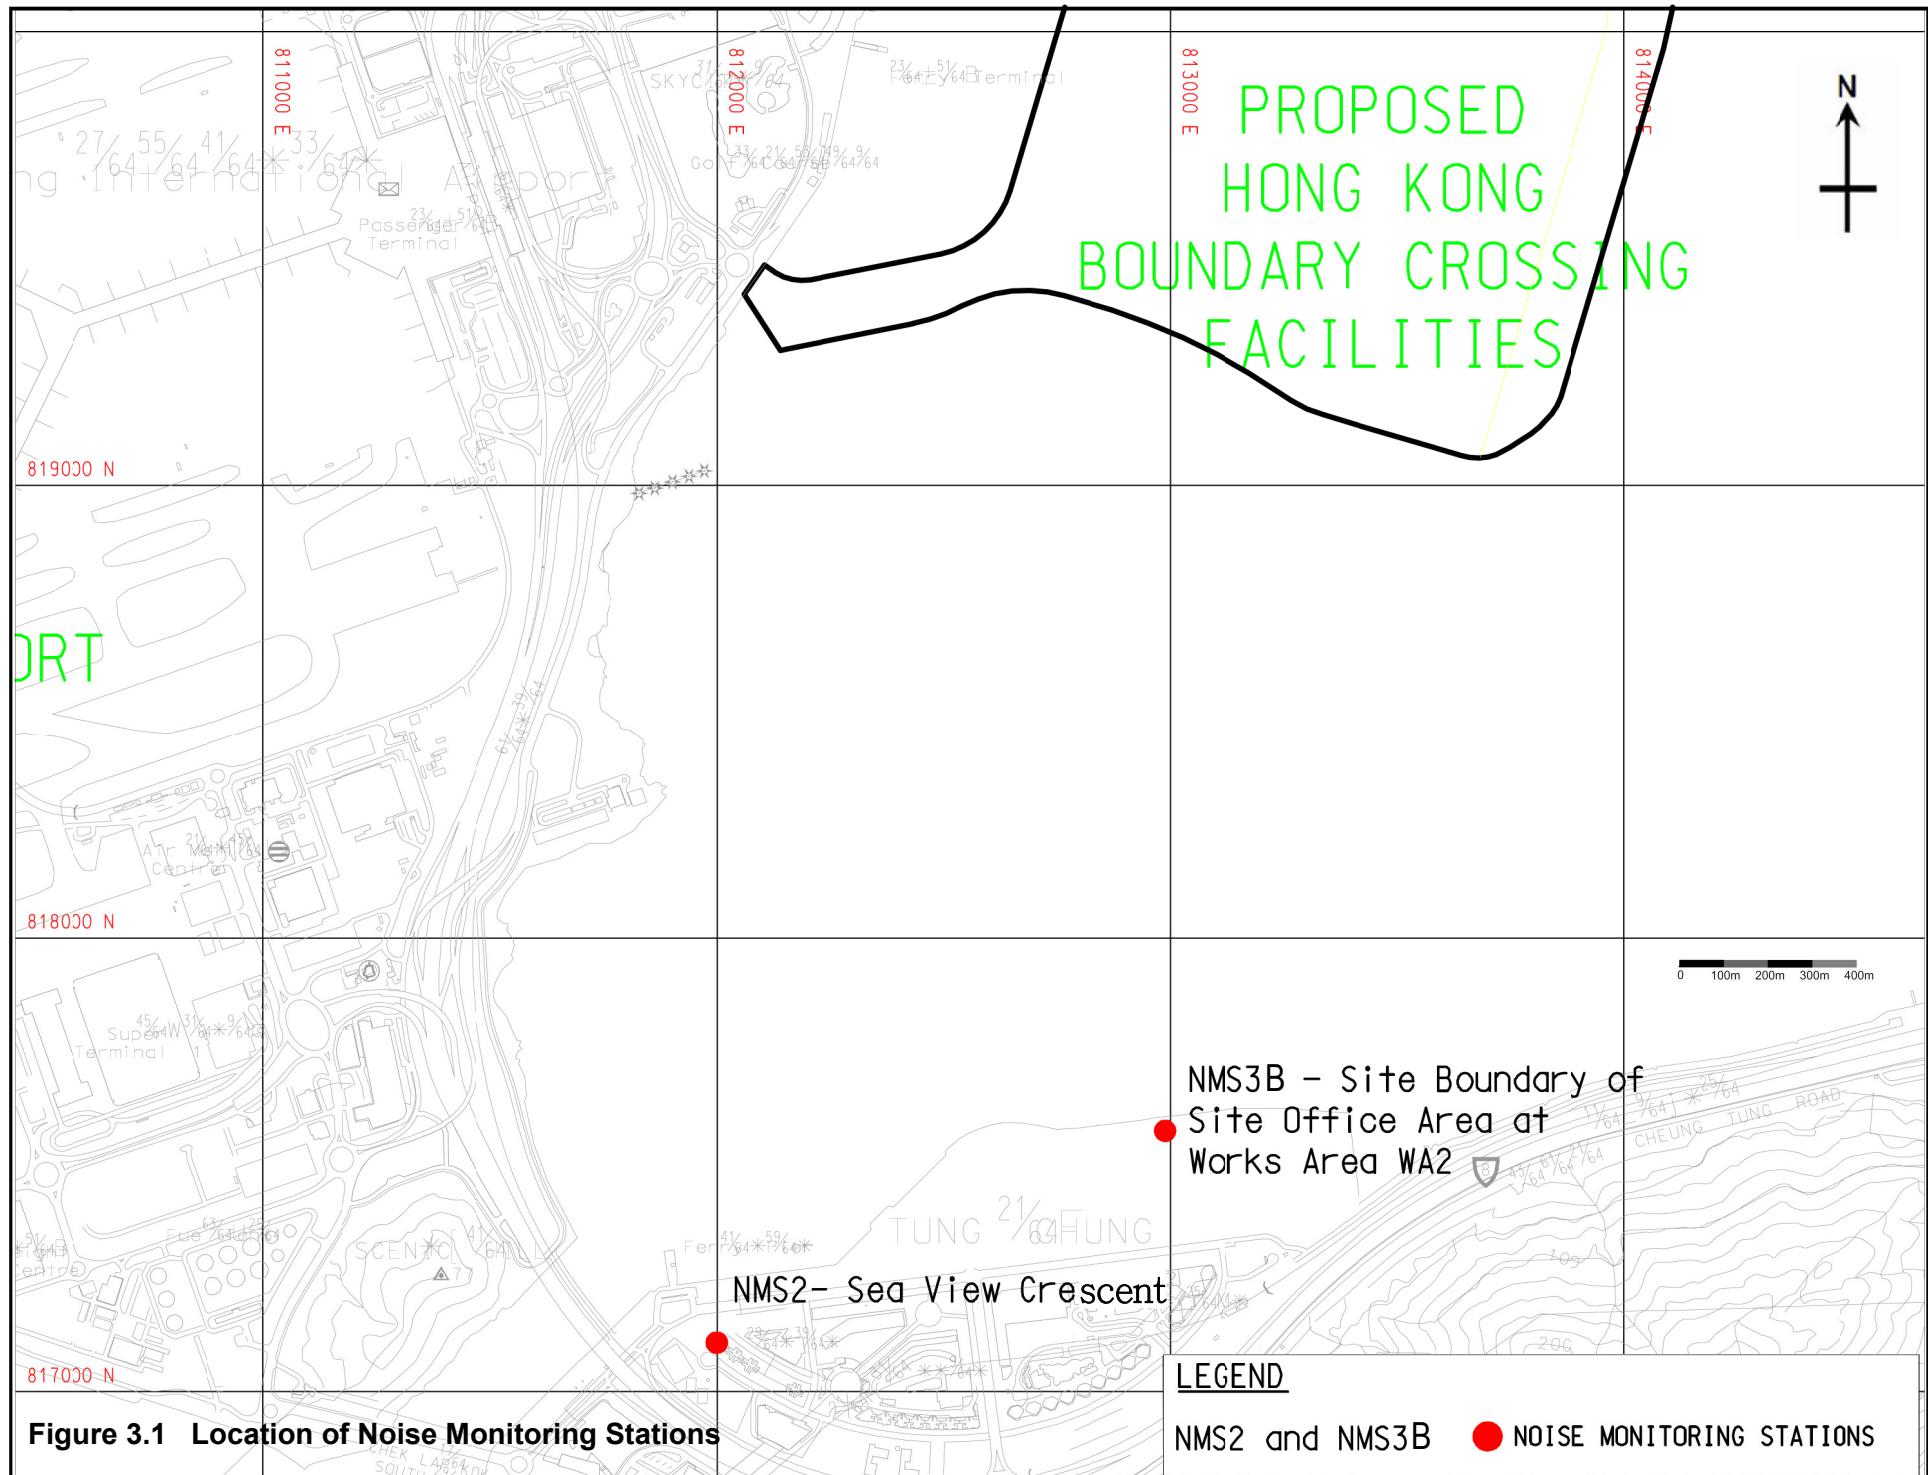
**Figure 3.1 Location of Noise Monitoring Stations**

NMS2 and NMS3B ● NOISE MONITORING STATIONS

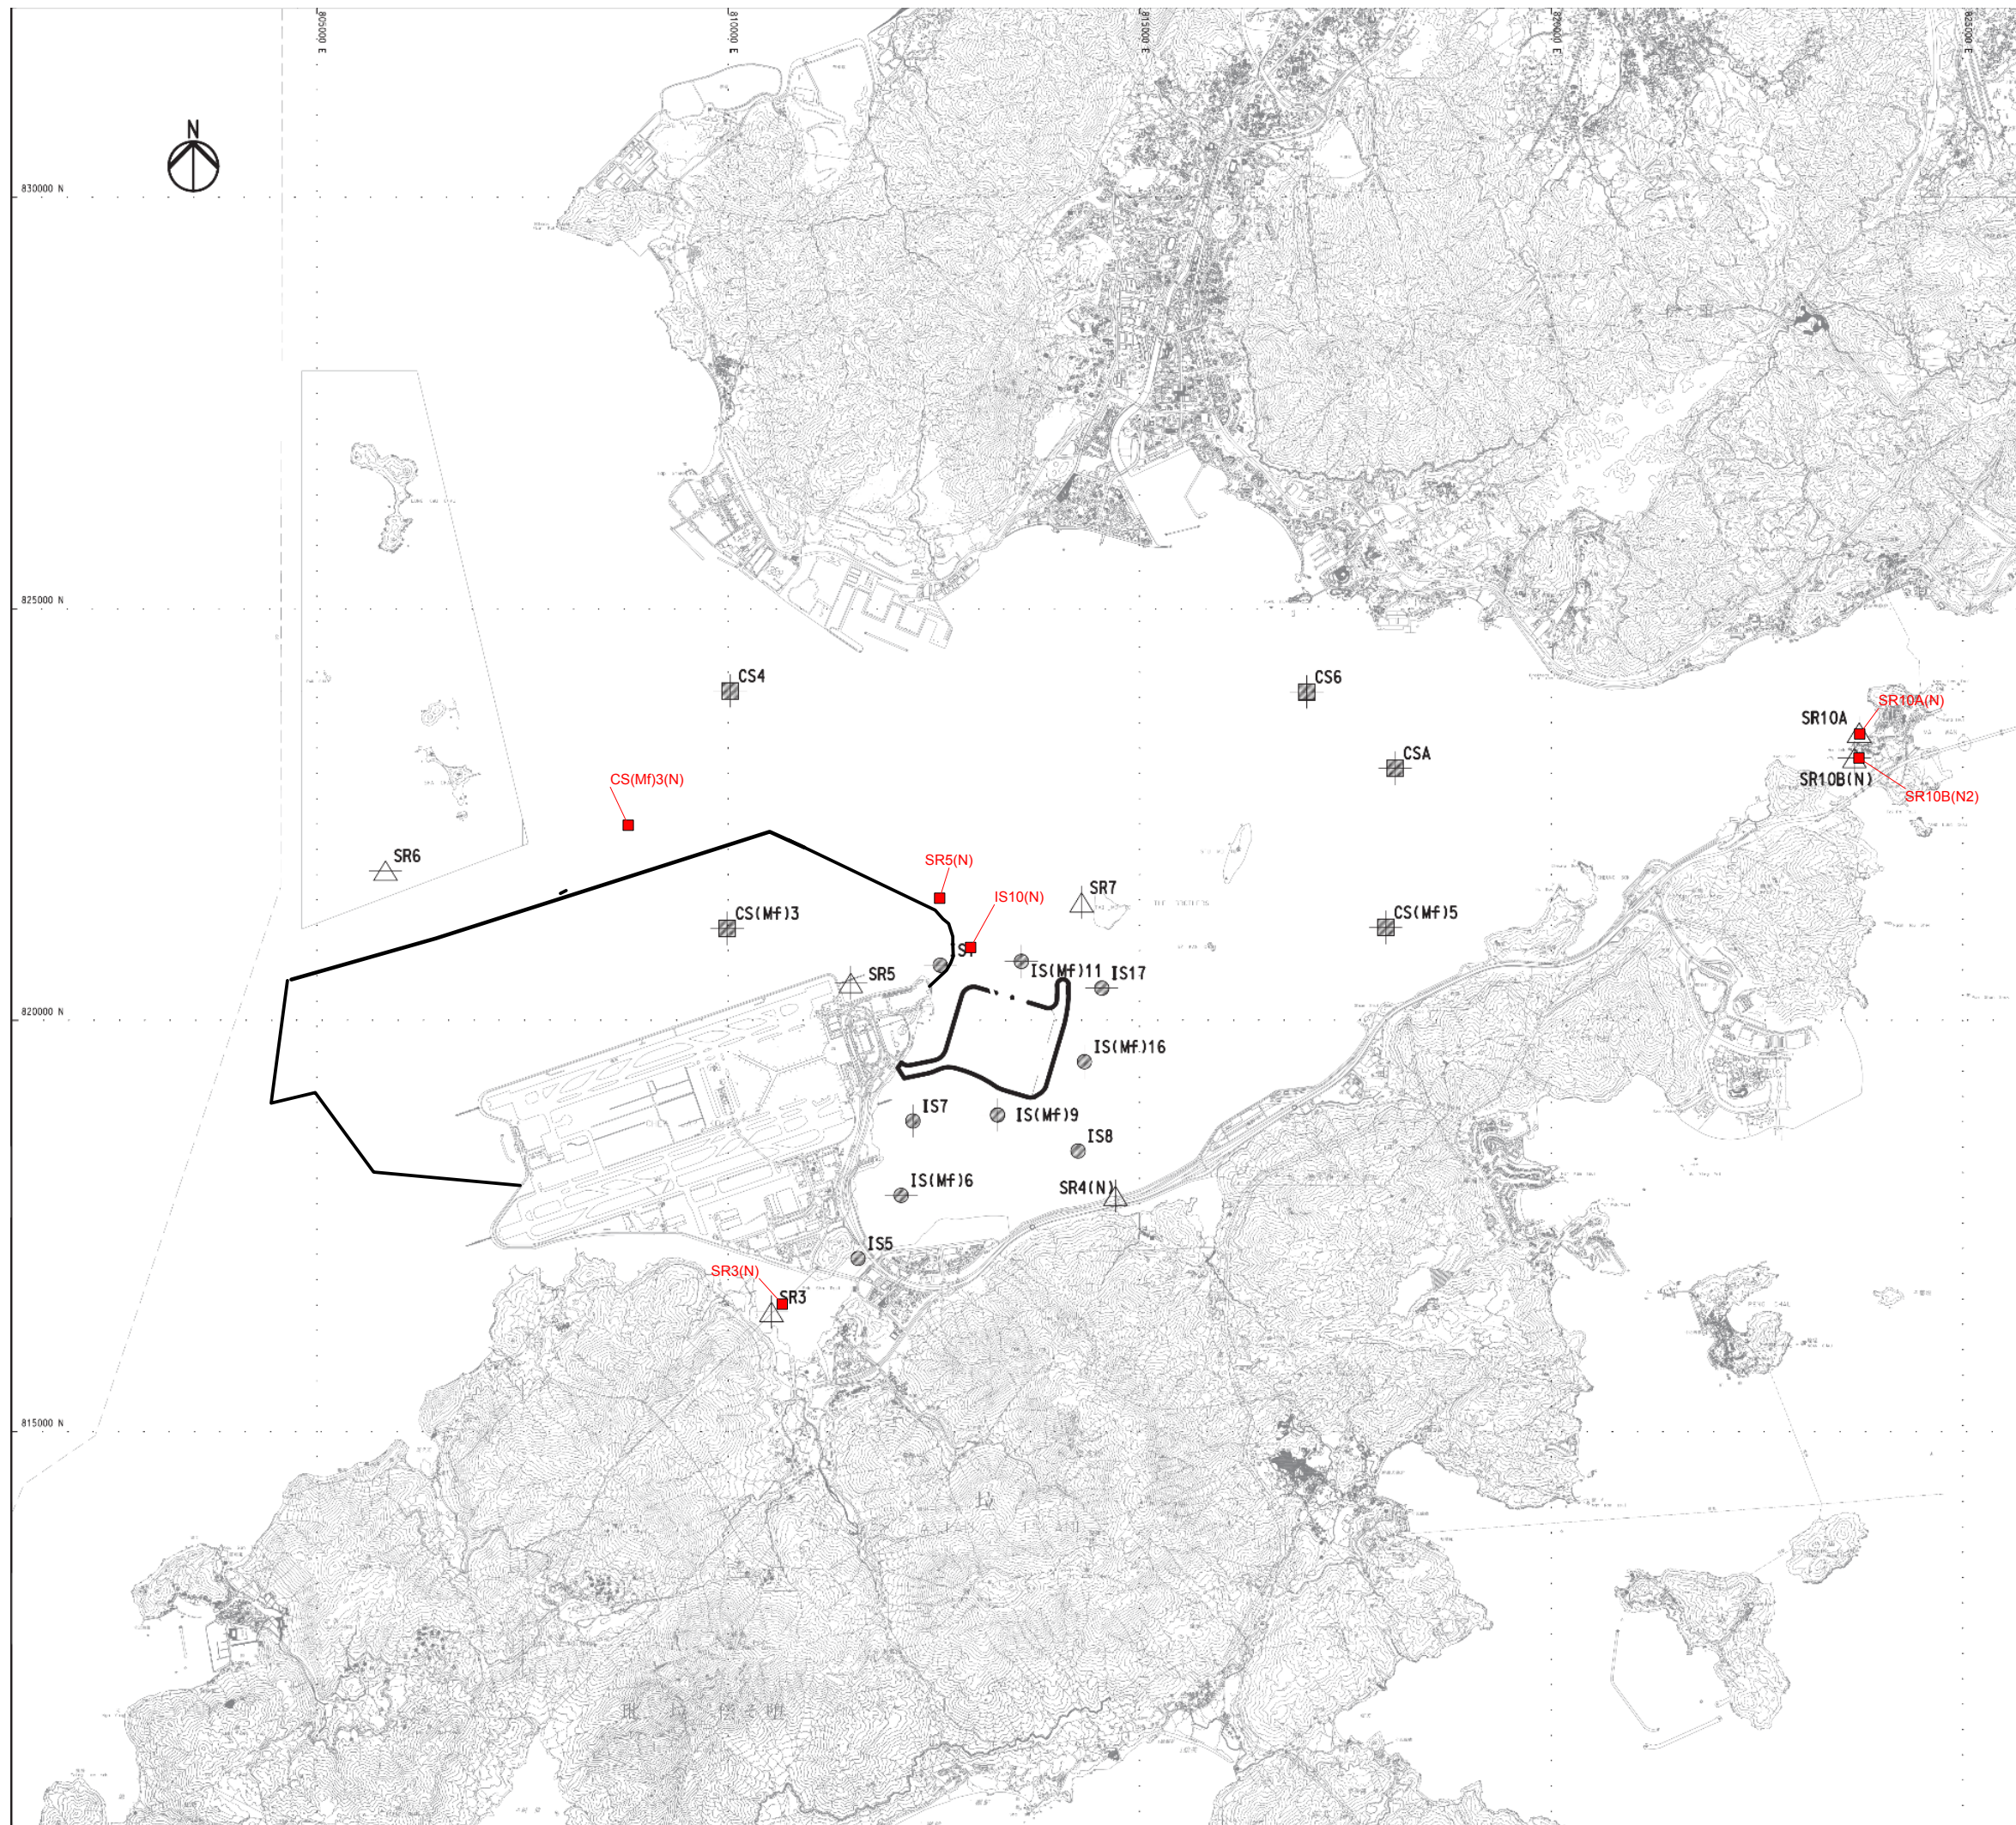
FIGURE 4.1— LOCATION OF WATER QUALITY MONITORING STATIONS

Station	East	North
IS5	811579	817106
IS(Mf)6	812101	817873
IS7	812244	818777
IS8	814251	818412
IS(Mf)9	813273	818850
IS10(N)	812942	820881
IS(Mf)11	813562	820716
IS(Mf)16	814328	819497
IS17	814539	820391
SR3(N)	810689	816591
SR4(N)	814705	817859
SR5(N)	812569	821475
SR6	805837	821818
SR7	814293	821431
SR10A(N)	823644	823484
SR10B(N2)	823689	823159
CS(Mf)3(N)	808814	822355
CS(Mf)5	817990	821129
CS4	810025	824004
CS6	817028	823992
CSA	818103	823064
