**Contract No. HY/2013/04 Hong Kong-Zhuhai-Macao Bridge (HZMB)  
Hong Kong Boundary Crossing Facilities – Infrastructure Works Stage II  
(Southern Portion)**

**Monthly EM&A Report for August 2018**

Monthly EM&A Report for August 2018

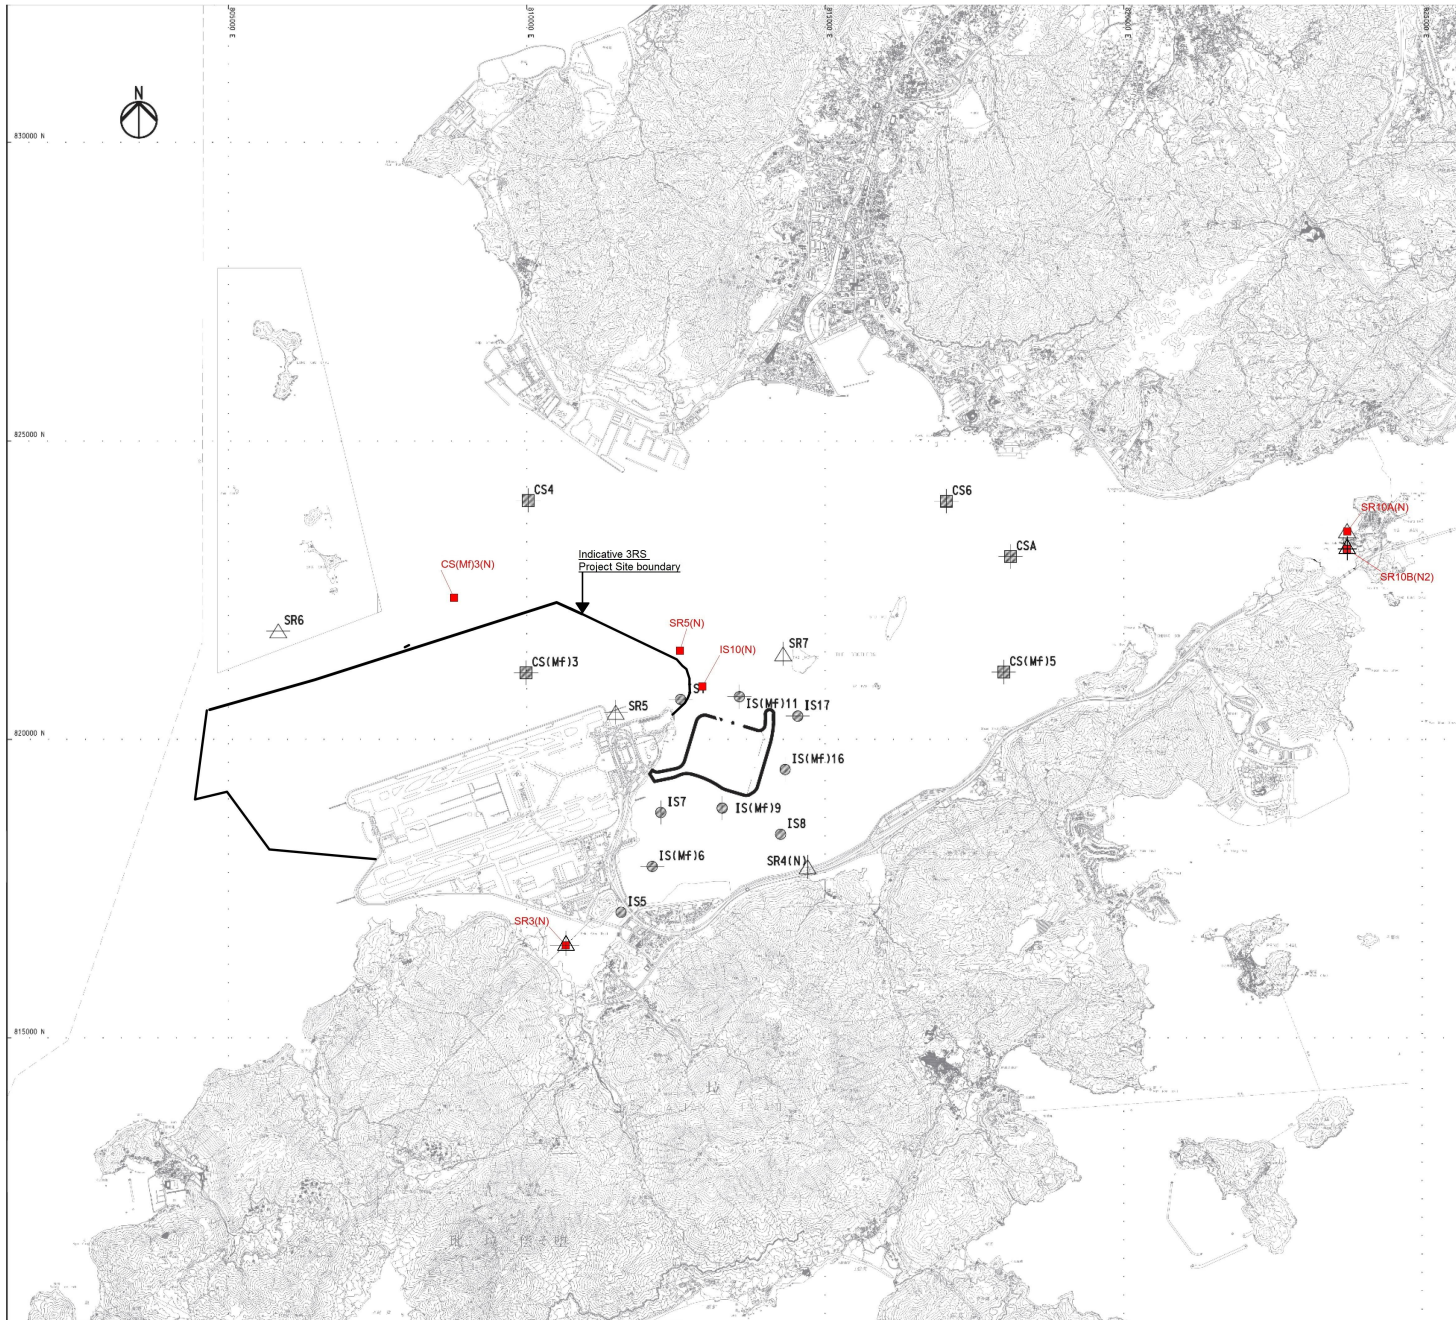
FIGURE 4.1— LOCATION OF WATER QUALITY MONITORING STATIONS

Station	East	North
IS5	811579	817106
IS(Mf)6	812101	817873
IS7	812244	818777
IS8	814251	818412
IS(Mf)9	813273	818850
IS10(N)	812942	820881
IS(Mf)11	813562	820716
IS(Mf)16	814328	819497
IS17	814539	820391
SR3(N)	810689	816591
SR4(N)	814705	817859
SR5(N)	812569	821475
SR6	805837	821818
SR7	814293	821431
SR10A(N)	823644	823484
SR10B(N2)	823689	823159
CS(Mf)3(N)	808814	822355
CS(Mf)5	817990	821129
CS4	810025	824004
CS6	817028	823992
CSA	818103	823064
