Contract No. HY/2013/04  
Hong Kong–Zhuhai–Macao Bridge  
Hong Kong Boundary Crossing Facilities –  
Infrastructure Works Stage II (Southern Portion)

Monthly EM&A Report for October 2018

November 2018

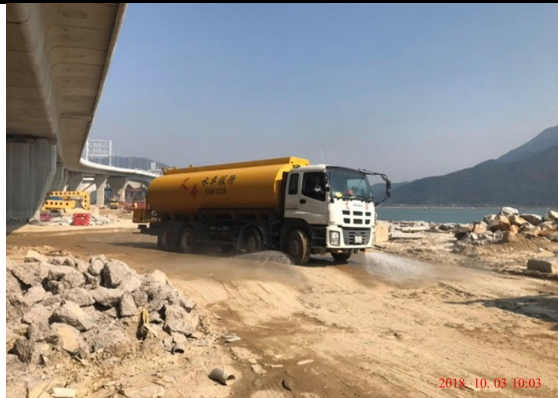
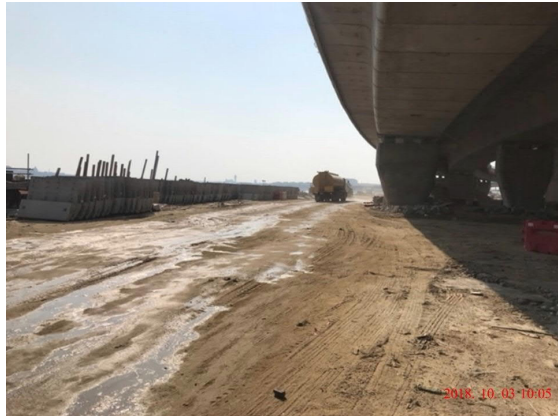
1(a)

1. Water spray by water truck for HY/2013/04 site.

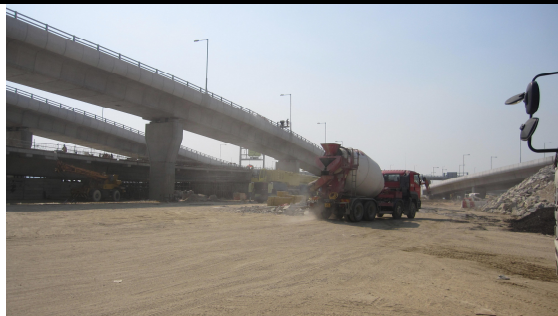
During ET's regular weekly site inspection on 3 October 2018 (between 14:00 and 15:00), a site observation regarding air quality was made, namely dust emission was observed along haul road near bridge D12 area; the Contractor was reminded to provide water spraying to ensure wet surface. Other haul roads within HY/2013/04 site were found to have been provided with water spray.

1. Site observation: Dust emission was observed along haul road near bridge D12 area. The Contractor was reminded to provide water spraying to ensure wet surface.

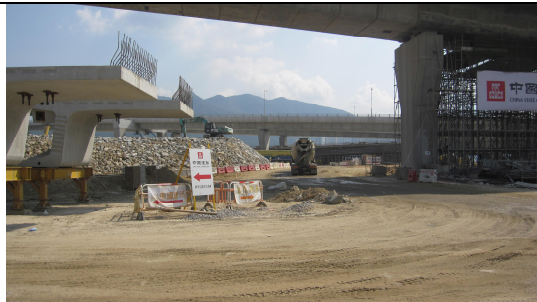
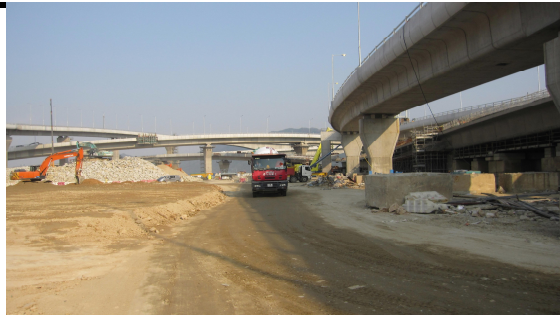
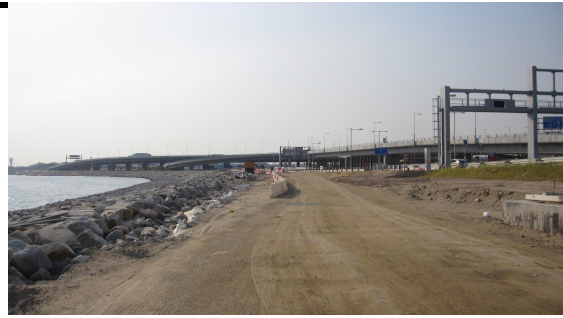
2(a)

2. Other haul roads within HY/2013/04 site were provided with water spray.

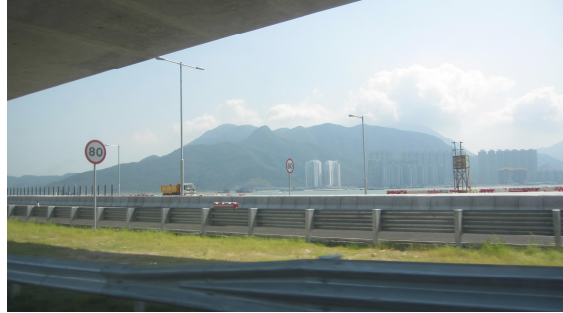
3(b)

3. The vehicular entrance of HY/2013/04 site boundary was also inspected and found to be operating normally with no fugitive dust observed.

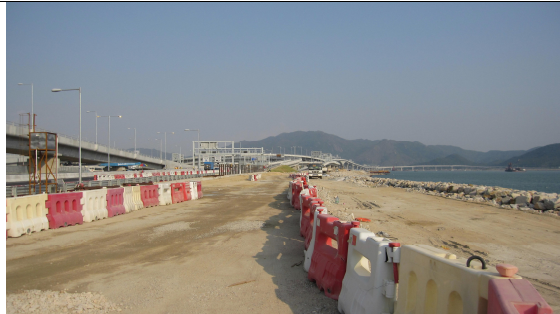
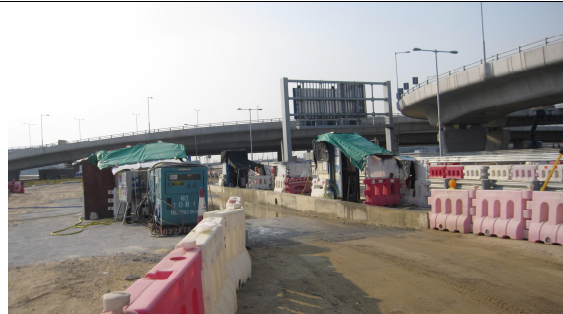
4(a)

The vehicular entrance of and the wheel wash facility at the vehicular exit of HY/2013/04 site boundary were also inspected and found to be operating normally with no fugitive dust observed.

4. The wheel wash facility at the vehicular exit of HY/2013/04 site boundary was also inspected and found to be operating normally with no fugitive dust observed.
