**Contract No. HY/2019/01
HZMB HKBCF – Phase 2 and Other Works
Monthly EM&A Report for March 2021**

Monthly EM&A Report (March 2021)

Contact No. HY/2019/01 Hong Kong-Zhuhai-Macao Bridge Hong Kong Boundary Crossing Facilities – Phase 2 and Other Works

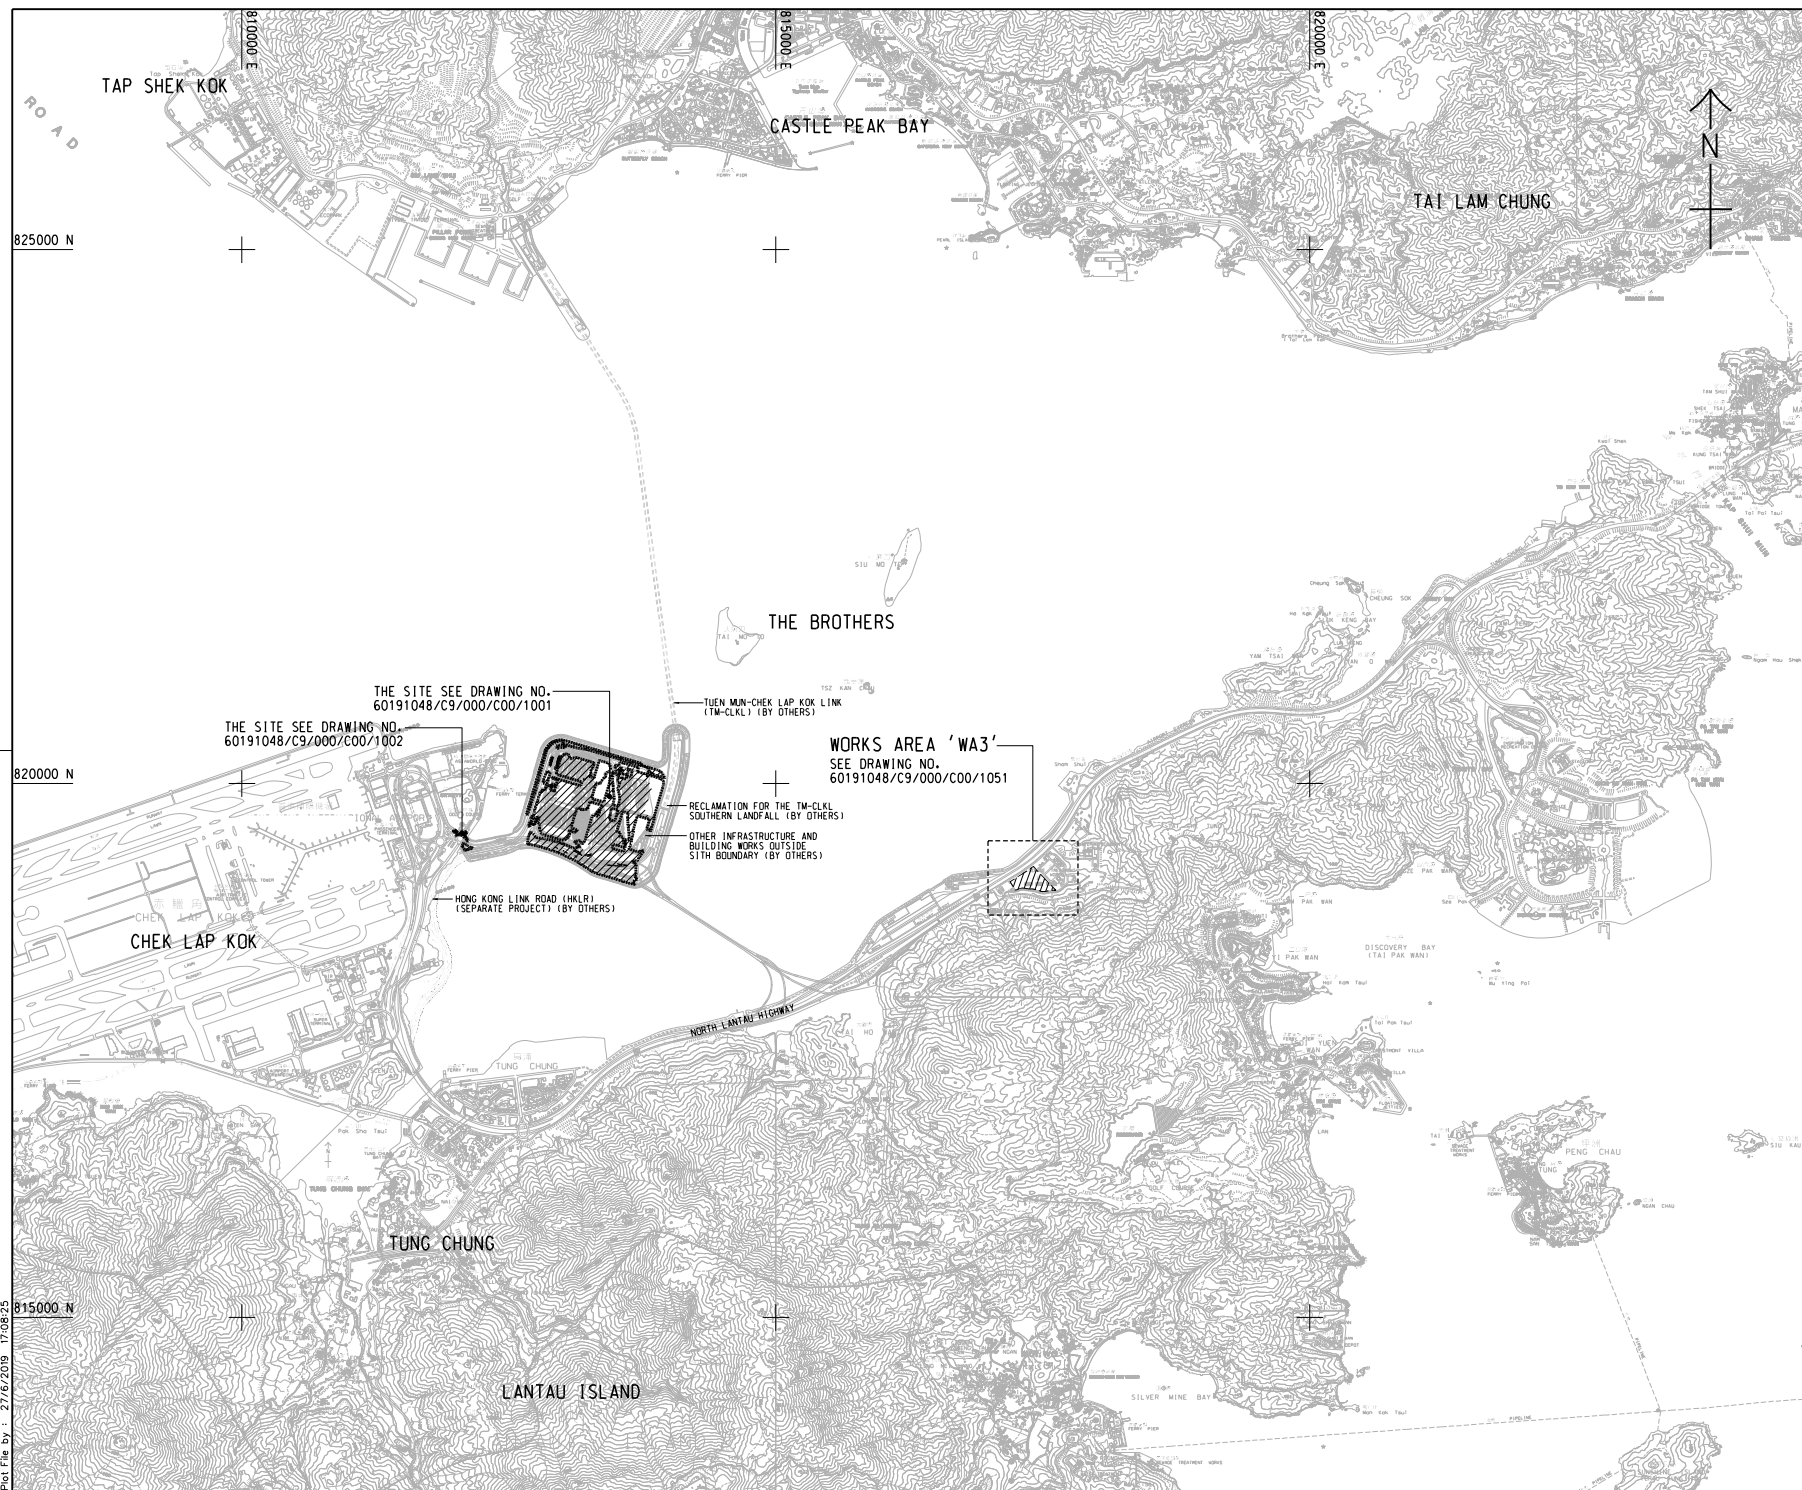
Figure 1

The Site Layout Plan of the Contract

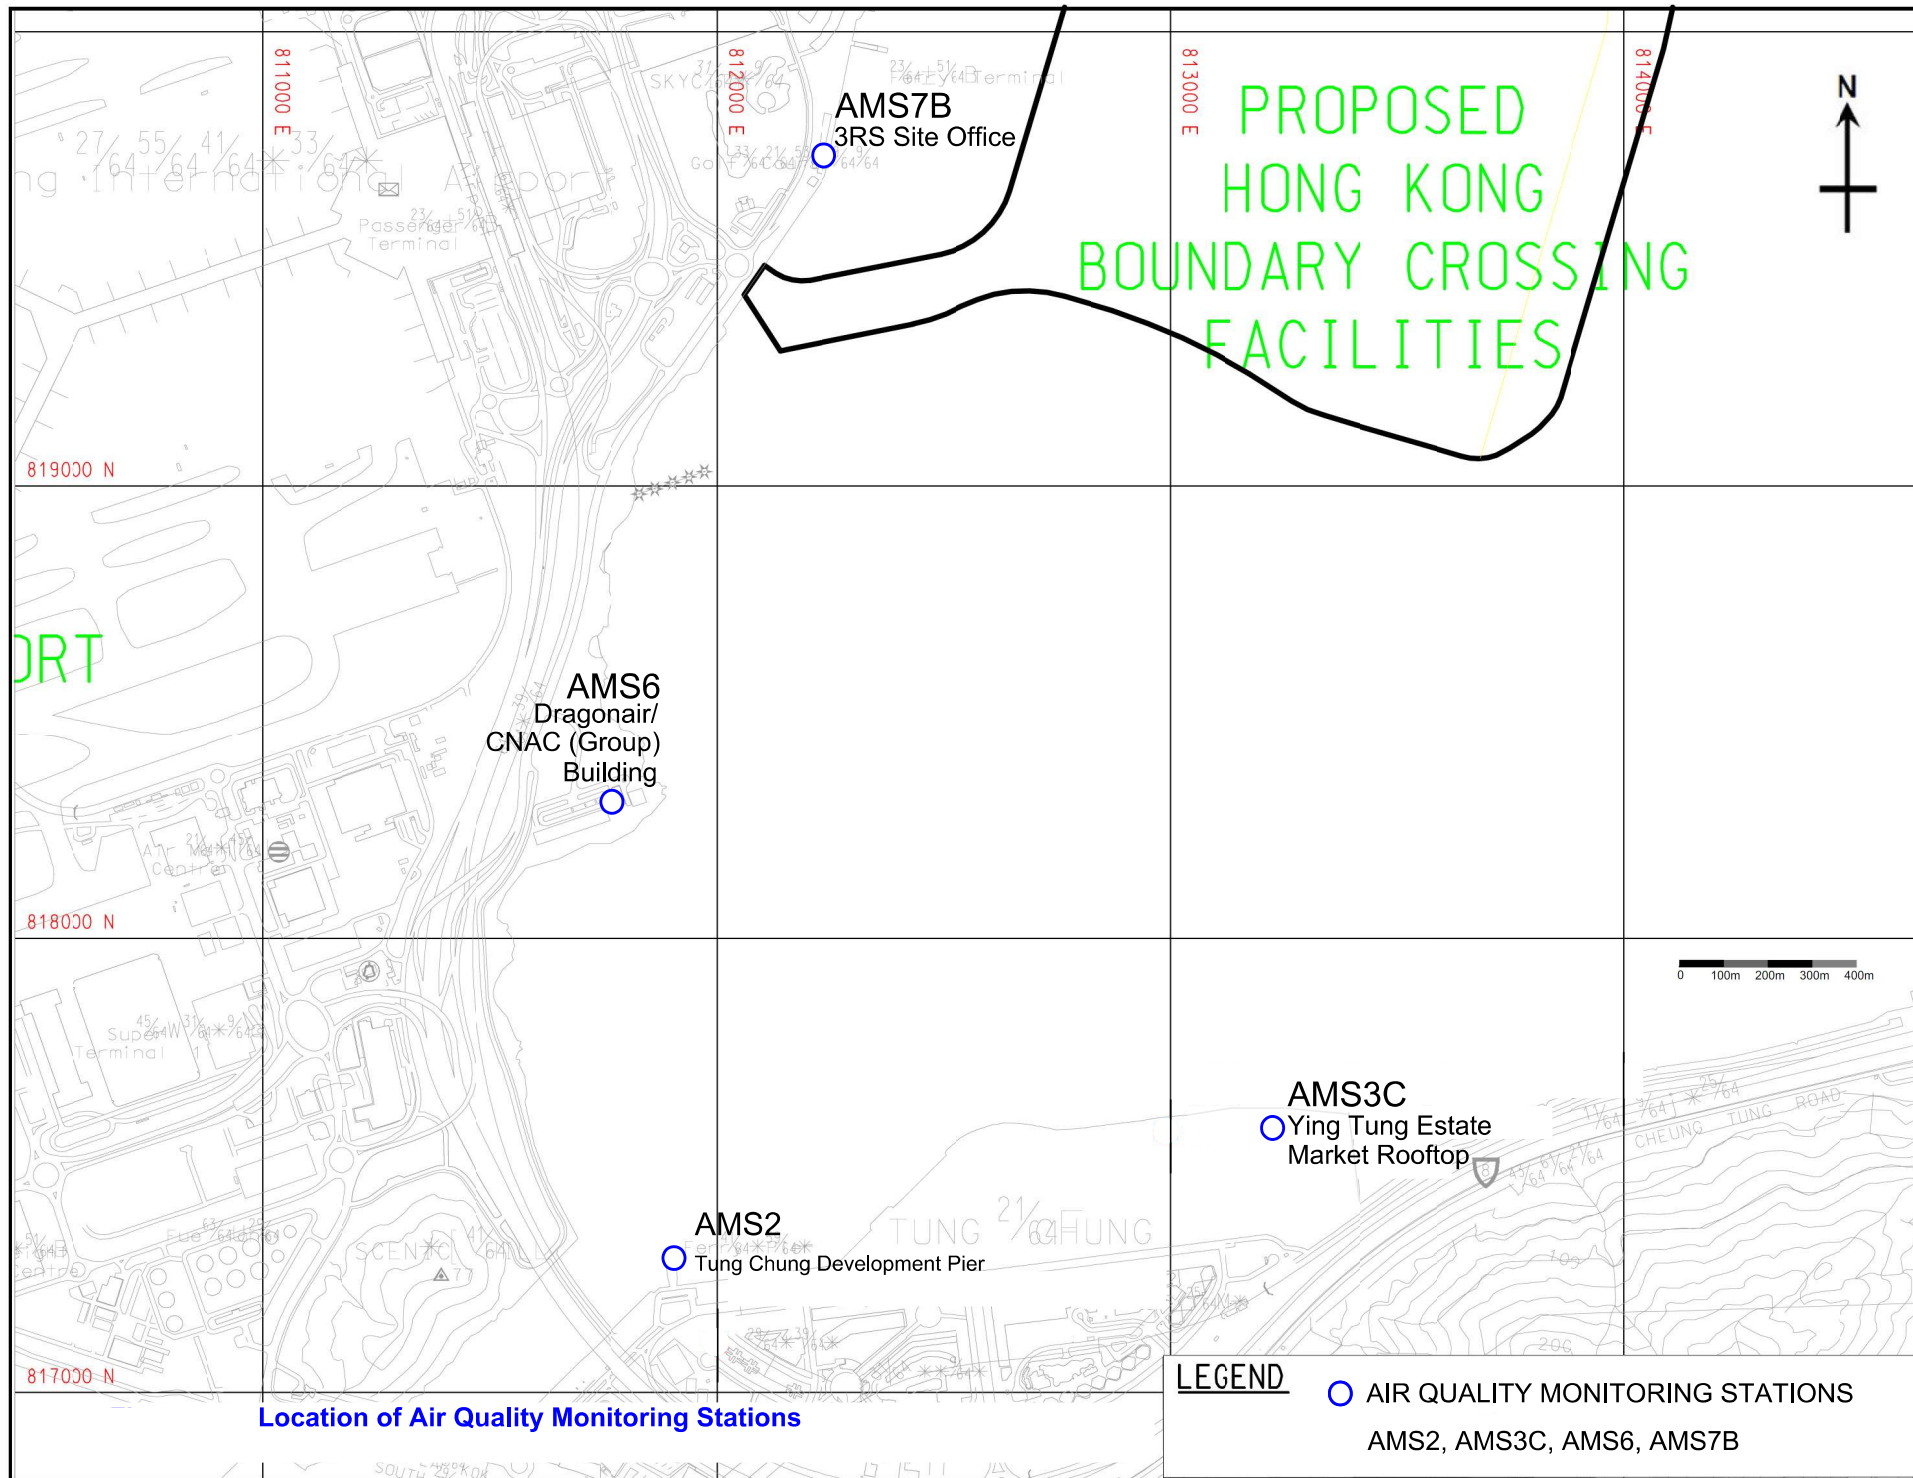
Figure 2

The Location of the Air Quality Monitoring Station

Location of Air Quality Monitoring Stations

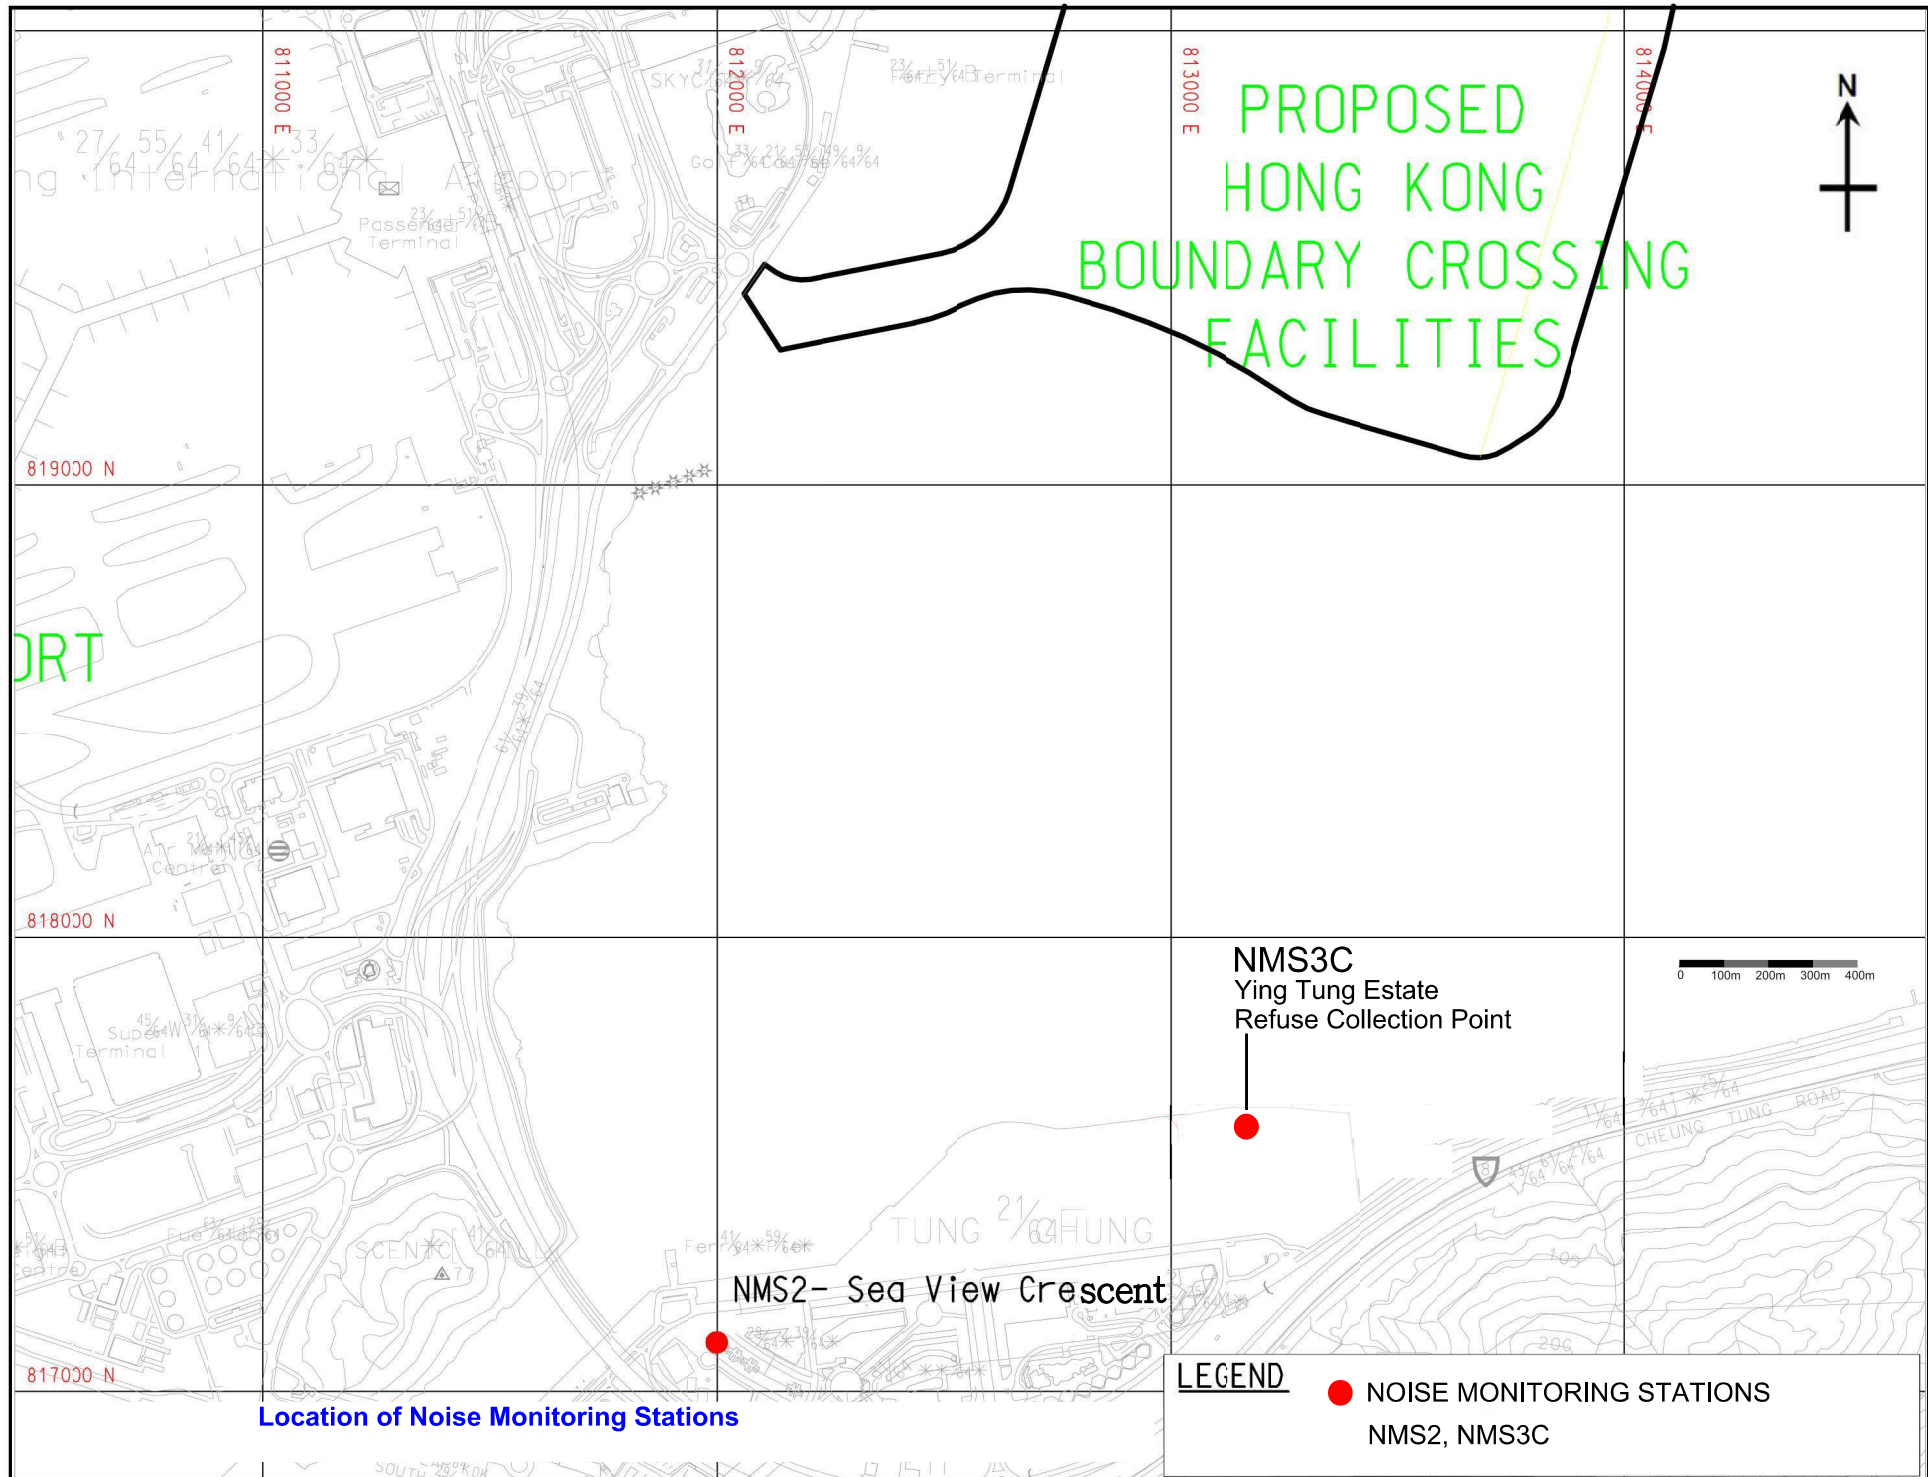
Figure 3

The Location of the Noise Monitoring Station

Location of Noise Monitoring Stations

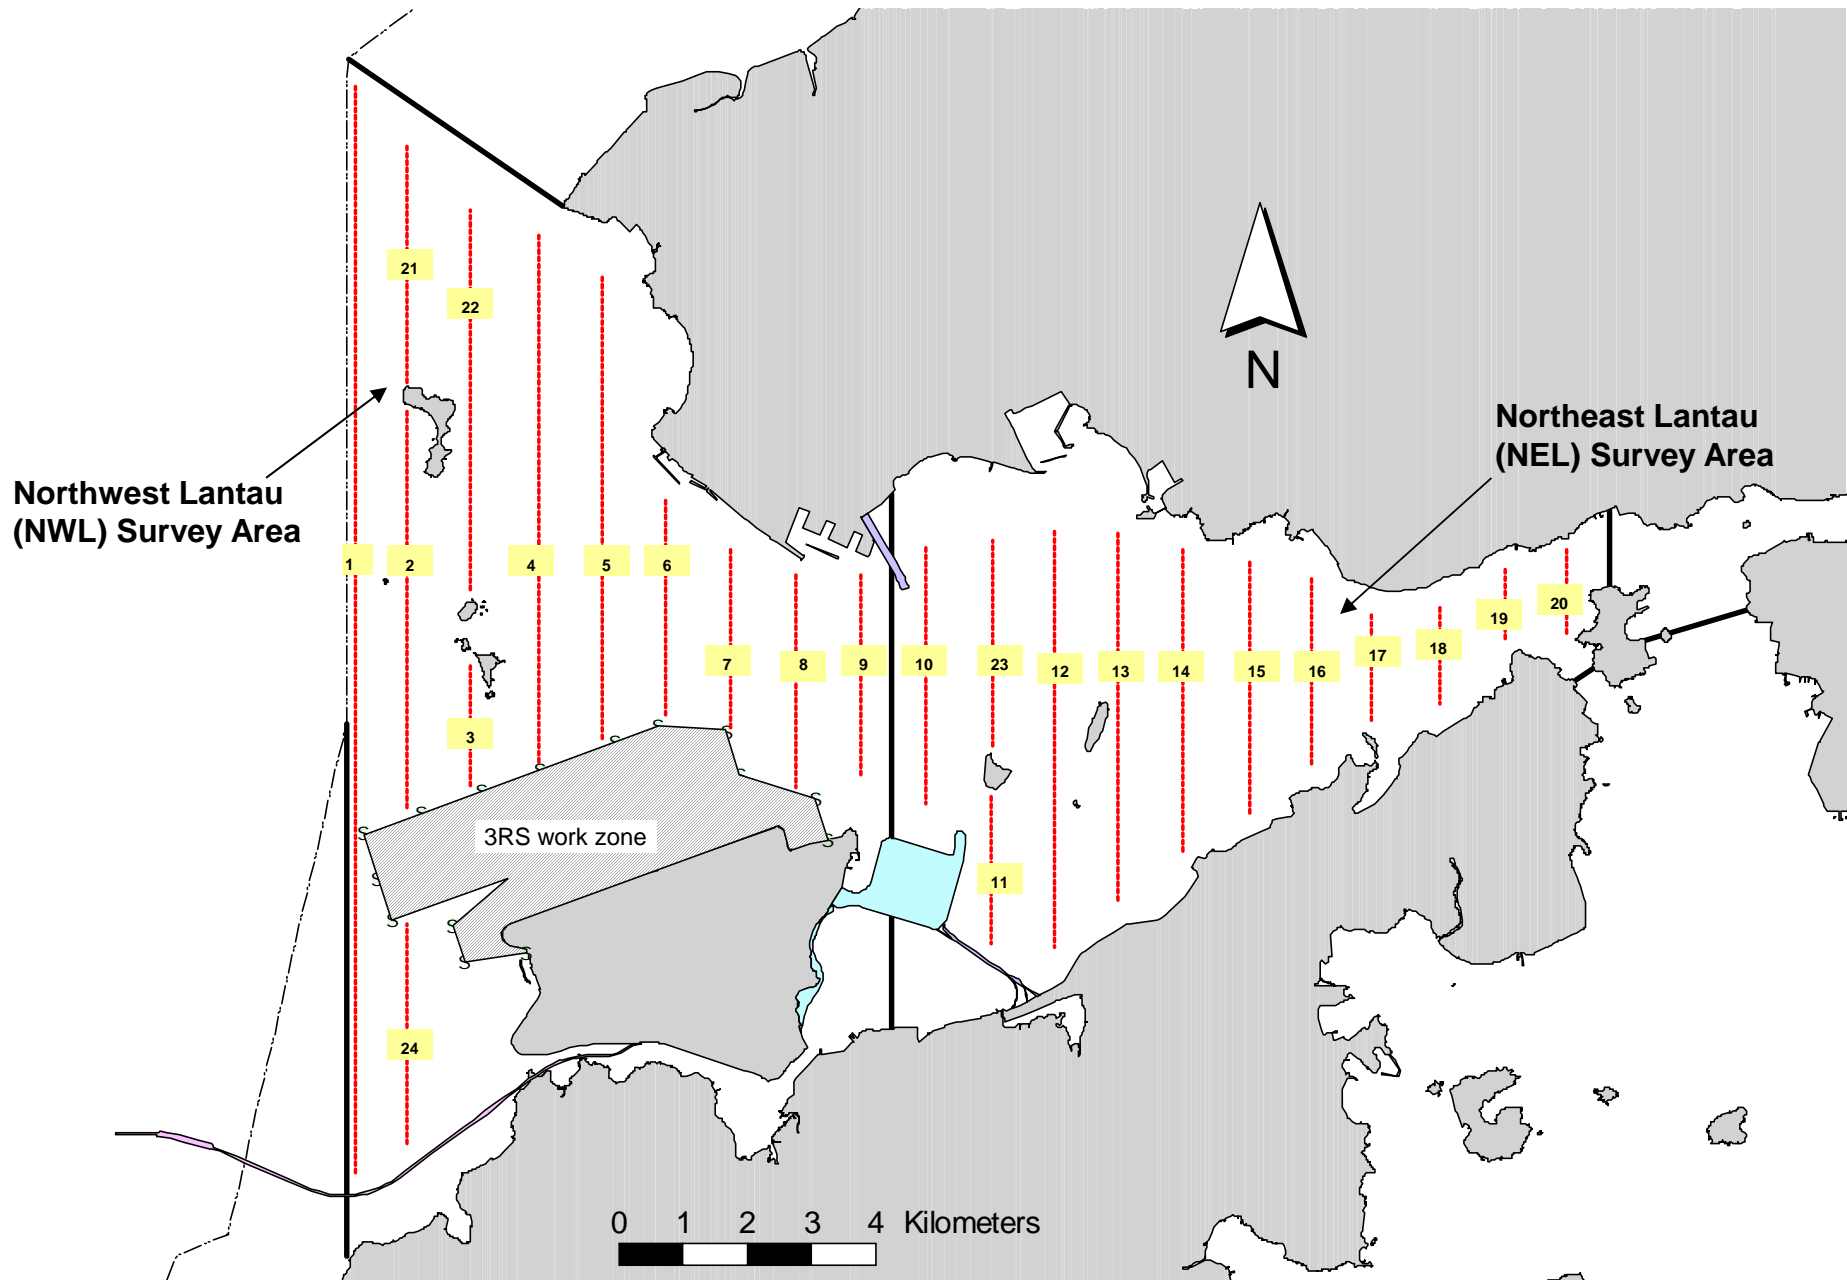
Figure 4

Post-Construction Dolphin Monitoring Line Transect
Layout Map

Transect Line Layout in Northwest and Northeast Lantau Survey Areas

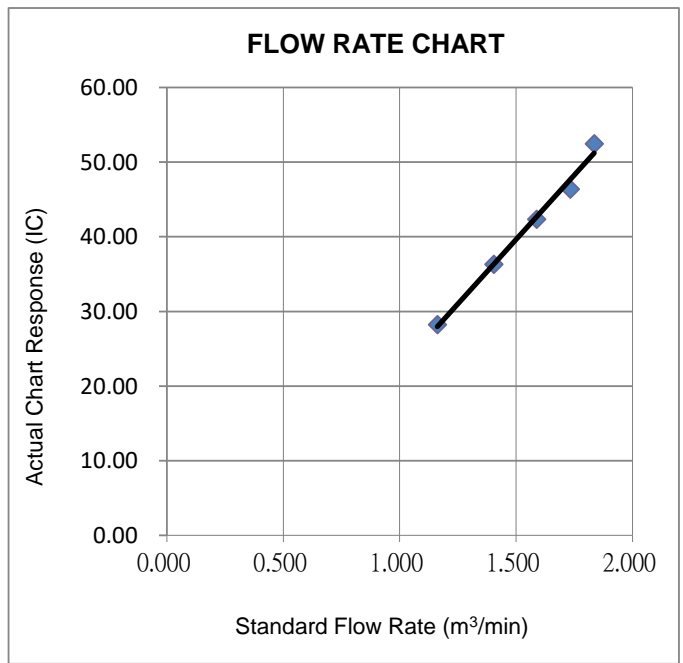
Calculations:
 $Q_{std} = 1/m[\sqrt{H_2O(P_a/P_{std})(T_{std}/T_a)}] - b$
 $IC = I[\sqrt{P_a/P_{std}}(T_{std}/T_a)]$
 Qstd = standard flow rate
 IC = corrected chart response
 I = actual chart response
 m = calibrator Qstd slope
 b = calibrator Qstd intercept
 T_a = actual temperature during calibration (deg K)
 P_a = actual pressure during calibration (mm Hg)
 T_{std} = 298 deg K
 P_{std} = 760 mm Hg

For subsequent calculation of sampler flow:
 $1/m(I[\sqrt{298/T_{av}}](P_{av}/760)] - b)$
 m = sampler slope
 b = sampler intercept
 I = chart response
 T_{av} = daily average temperature
 P_{av} = daily average pressure

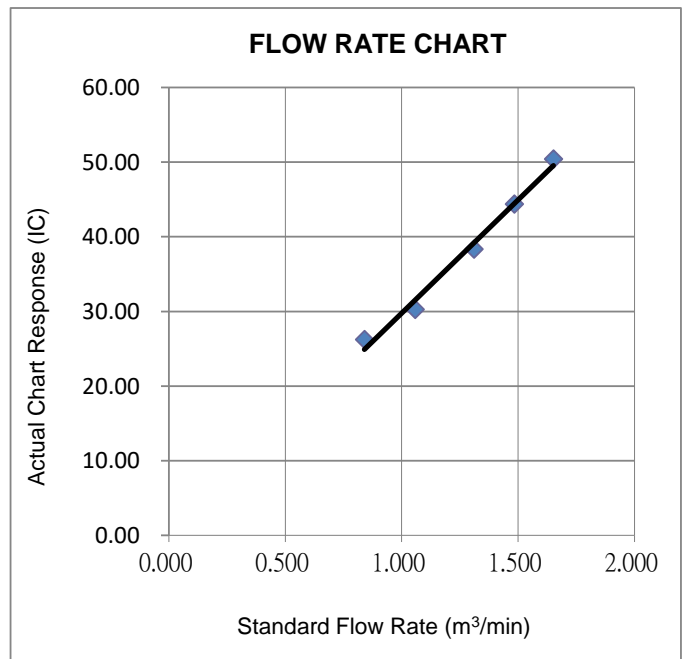
Calculations:
 $Q_{std} = 1/m[\sqrt{H_2O(P_a/P_{std})(T_{std}/T_a)}] - b$
 $IC = I[\sqrt{P_a/P_{std}}(T_{std}/T_a)]$
 Qstd = standard flow rate
 IC = corrected chart response
 I = actual chart response
 m = calibrator Qstd slope
 b = calibrator Qstd intercept
 T_a = actual temperature during calibration (deg K)
 P_a = actual pressure during calibration (mm Hg)
 T_{std} = 298 deg K
 P_{std} = 760 mm Hg

For subsequent calculation of sampler flow:
 $1/m((I)[\sqrt{298/T_{av}}](P_{av}/760)] - b$
 m = sampler slope
 b = sampler intercept
 I = chart response
 T_{av} = daily average temperature
 P_{av} = daily average pressure

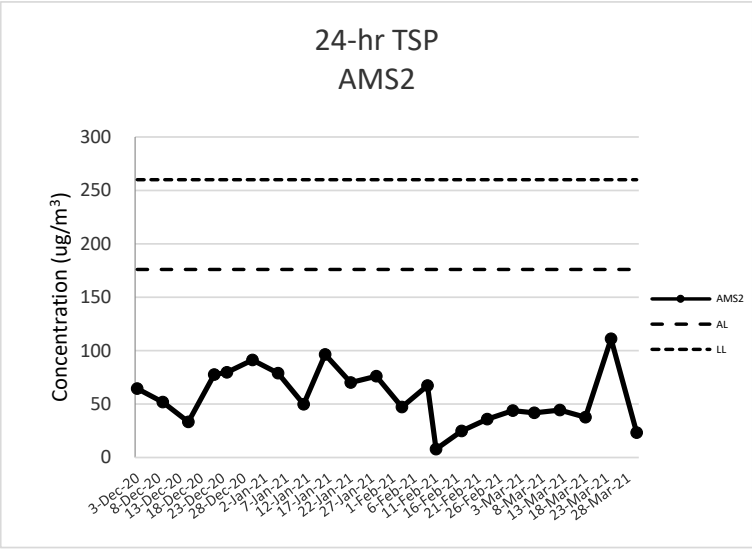
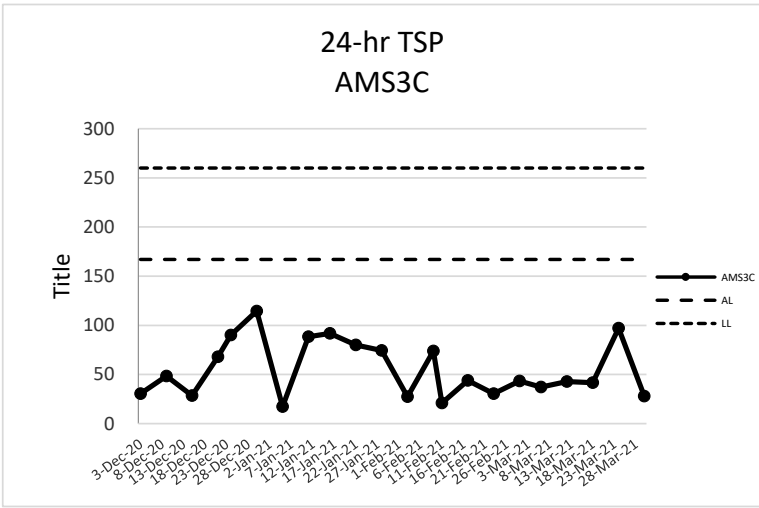
1-hour TSP Monitoring Result for Hong Kong-Zhuhai-Macao Bridge Hong Kong Boundary Crossing Facilities – Phase 2 and Other Works

AMS2 - Tung Chung Development Pier
