**Shatin to Central Link –
Tai Wai to Hung Hom Section and
Mong Kok East to Hung Hom Section**

Monthly EM&A Report No. 51

[Period from 1 to 30 November 2016]

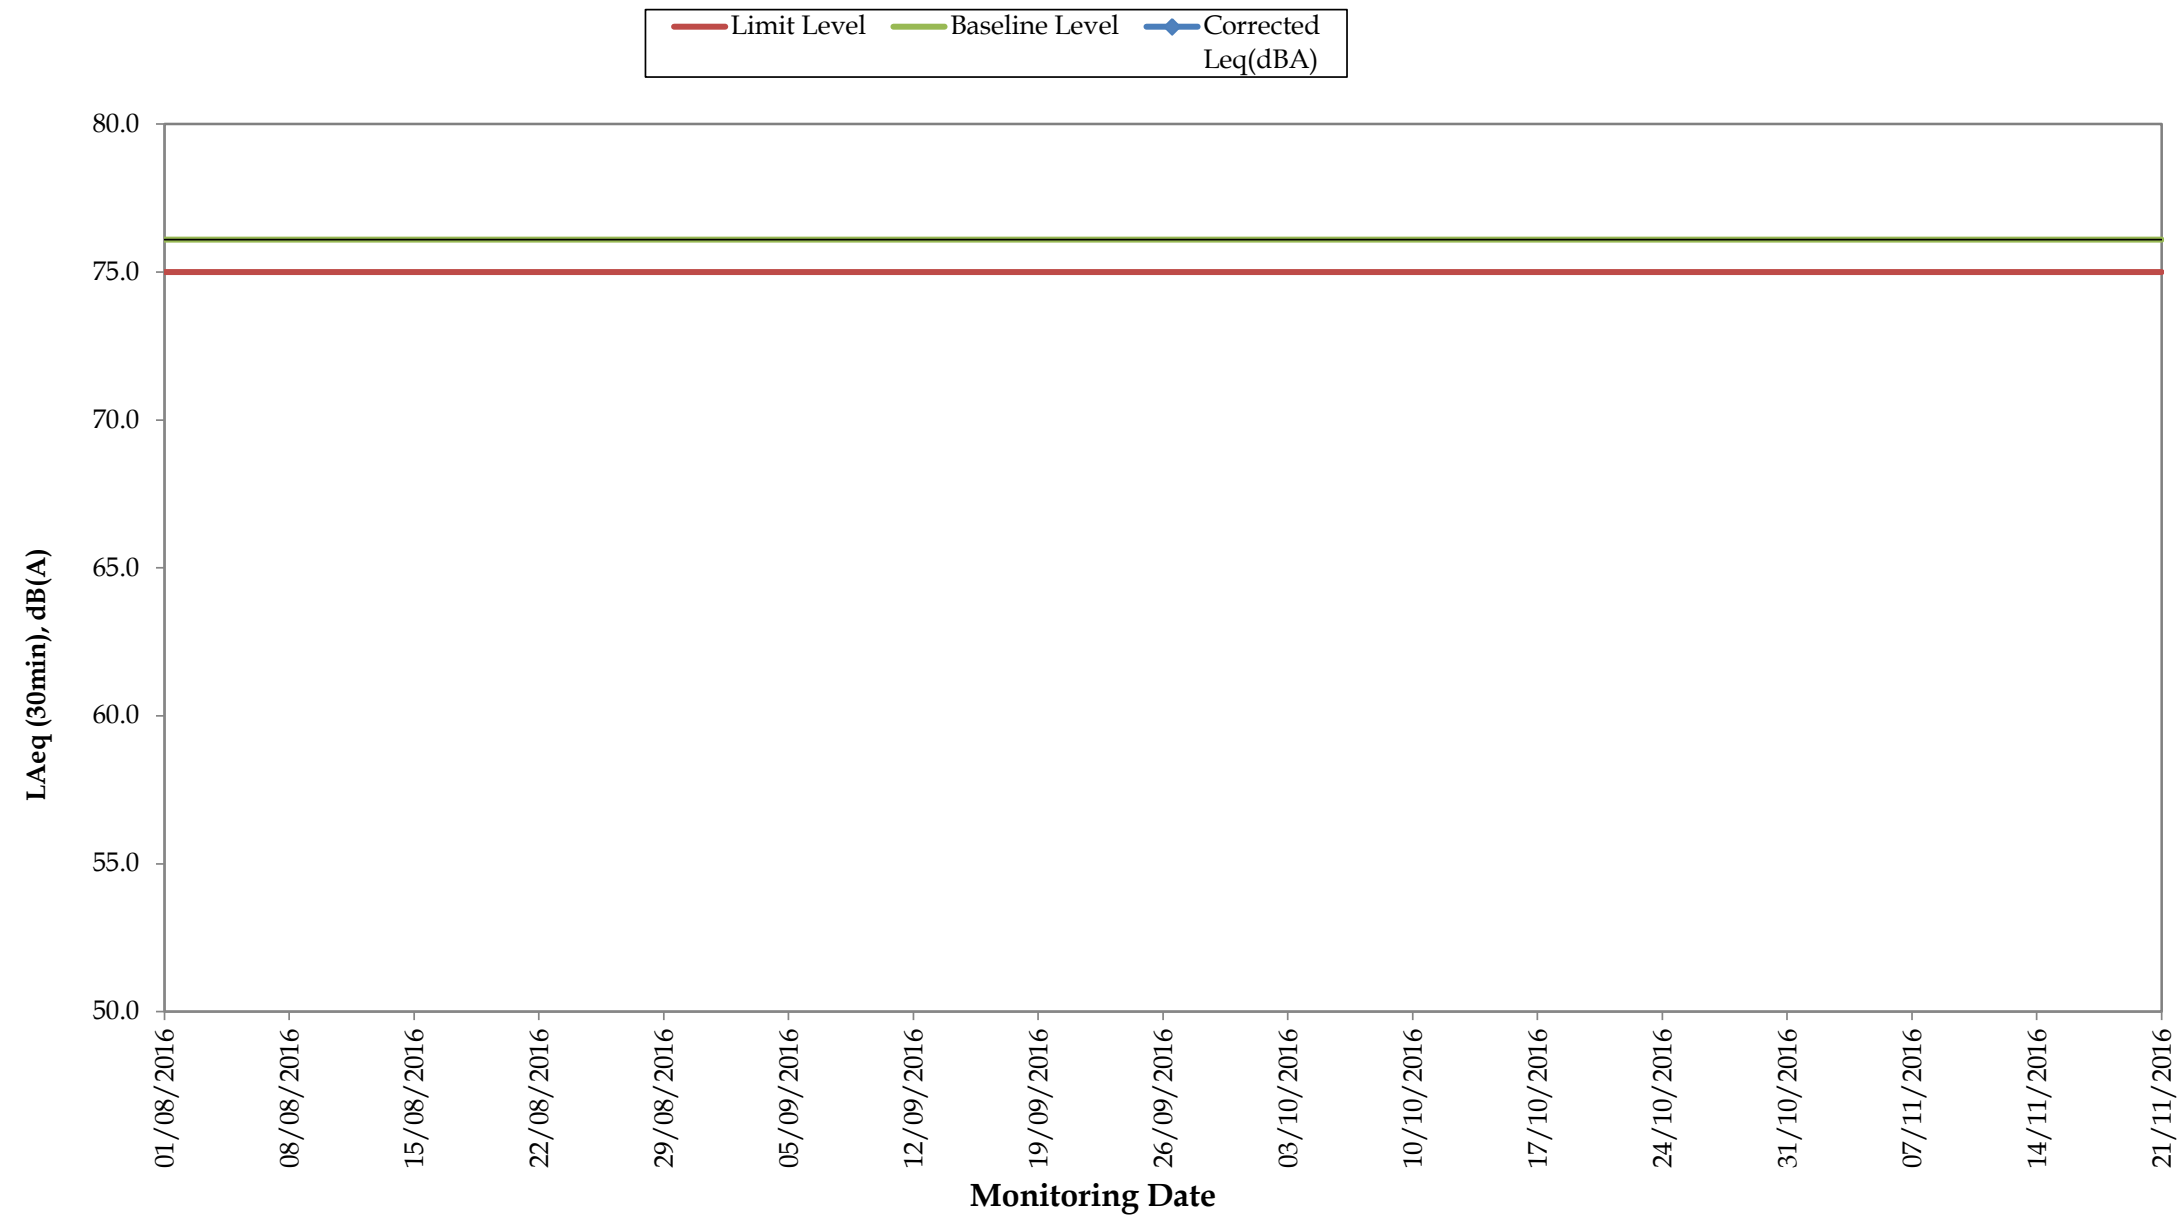
Regular Noise Monitoring Results at NMS-CA-6 (No. 16-23 Nam Kok Road) (LAeq, 30min) for the Past 4 Months

- For those corrected noise levels that are not shown in this graph, the measured noise levels are equal to or below baseline level.

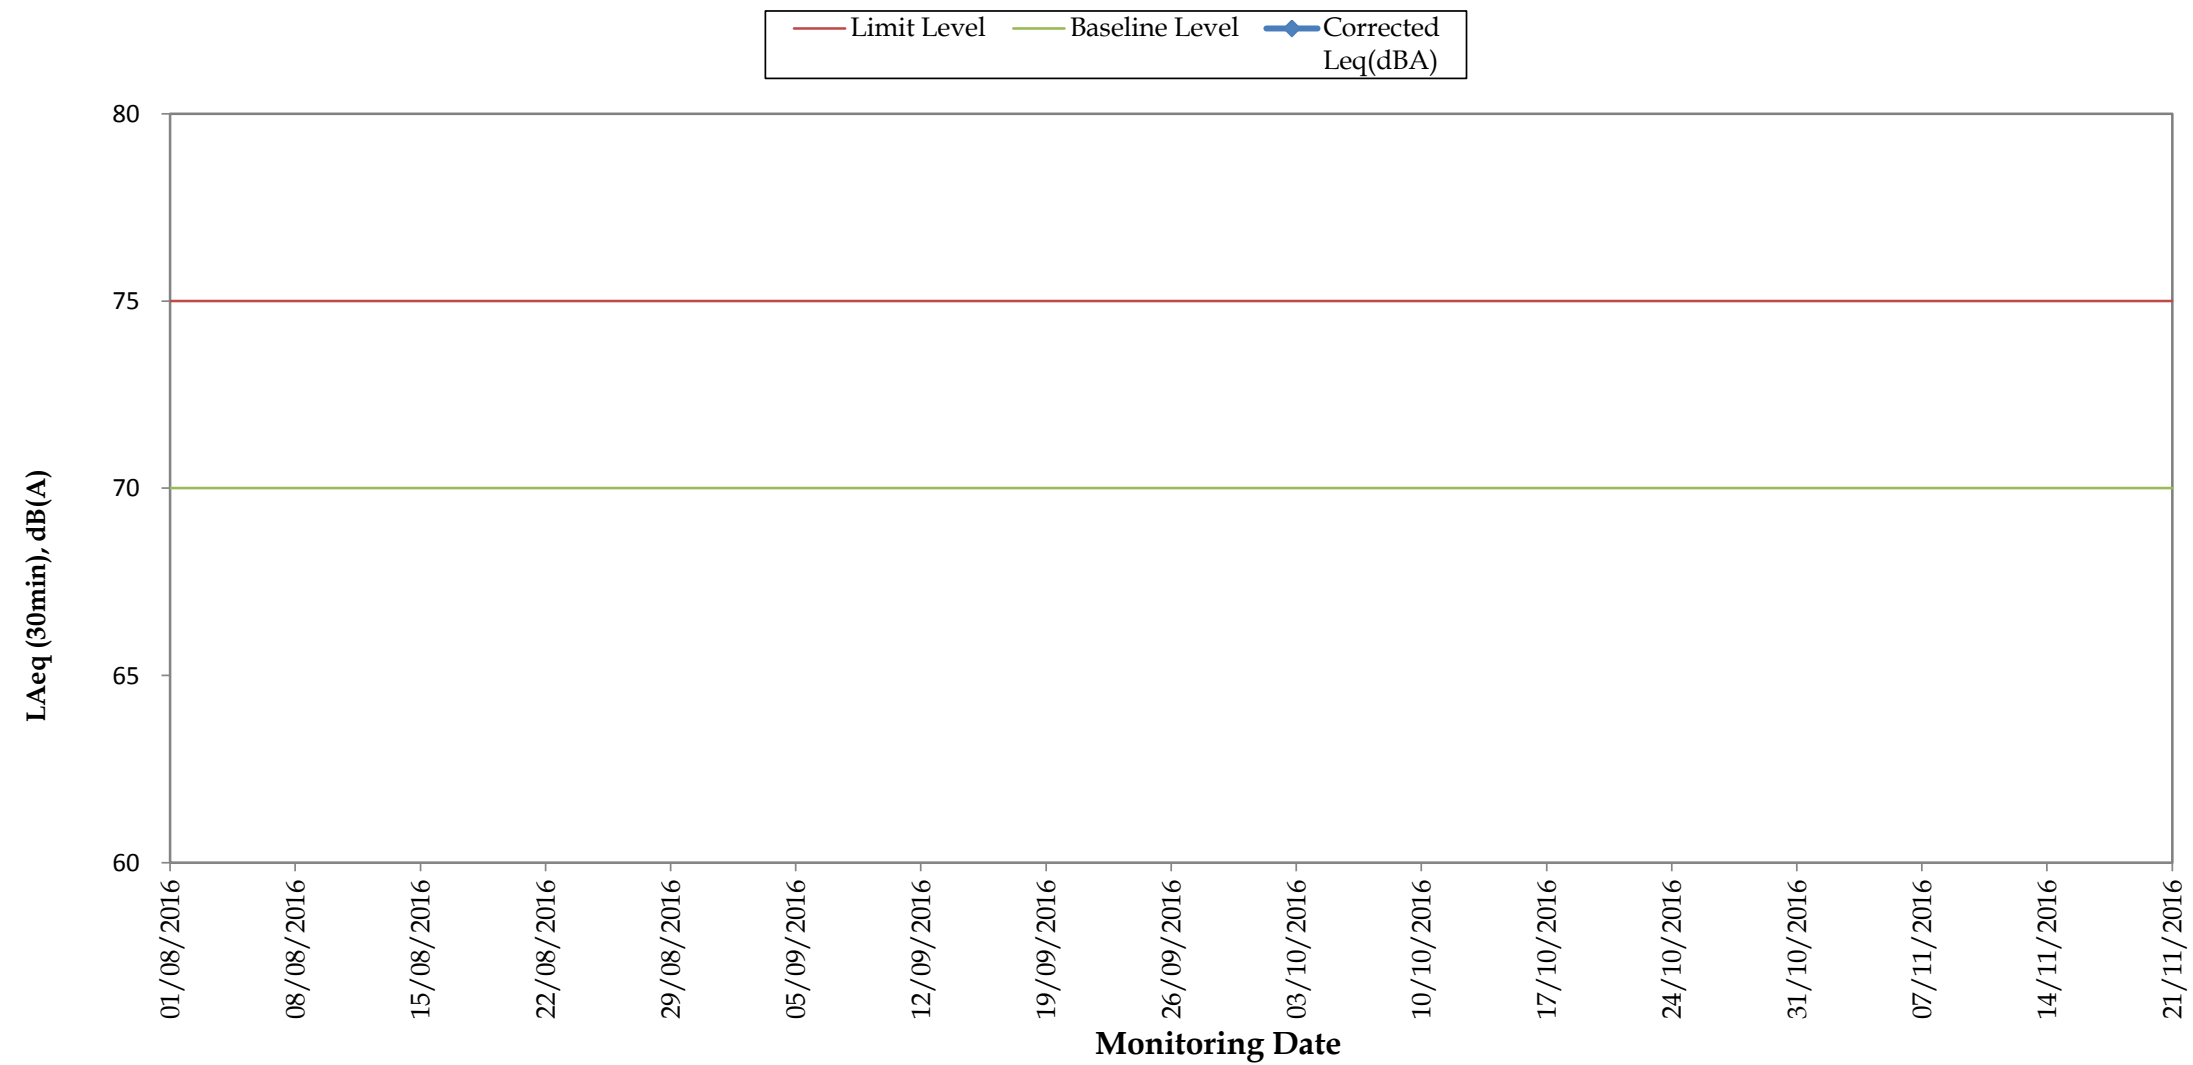
Regular Noise Monitoring Results at NMS-CA-7 (Skytower Tower 2) (LAeq, 30min) for the Past 4 Months

- For those corrected noise levels that are not shown in this graph, the measured noise levels are equal to or below baseline level.

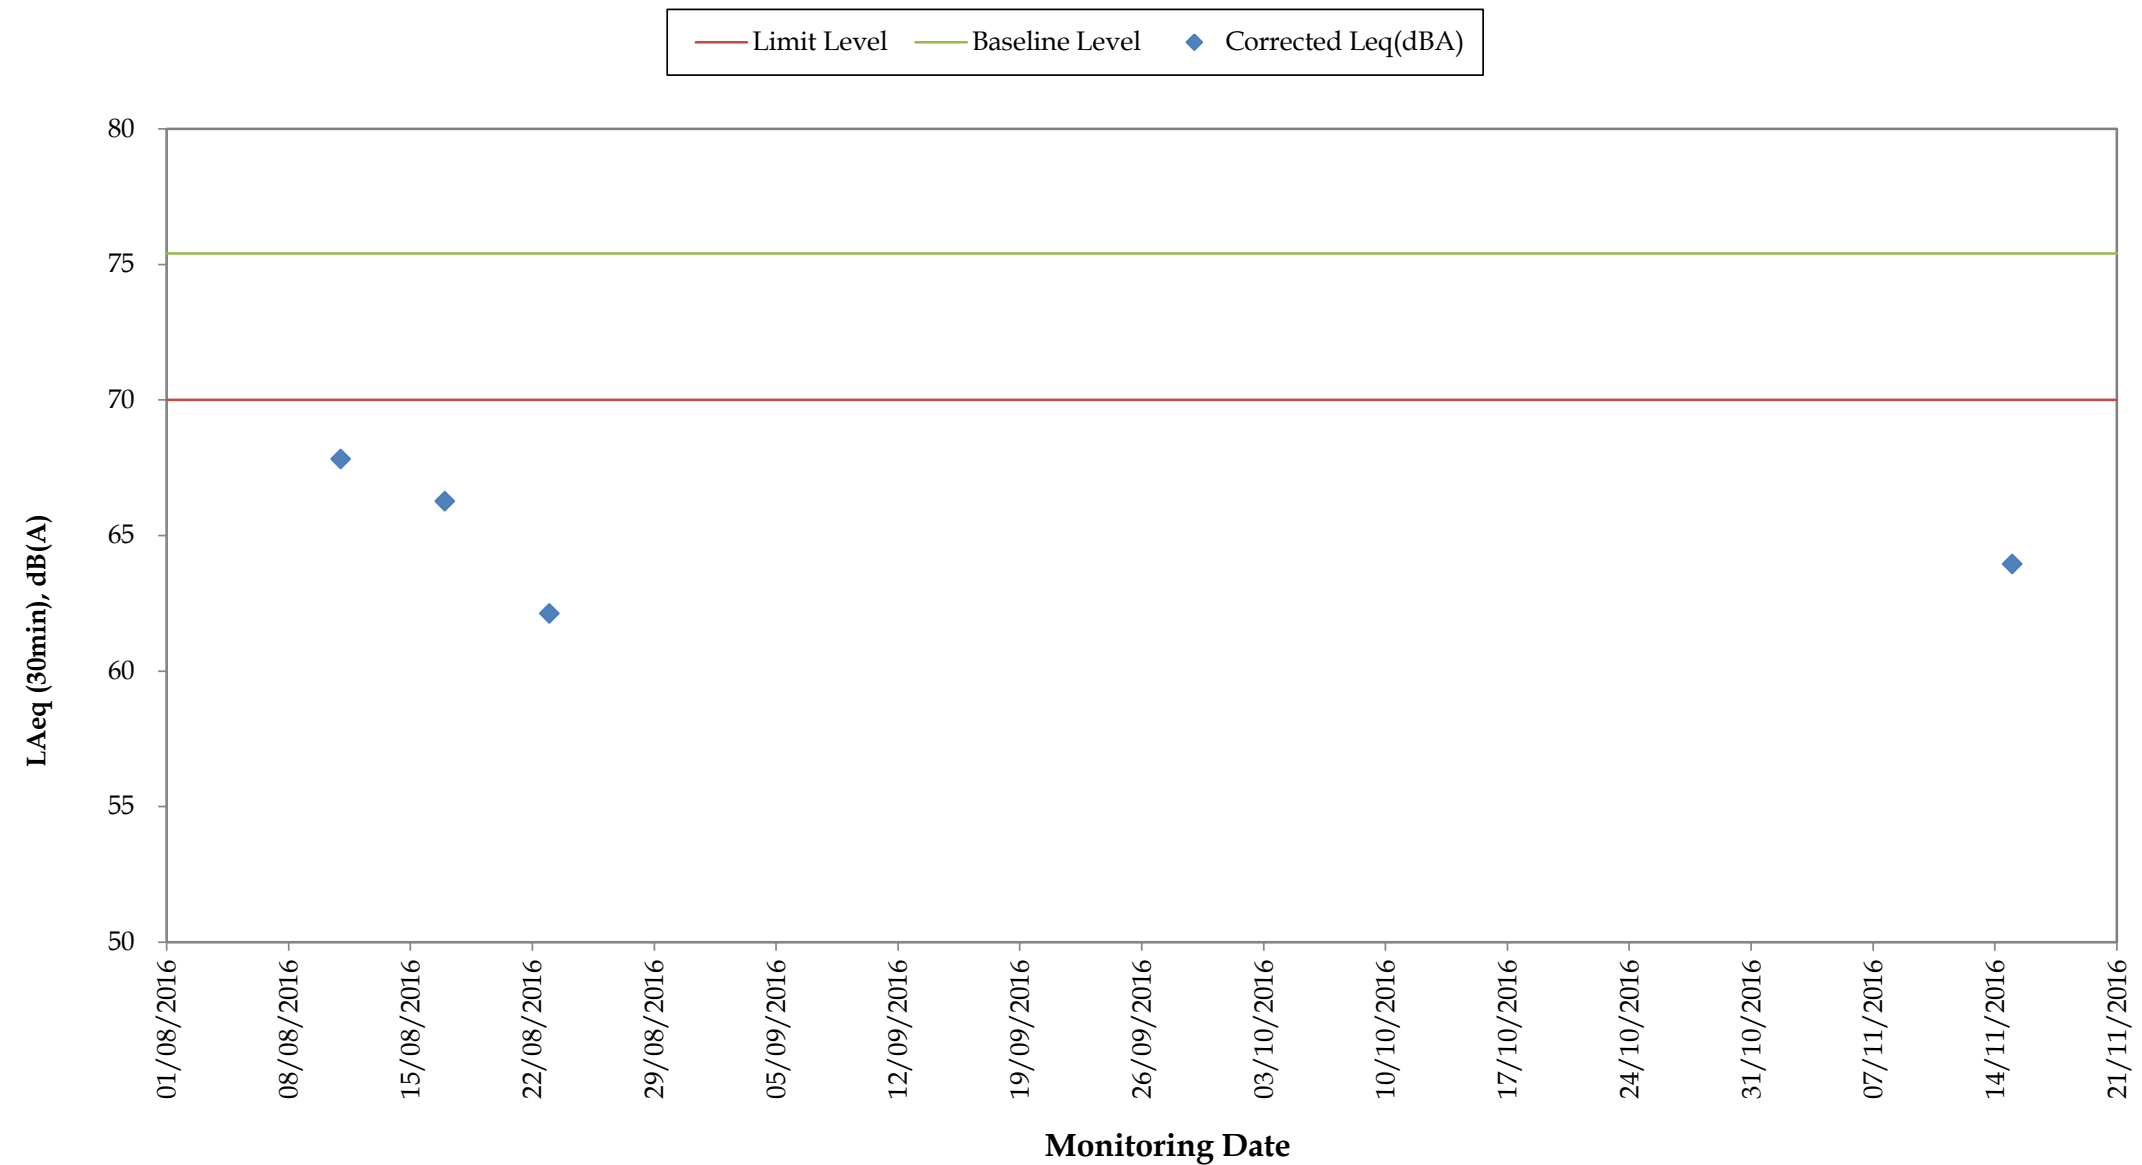
Regular Noise Monitoring Results at NMS-CA- 8 (SKH Good Shepherd Primary School) (LAeq, 30min) for the Past 4 Months

- For those corrected noise levels that are not shown in this graph, the measured noise levels are equal to or below baseline level.
- The limit level was updated from 78dB(A) to 79 dB(A) on 22 Aug 2013 as per the latest CNMP and CNMMP.
- The limit level was updated from 79dB(A) to 70dB(A)/65dB(A) (during normal/examination period) from April 2016, as the continuous noise monitoring was completed in March 2016 according to the latest CNMP

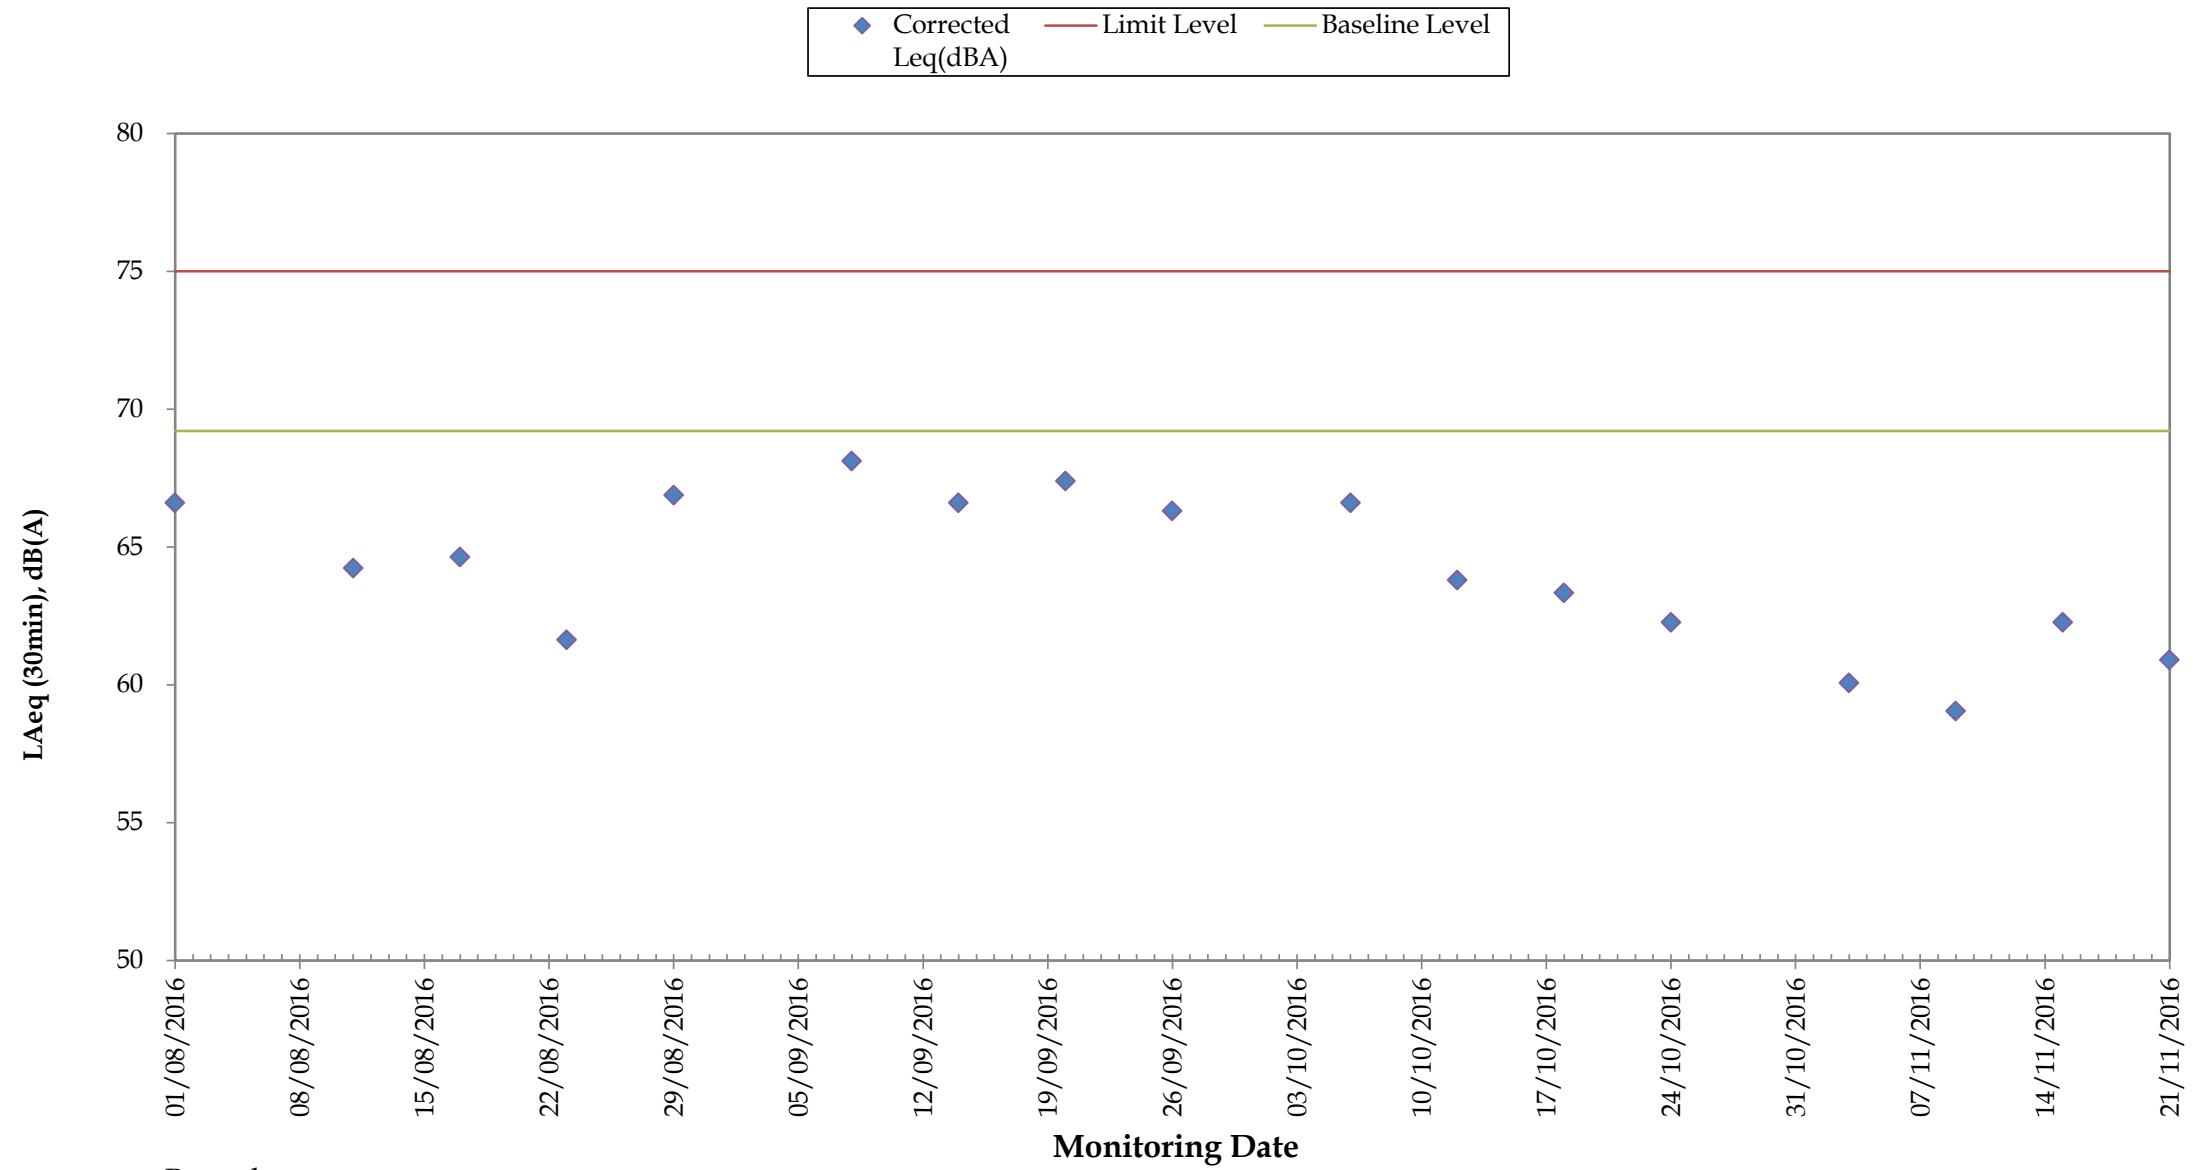
Regular Noise Monitoring Results at NMS-CA-9 (Kong Yiu Mansion) (LAeq, 30min)) for the Past 4 Months

- For those corrected noise levels that are not shown in this graph, the measured noise levels are equal to or below baseline level.

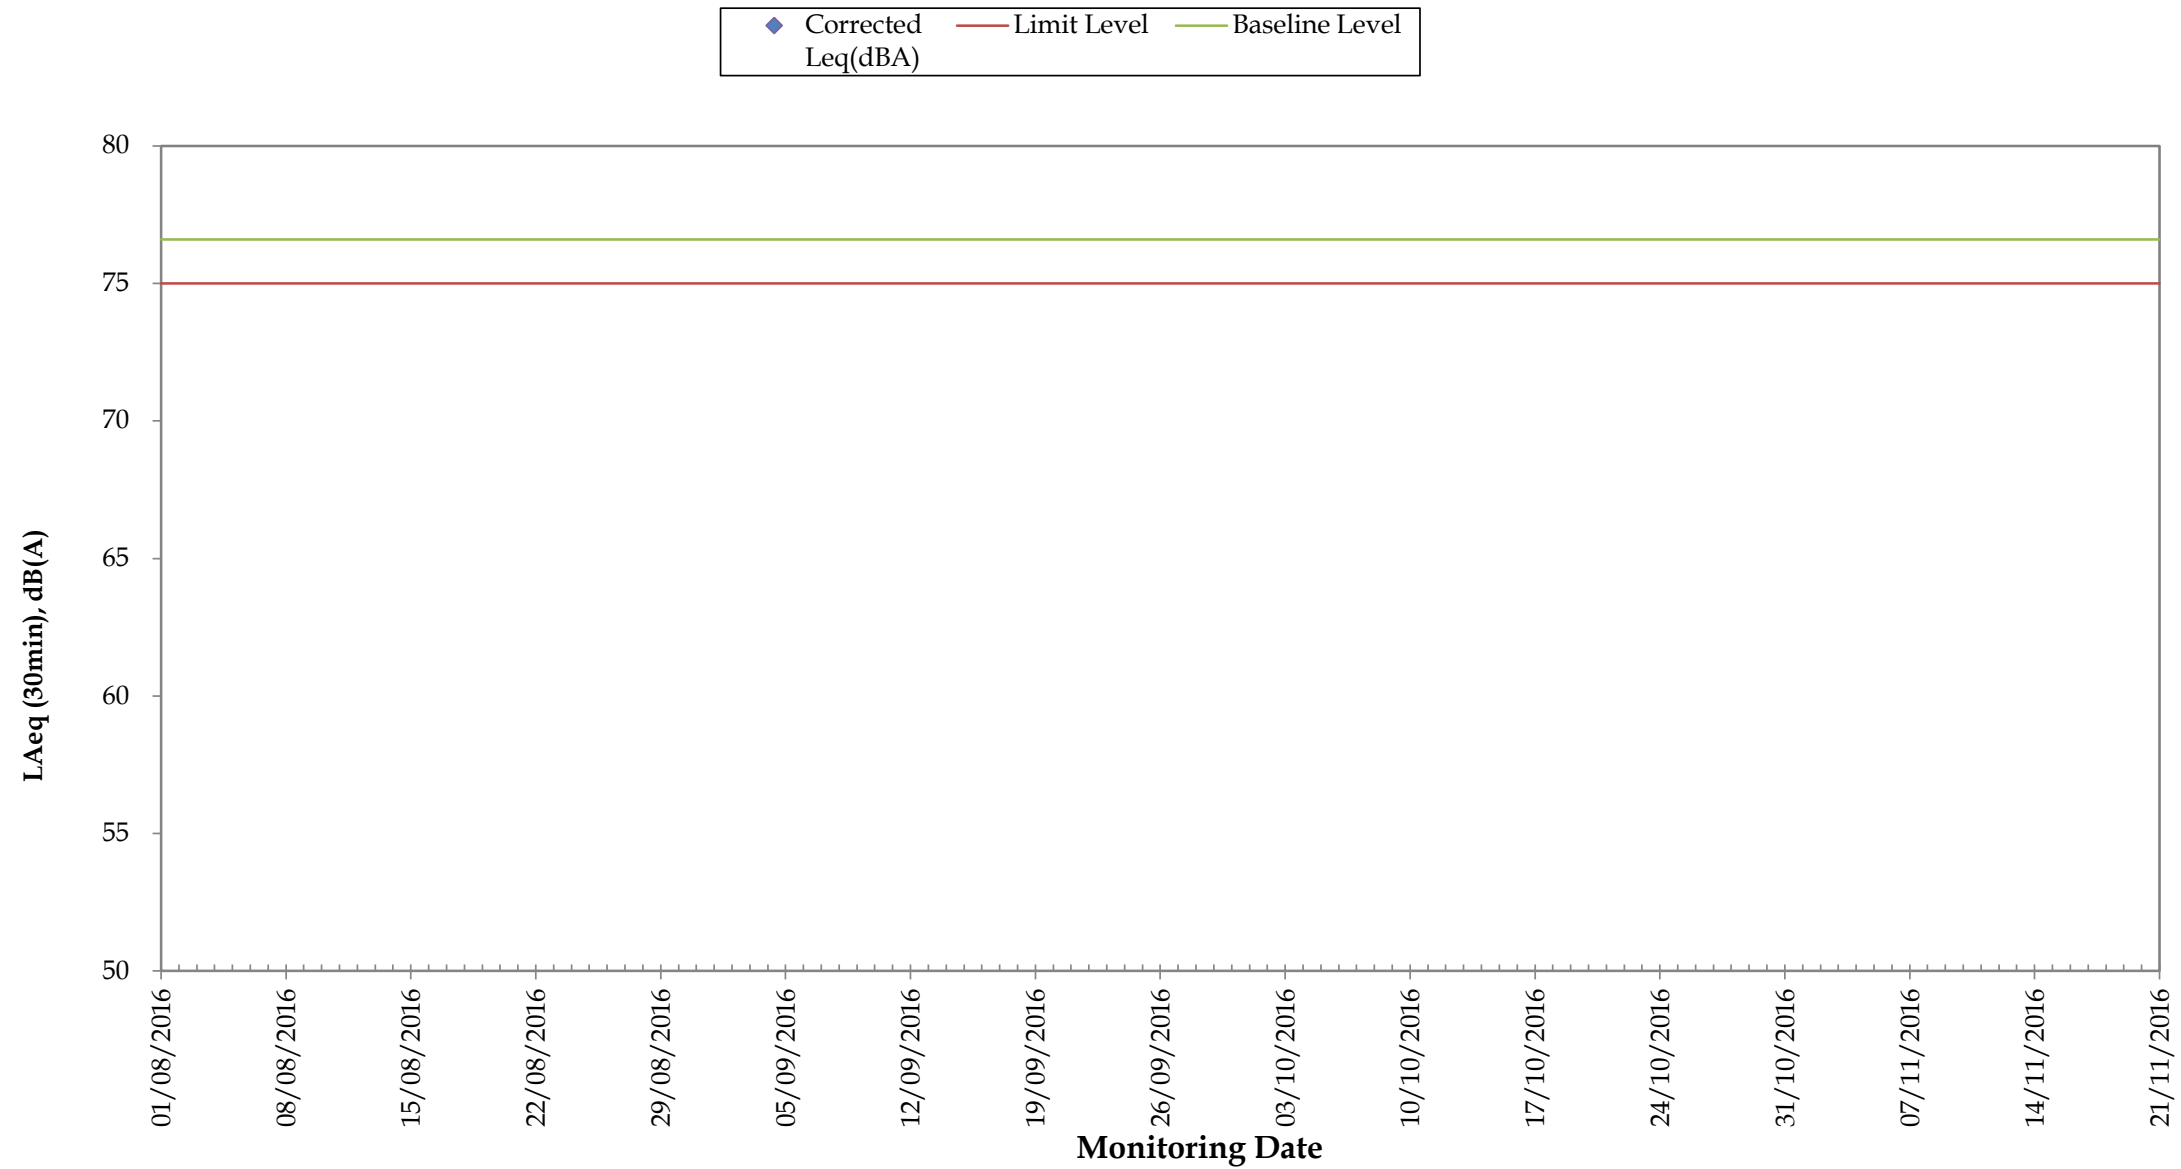
Regular Noise Monitoring Results at NMS-CA-10 (Chat Ma Mansion) (LAeq, 30min) for the Past 4 Months

- For those corrected noise levels that are not shown in this graph, the measured noise levels are equal to or below baseline level.

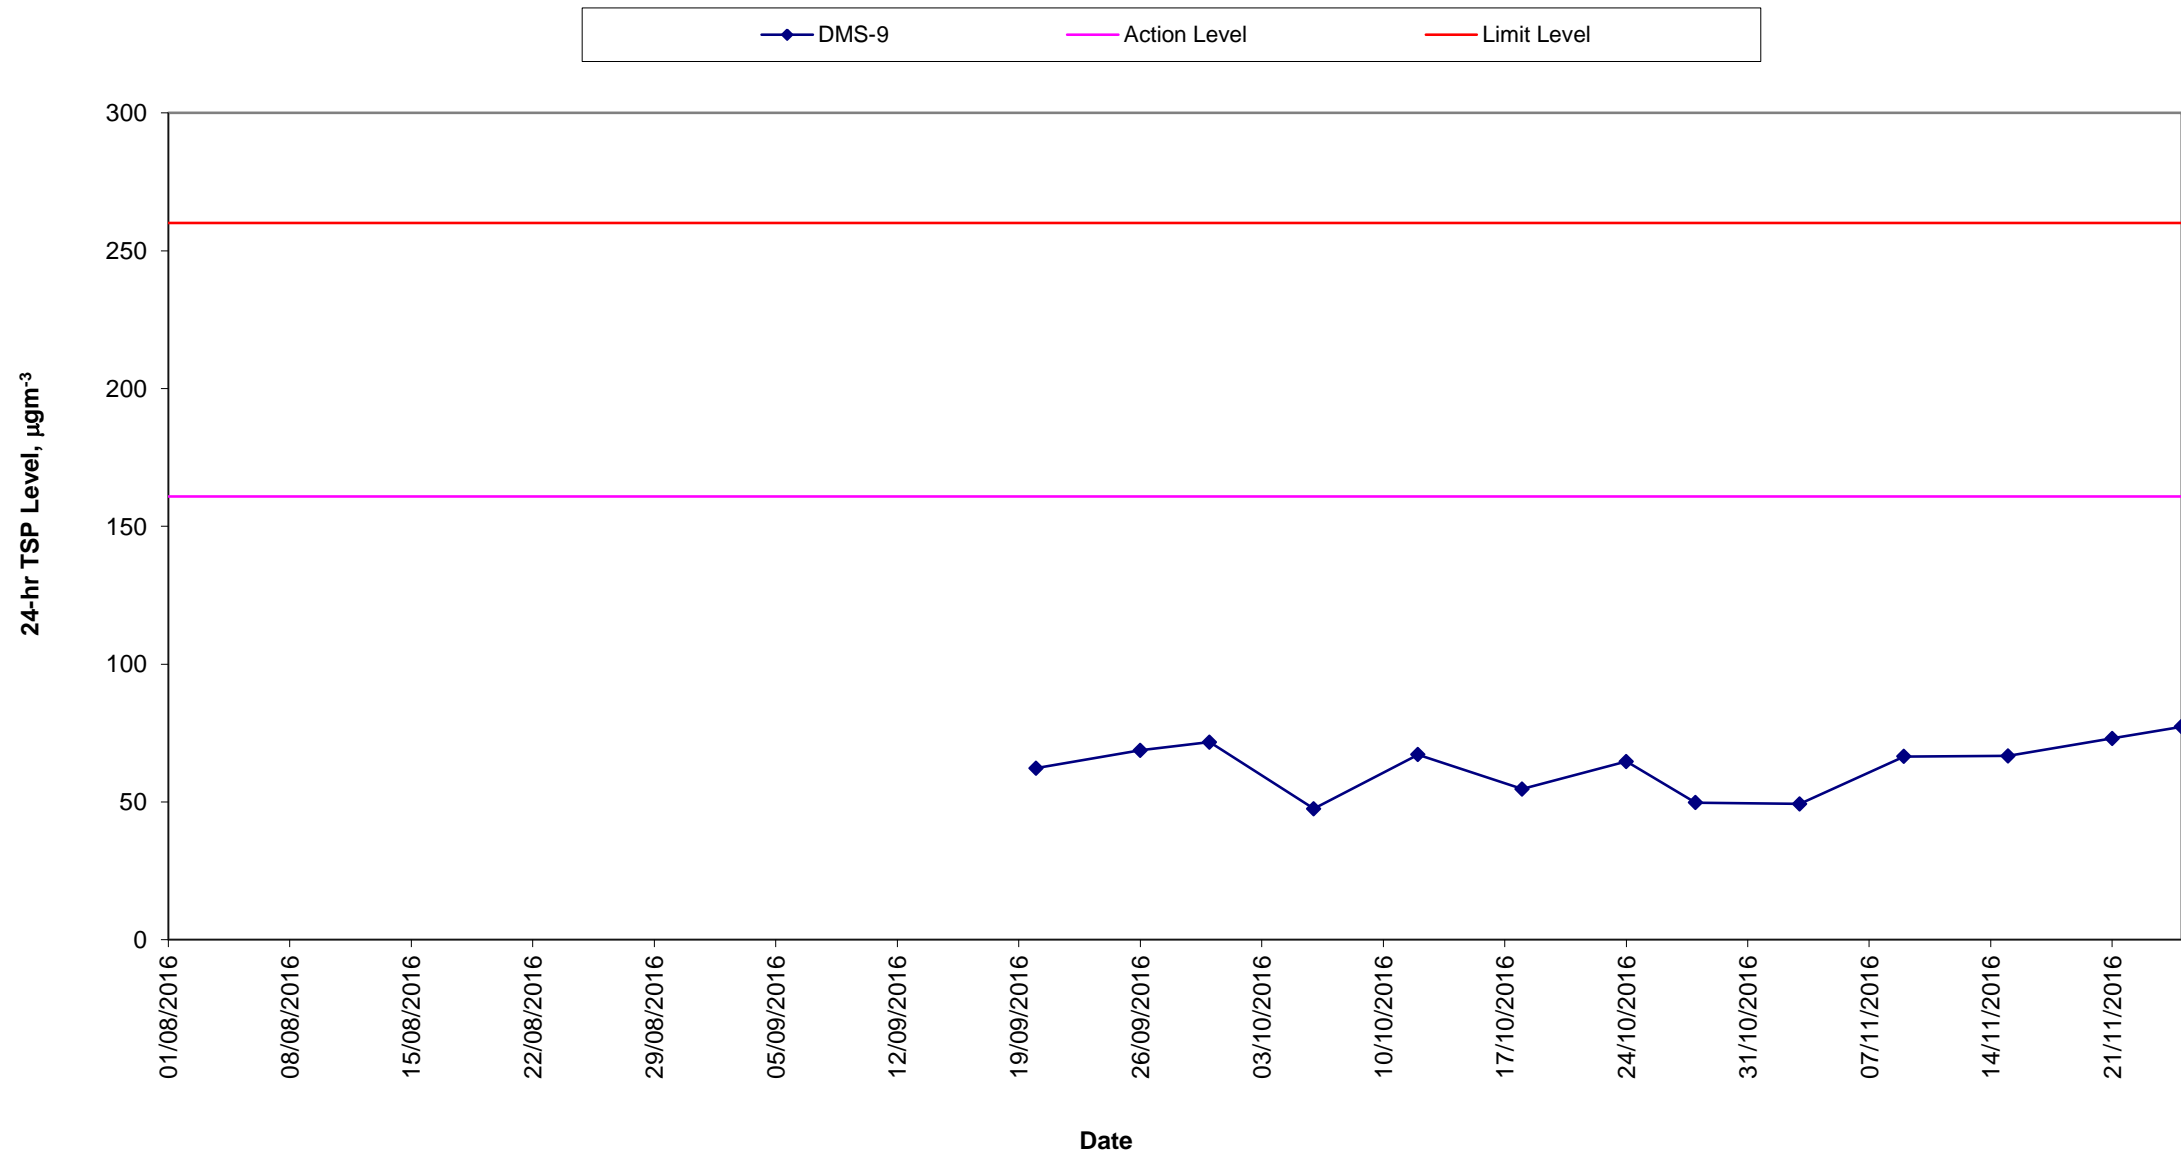
Construction Dust Monitoring Results for the Past 4 Months DMS-9 (No.12 Pau Chung Street)

- 24-hour averaged dust monitoring at DMS-9 (No. 12 Pau Chung Street) was temporary suspended since July 2016 due to request from the Management Office and was resumed on 20 September 2016.

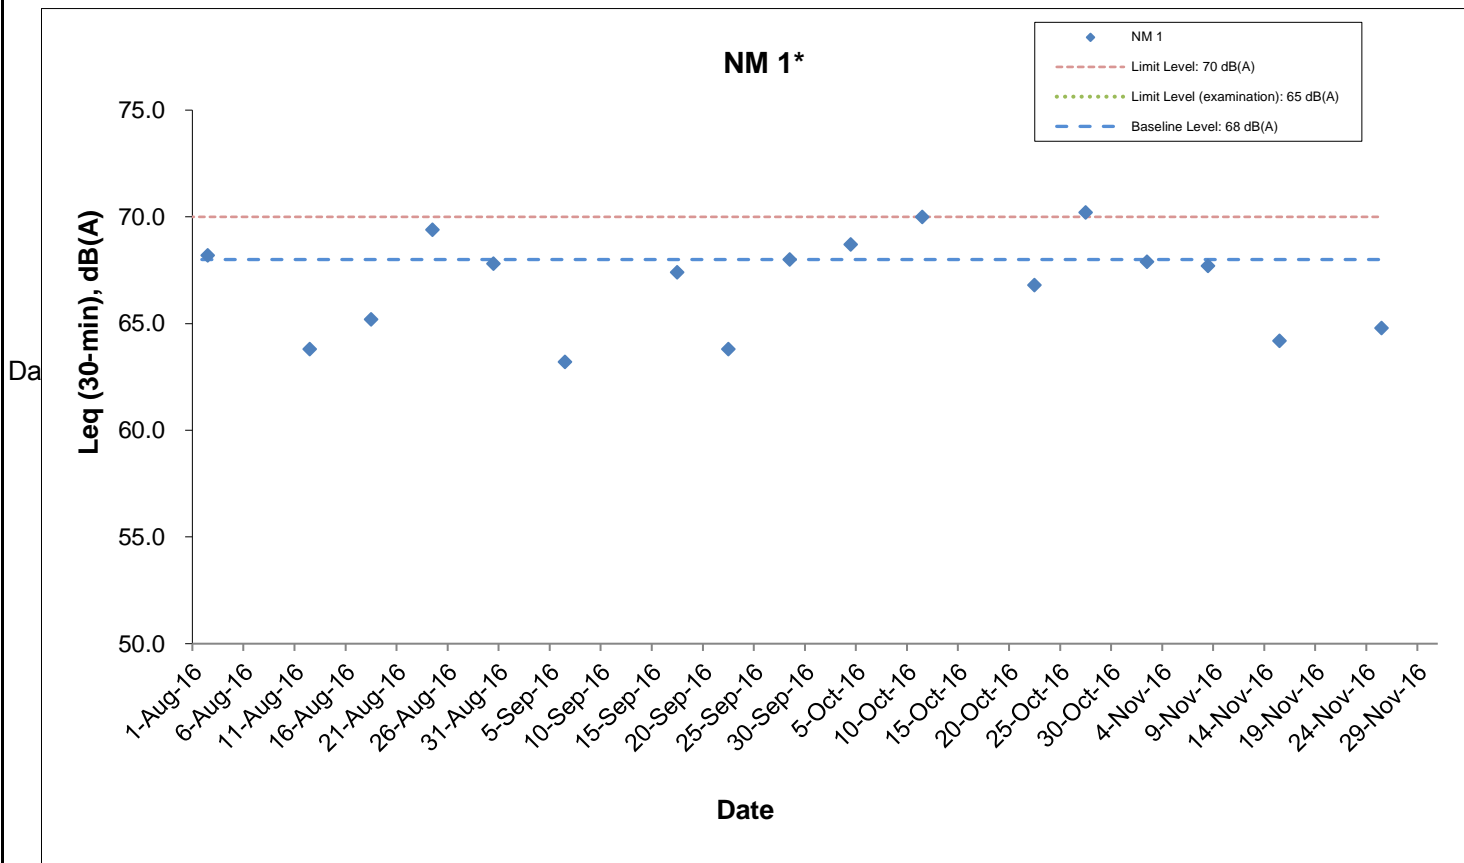
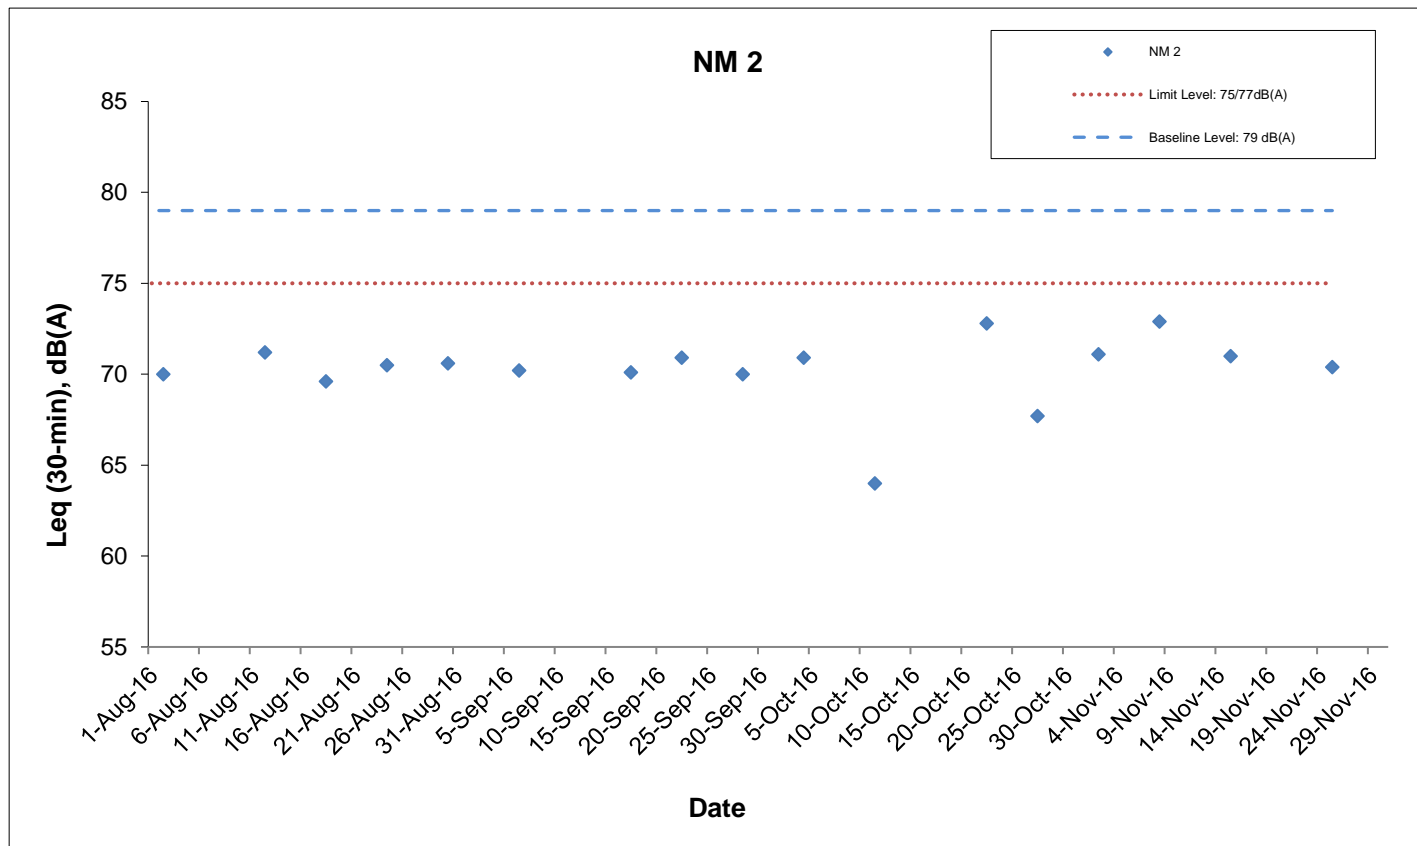
Appendix H Regular Construction Noise Monitoring Results

* - The noise monitoring results of the measurements are higher than the daytime construction noise criterion. However, the results are not considered as exceedance if they are either below the baseline level or below the limit level after deducting the baseline noise level.
