**Shatin to Central Link –
Tai Wai to Hung Hom Section and
Mong Kok East to Hung Hom Section**

Monthly EM&A Report No. 56

[Period from 1 to 30 April 2017]

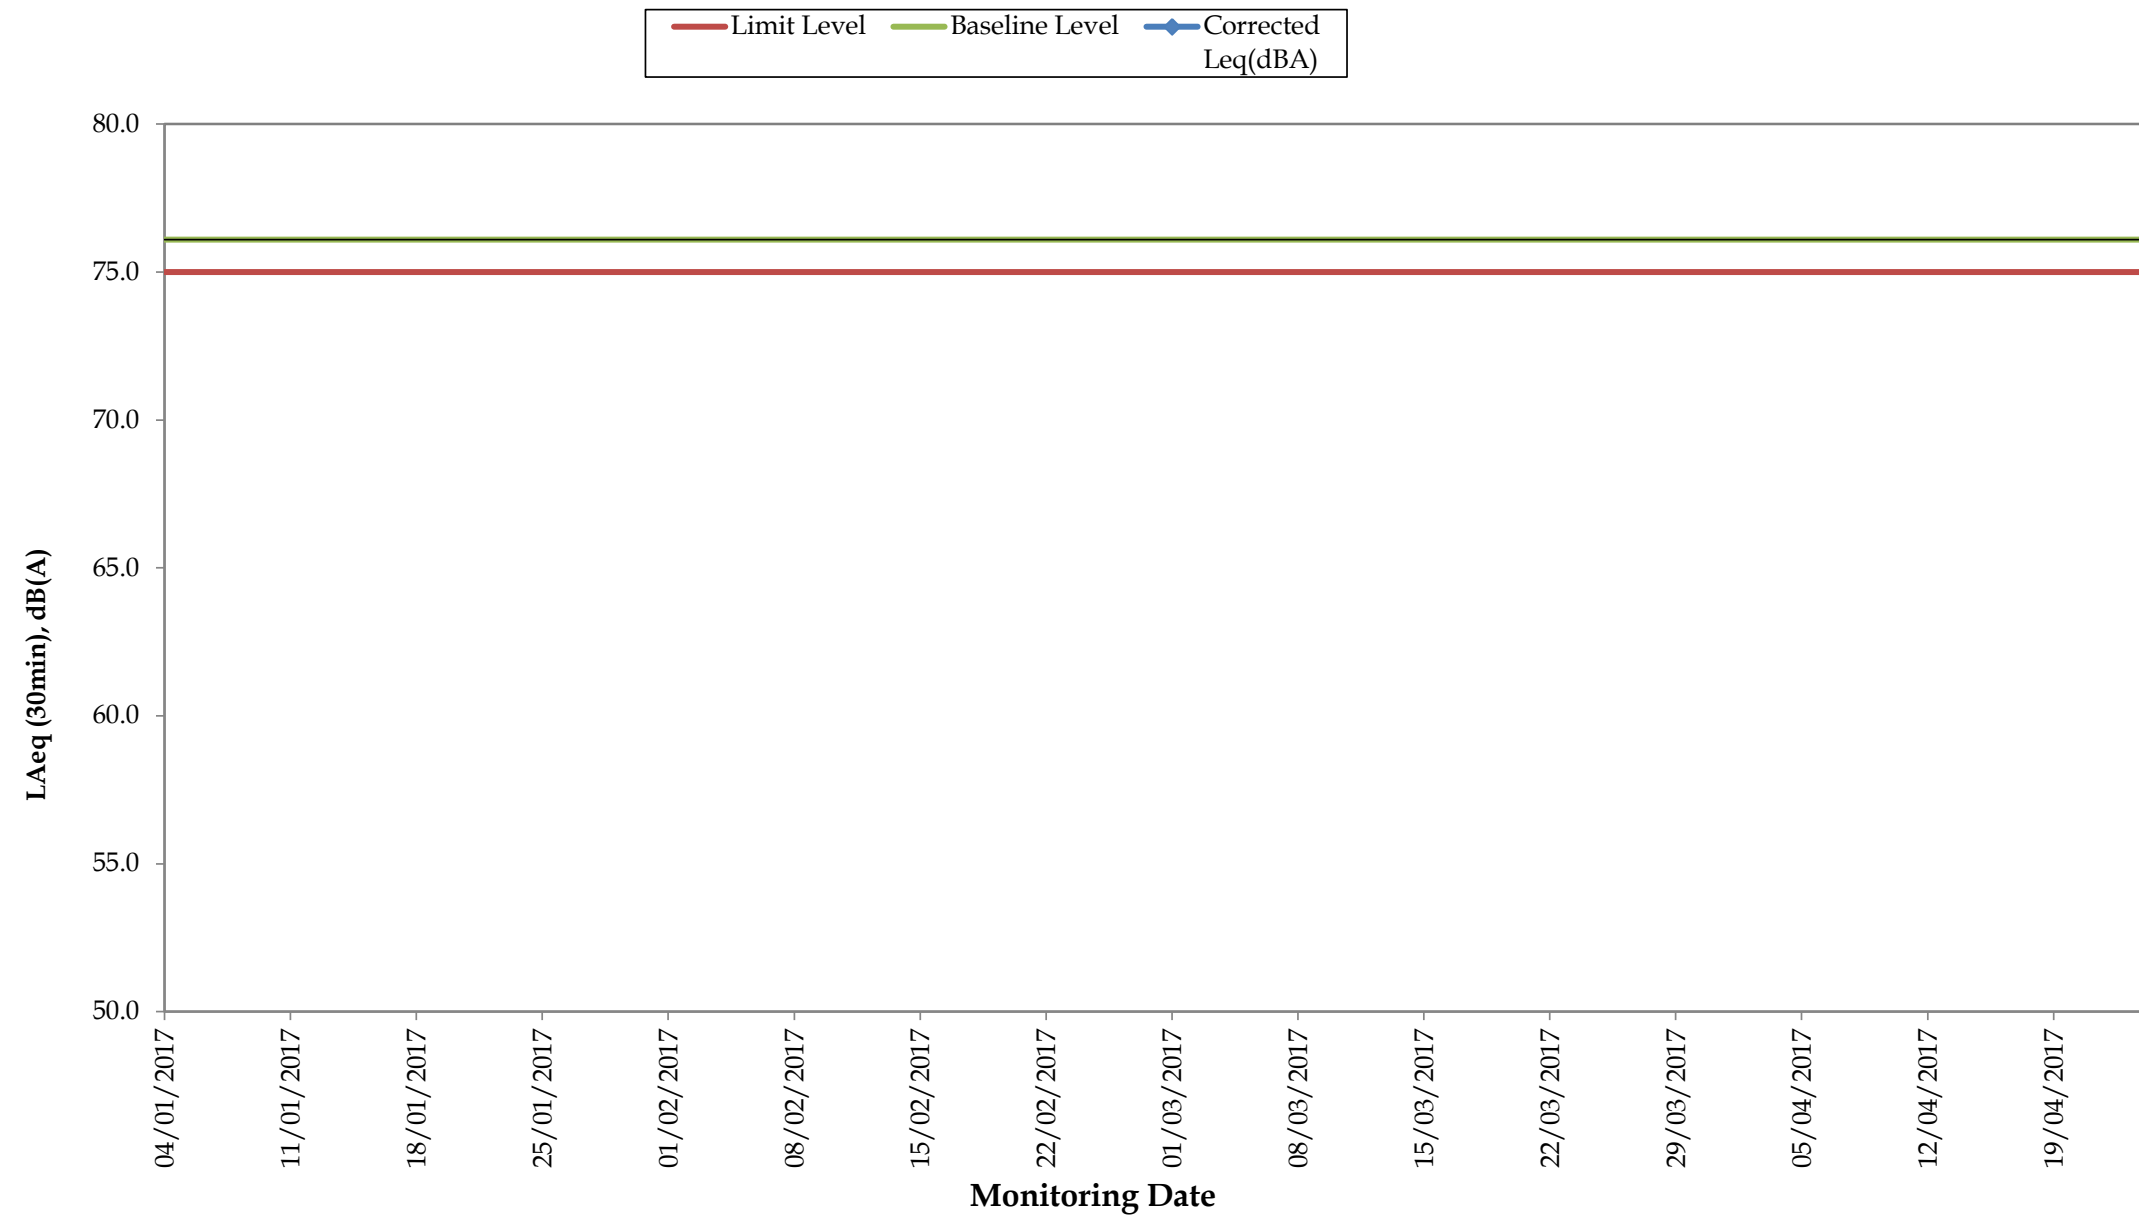
Regular Noise Monitoring Results at NMS-CA-6 (No. 16-23 Nam Kok Road) (LAeq, 30min) for the Past 4 Months

- For those corrected noise levels that are not shown in this graph, the measured noise levels are equal to or below baseline level.

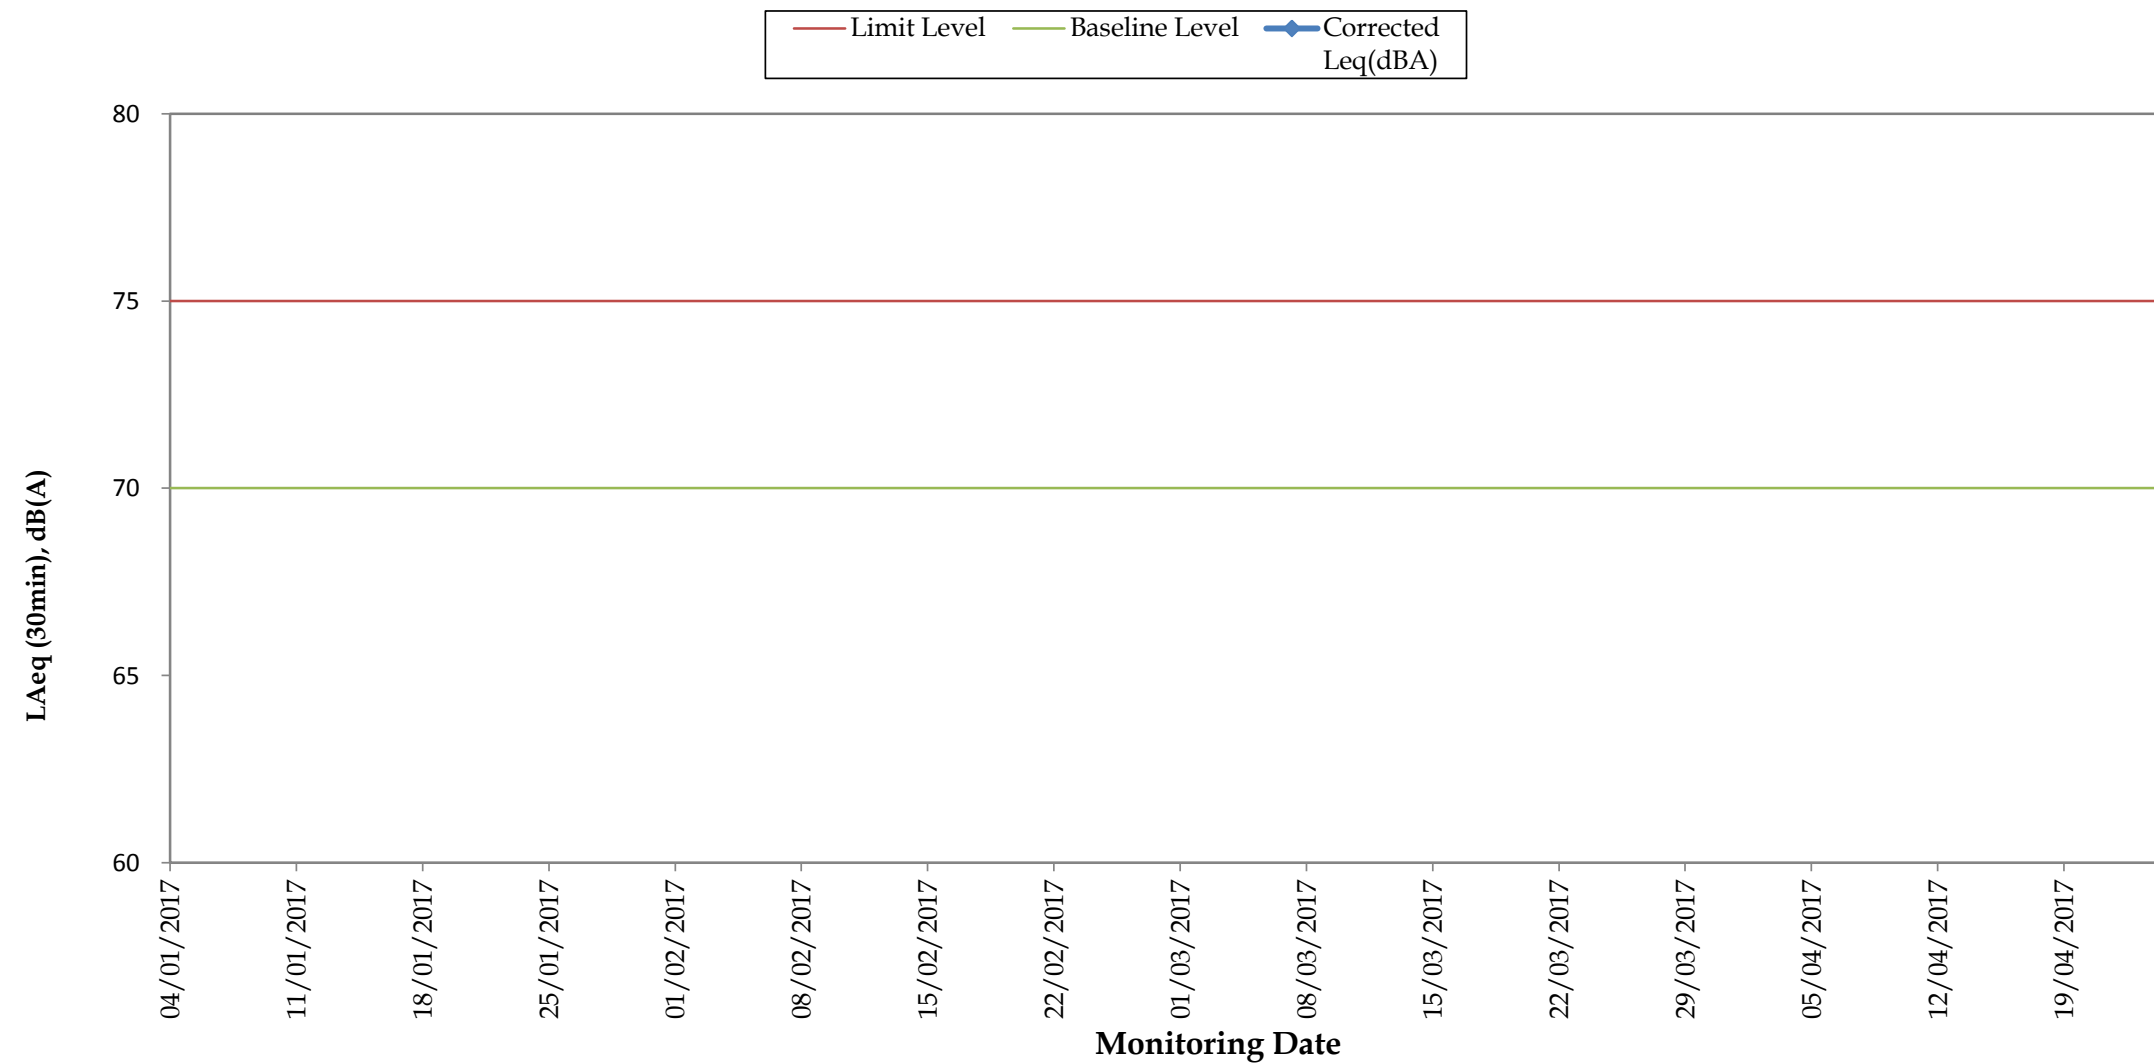
Regular Noise Monitoring Results at NMS-CA-7 (Skytower Tower 2) (LAeq, 30min) for the Past 4 Months

- For those corrected noise levels that are not shown in this graph, the measured noise levels are equal to or below baseline level.

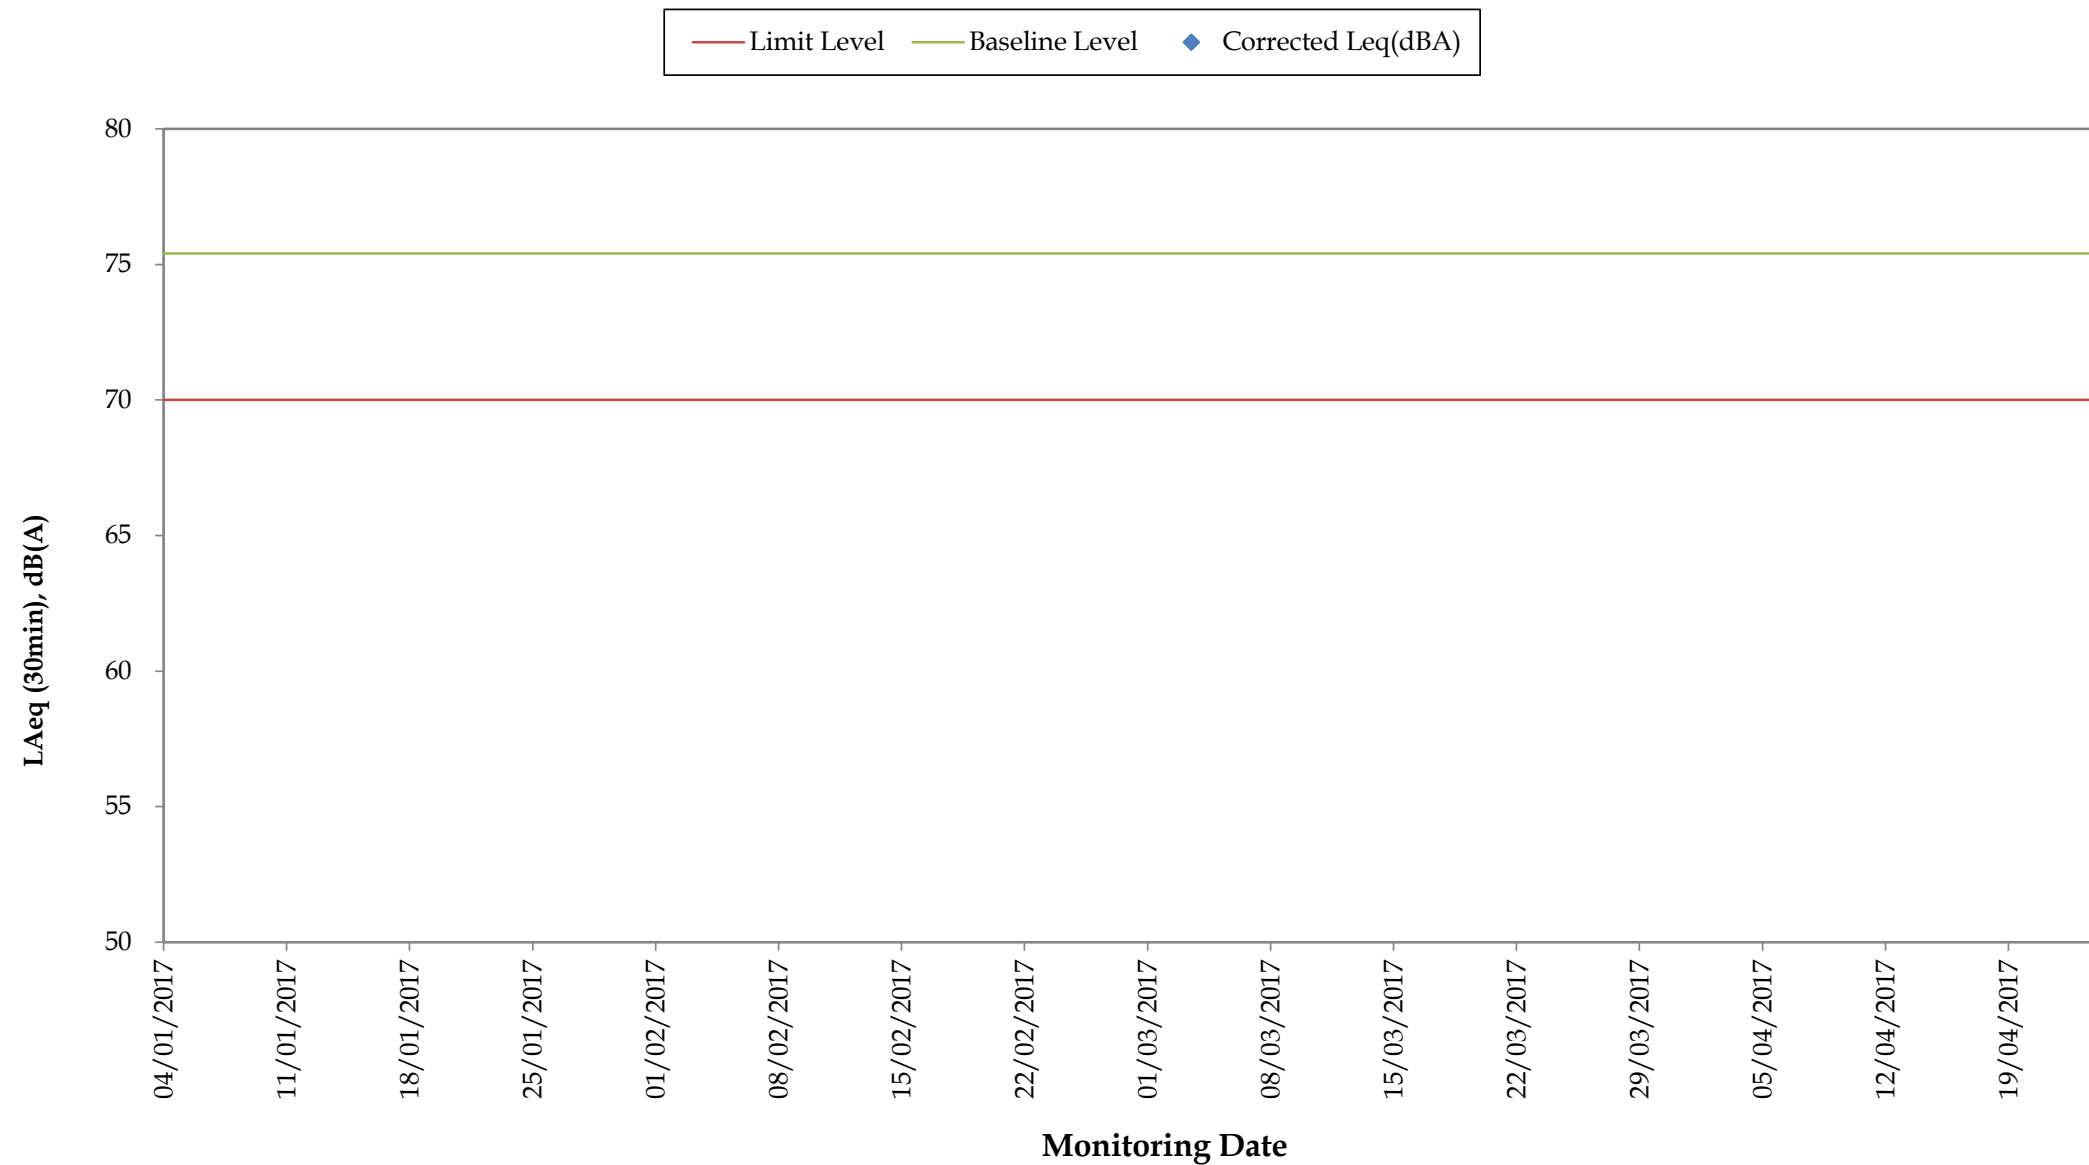
Regular Noise Monitoring Results at NMS-CA- 8 (SKH Good Shepherd Primary School) (LAeq, 30min) for the Past 4 Months

- For those corrected noise levels that are not shown in this graph, the measured noise levels are equal to or below baseline level.
- The limit level was updated from 78dB(A) to 79 dB(A) on 22 Aug 2013 as per the latest CNMP and CNMMP.
- The limit level was updated from 79dB(A) to 70dB(A)/65dB(A) (during normal/examination period) from April 2016, as the continuous noise monitoring was completed in March 2016 according to the latest CNMP

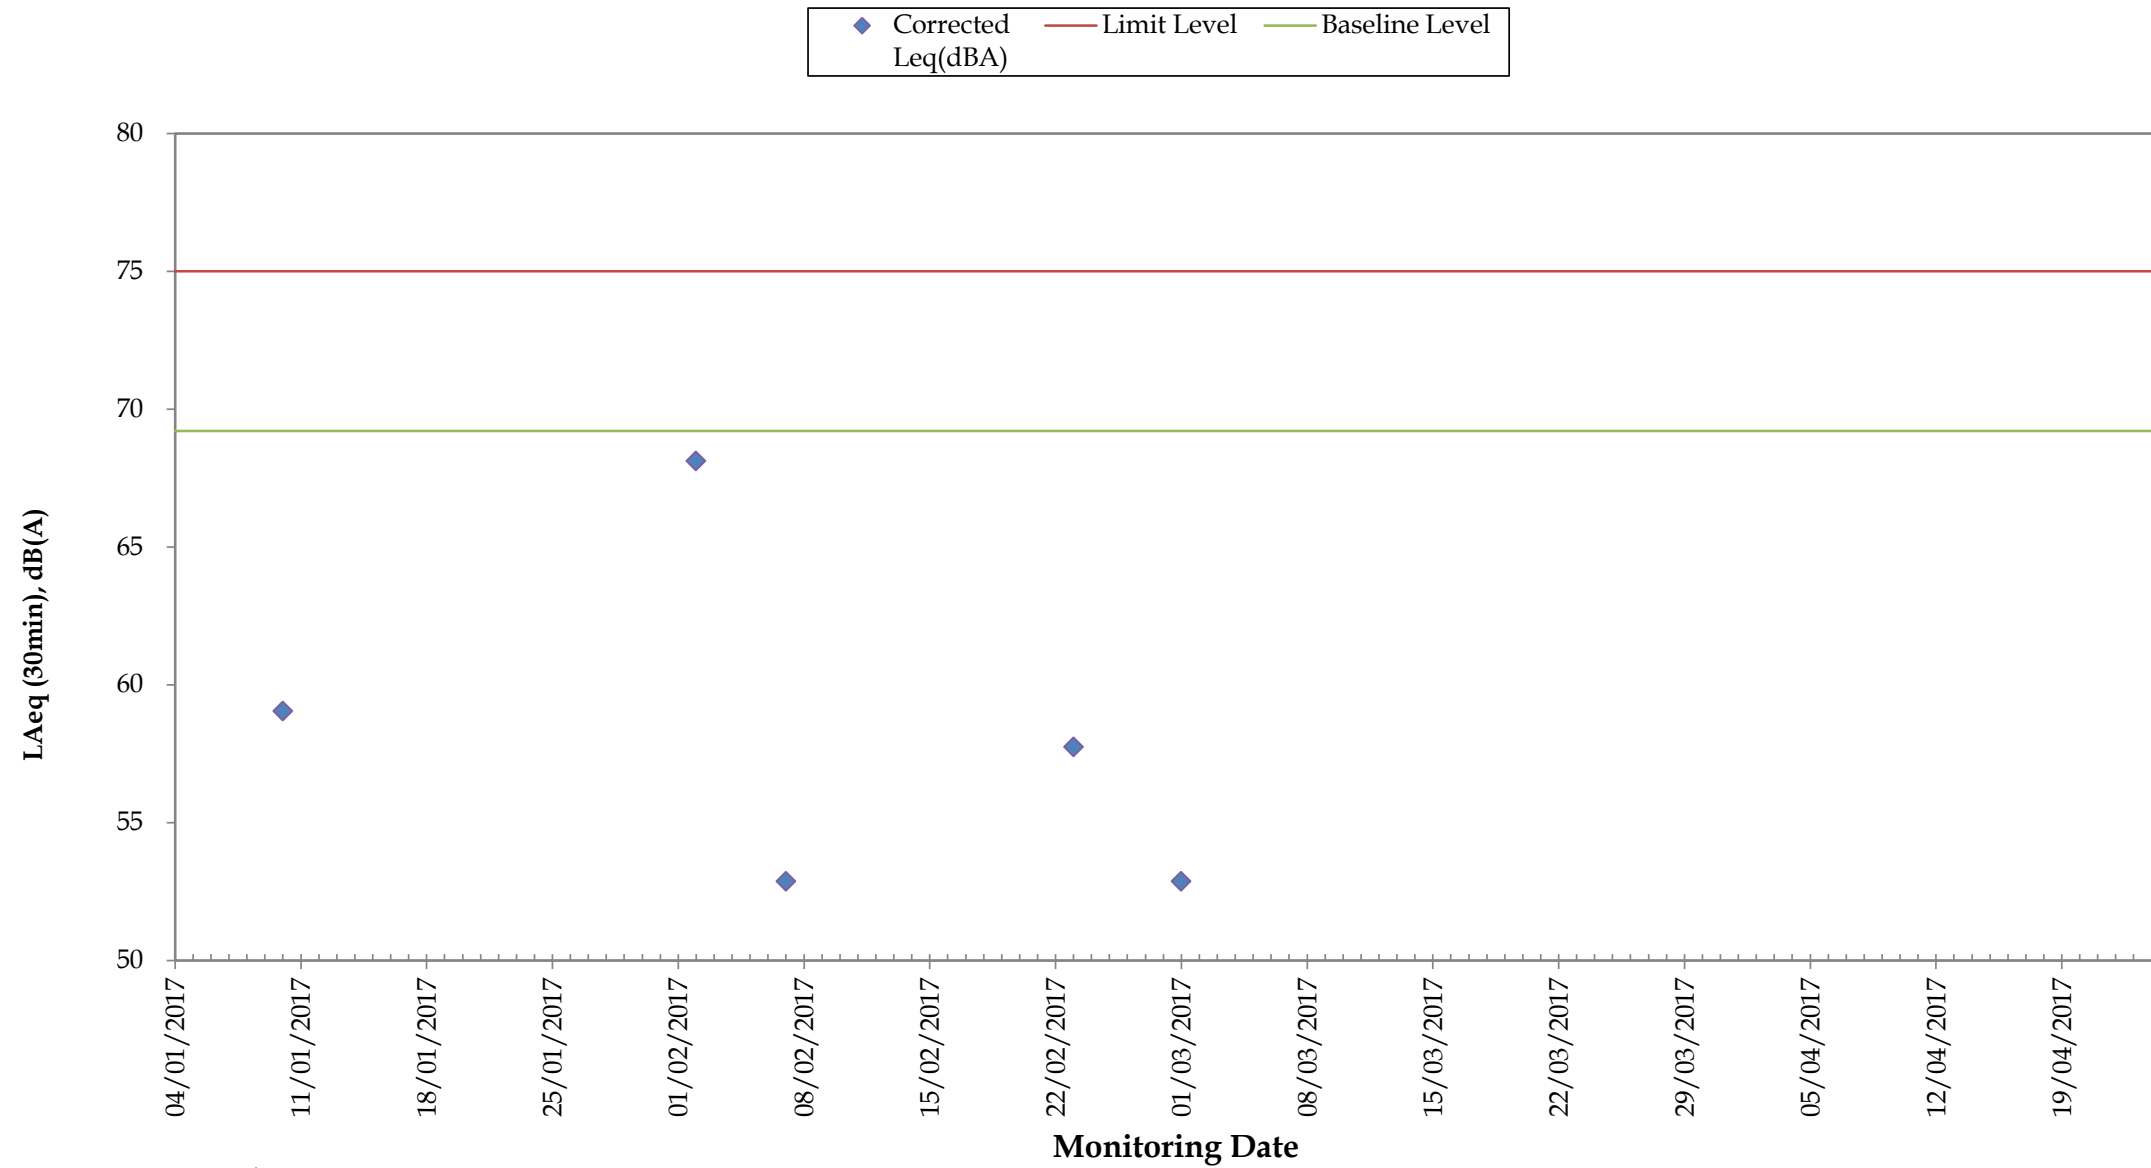
Regular Noise Monitoring Results at NMS-CA-9 (Kong Yiu Mansion) (LAeq, 30min)) for the Past 4 Months

- For those corrected noise levels that are not shown in this graph, the measured noise levels are equal to or below baseline level.

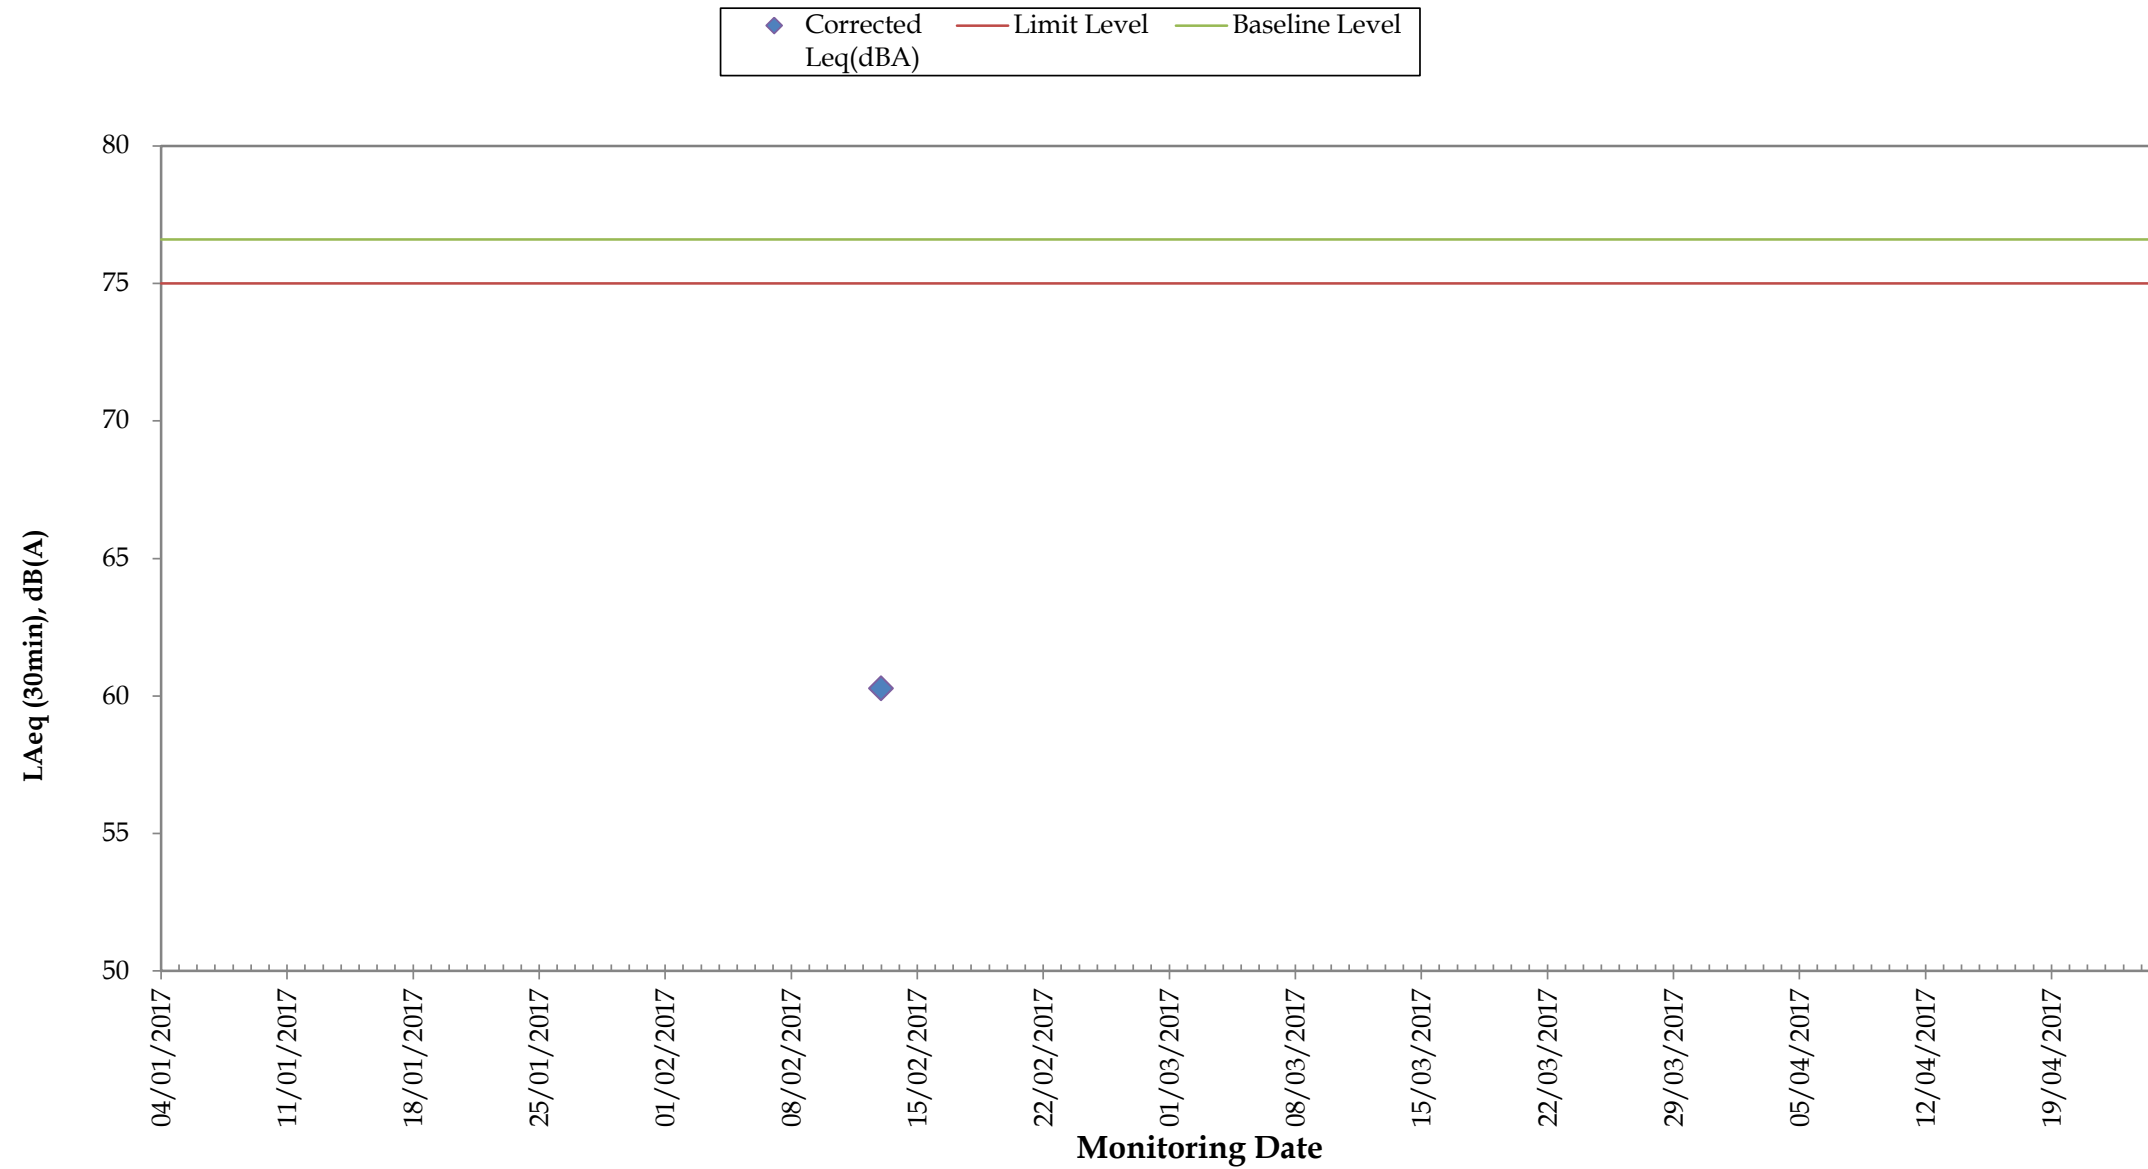
Regular Noise Monitoring Results at NMS-CA-10 (Chat Ma Mansion) (LAeq, 30min) for the Past 4 Months

- For those corrected noise levels that are not shown in this graph, the measured noise levels are equal to or below baseline level.

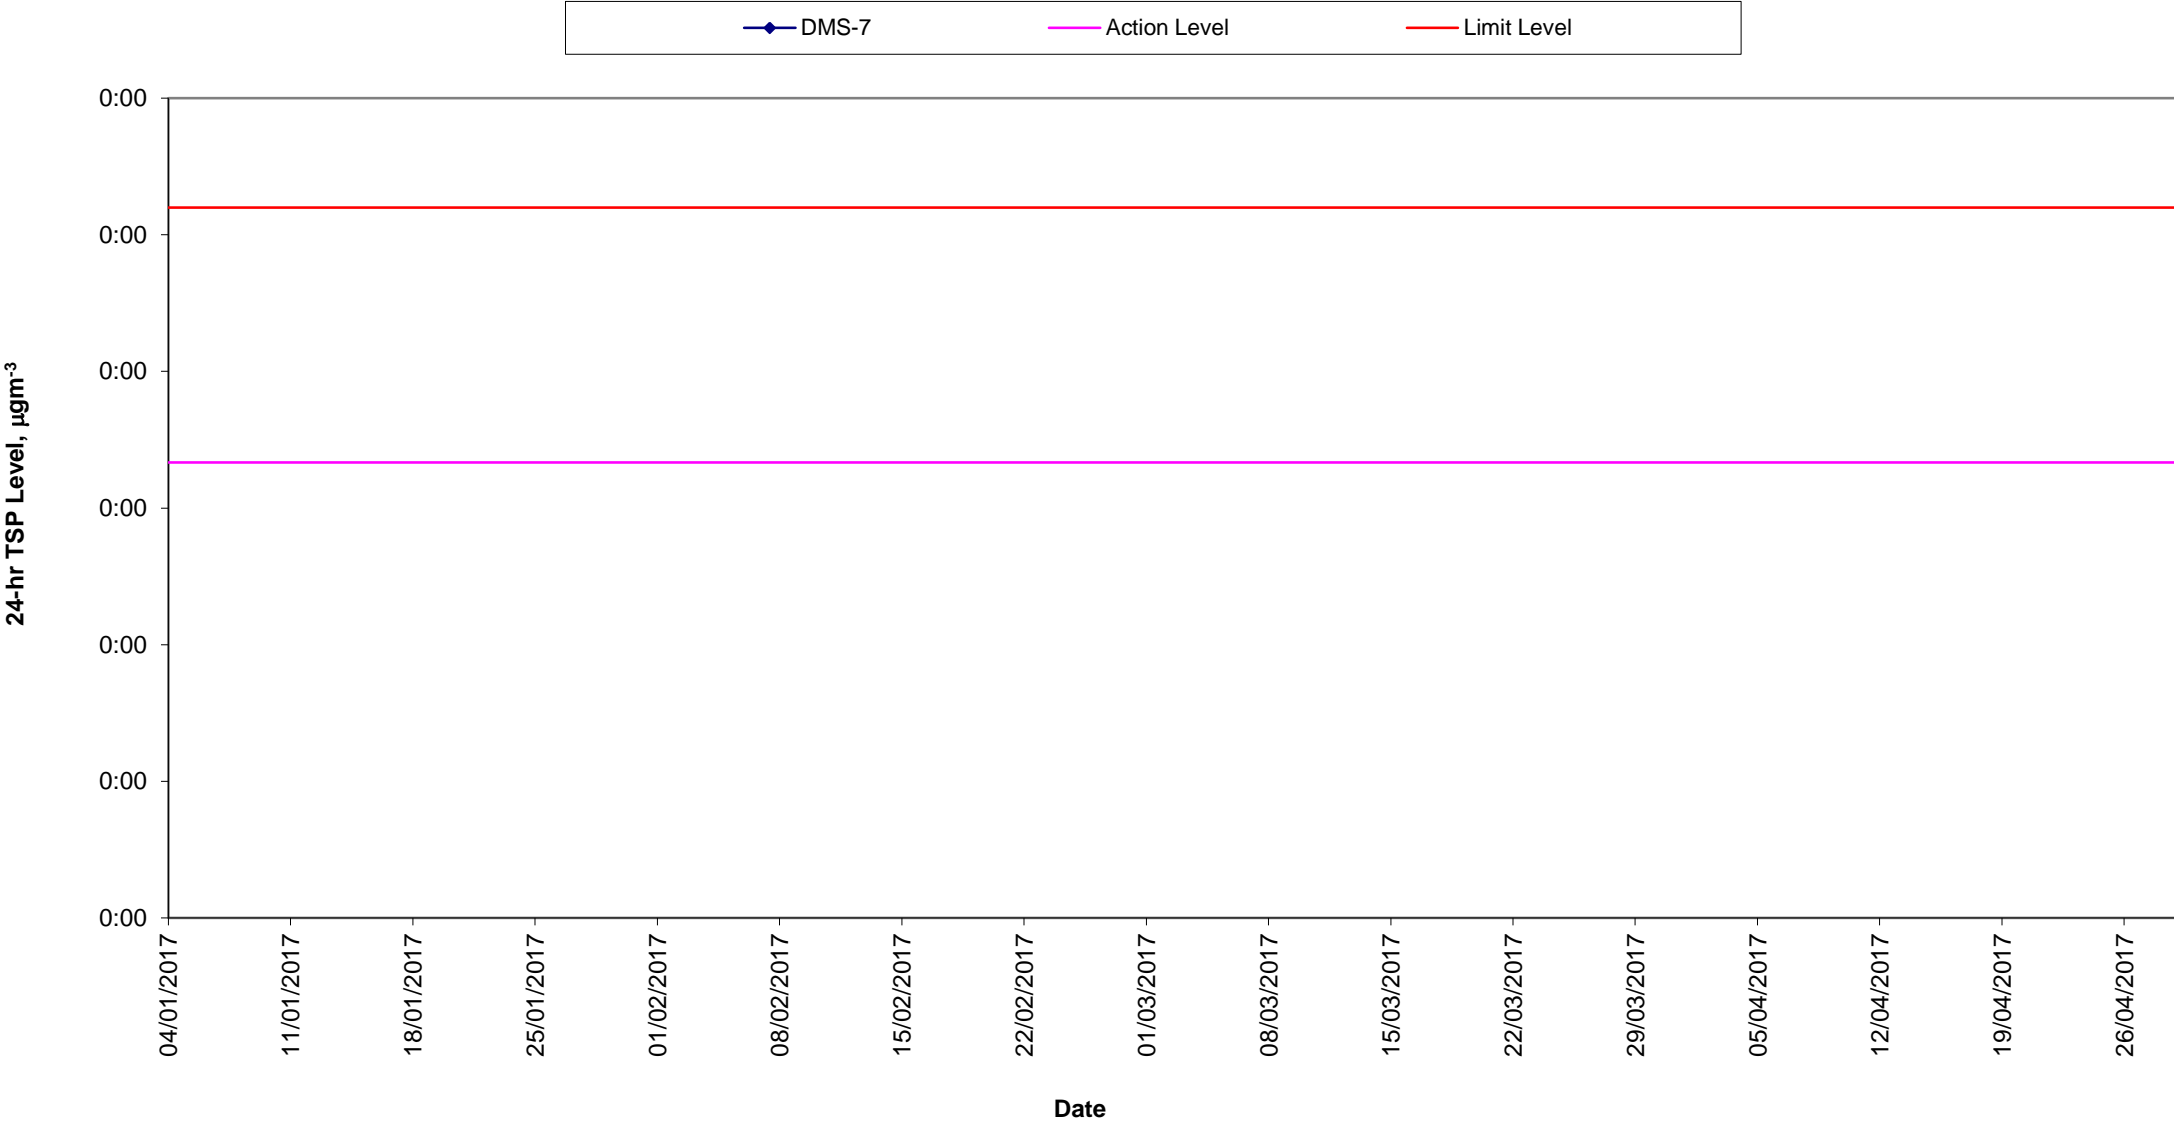
**Construction Dust Monitoring Results for the Past 4 Months
DMS- 7 (Parc 22)**

Remark:
- 24-hour averaged dust monitoring at DMS-7 (Parc-22) was temporary suspended since 13 December 2016 due to request from the Management Office.
