**Shatin to Central Link –  
Tai Wai to Hung Hom Section and  
Mong Kok East to Hung Hom Section**

Monthly EM&A Report No. 58

[Period from 1 to 30 June 2017]

Consultancy Agreements  
No. C11033 & C11033B

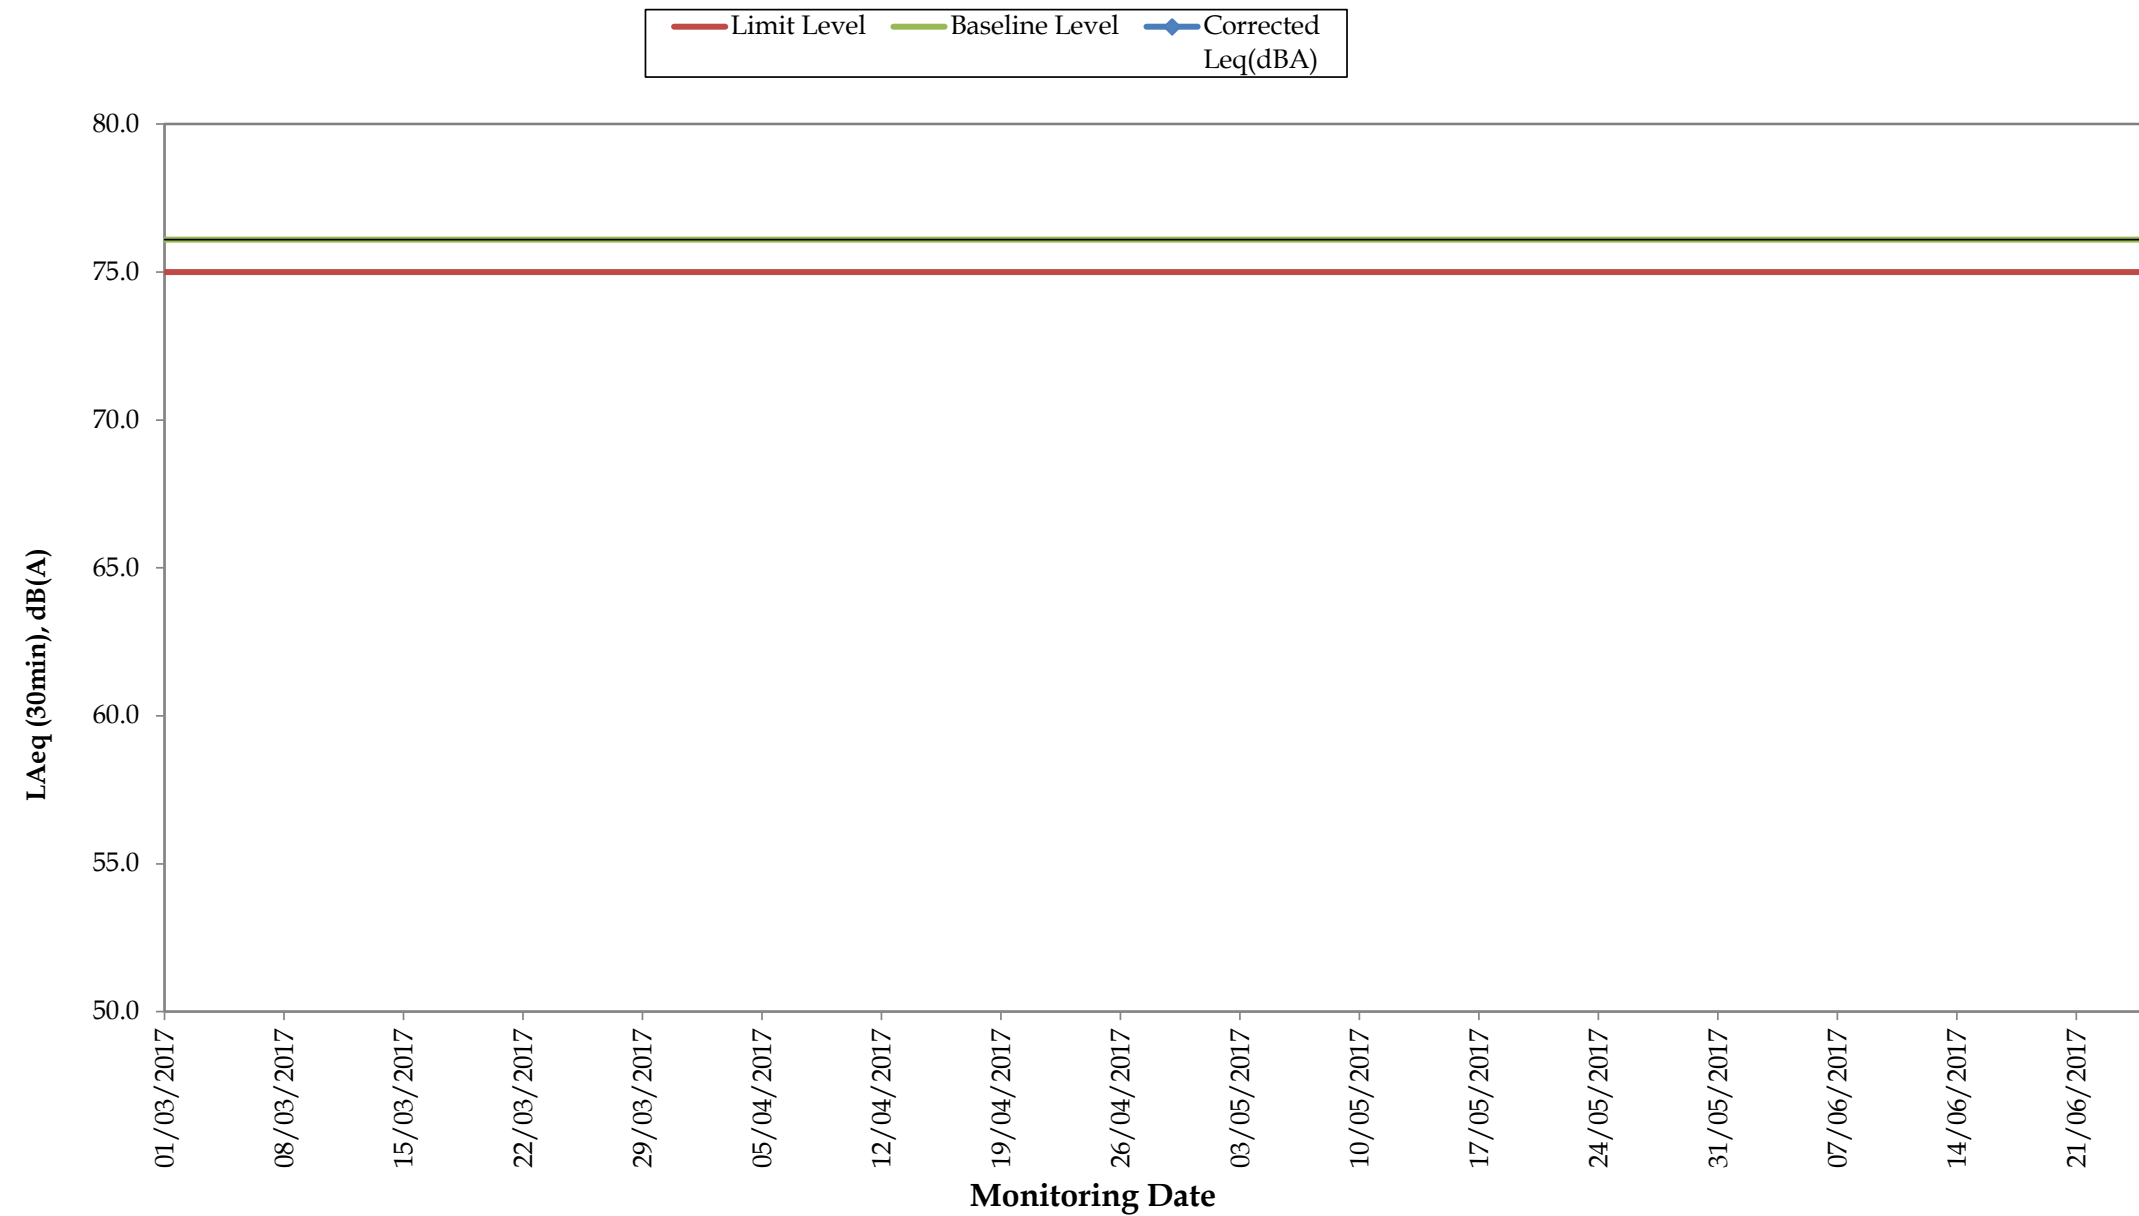
## Regular Noise Monitoring Results at NMS-CA-6 (No. 16-23 Nam Kok Road) (LAeq, 30min) for the Past 4 Months

- For those corrected noise levels that are not shown in this graph, the measured noise levels are equal to or below baseline level.

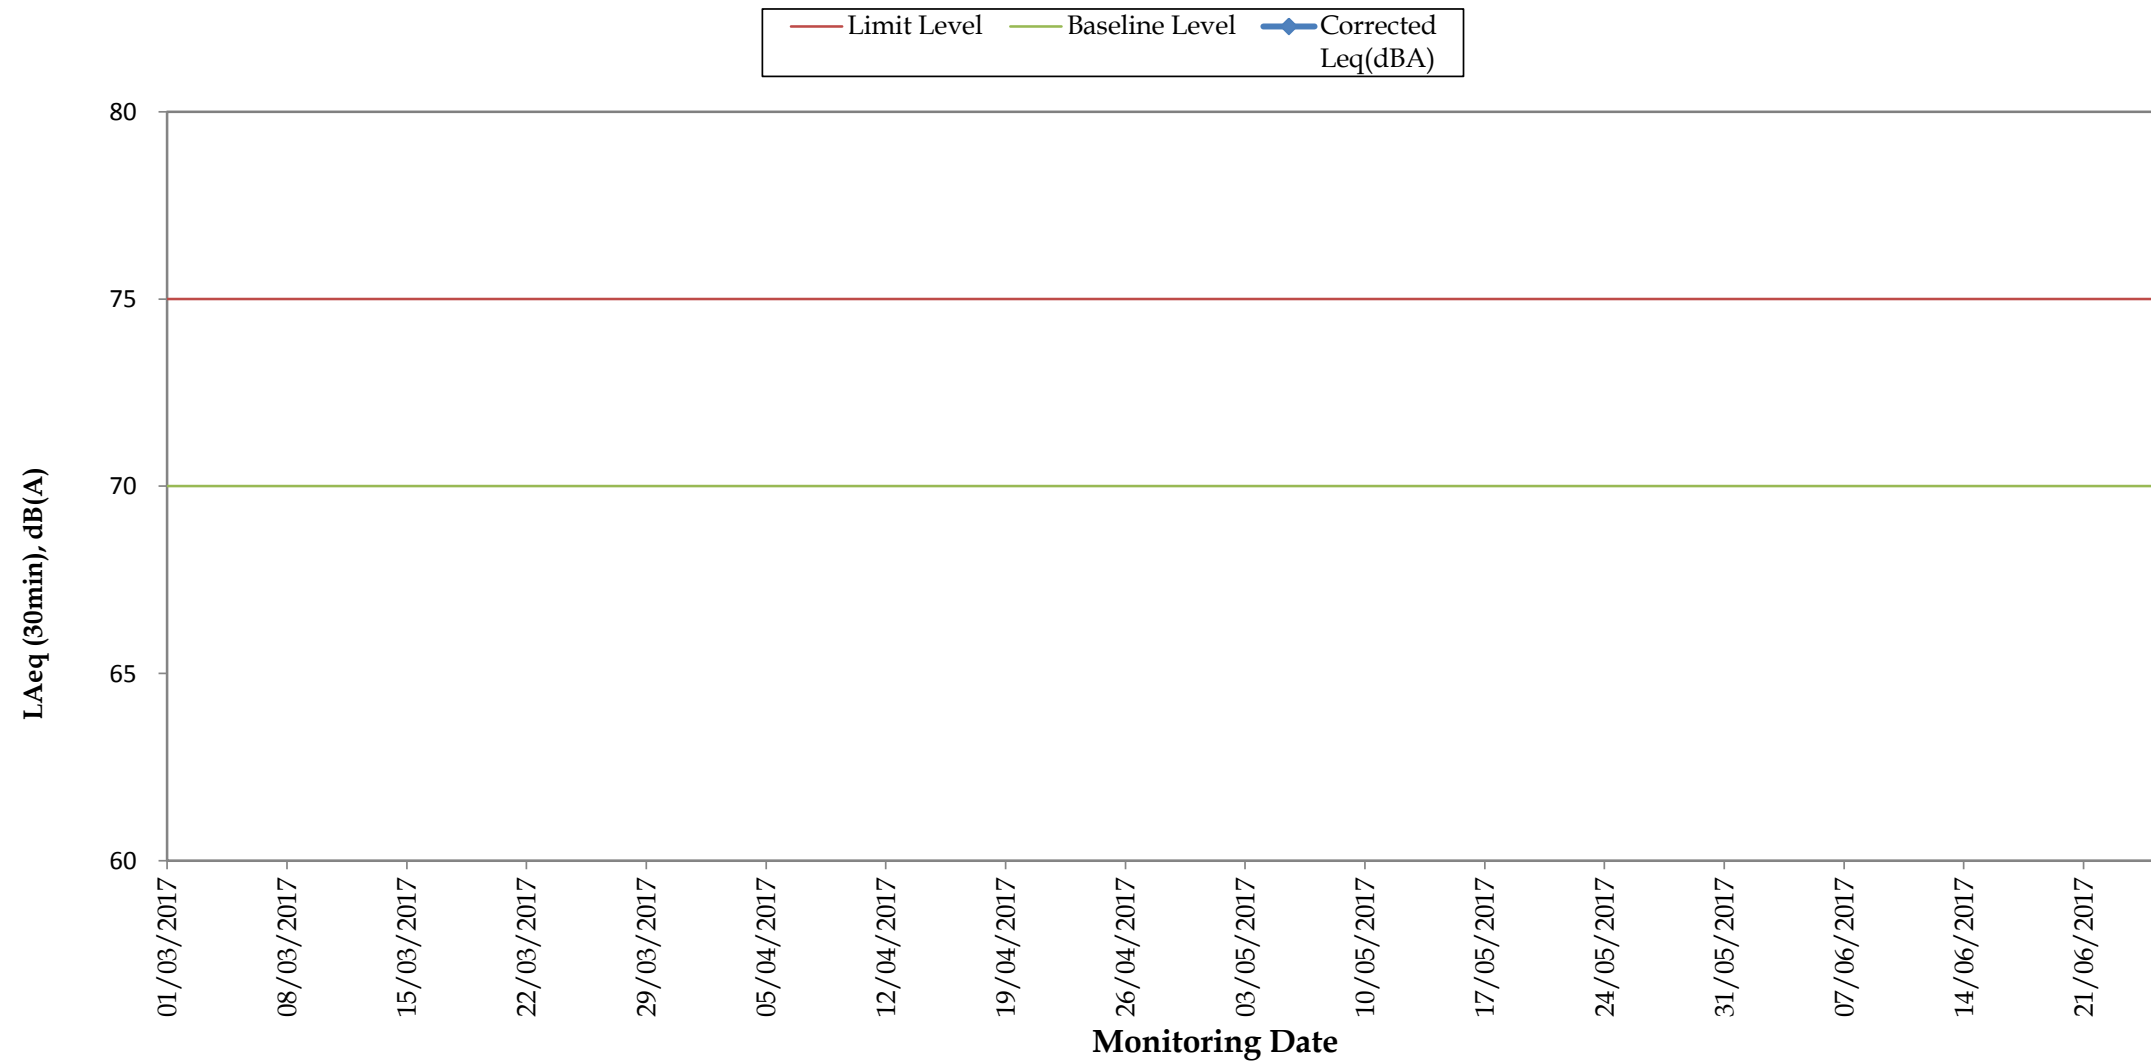
## Regular Noise Monitoring Results at NMS-CA-7 (Skytower Tower 2) (LAeq, 30min) for the Past 4 Months

- For those corrected noise levels that are not shown in this graph, the measured noise levels are equal to or below baseline level.

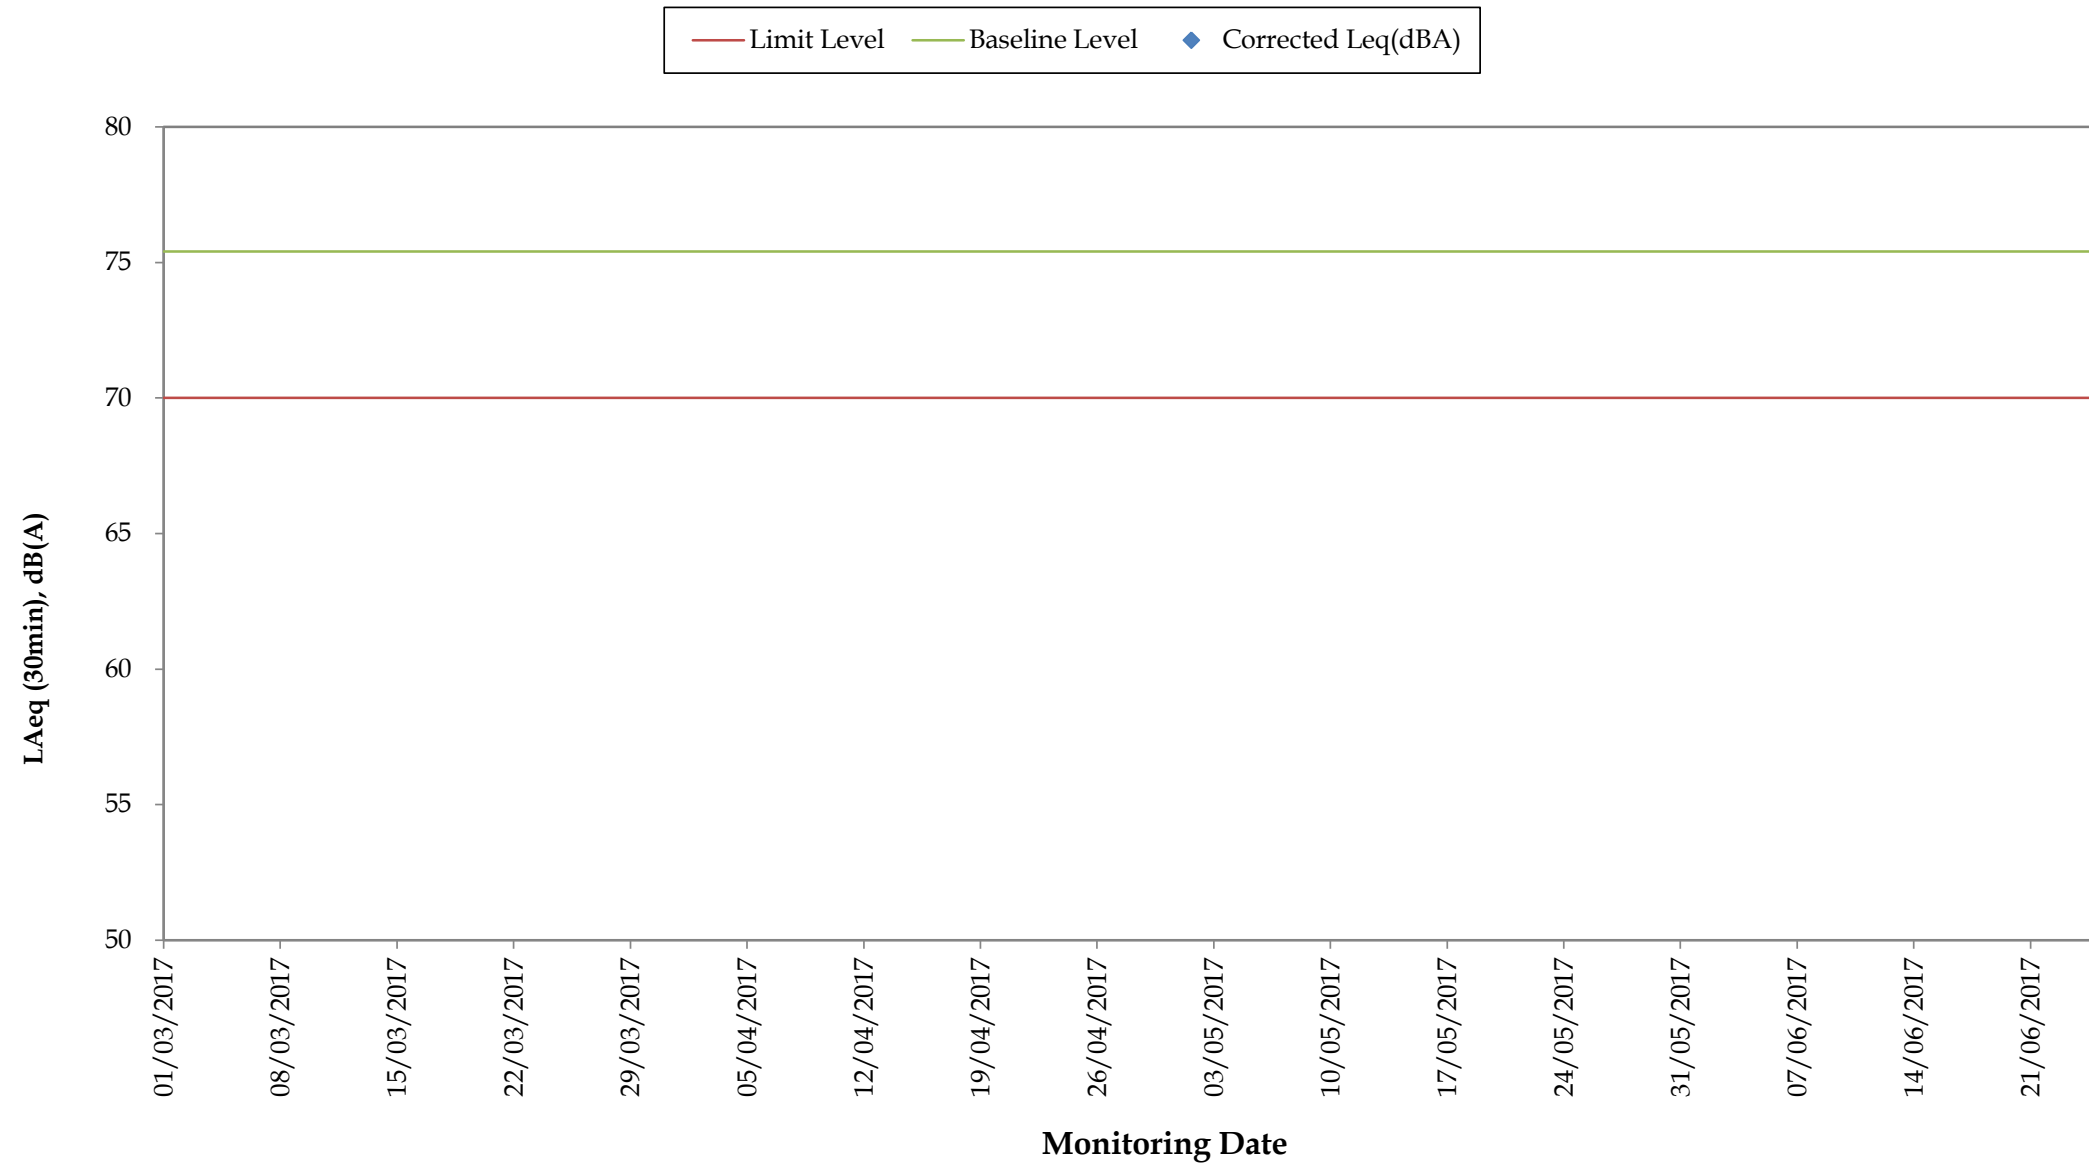
## Regular Noise Monitoring Results at NMS-CA- 8 (SKH Good Shepherd Primary School) (LAeq, 30min) for the Past 4 Months

- For those corrected noise levels that are not shown in this graph, the measured noise levels are equal to or below baseline level.
- The limit level was updated from 78dB(A) to 79 dB(A) on 22 Aug 2013 as per the latest CNMP and CNMMP.
- The limit level was updated from 79dB(A) to 70dB(A)/65dB(A) (during normal/examination period) from April 2016, as the continuous noise monitoring was completed in March 2016 according to the latest CNMP

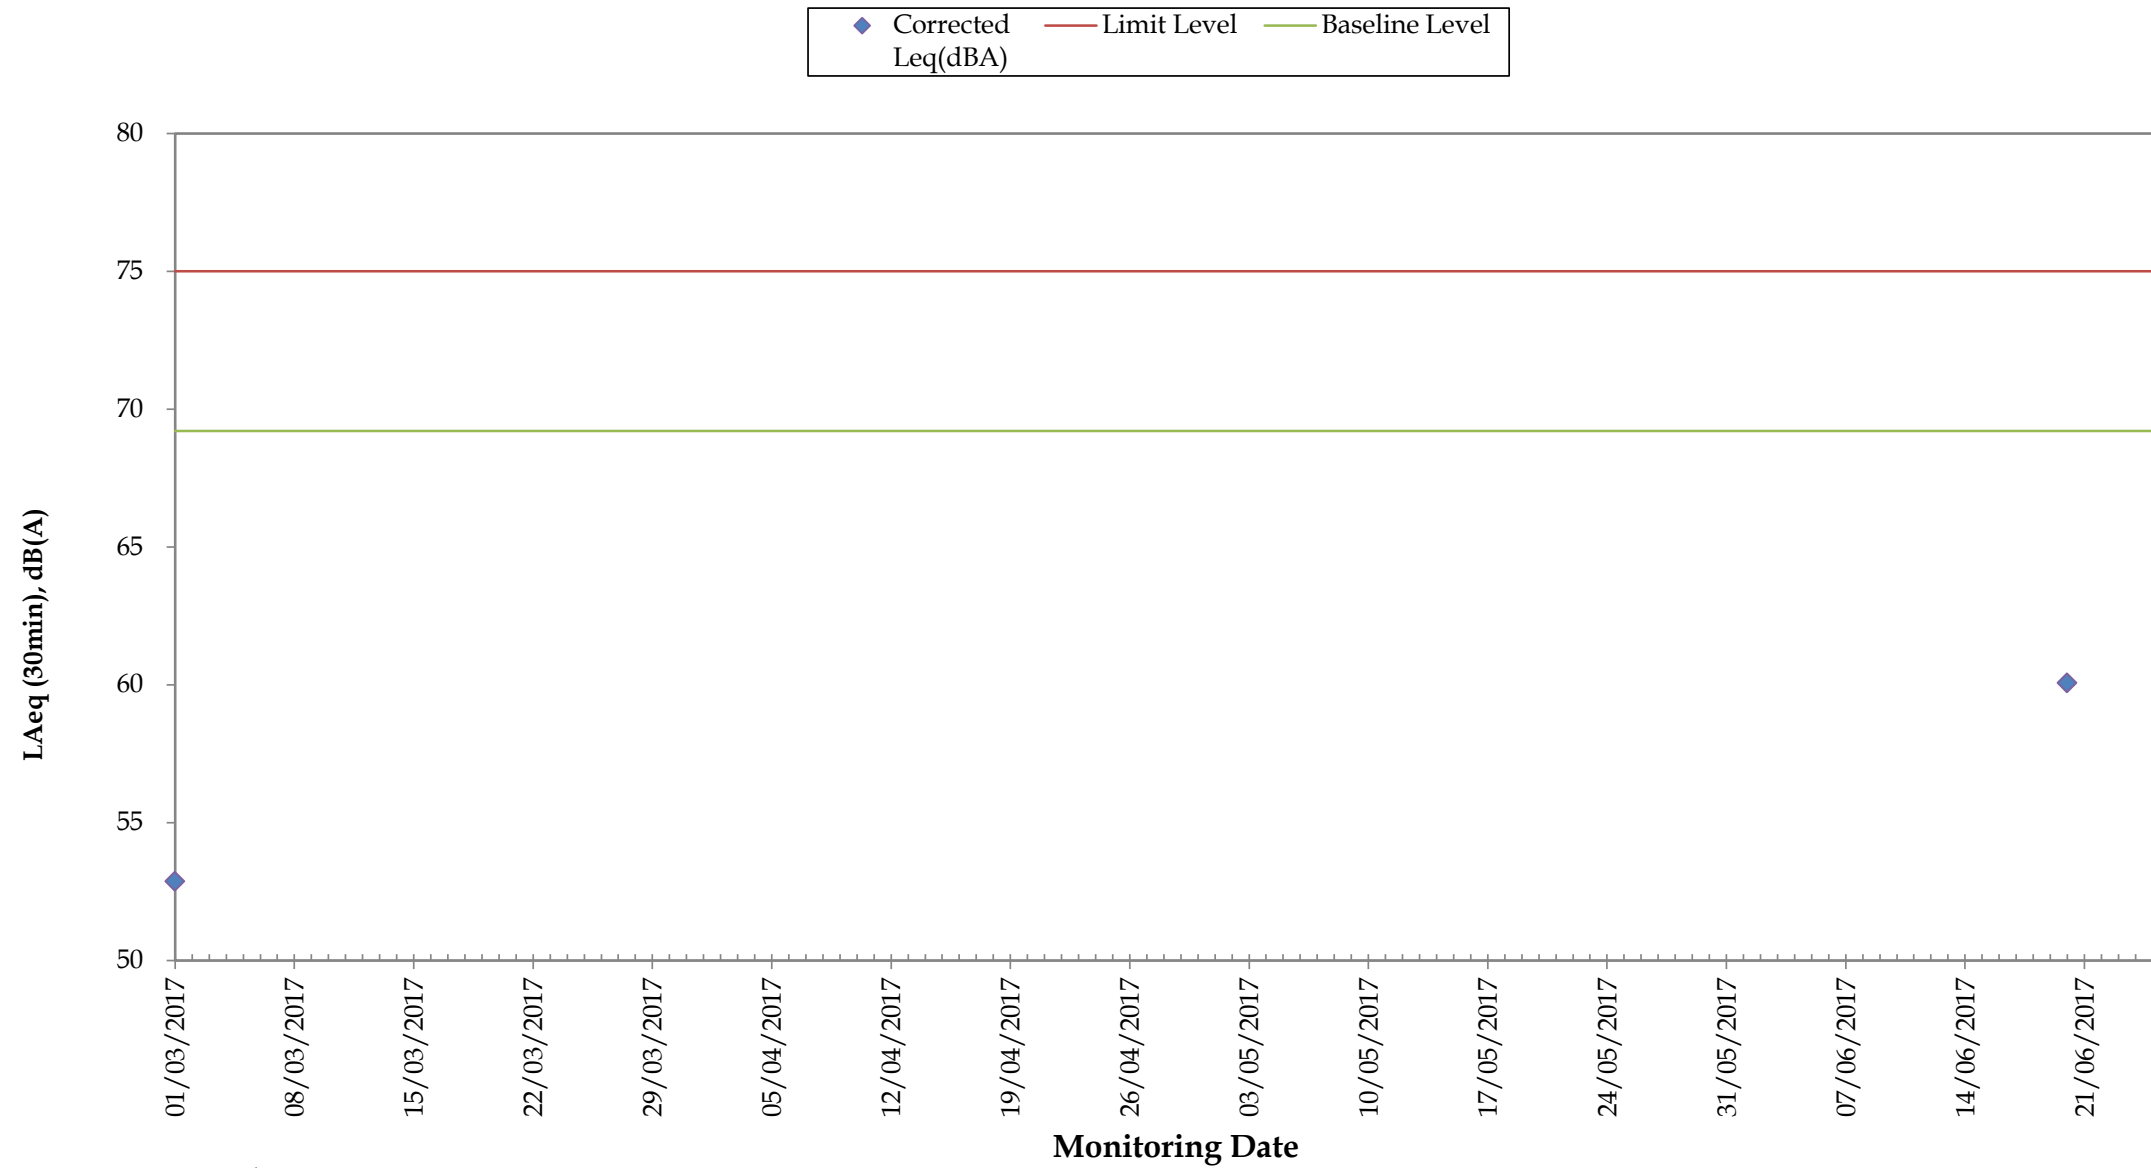
## Regular Noise Monitoring Results at NMS-CA-9 (Kong Yiu Mansion) (LAeq, 30min) ) for the Past 4 Months

- For those corrected noise levels that are not shown in this graph, the measured noise levels are equal to or below baseline level.

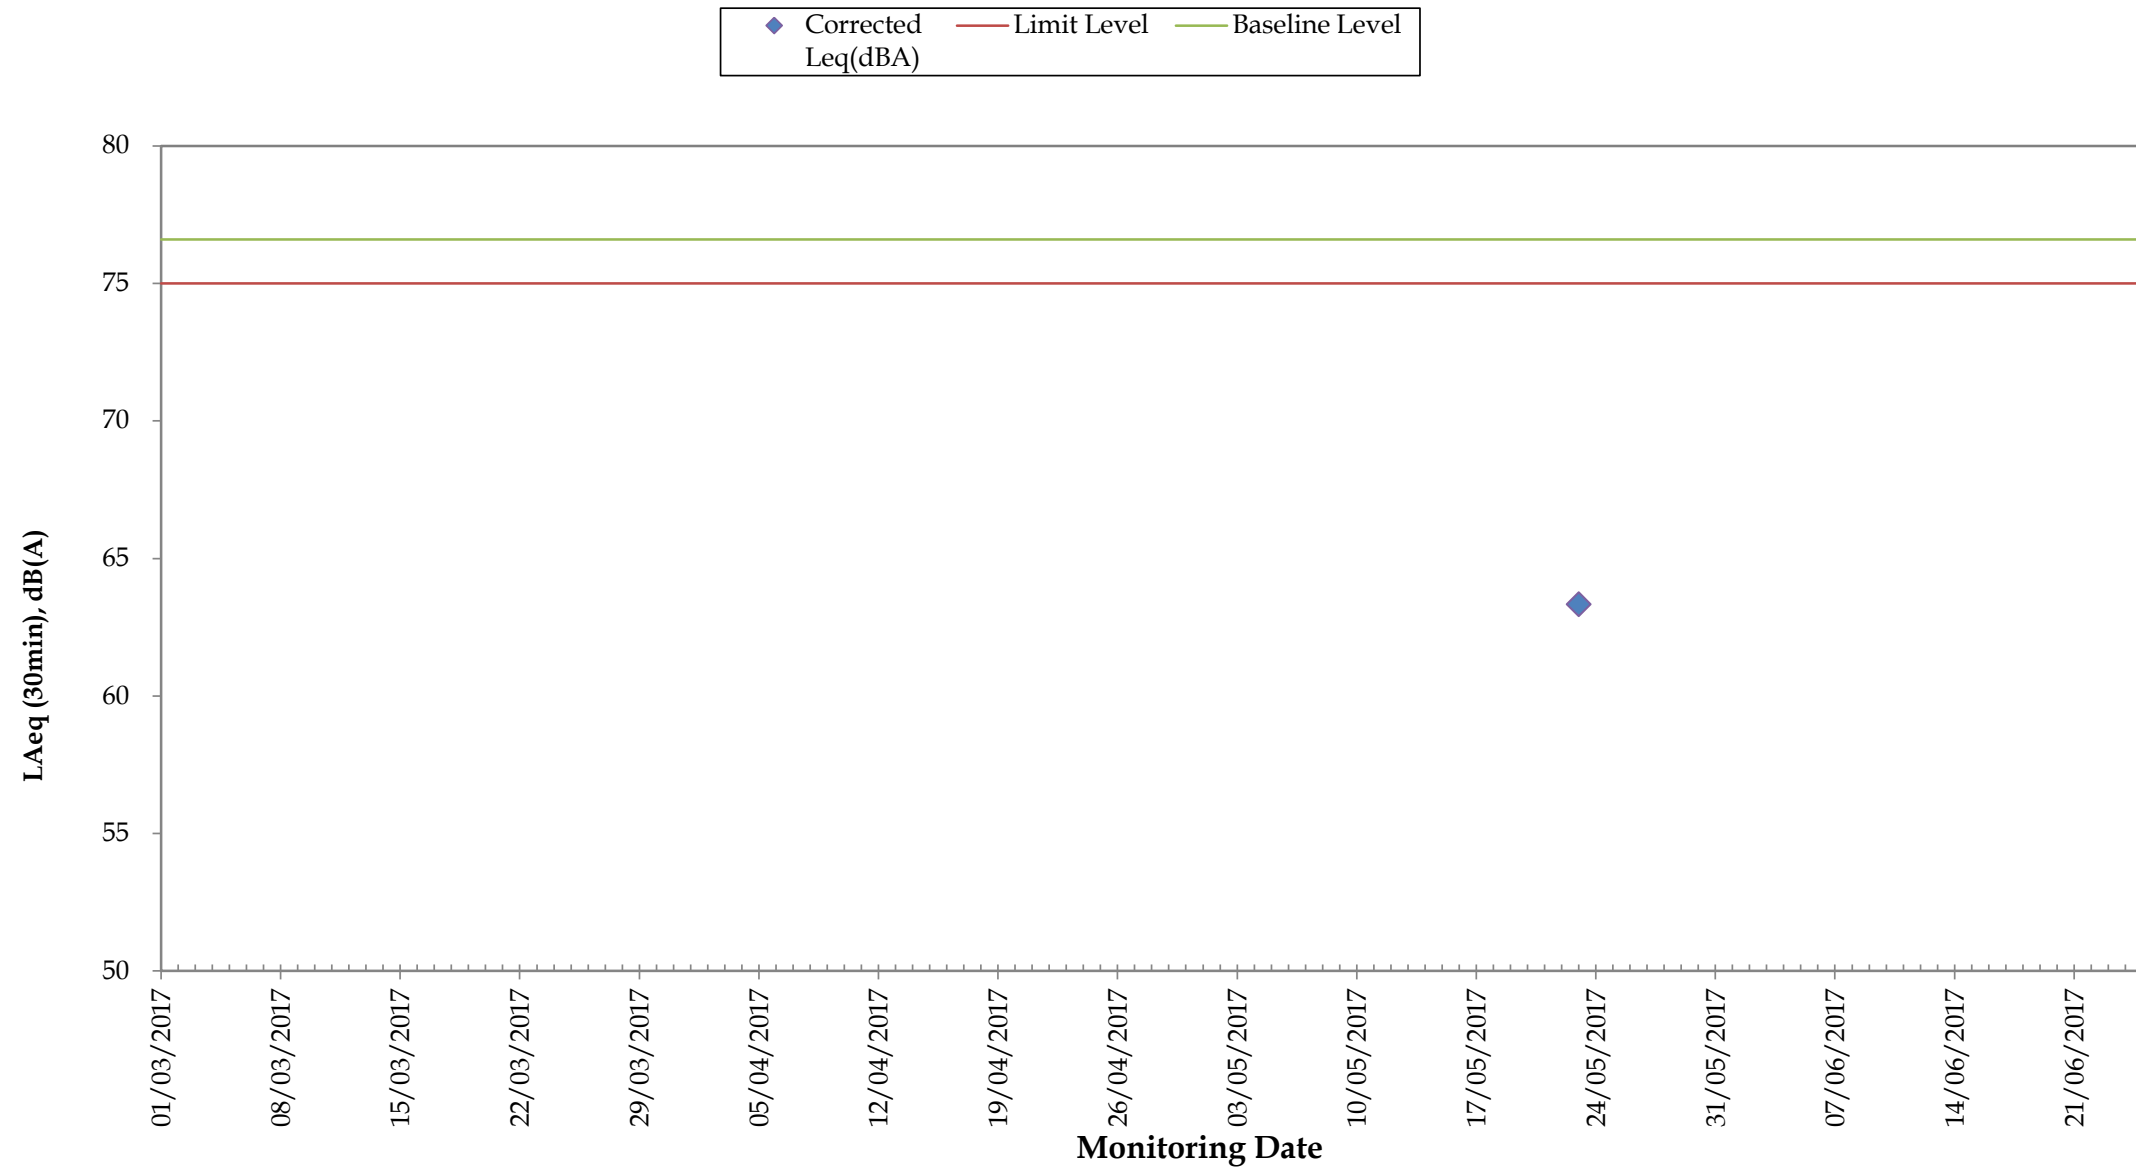
## Regular Noise Monitoring Results at NMS-CA-10 (Chat Ma Mansion) (LAeq, 30min) for the Past 4 Months

- For those corrected noise levels that are not shown in this graph, the measured noise levels are equal to or below baseline level.

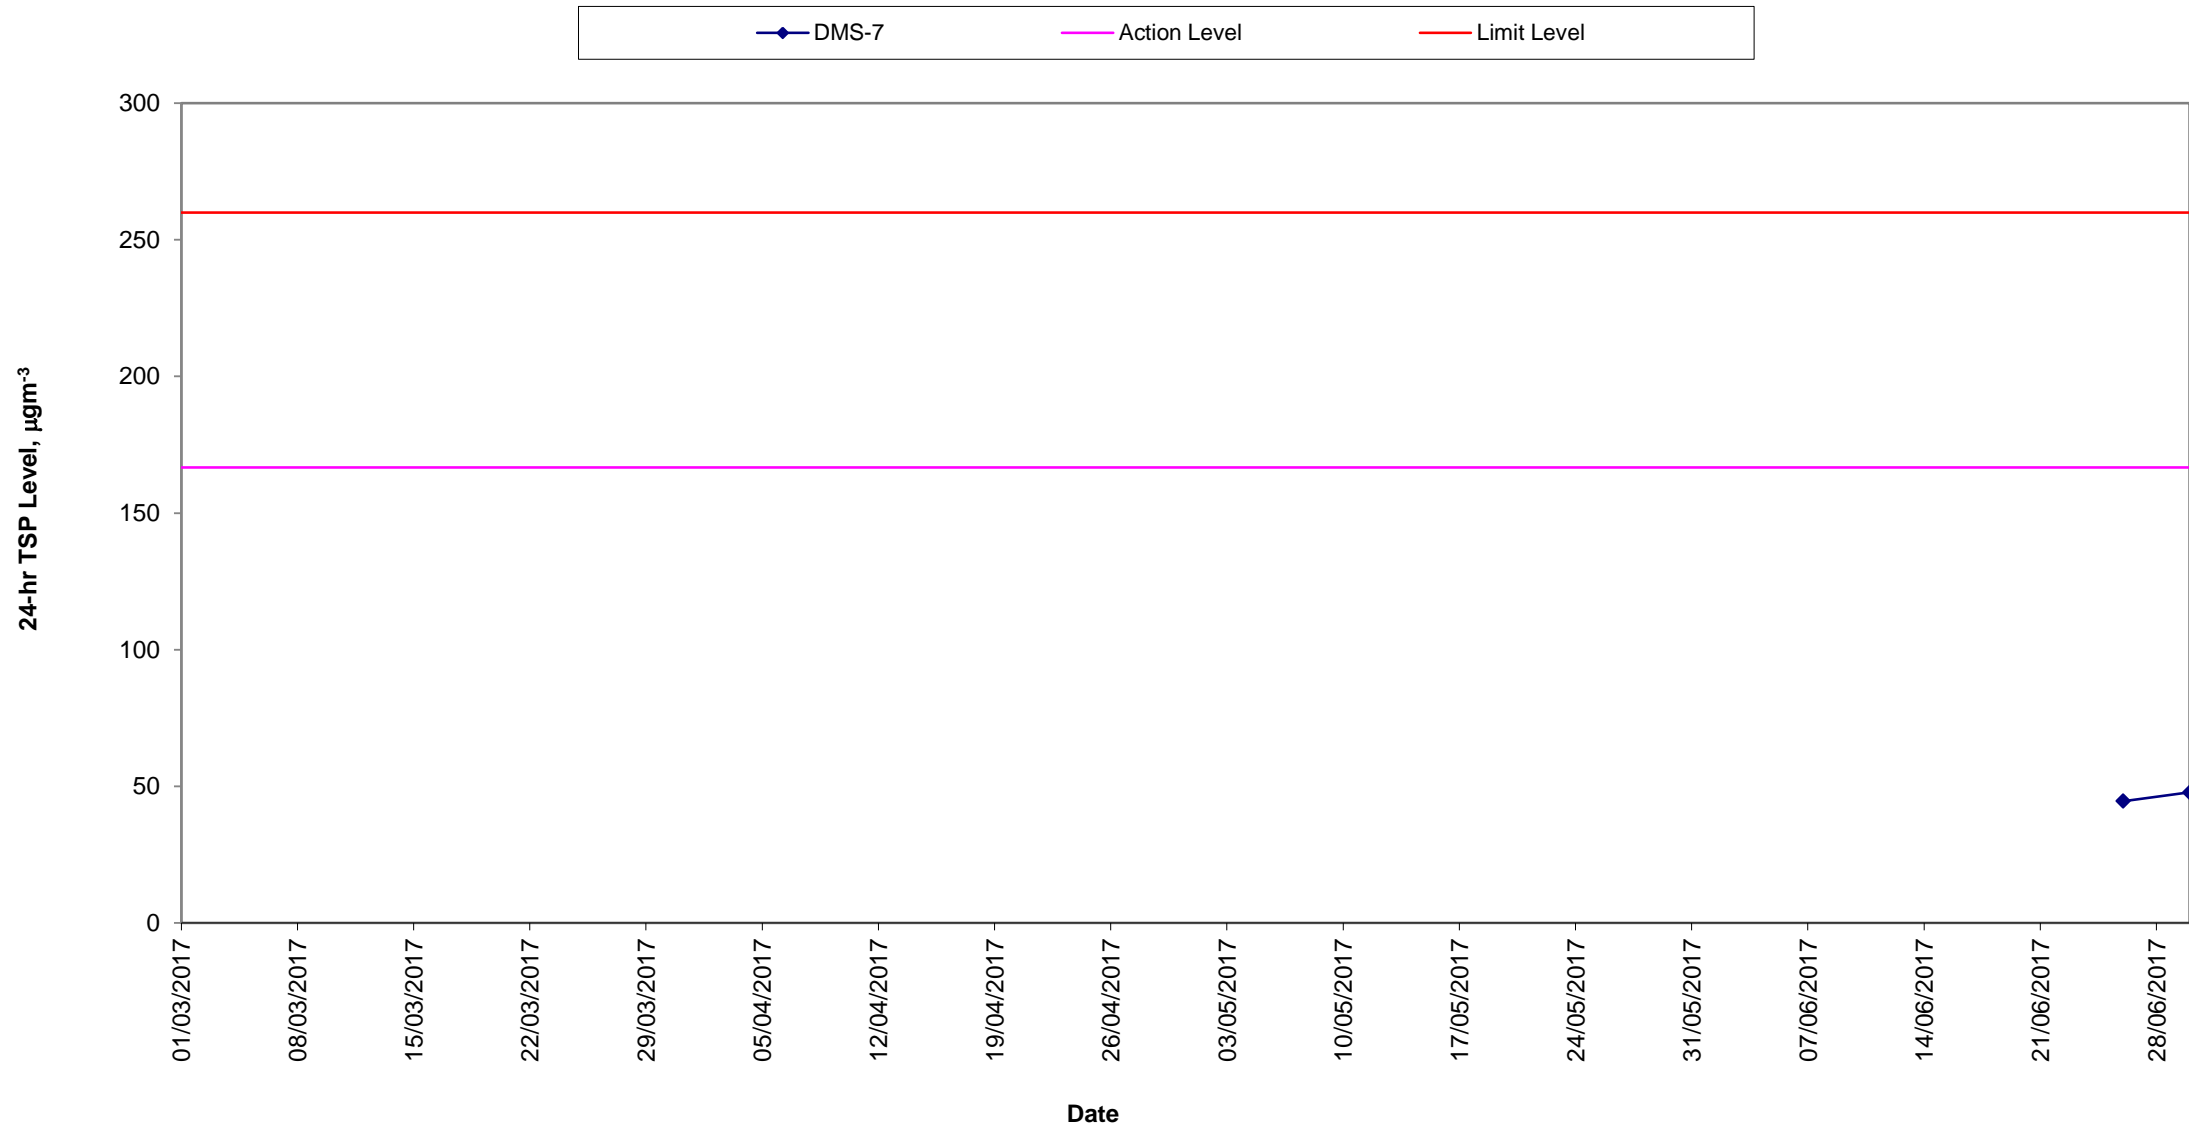
### Construction Dust Monitoring Results for the Past 4 Months DMS- 7 (Parc 22)

- 24-hour averaged dust monitoring at DMS-7 (Parc-22) was temporary suspended since 13 December 2016 due to request from the Management Office and was resumed on 26 June 2017.

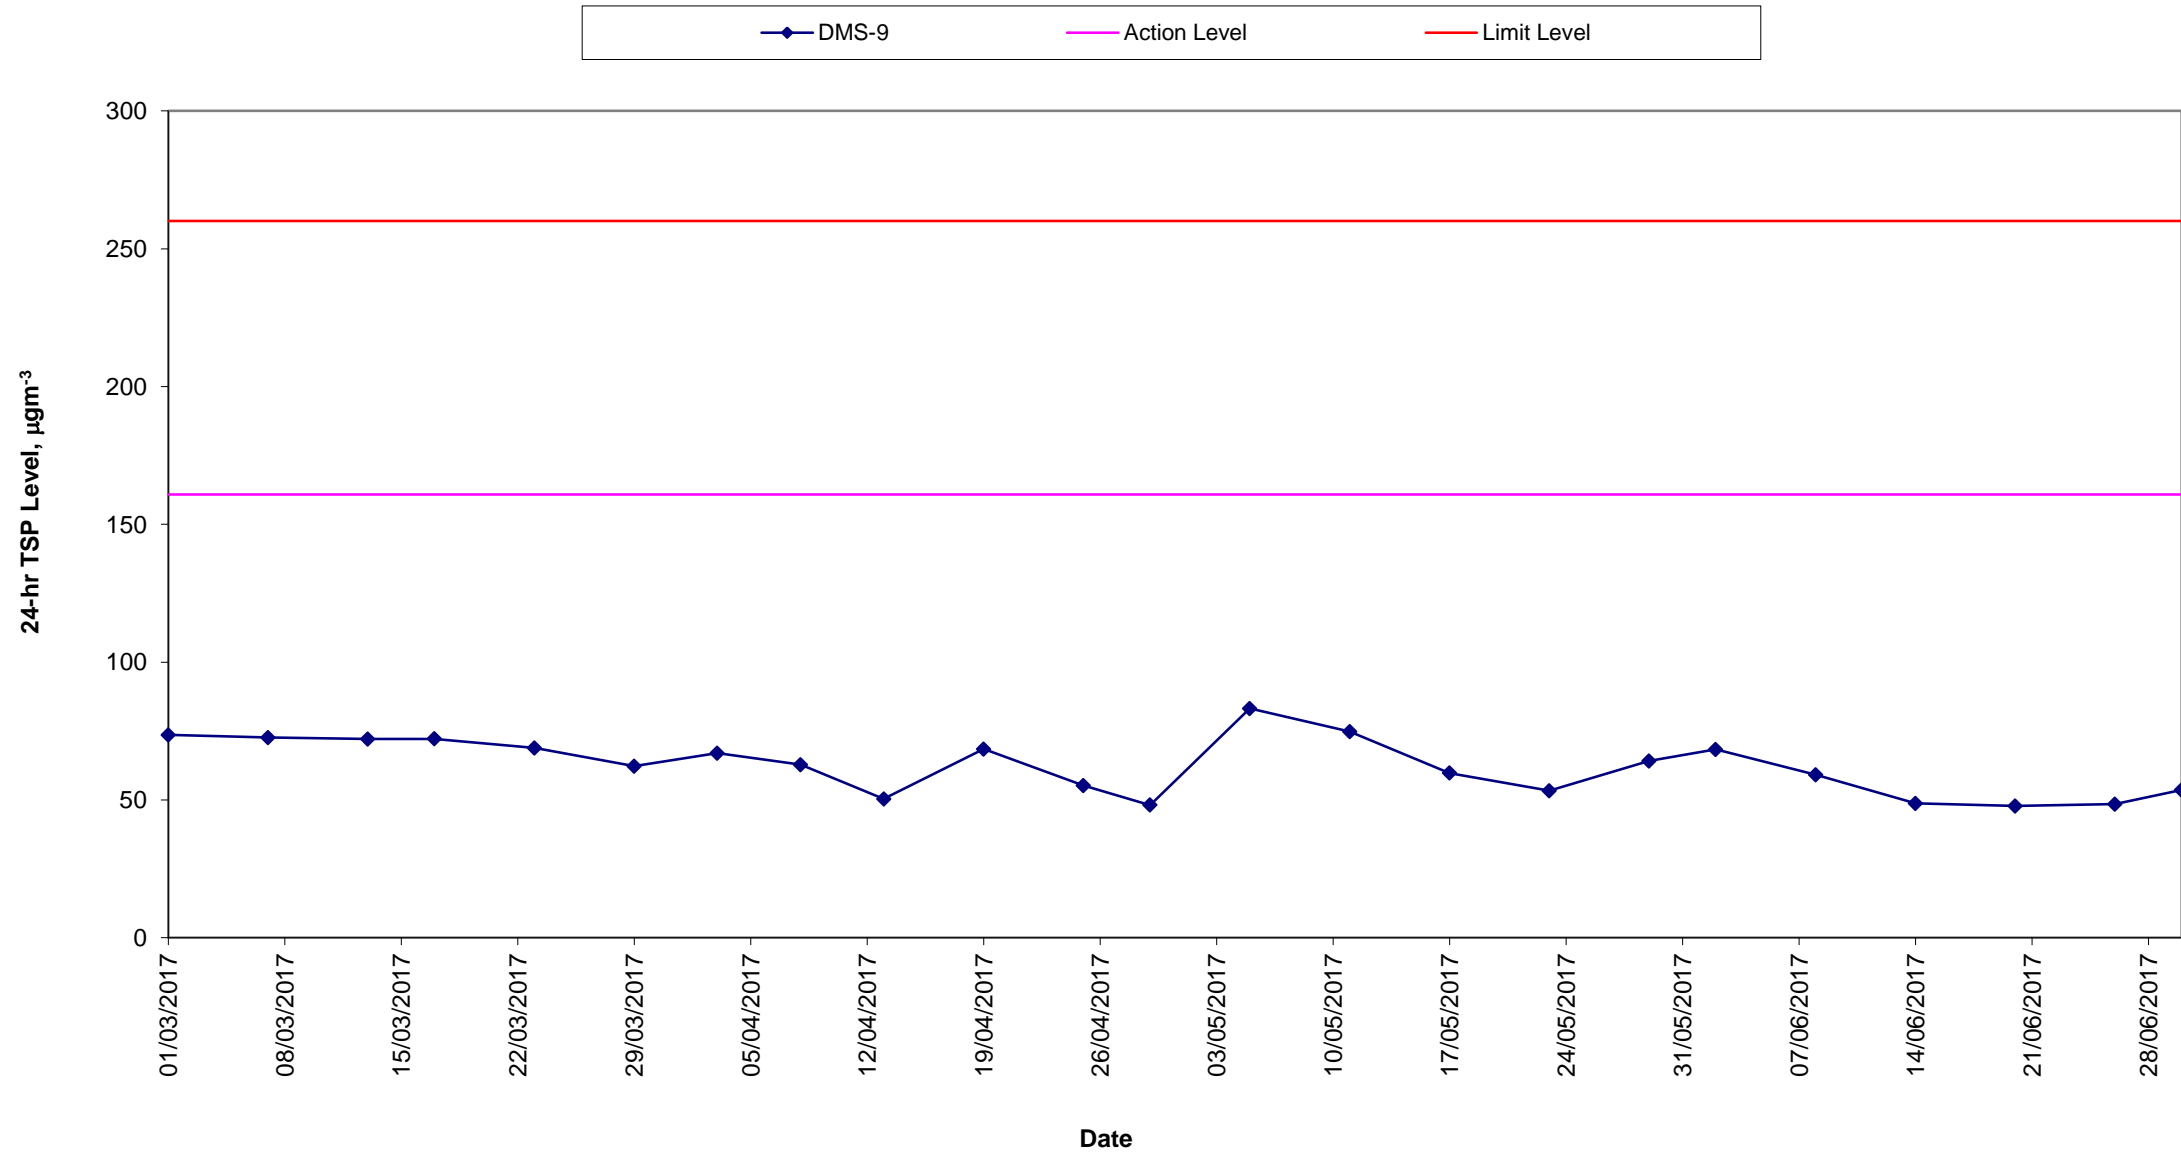
**Construction Dust Monitoring Results for the Past 4 Months  
DMS-9 (No.12 Pau Chung Street)**

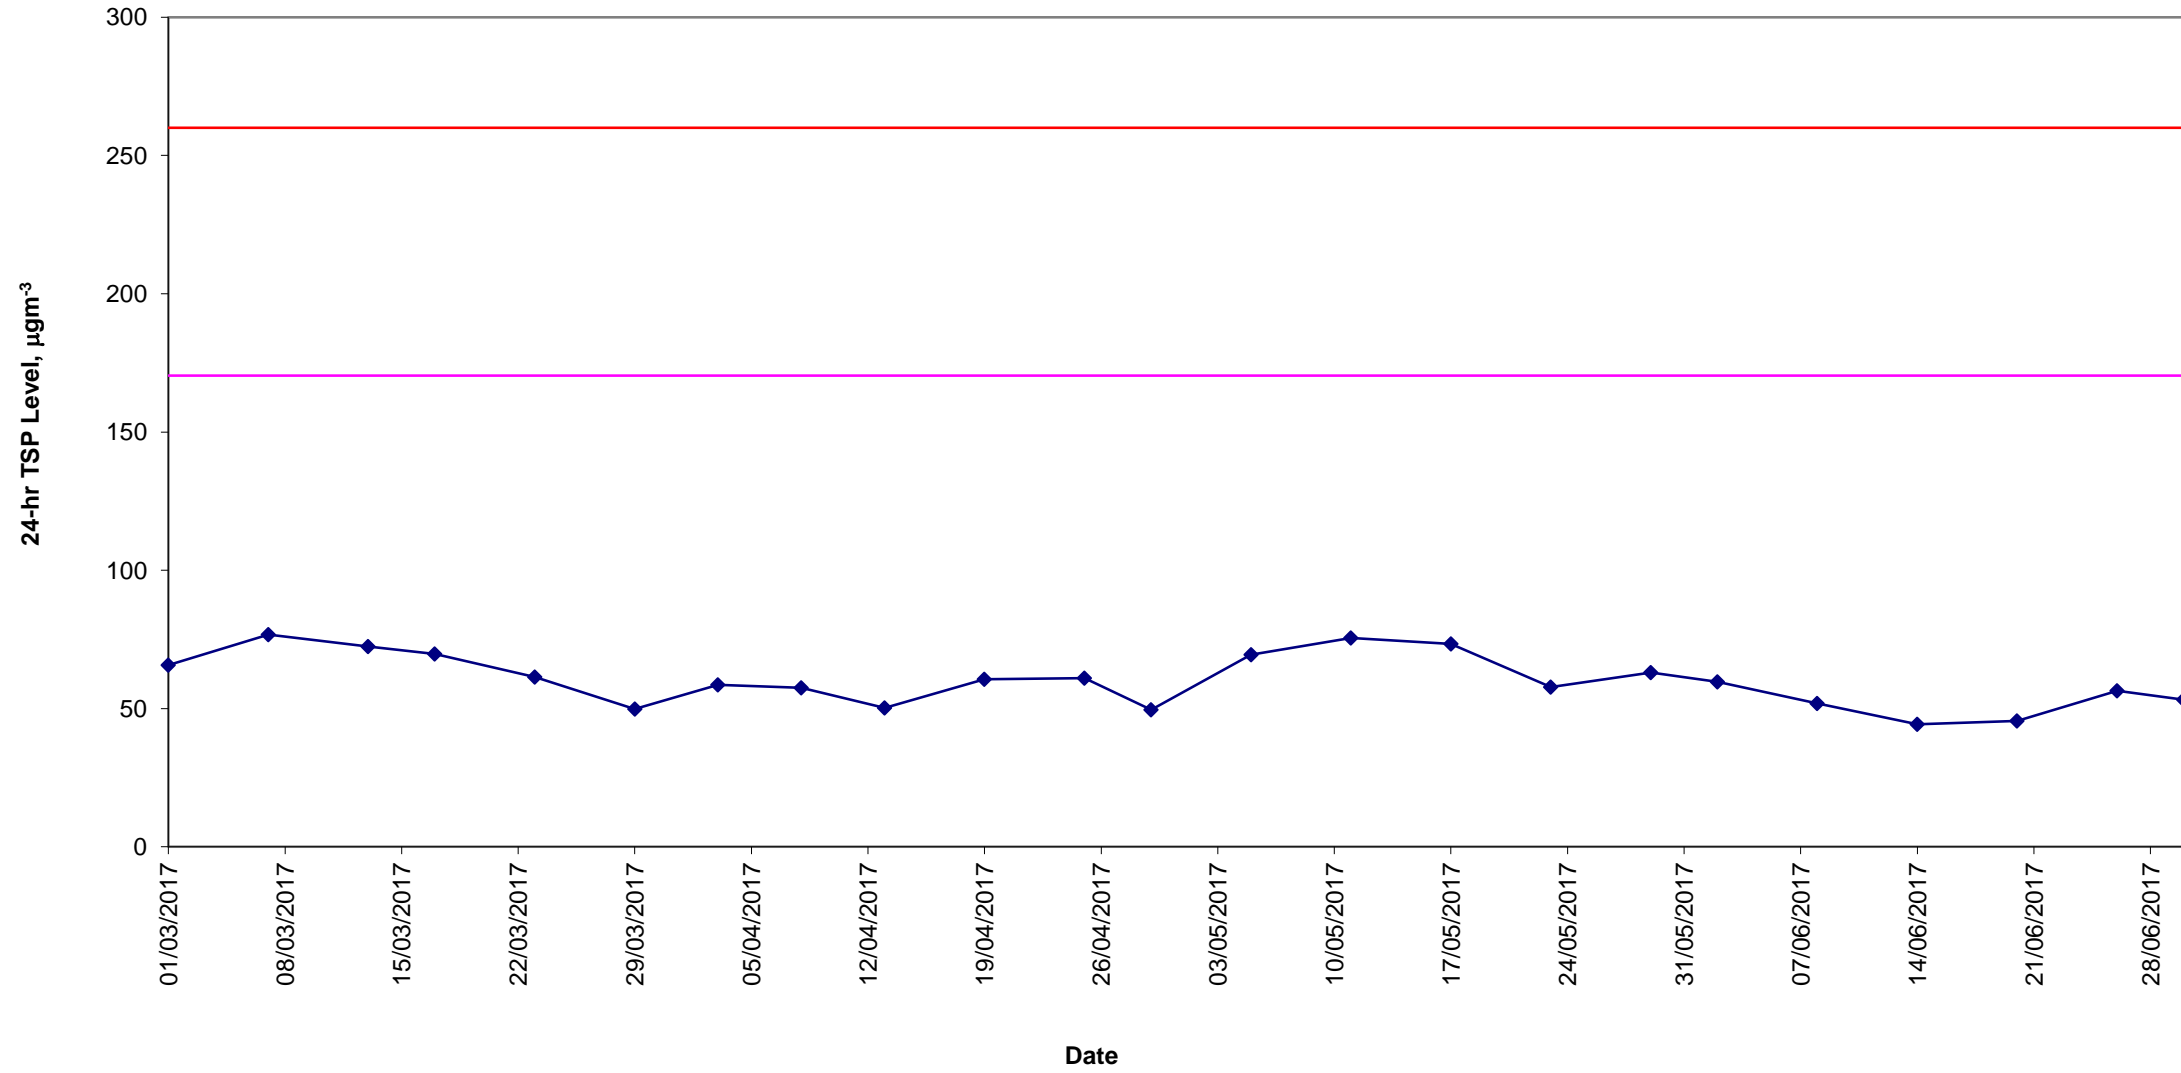
### Construction Dust Monitoring Results for the Past 4 Months DMS-10 (Chat Ma Mansion)

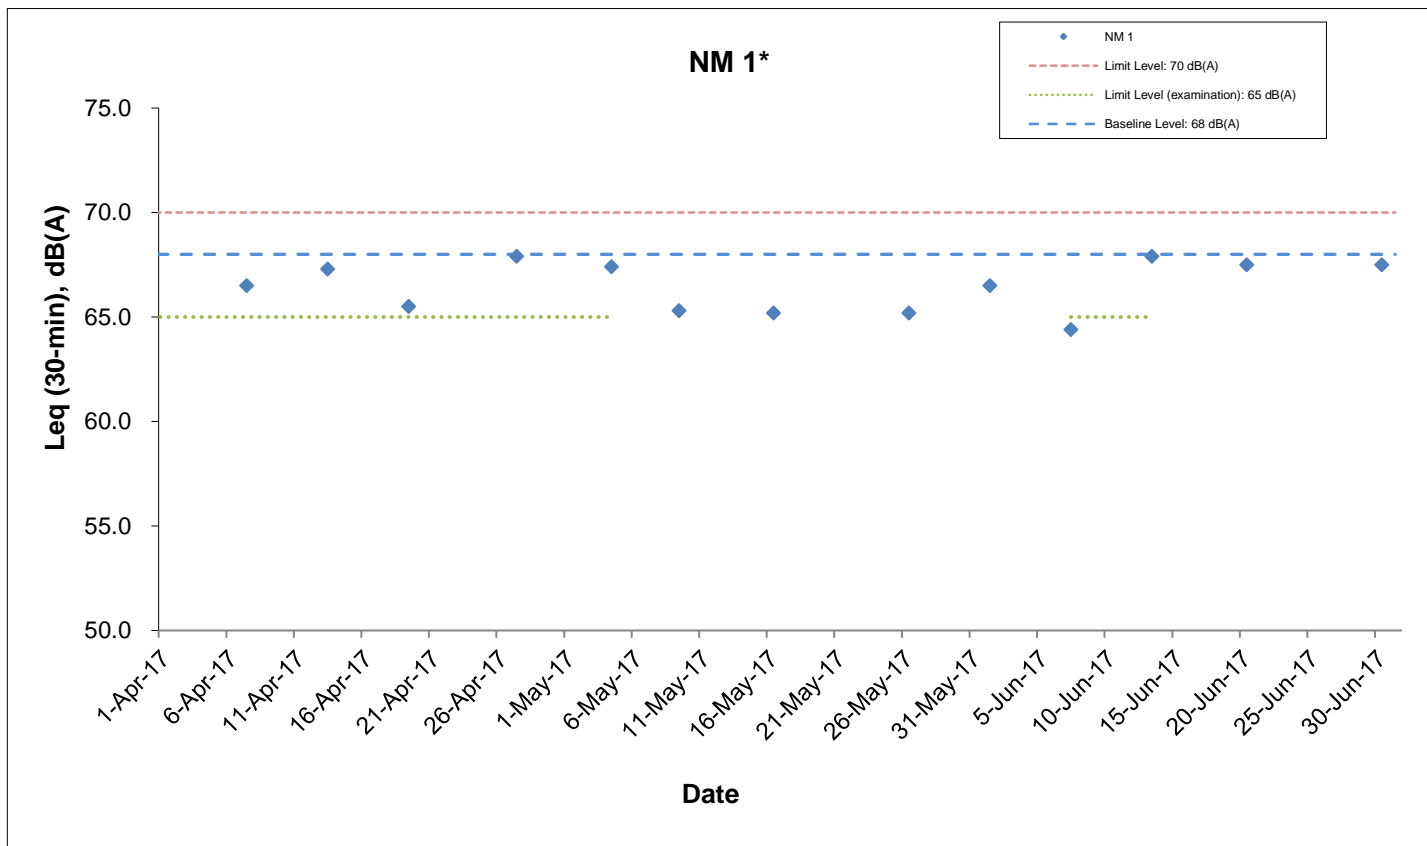
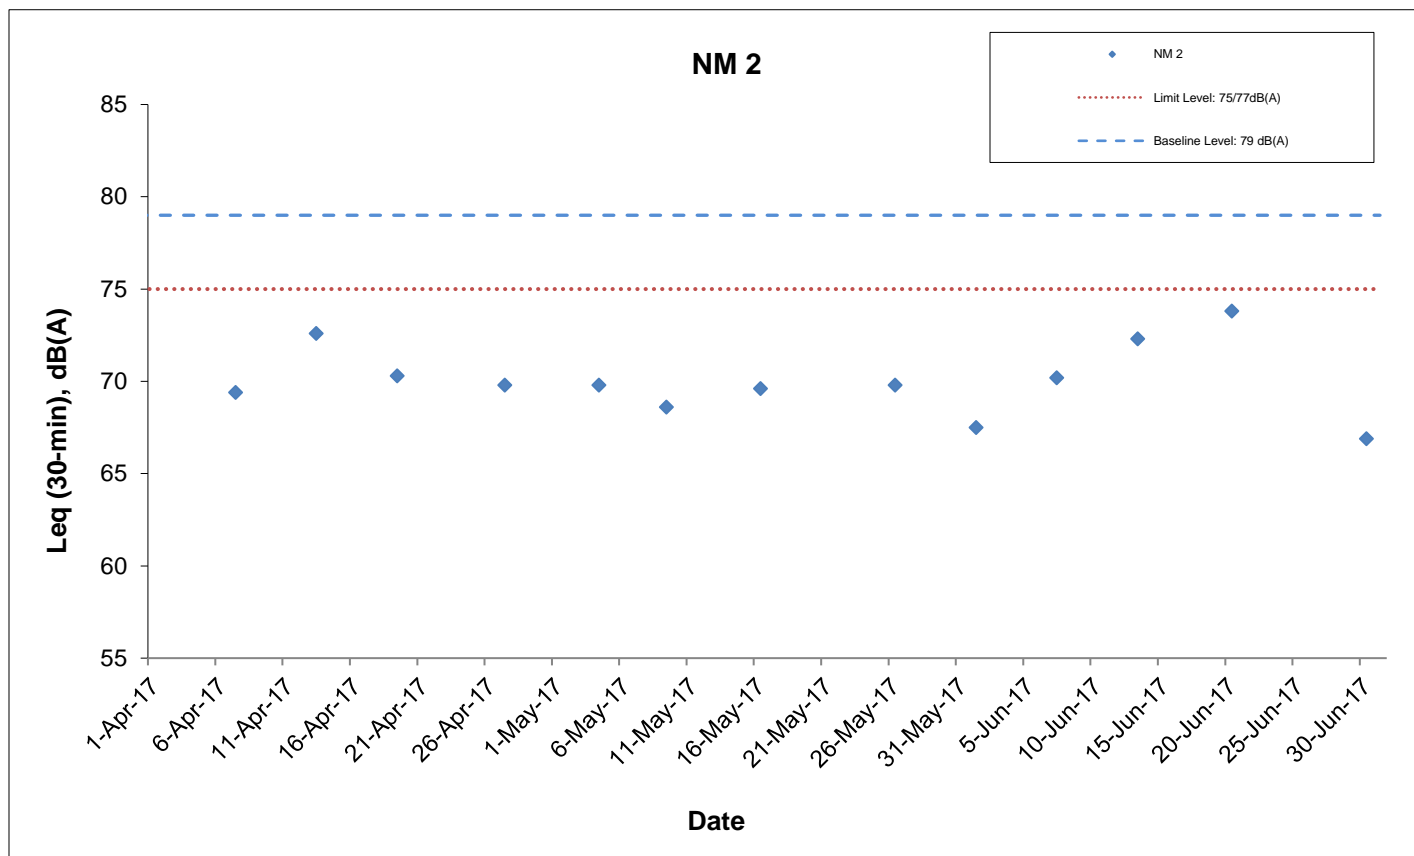
# Appendix H Regular Construction Noise Monitoring Results

\* - The noise monitoring results of the measurements are higher than the daytime construction noise criterion. However, the results are not considered as exceedance if they are either below the baseline level or below the limit level after deducting the baseline noise level.
