**Shatin to Central Link –  
Tai Wai to Hung Hom Section and  
Mong Kok East to Hung Hom Section**

Monthly EM&A Report No. 58

[Period from 1 to 30 June 2017]

Consultancy Agreements  
No. C11033 & C11033B

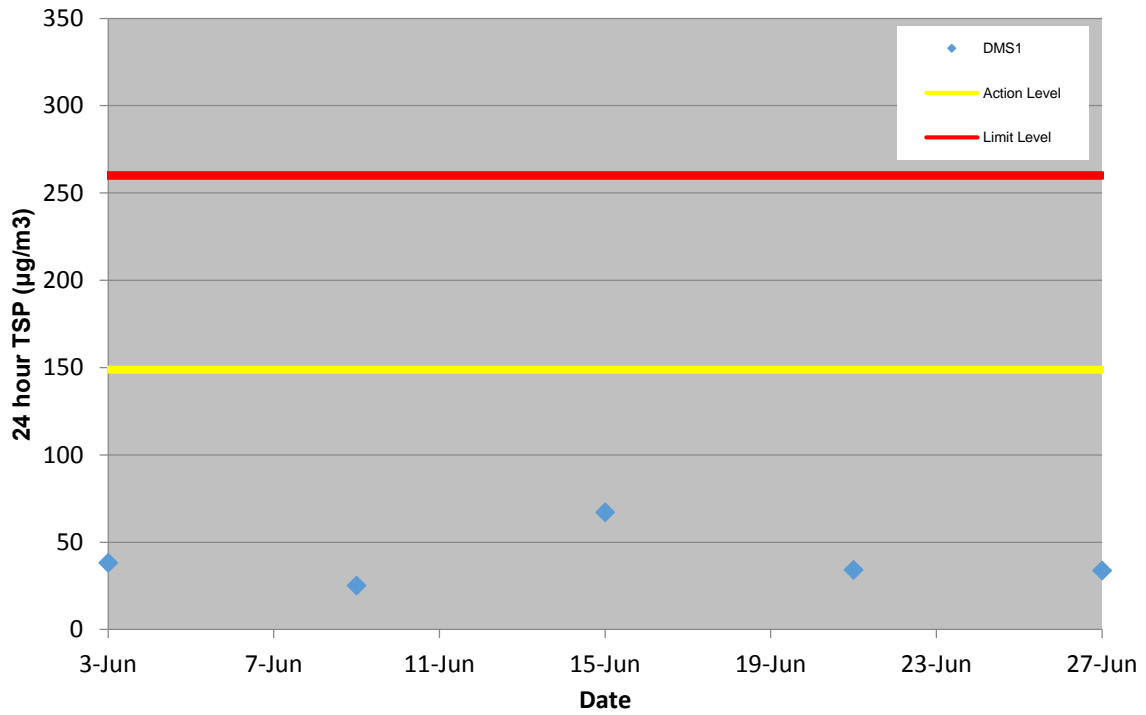
Impact 24-hour TSP Monitoring at Air Monitoring Station DMS-1

Impact 24-hour TSP Monitoring at Air Monitoring Station DMS-1  
From March 2017 to June 2017

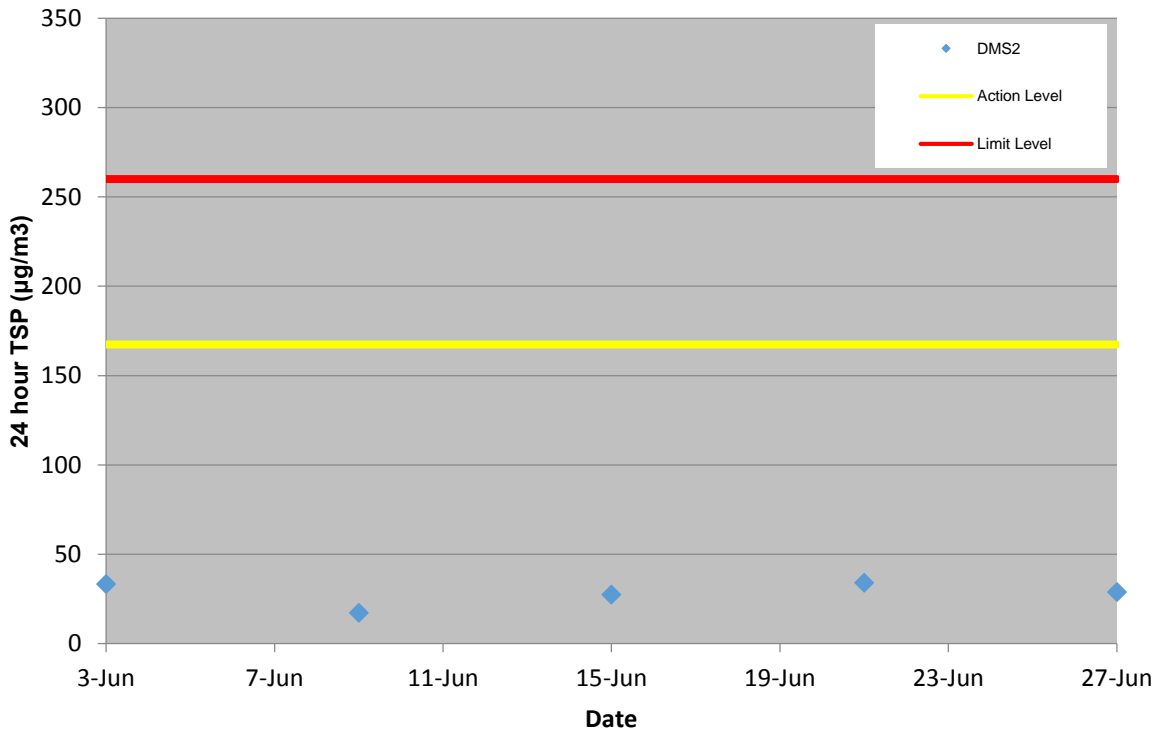
Impact 24-hour TSP Monitoring at Air Monitoring Station DMS-2

Impact 24-hour TSP Monitoring at Air Monitoring Station DMS-2  
From March 2017 to June 2017

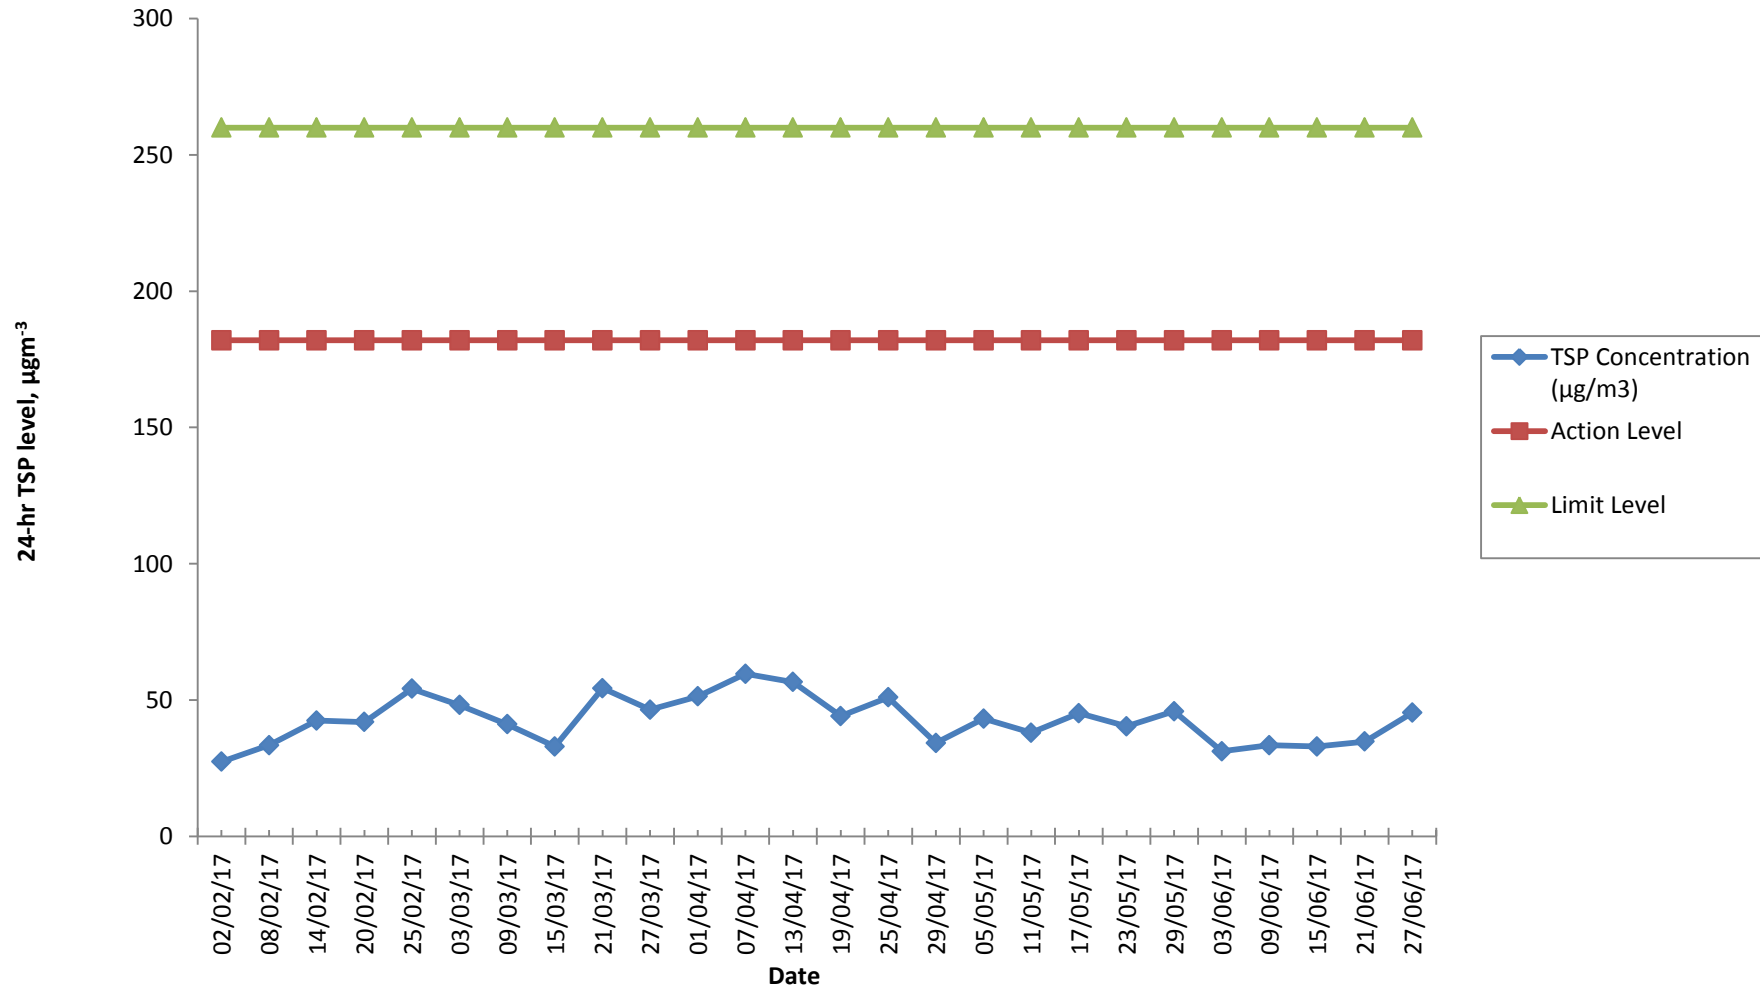
### Construction Dust Monitoring Results for AM2 (Harbourfront Horizon)
