MTR Corporation Limited

**Shatin to Central Link - Tai Wai to Hung
Hom Section and Mong Kok East
to Hung Hom Section**

Monthly EM&A Report No. 59

[Period from 1 to 31 Jul 2017]

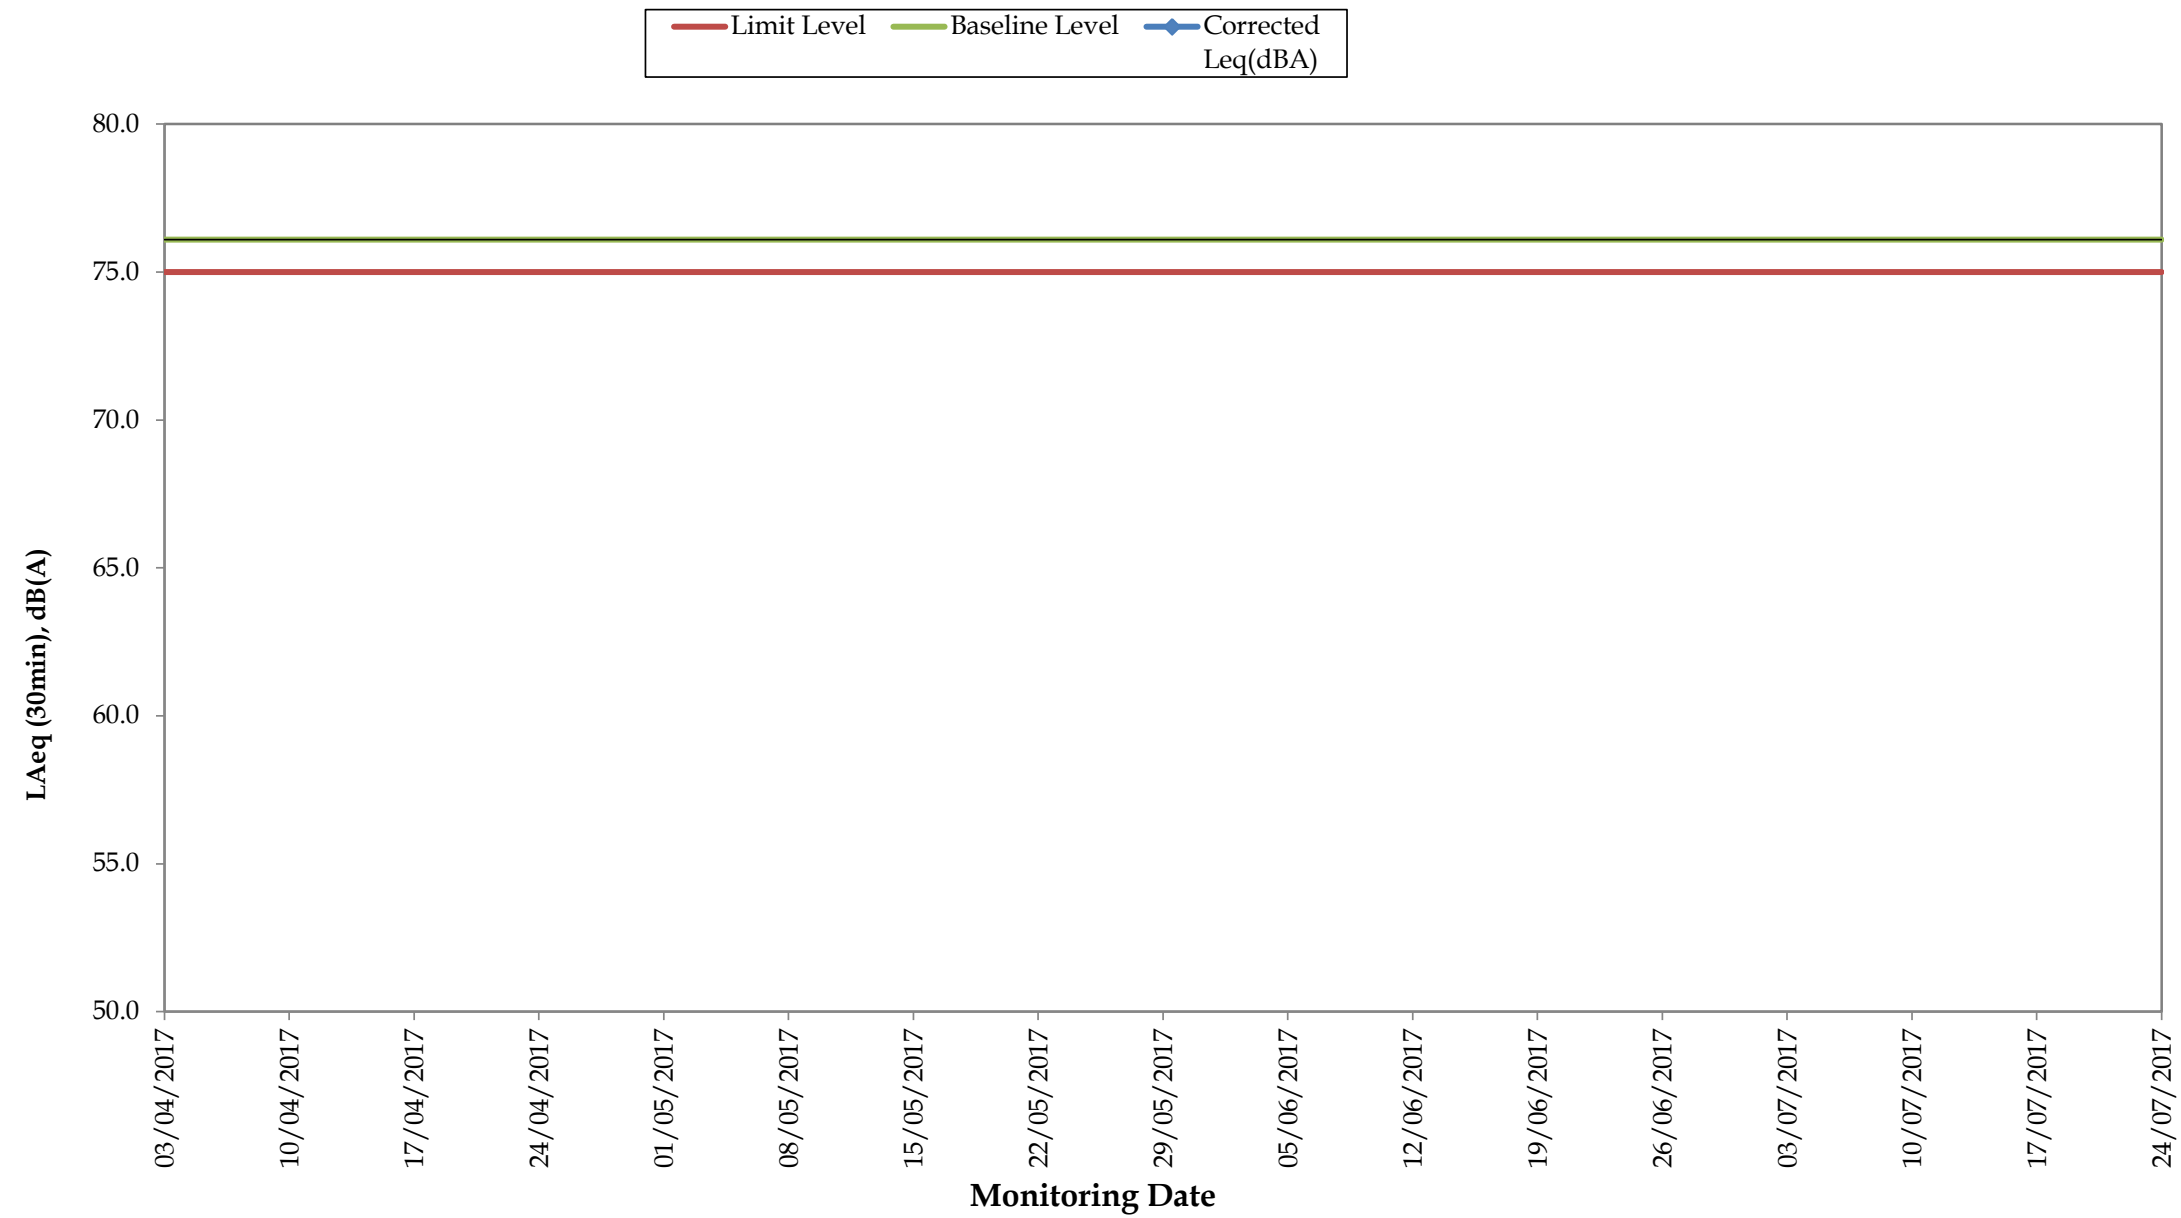
Regular Noise Monitoring Results at NMS-CA-6 (No. 16-23 Nam Kok Road) (LAeq, 30min) for the Past 4 Months

- For those corrected noise levels that are not shown in this graph, the measured noise levels are equal to or below baseline level.

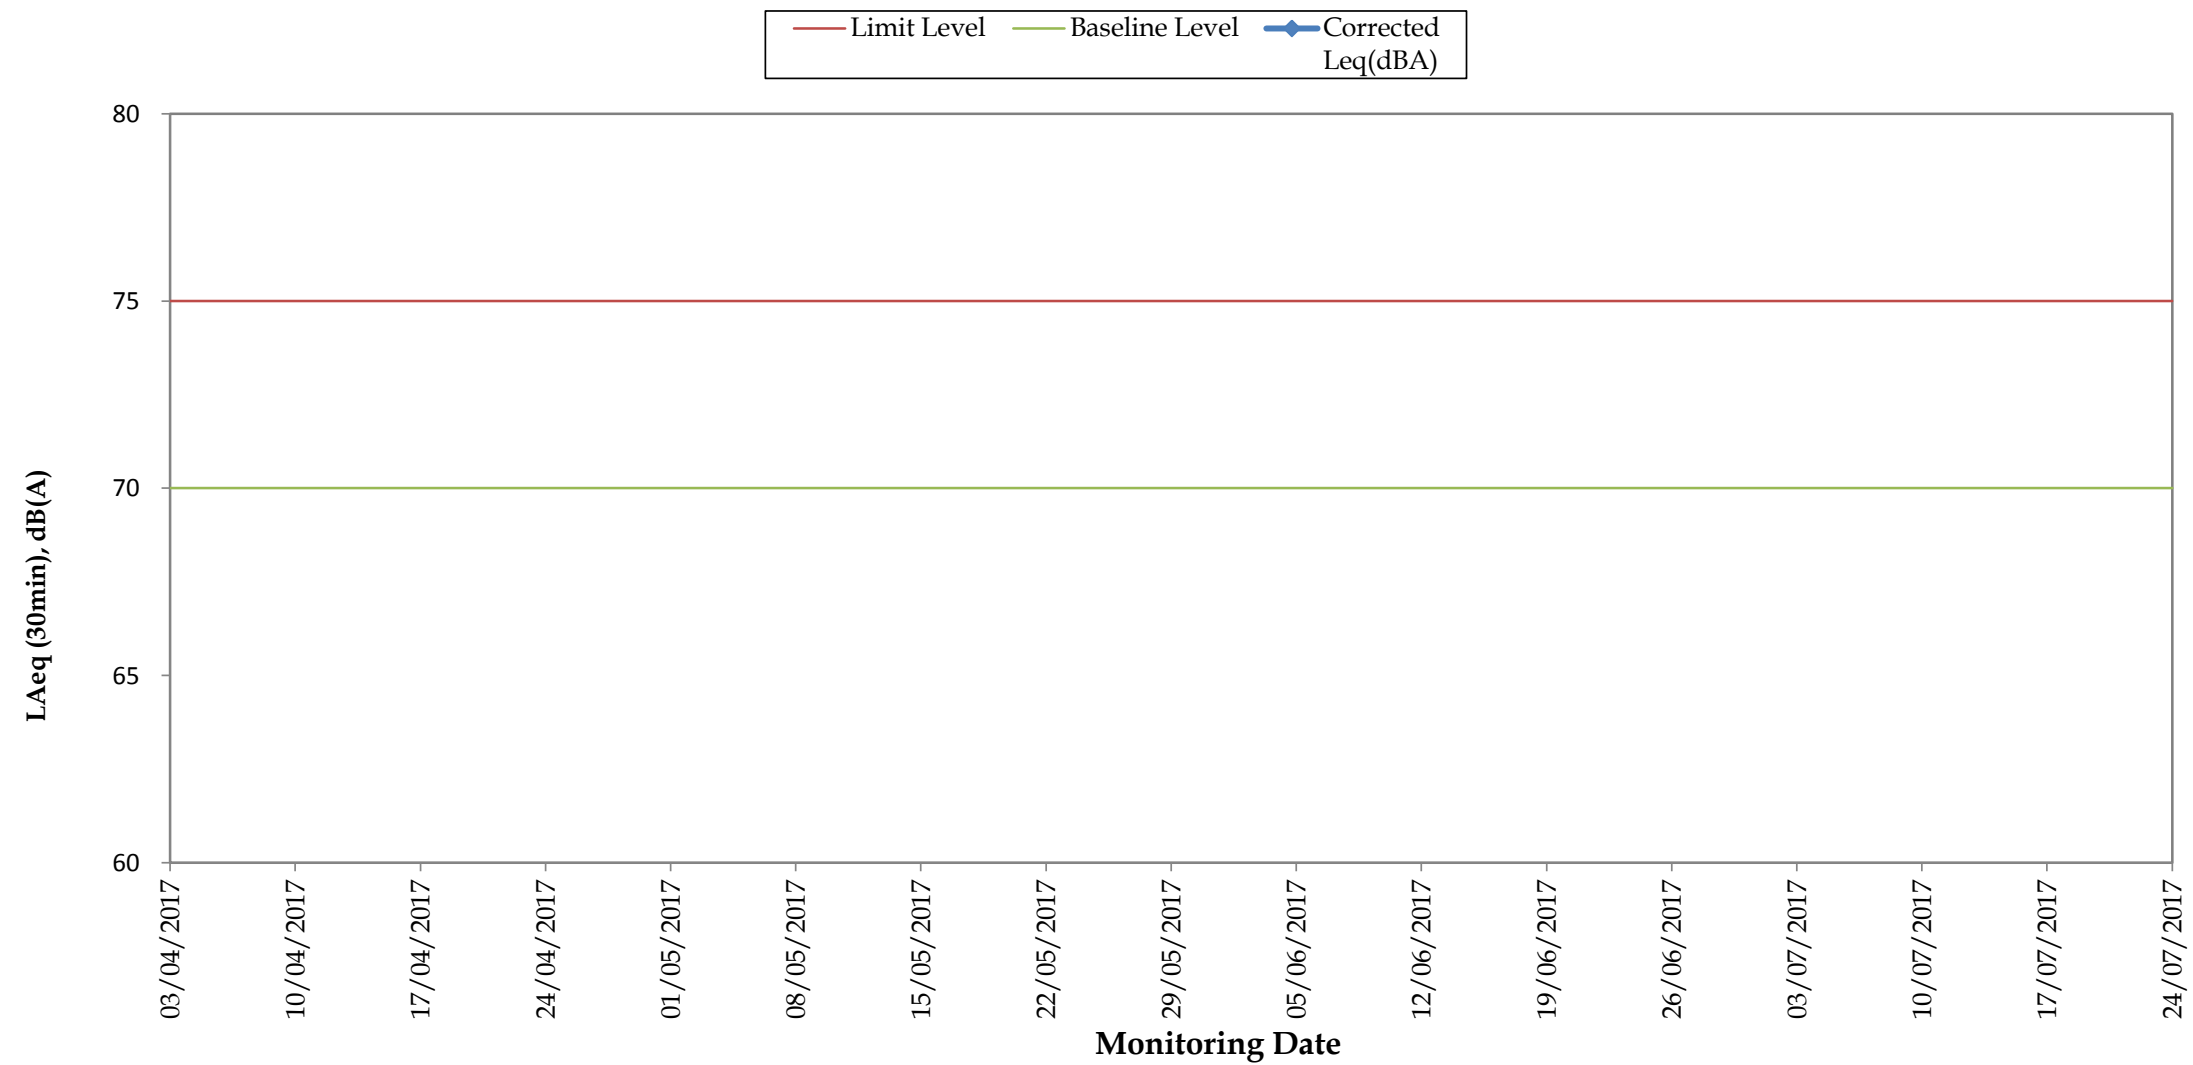
Regular Noise Monitoring Results at NMS-CA-7 (Skytower Tower 2) (LAeq, 30min) for the Past 4 Months

- For those corrected noise levels that are not shown in this graph, the measured noise levels are equal to or below baseline level.

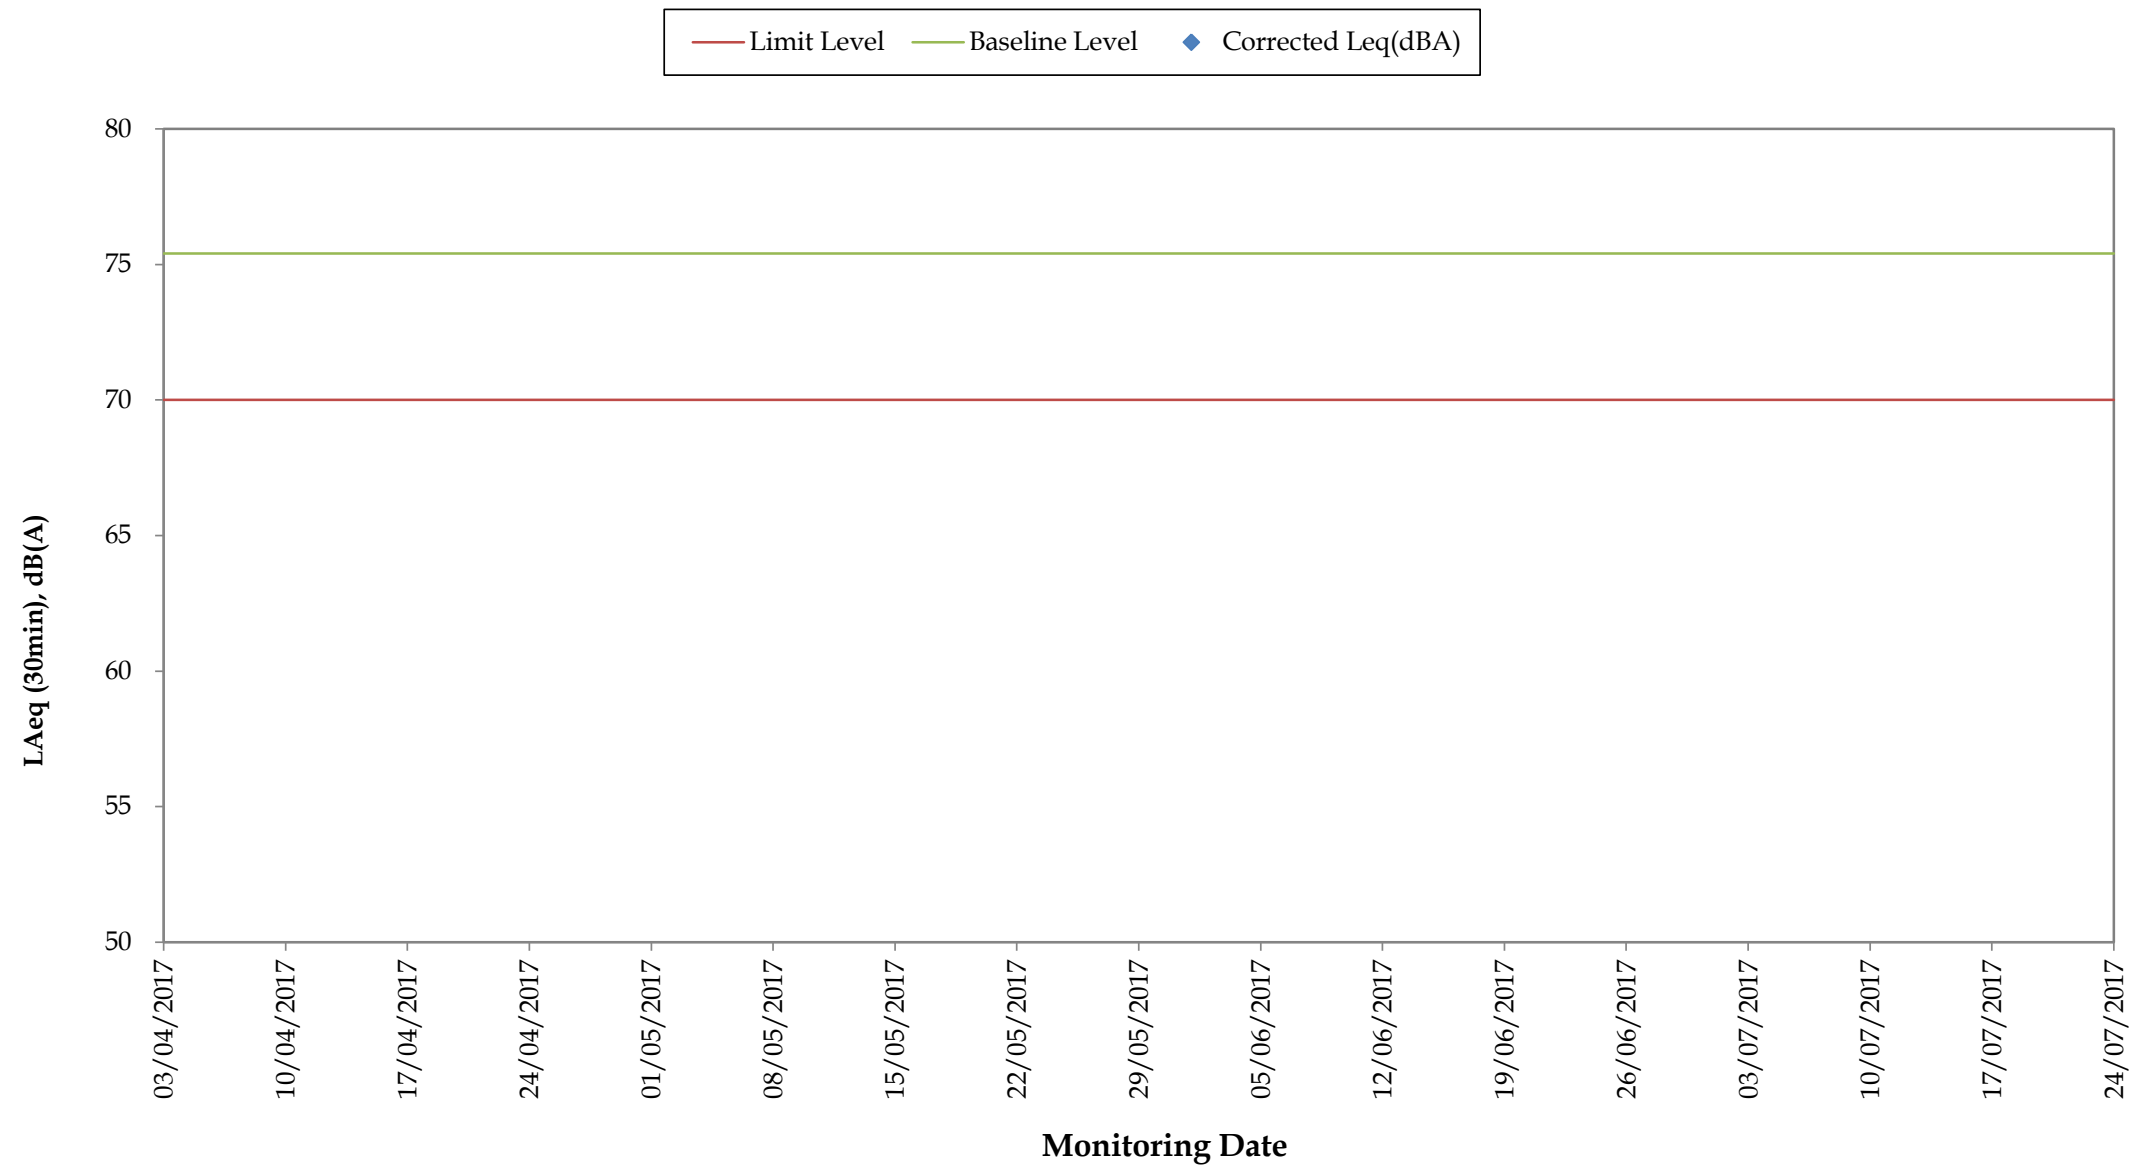
Regular Noise Monitoring Results at NMS-CA- 8 (SKH Good Shepherd Primary School) (LAeq, 30min) for the Past 4 Months

- For those corrected noise levels that are not shown in this graph, the measured noise levels are equal to or below baseline level.
- The limit level was updated from 78dB(A) to 79 dB(A) on 22 Aug 2013 as per the latest CNMP and CNMMP.
- The limit level was updated from 79dB(A) to 70dB(A)/65dB(A) (during normal/examination period) from April 2016, as the continuous noise monitoring was completed in March 2016 according to the latest CNMP

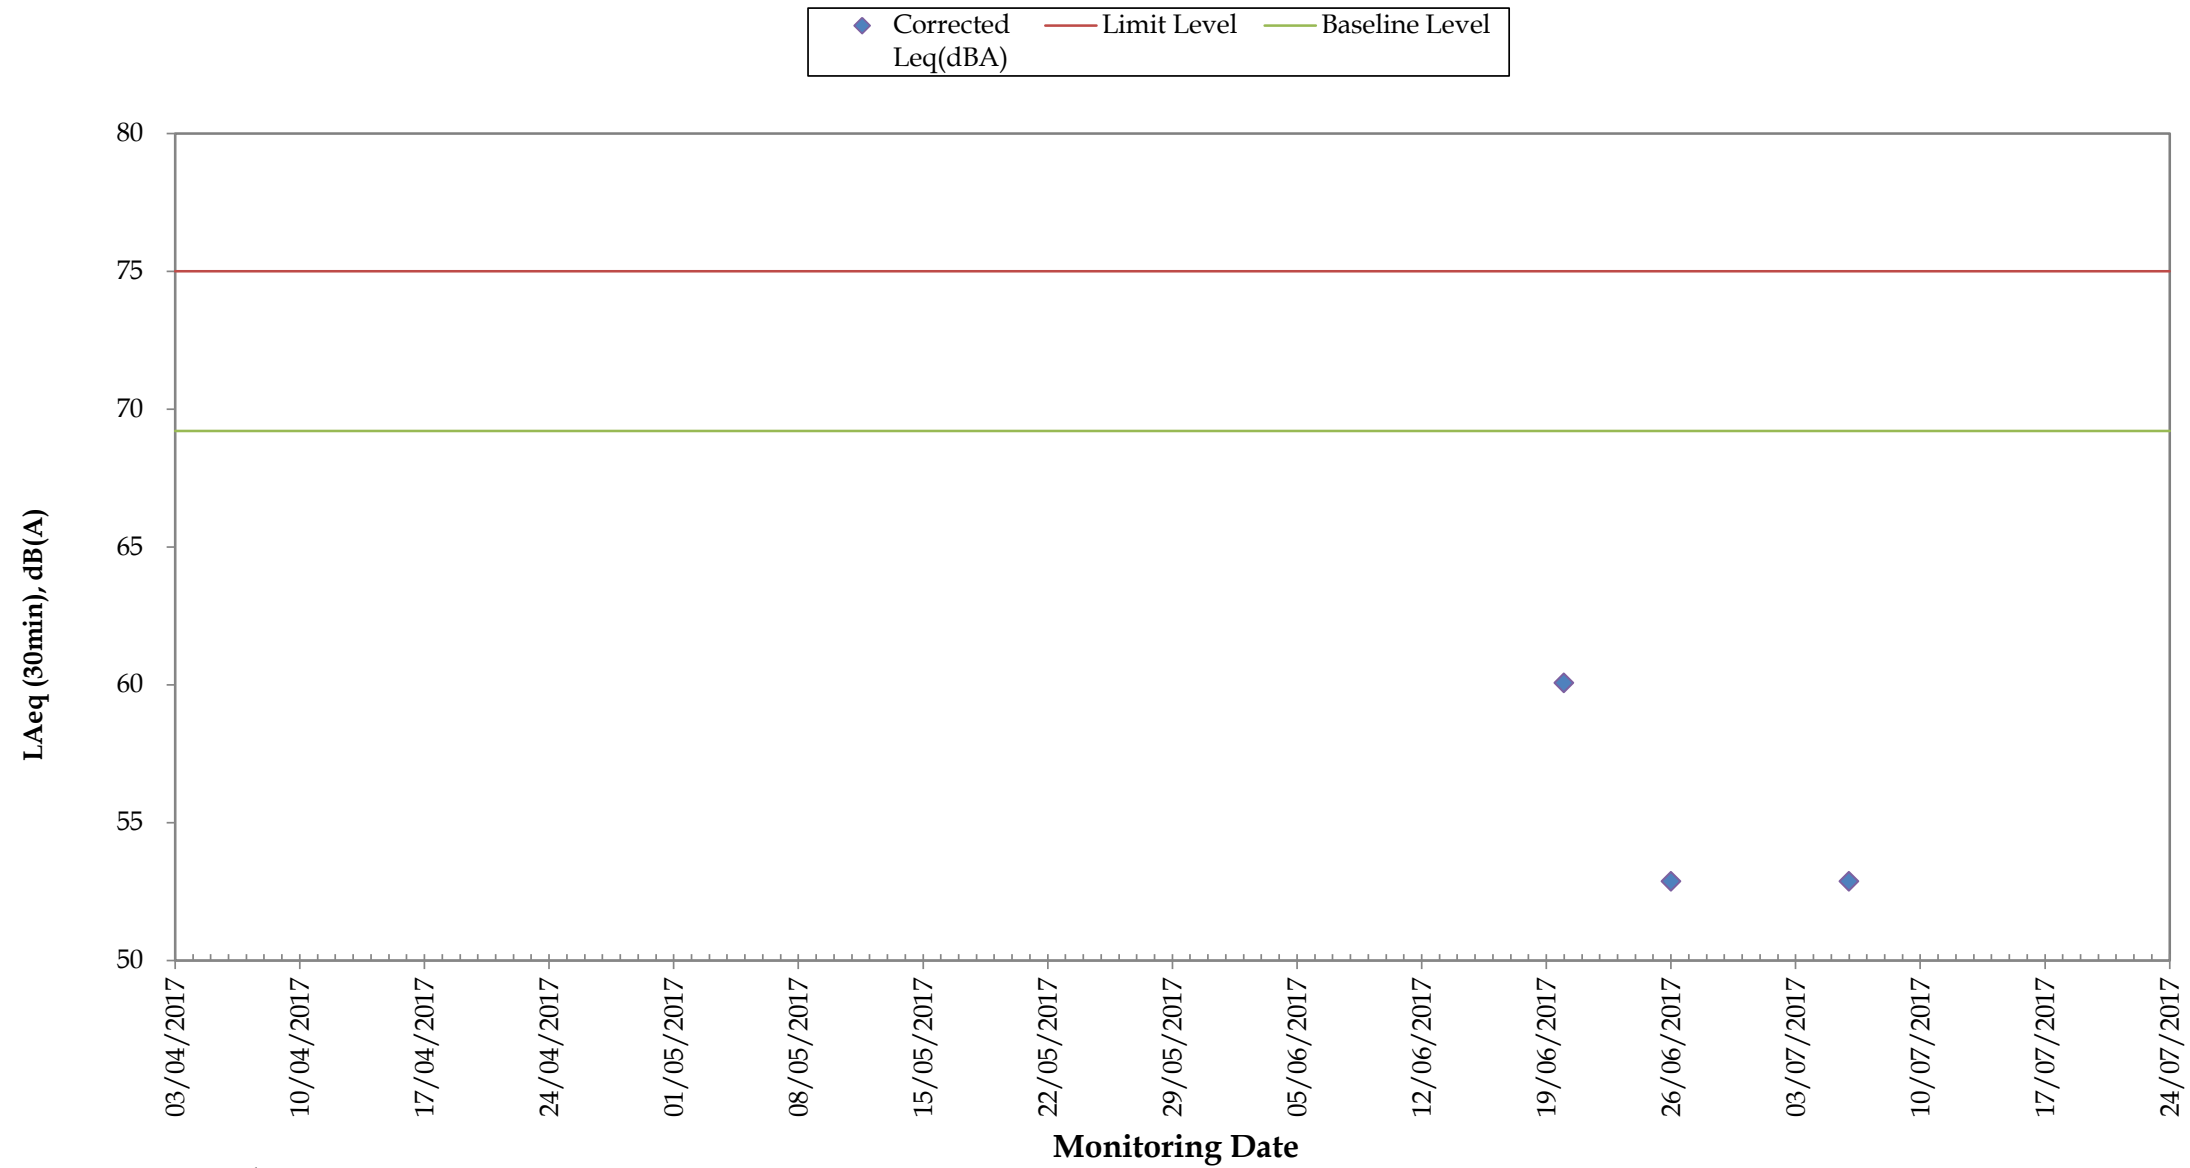
Regular Noise Monitoring Results at NMS-CA-9 (Kong Yiu Mansion) (LAeq, 30min)) for the Past 4 Months

- For those corrected noise levels that are not shown in this graph, the measured noise levels are equal to or below baseline level.

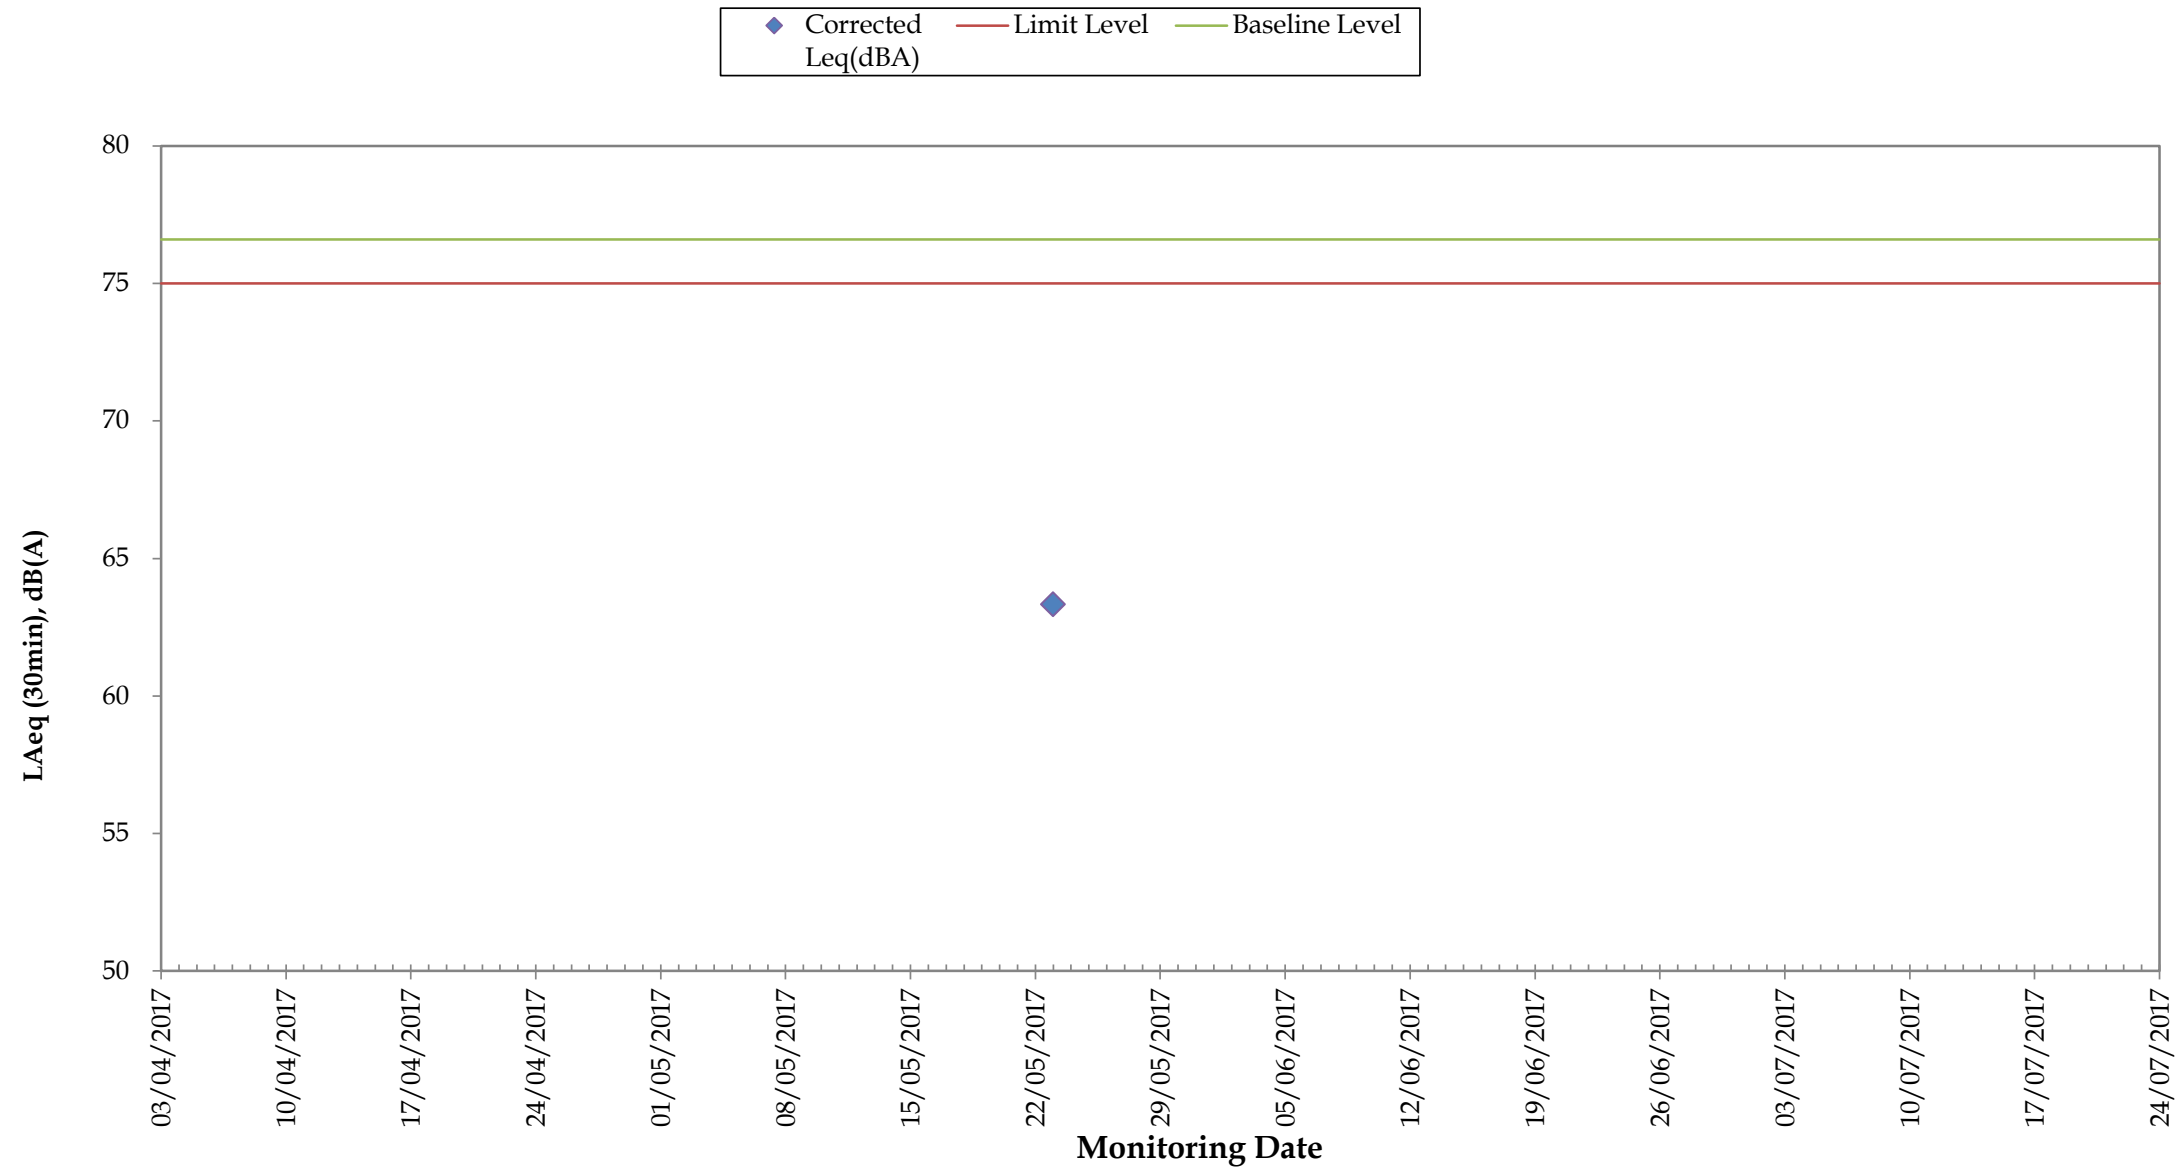
Regular Noise Monitoring Results at NMS-CA-10 (Chat Ma Mansion) (LAeq, 30min) for the Past 4 Months

- For those corrected noise levels that are not shown in this graph, the measured noise levels are equal to or below baseline level.

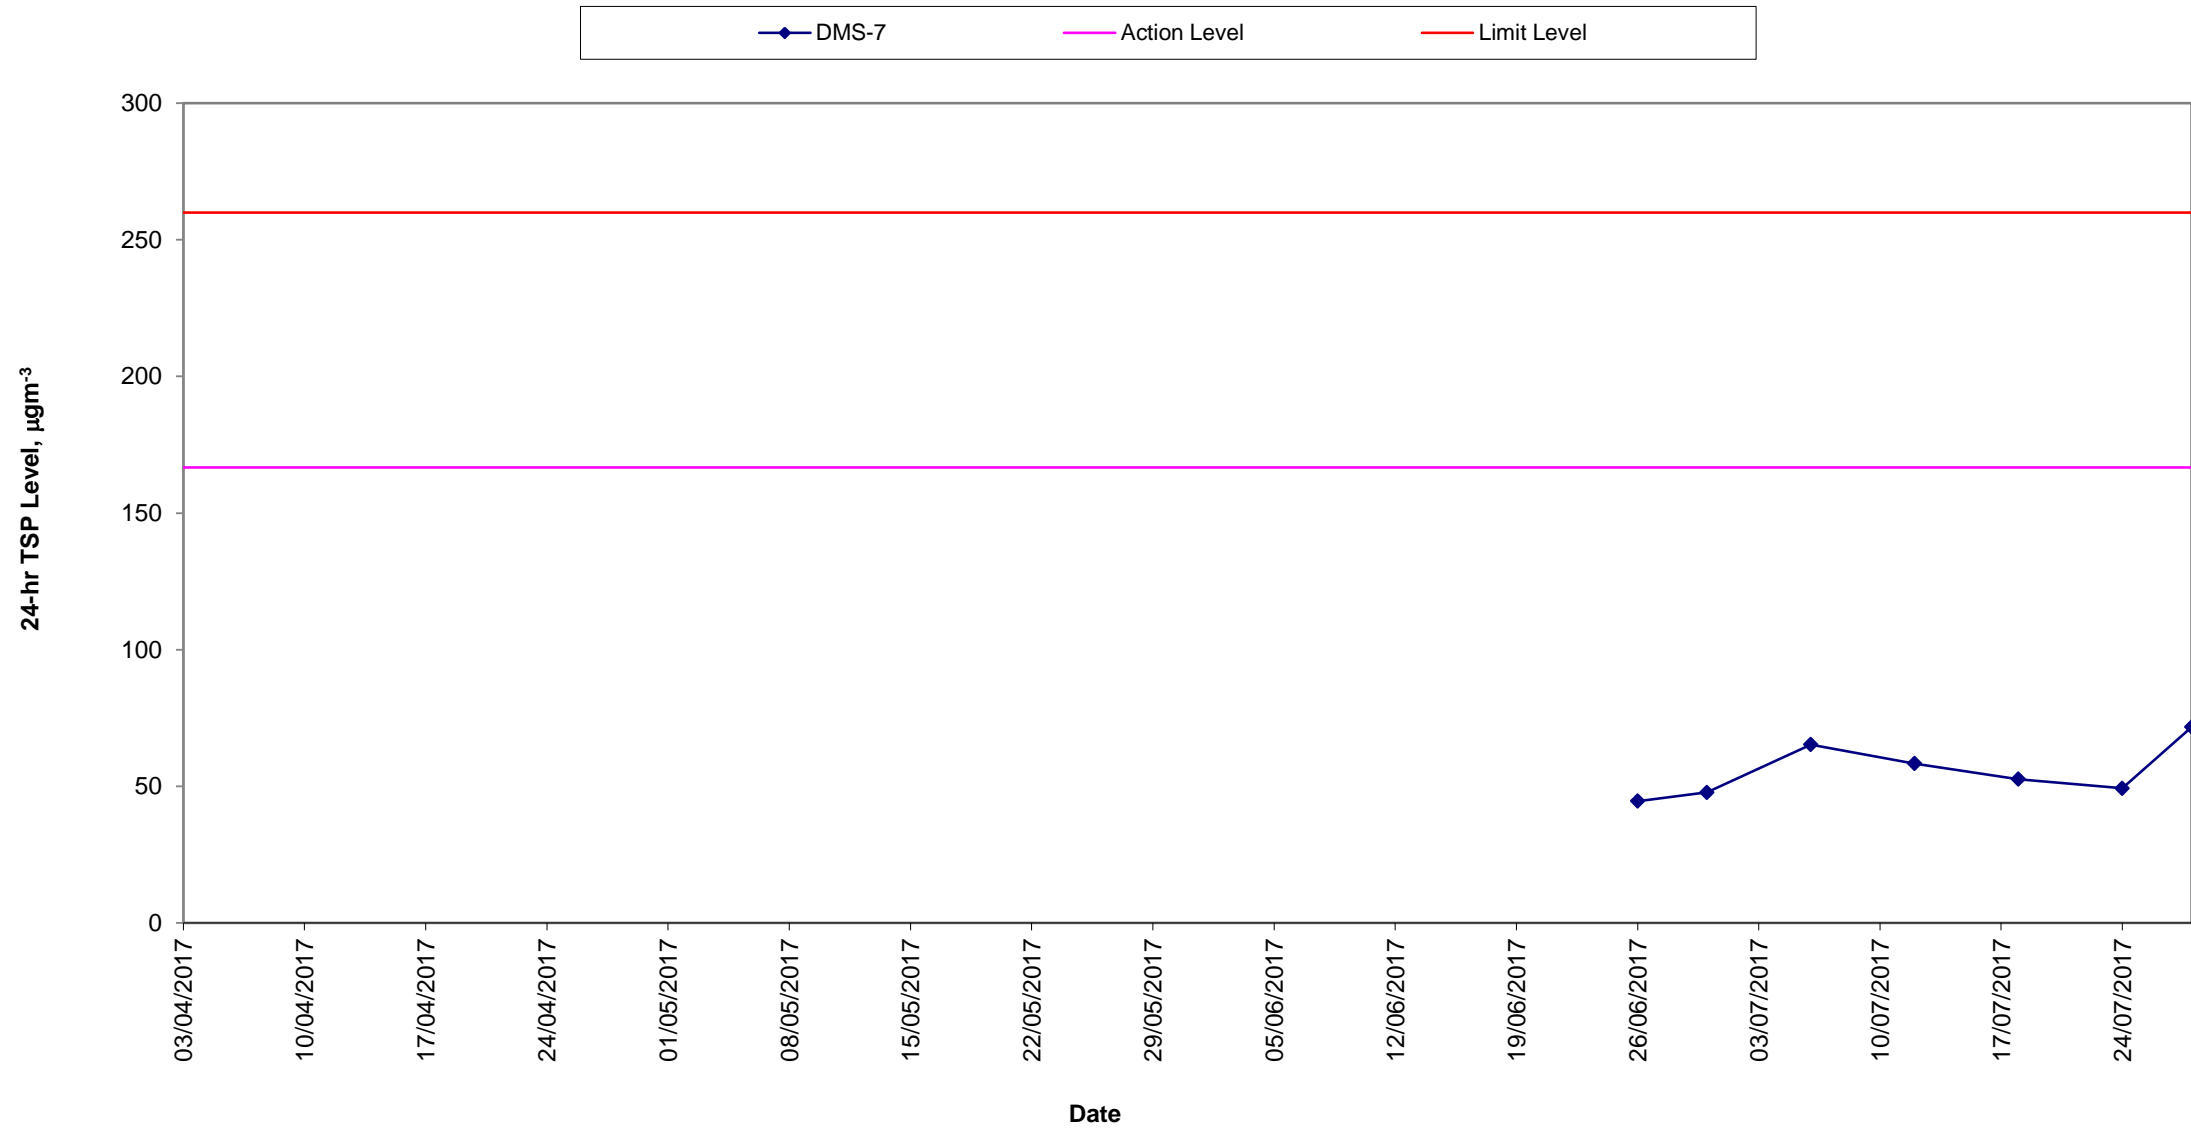
Construction Dust Monitoring Results for the Past 4 Months DMS- 7 (Parc 22)

- 24-hour averaged dust monitoring at DMS-7 (Parc-22) was temporary suspended since 13 December 2016 due to request from the Management Office and was resumed on 26 June 2017.

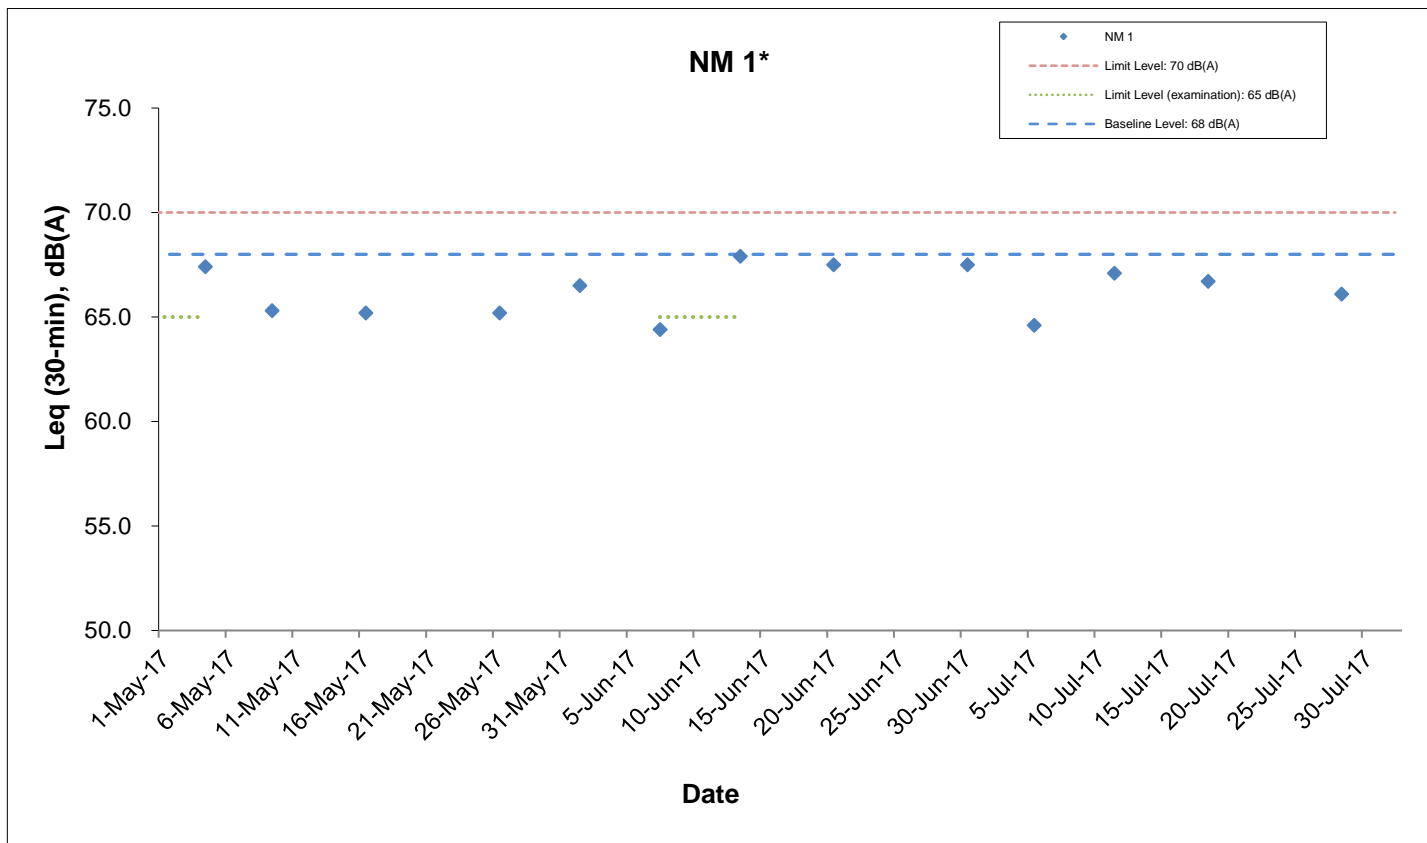
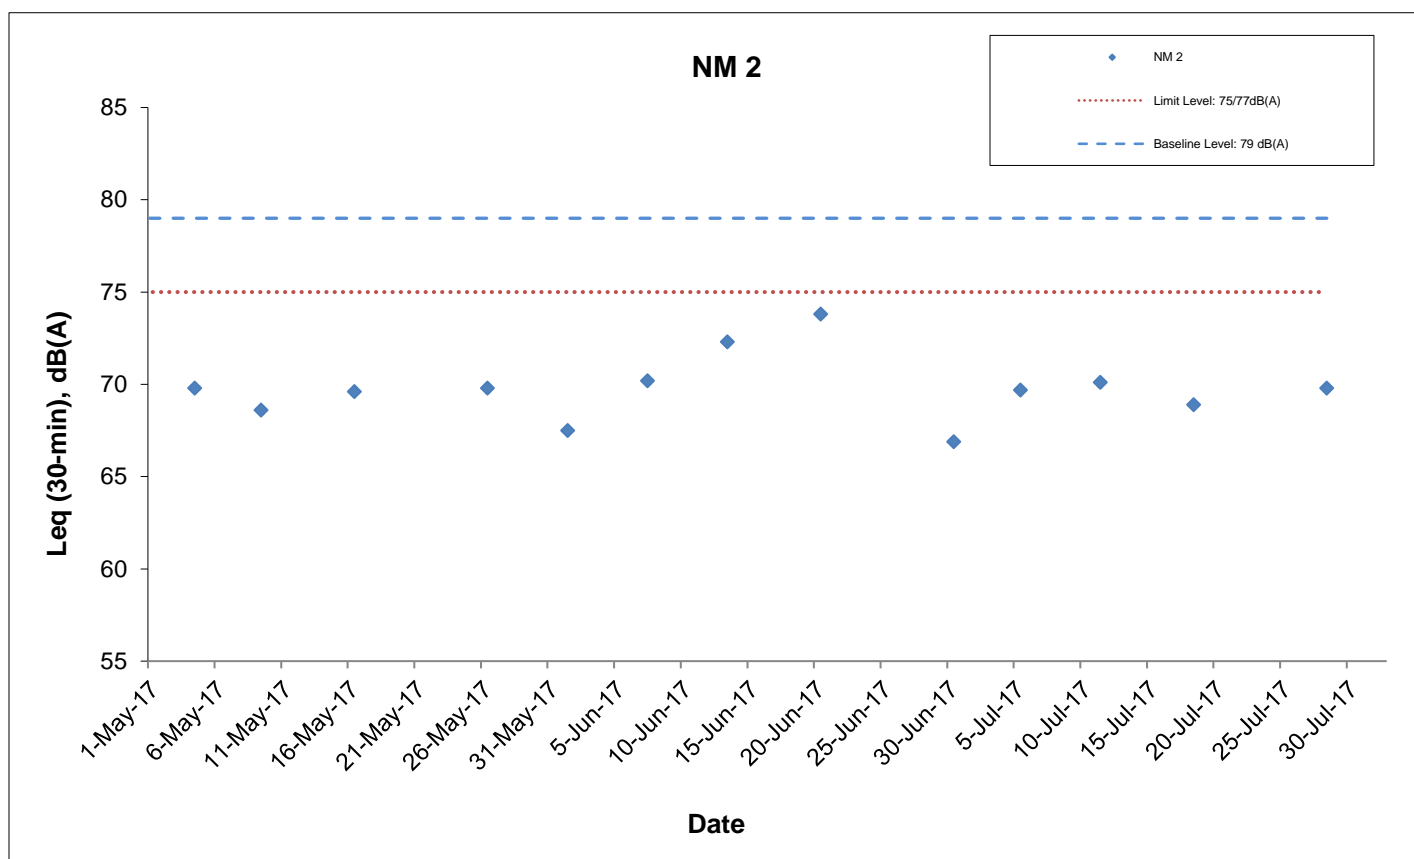
Appendix H Regular Construction Noise Monitoring Results

* - The noise monitoring results of the measurements are higher than the daytime construction noise criterion. However, the results are not considered as exceedance if they are either below the baseline level or below the limit level after deducting the baseline noise level.
