**Shatin to Central Link –  
Tai Wai to Hung Hom Section and  
Mong Kok East to Hung Hom Section**

Monthly EM&A Report No. 61

[Period from 1 to 30 September 2017]

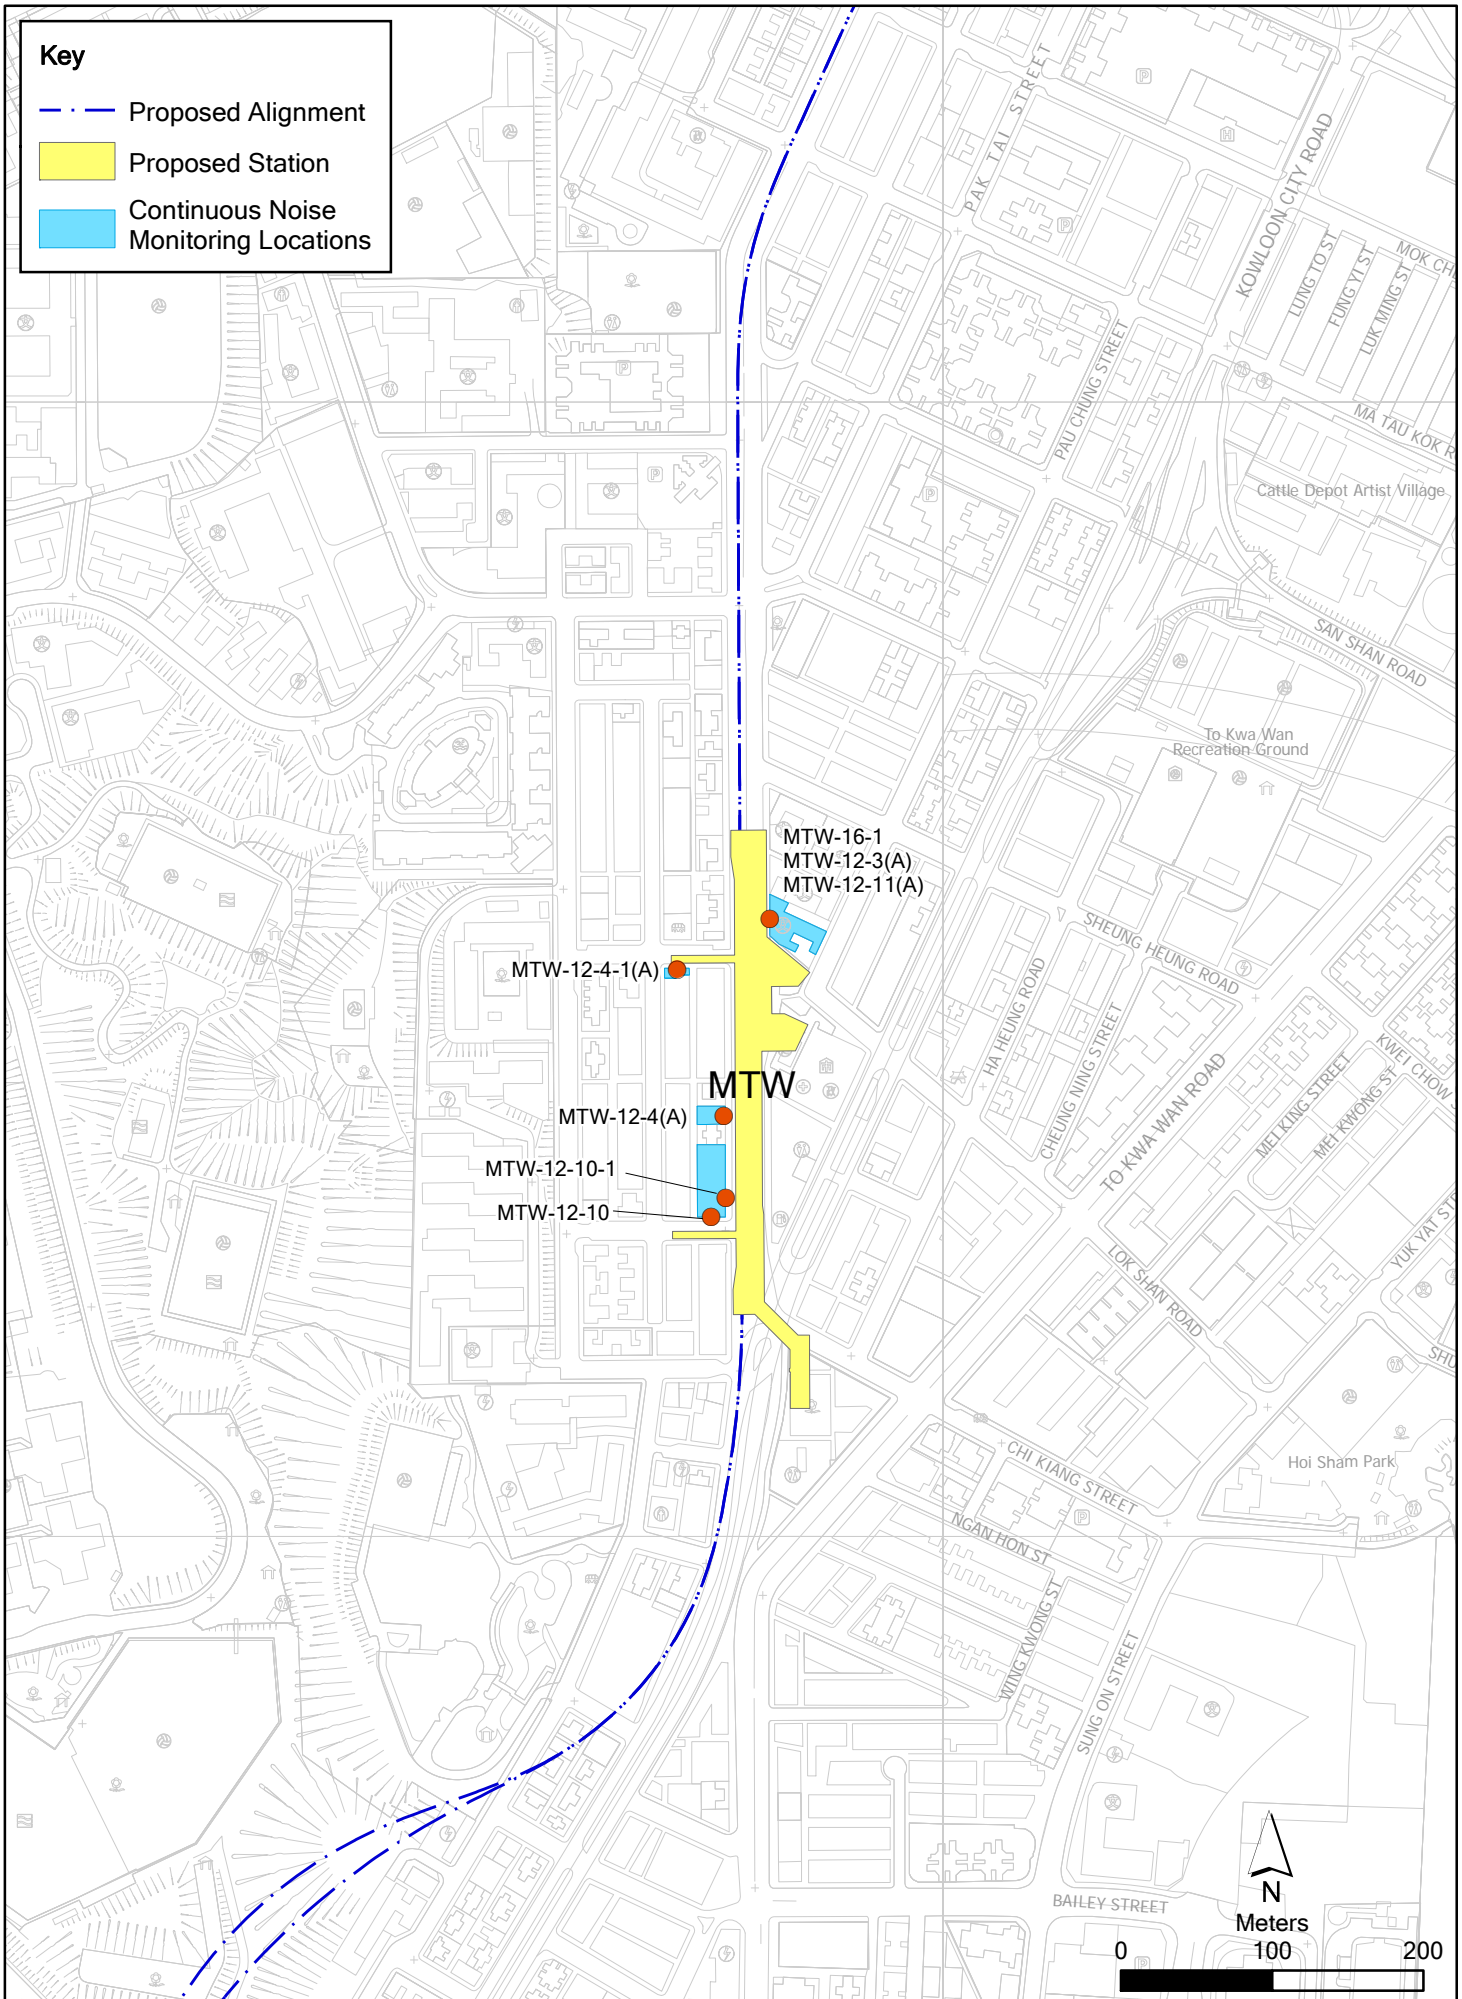
Figure 2.2b

Continuous Noise Monitoring Locations
