**Shatin to Central Link –
Tai Wai to Hung Hom Section and
Mong Kok East to Hung Hom Section**

Monthly EM&A Report No. 62

[Period from 1 to 31 October 2017]

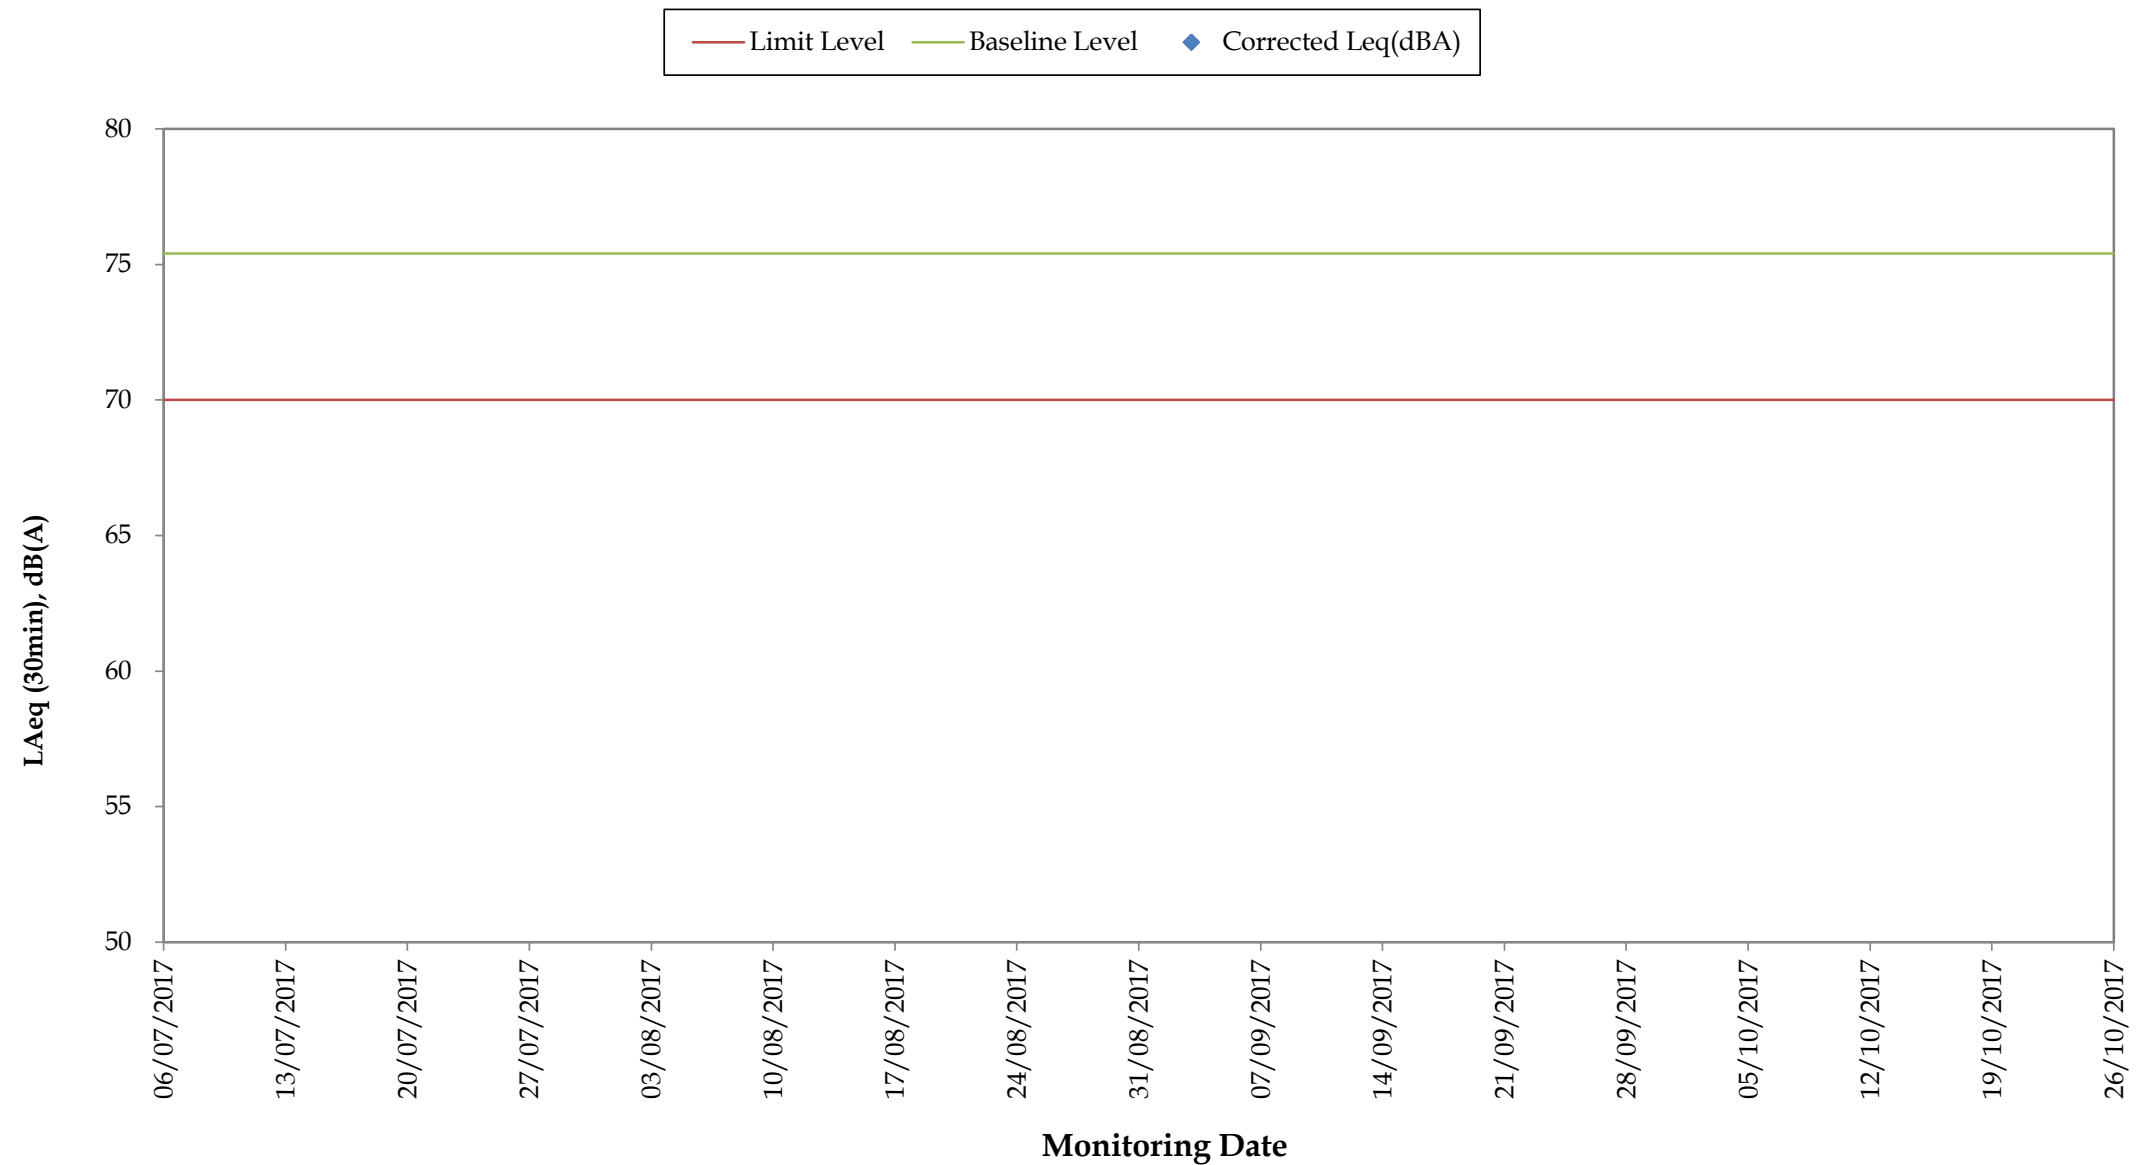
Regular Noise Monitoring Results at NMS-CA- 8 (SKH Good Shepherd Primary School) (LAeq, 30min) for the Past 4 Months

- For those corrected noise levels that are not shown in this graph, the measured noise levels are equal to or below baseline level.
- The limit level was updated from 78dB(A) to 79 dB(A) on 22 Aug 2013 as per the latest CNMP and CNMMP.
- The limit level was updated from 79dB(A) to 70dB(A)/65dB(A) (during normal/examination period) from April 2016, as the continuous noise monitoring was completed in March 2016 according to the latest CNMP

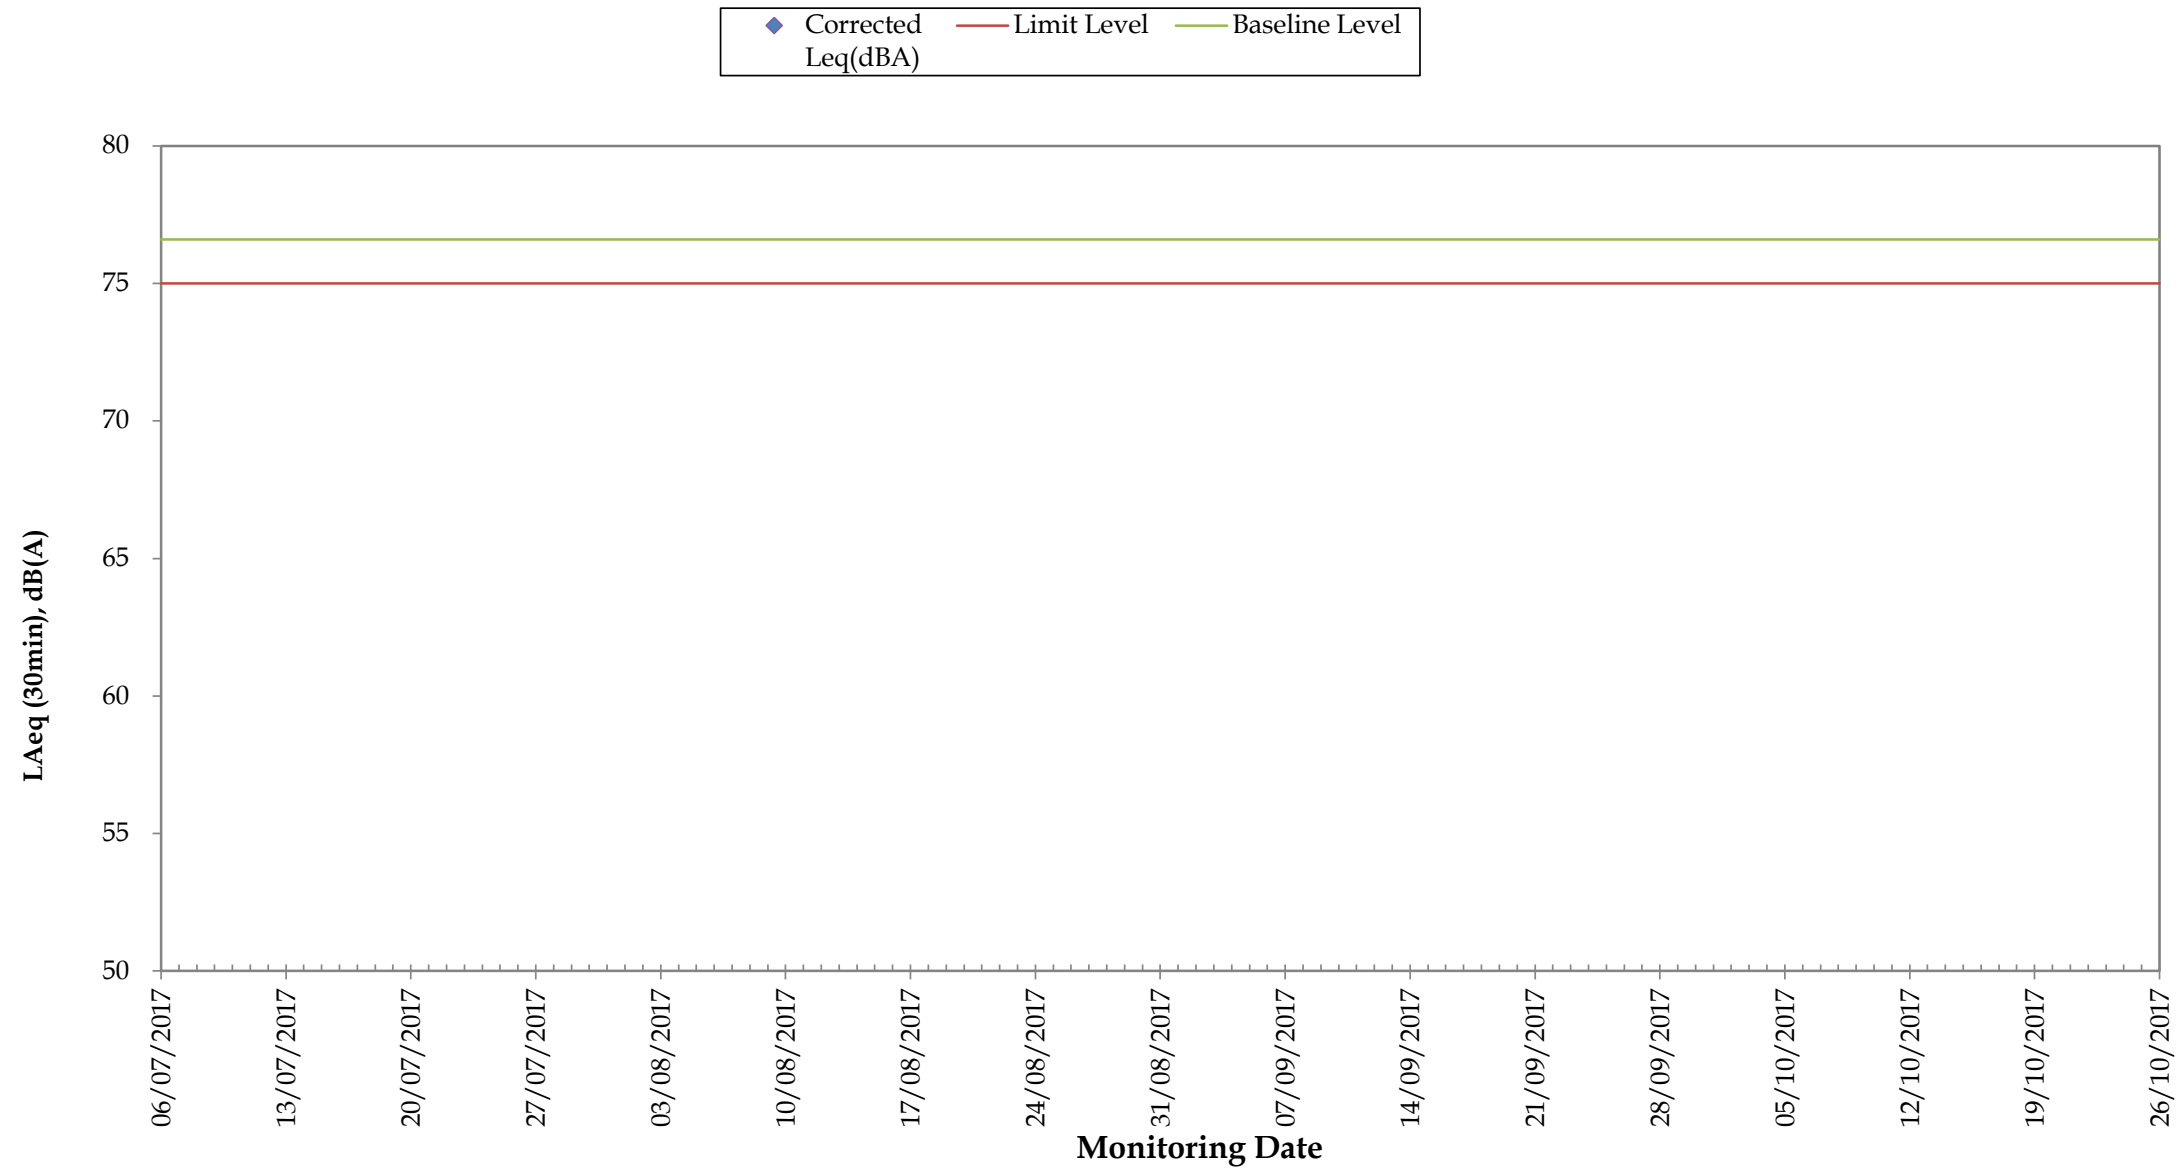
Regular Noise Monitoring Results at NMS-CA-10 (Chat Ma Mansion) (LAeq, 30min) for the Past 4 Months

- For those corrected noise levels that are not shown in this graph, the measured noise levels are equal to or below baseline level.
