**Shatin to Central Link –  
Tai Wai to Hung Hom Section and  
Mong Kok East to Hung Hom Section**

Monthly EM&A Report No. 65

[Period from 1 to 31 January 2018]

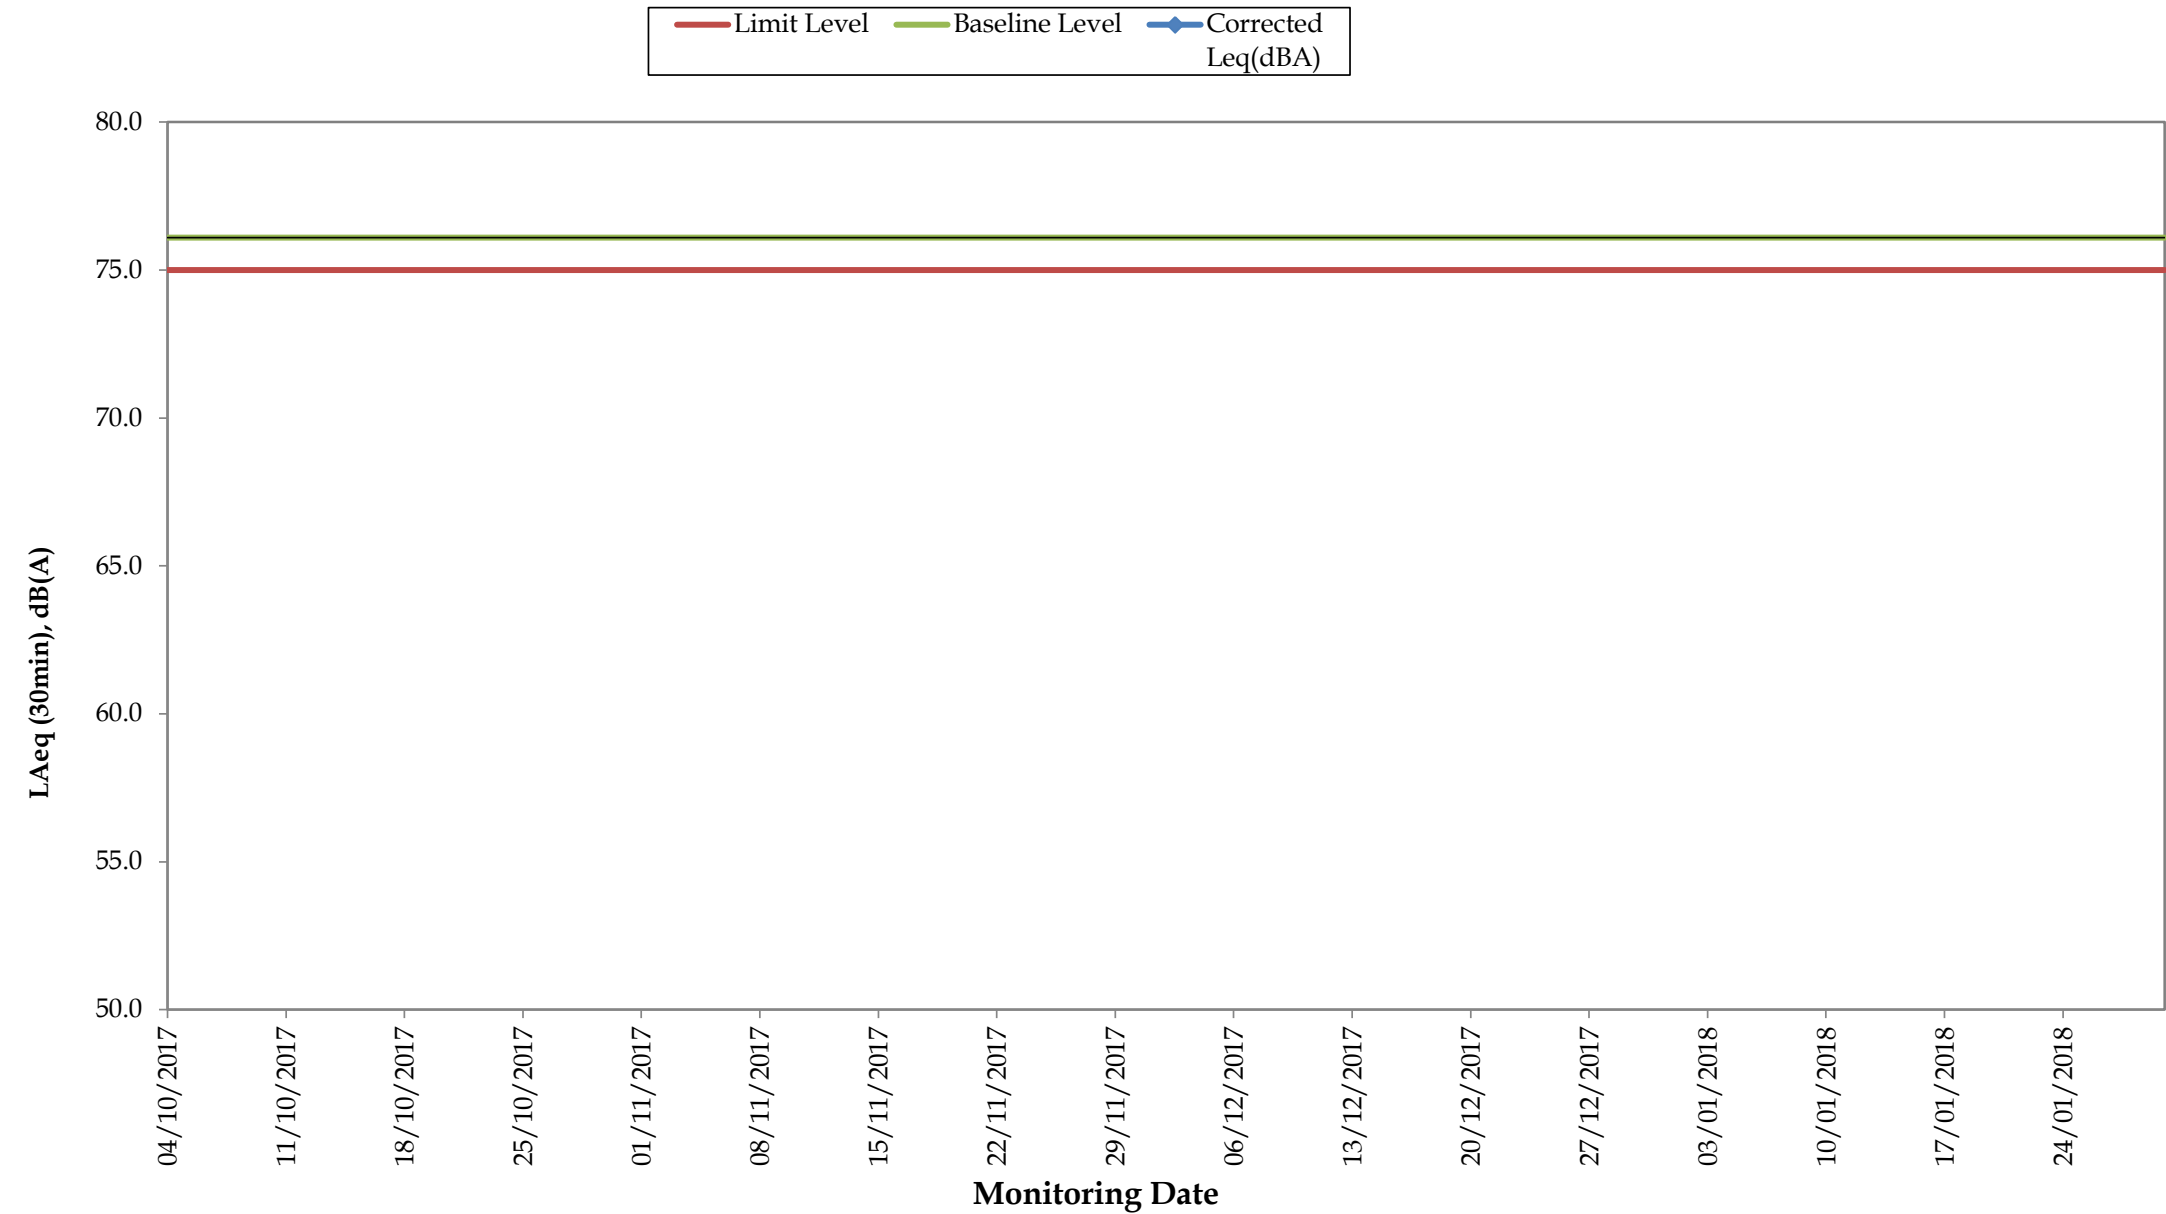
**Regular Noise Monitoring Results at NMS-CA-6 (No. 16-23 Nam Kok Road) (LAeq, 30min)  
for the Past 4 Months**

Remarks:

- For those corrected noise levels that are not shown in this graph, the measured noise levels are equal to or below baseline level.

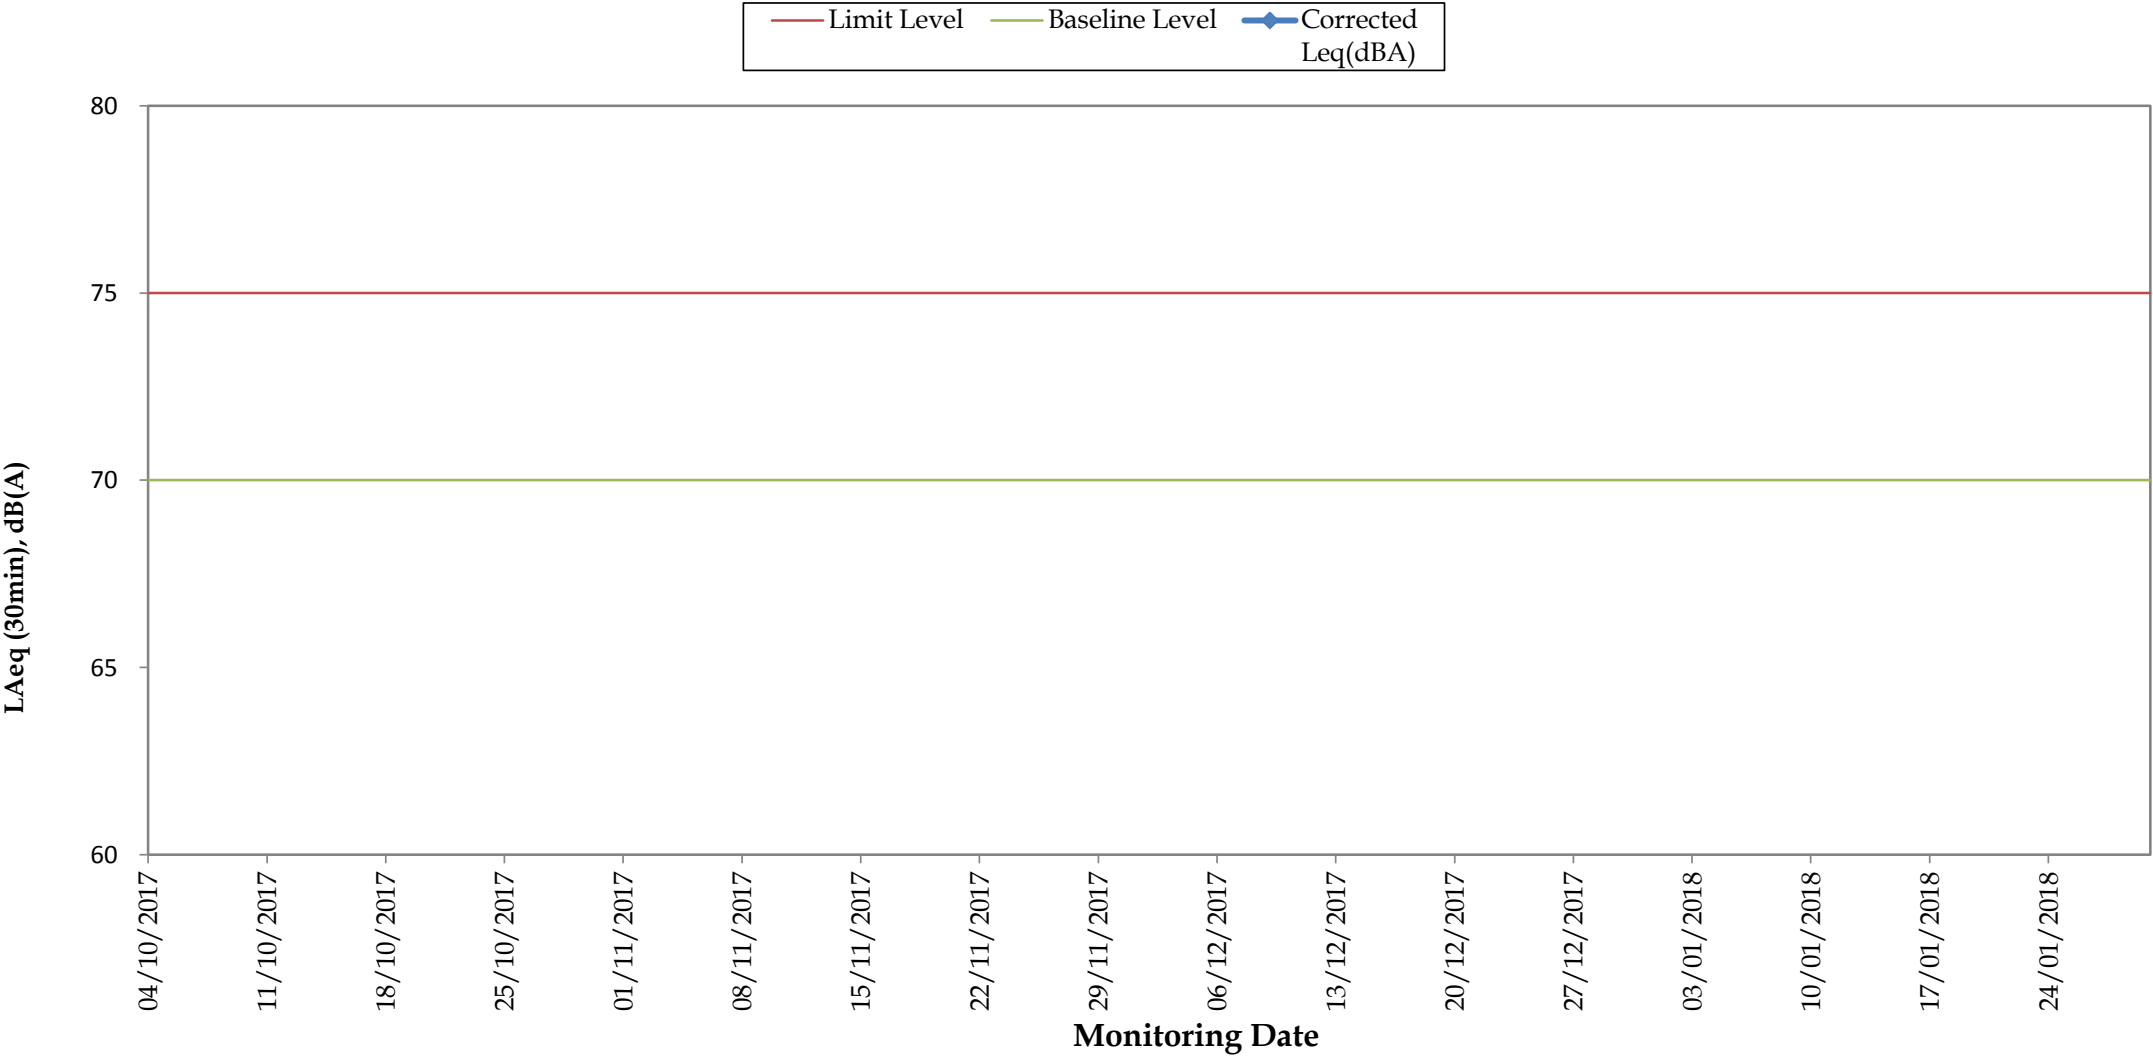
**Regular Noise Monitoring Results at NMS-CA-7 (Skytower Tower 2) (LAeq, 30min)  
for the Past 4 Months**

**Remarks:**

- For those corrected noise levels that are not shown in this graph, the measured noise level s are equal to or below baseline level.

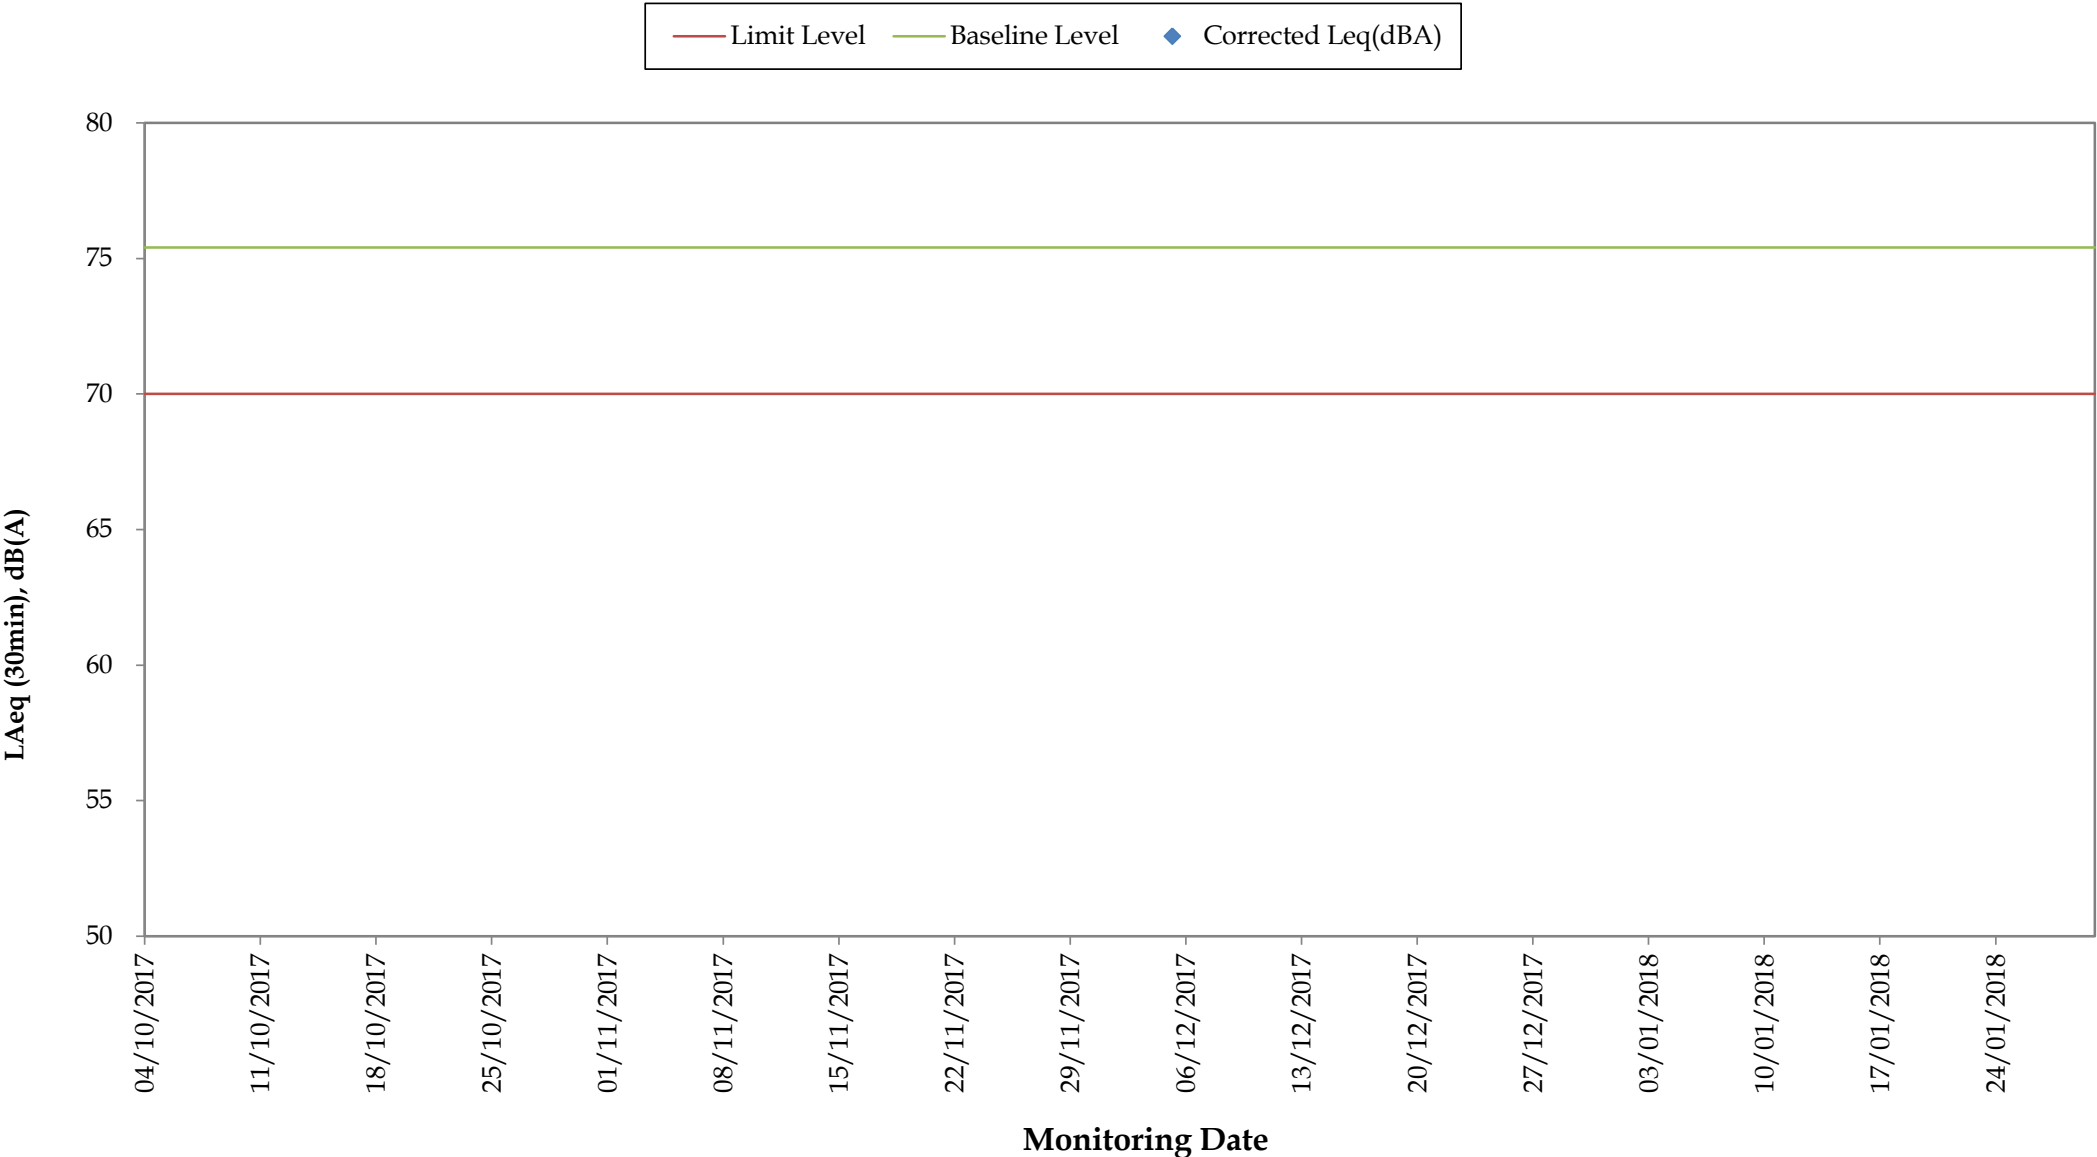
**Regular Noise Monitoring Results at NMS-CA- 8 (SKH Good Shepherd Primary School)  
(LAeq, 30min) for the Past 4 Months**

**Remarks:**

- For those corrected noise levels that are not shown in this graph, the measured noise level s are equal to or below baseline level.
- The limit level was updated from 78dB(A) to 79 dB(A) on 22 Aug 2013 as per the latest CNMP and CNMMMP.
- The limit level was updated from 79dB(A) to 70dB(A)/65dB(A) (during normal/examination period) from April 2016, as the continuous noise monitoring was completed in March 2016 according to the latest CNMP

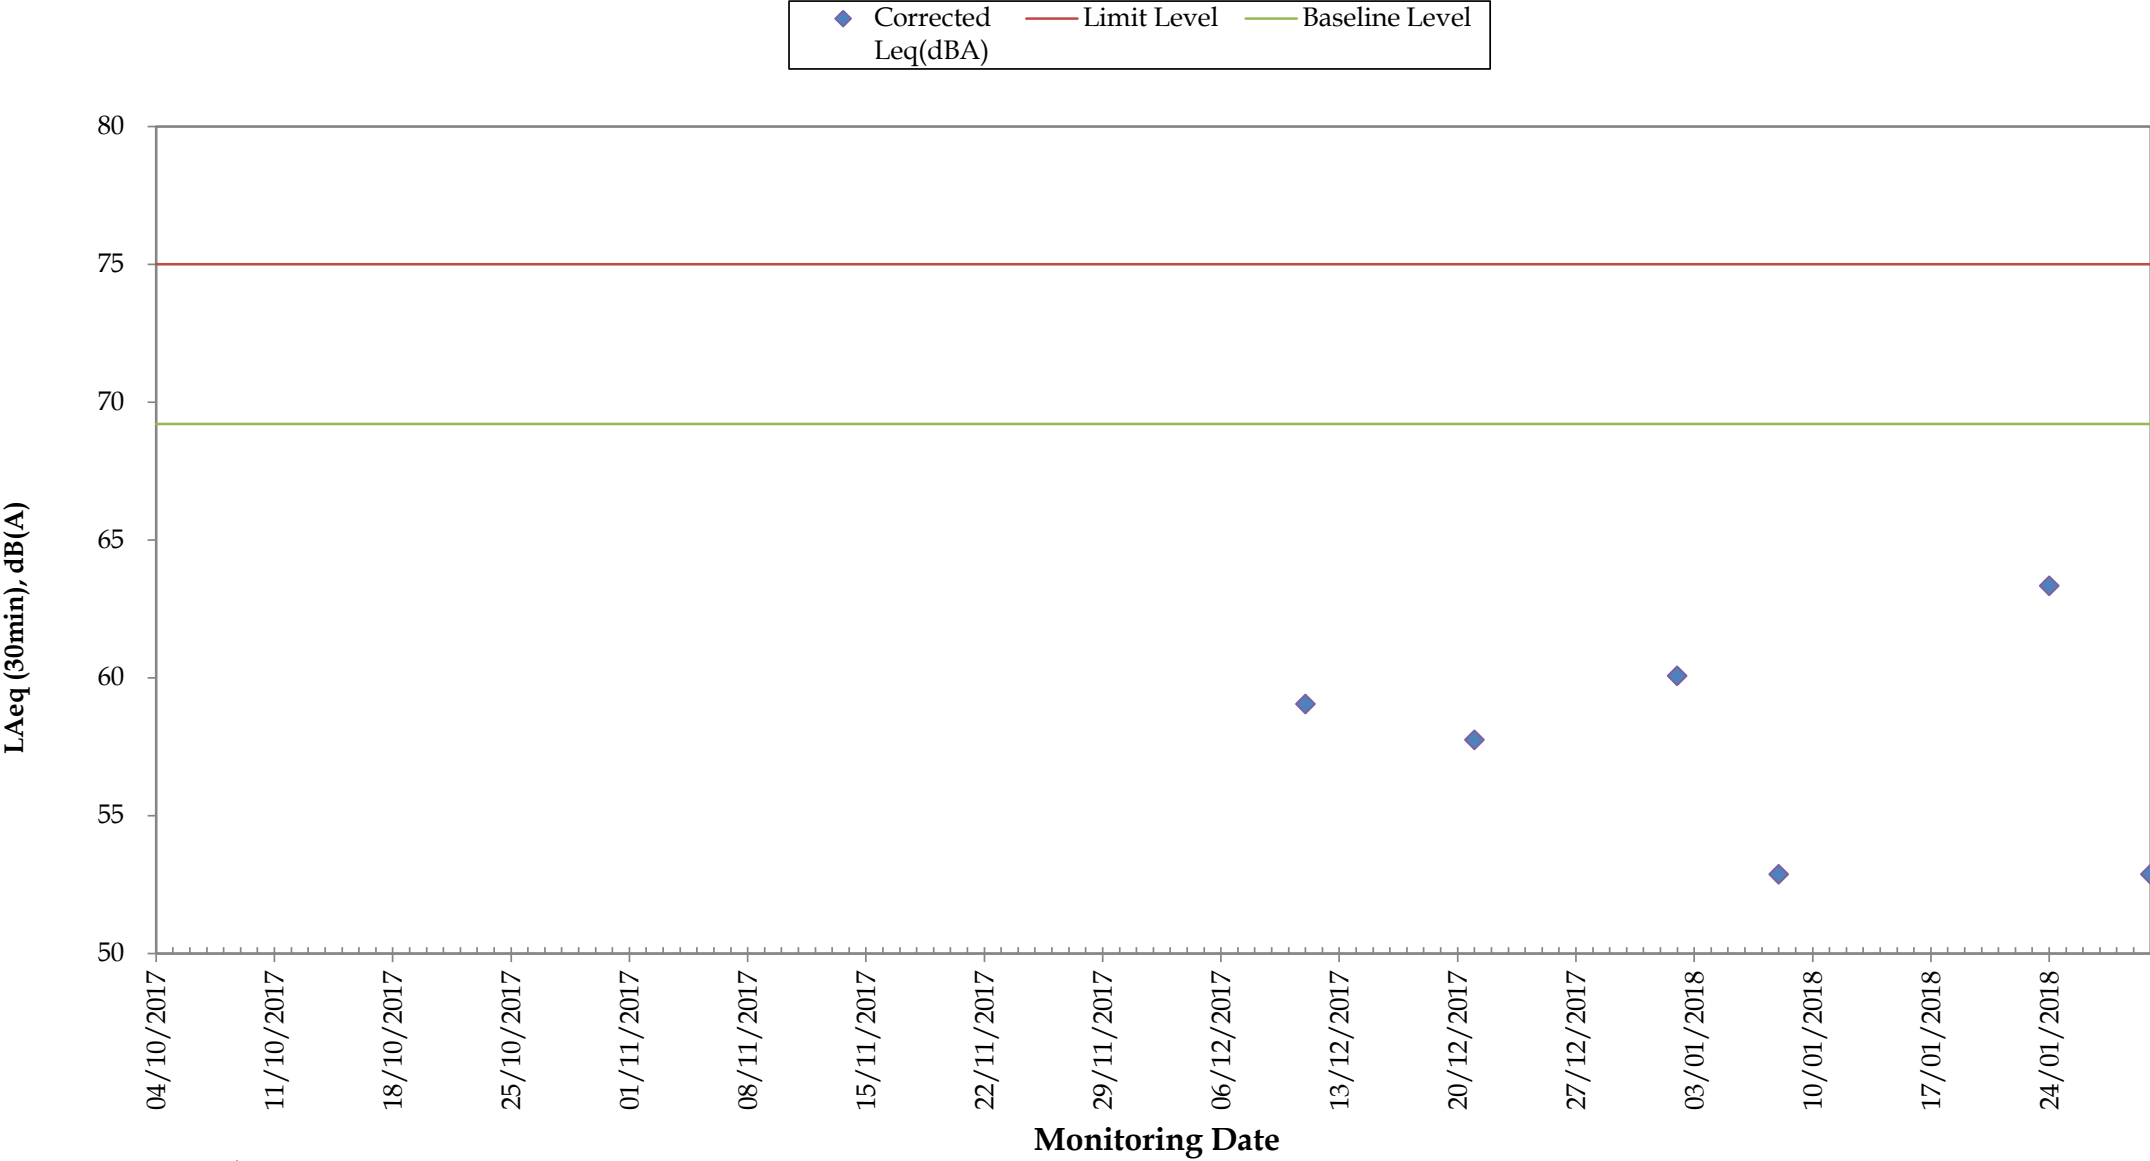
Regular Noise Monitoring Results at NMS-CA-9 (Kong Yiu Mansion)  
(LAeq, 30min) ) for the Past 4 Months

Remarks:  
- For those corrected noise levels that are not shown in this graph, the measured noise level s are equal to or below baseline level.

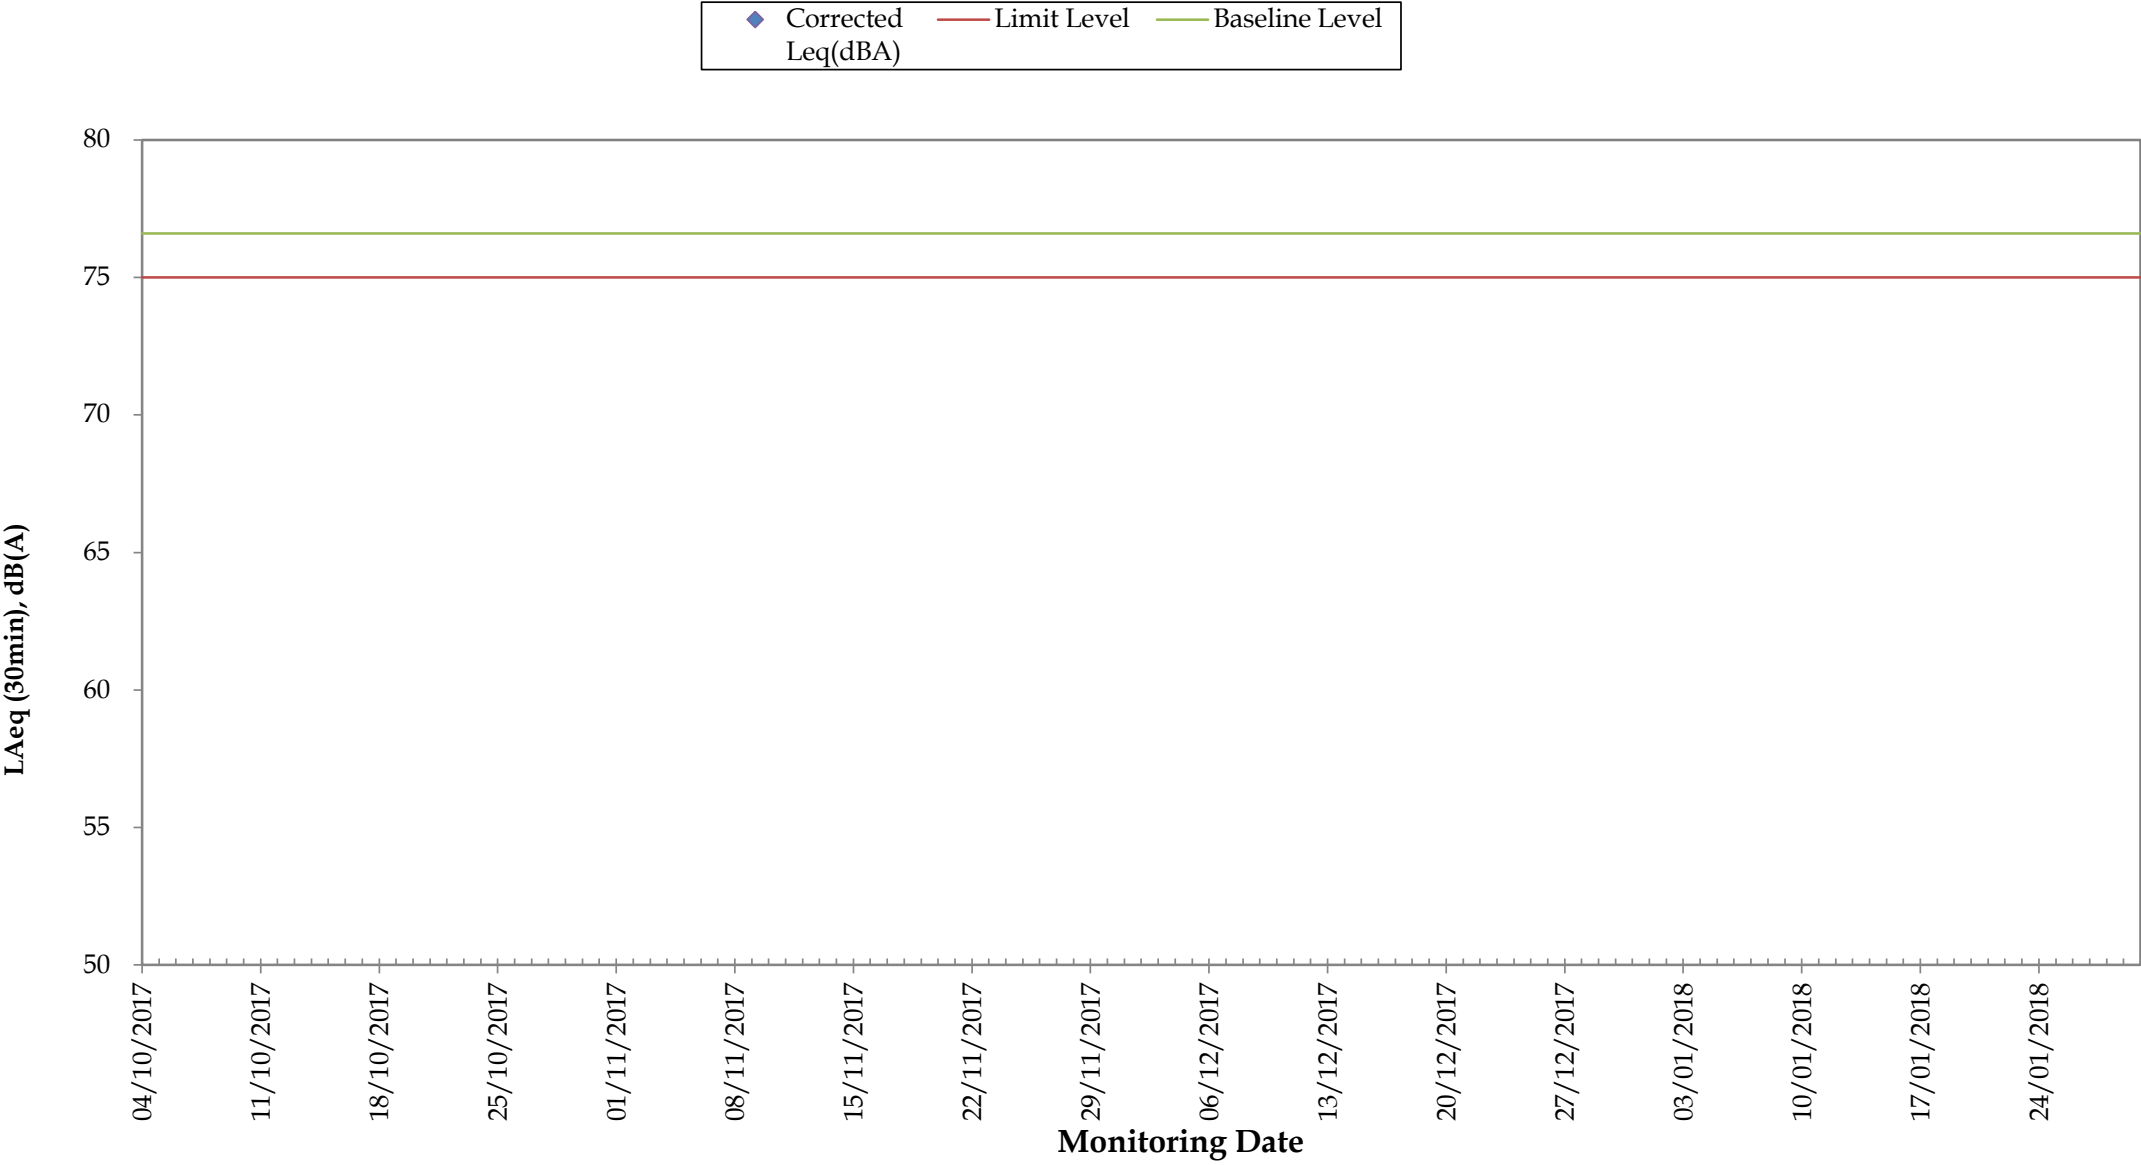
**Regular Noise Monitoring Results at NMS-CA-10 (Chat Ma Mansion) (LAeq, 30min)  
for the Past 4 Months**

Remarks:

- For those corrected noise levels that are not shown in this graph, the measured noise level s are equal to or below baseline level.

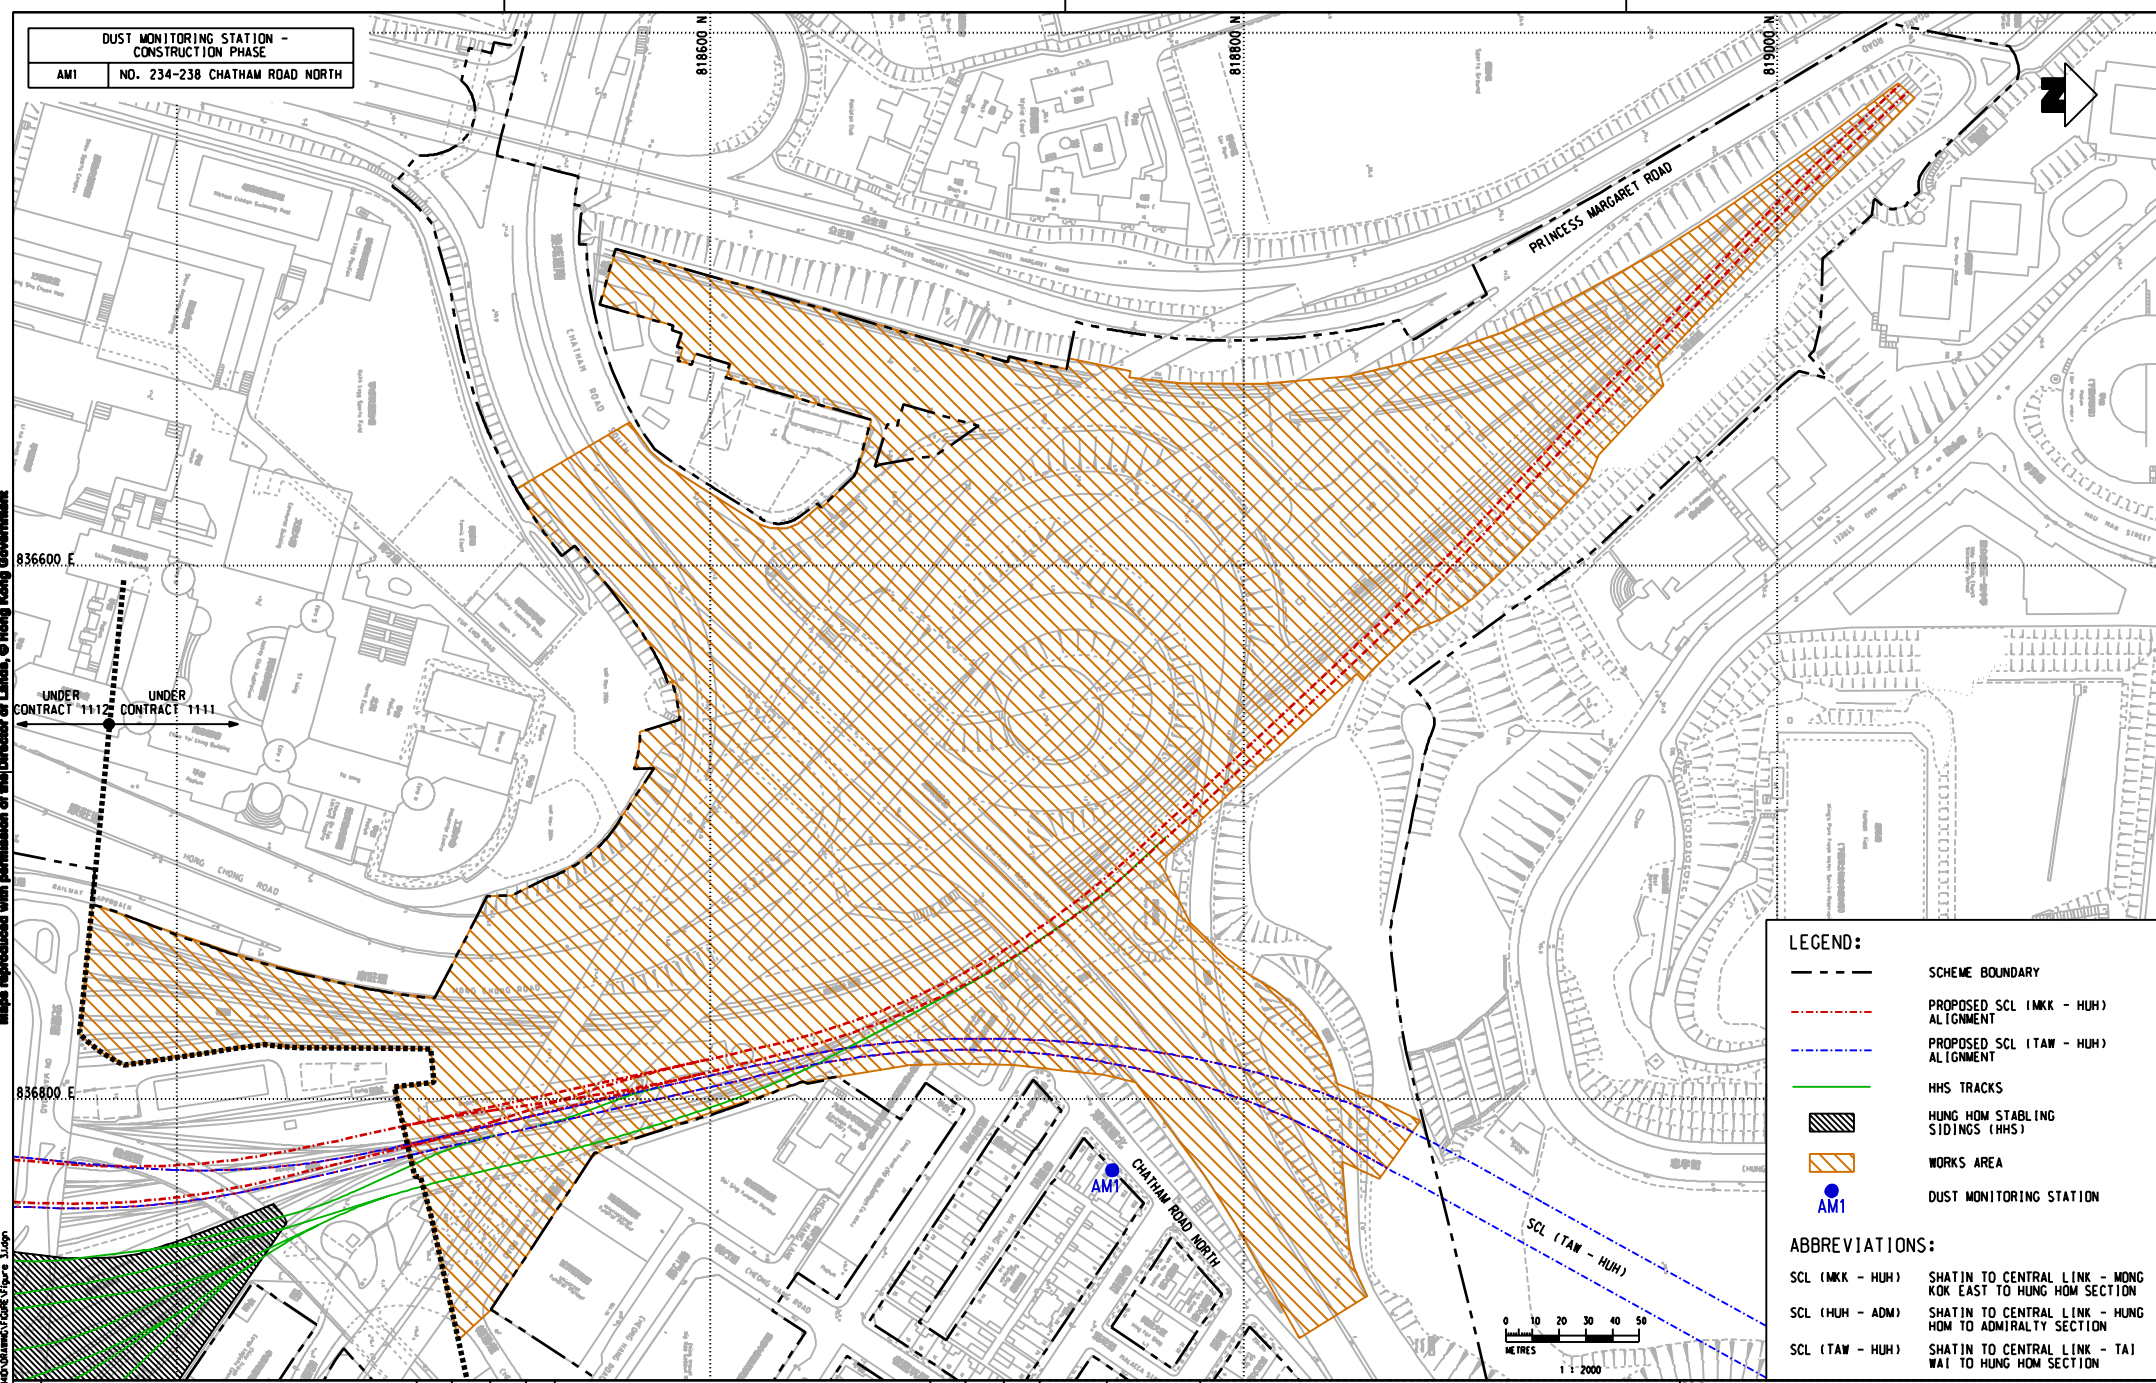
PROJECT: SHATIN TO CENTRAL LINK  
DRAWING: CONTRACT 1111  
FIGURE 2.1

- 3.1.3 One monitoring station was set up at the proposed location in accordance with the approved EM&A Manuals for SCL (TAW-HUH), SCL (MKK-HUH) and SCL (HHS) as well as the works areas of the Project. The location of the construction dust monitoring station is summarised in **Table 3.2** and shown in **Figure 2.1**.

DRAWN: HD DESIGNED: LCLL CHECKED: LCLL APPROVED: (MTR) DATE: 08/JAN/2013		<b>MTR</b> <b>SHATIN TO CENTRAL LINK</b> CONTRACTOR: Gammon Kaden ORIGINATOR: AECOM		TITLE: CONTRACT 1111 HUNG HOM NORTH APPROACH TUNNELS LOCATION OF AIR QUALITY MONITORING STATION	
SCALE: 1:2000 (A3) FIGURE NO.: FIGURE 2.1		REVISIONS:		REV. -

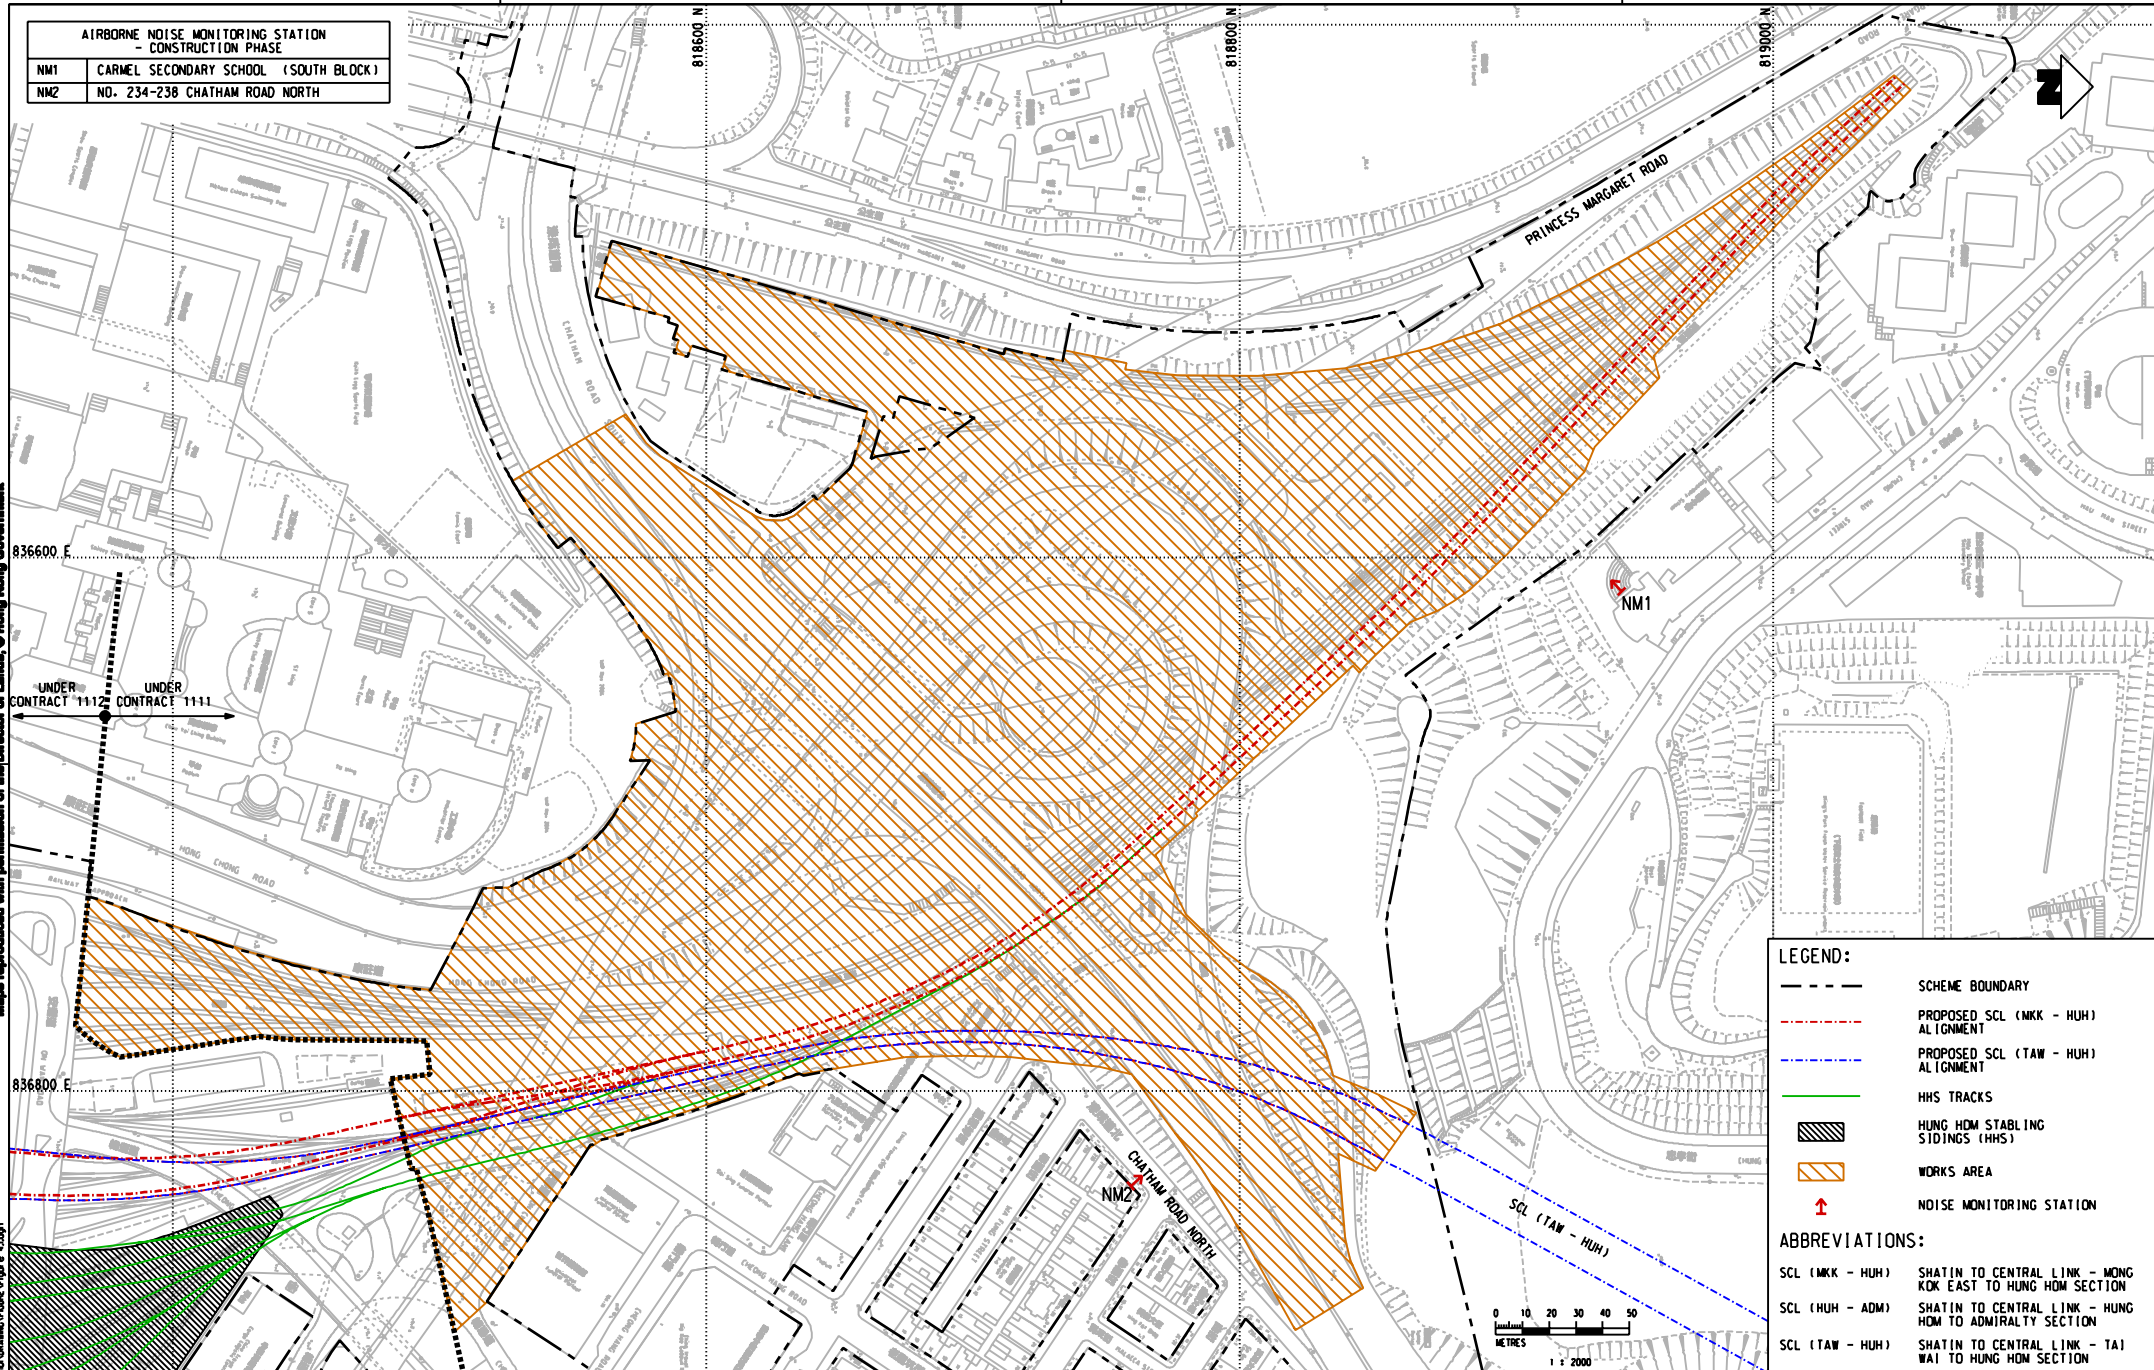
- 3.3.2 With reference to the CNMP, continuous noise monitoring should be conducted during period at which the predicted airborne construction noise levels exceed the relevant noise criteria at the respective NSRs. The proposed continuous noise monitoring locations are presented in **Table 3.7** and shown in **Figure 2.1**.

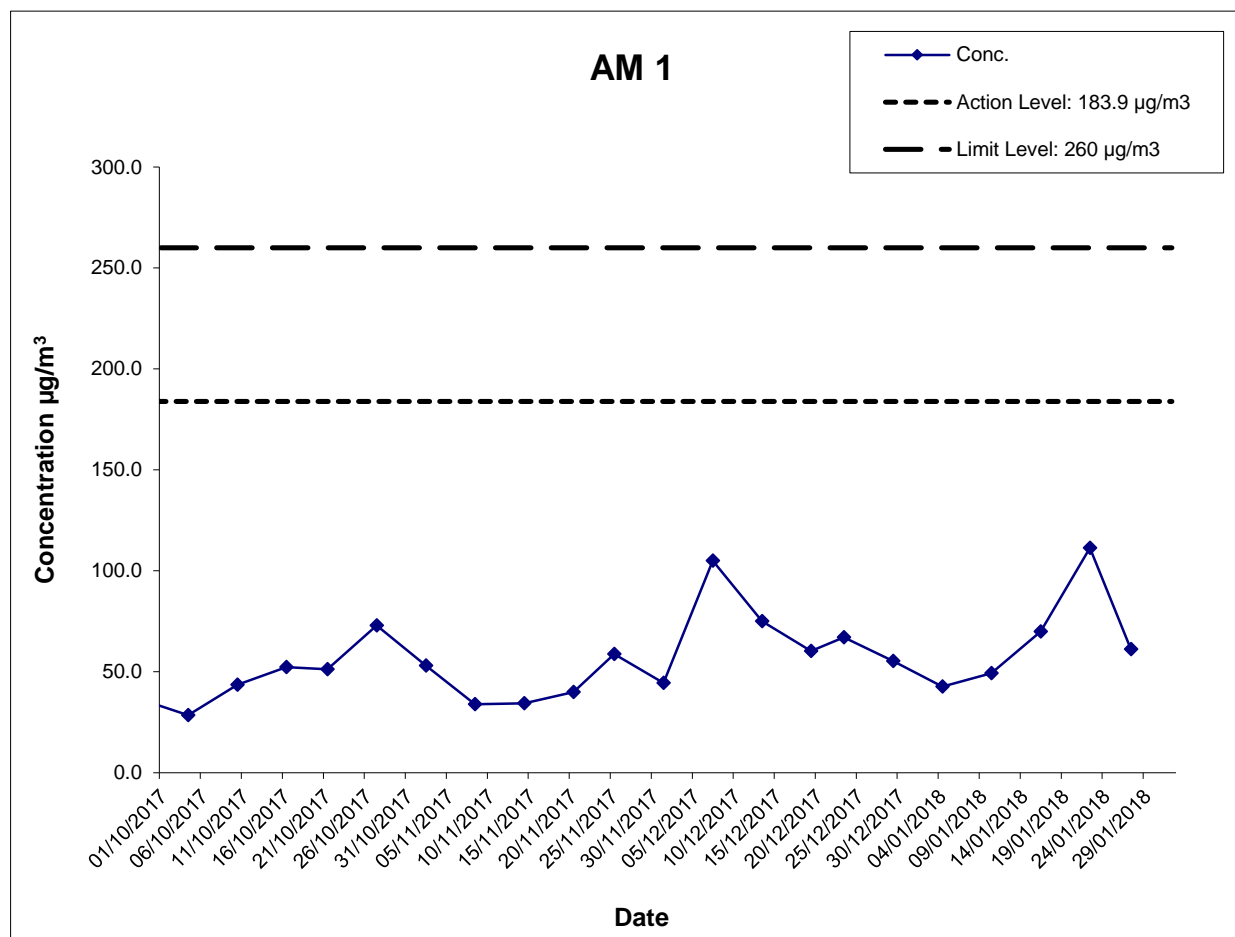
**Shatin to Central Link Works Contract 1111-  
Hung Hom North Approach Tunnels**

**Graphical Presentations of Impact 24-hour TSP  
Monitoring Results**

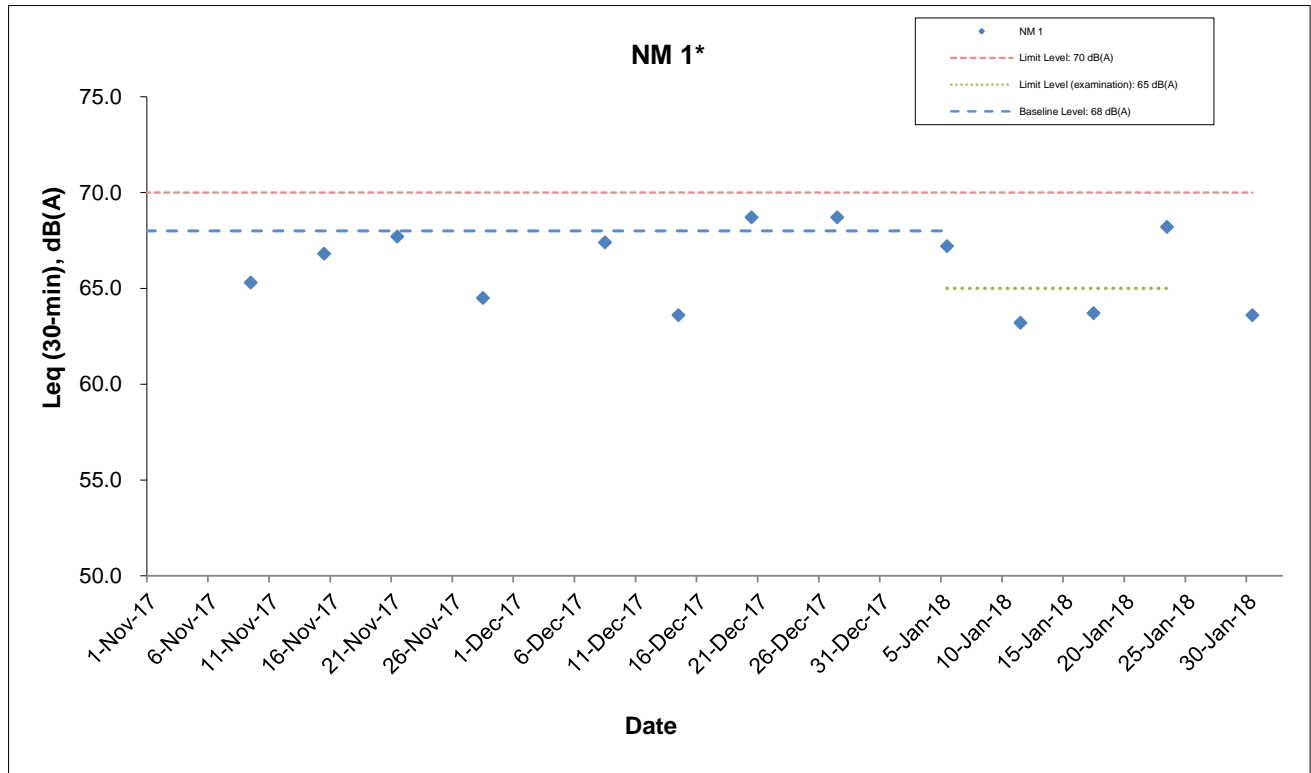
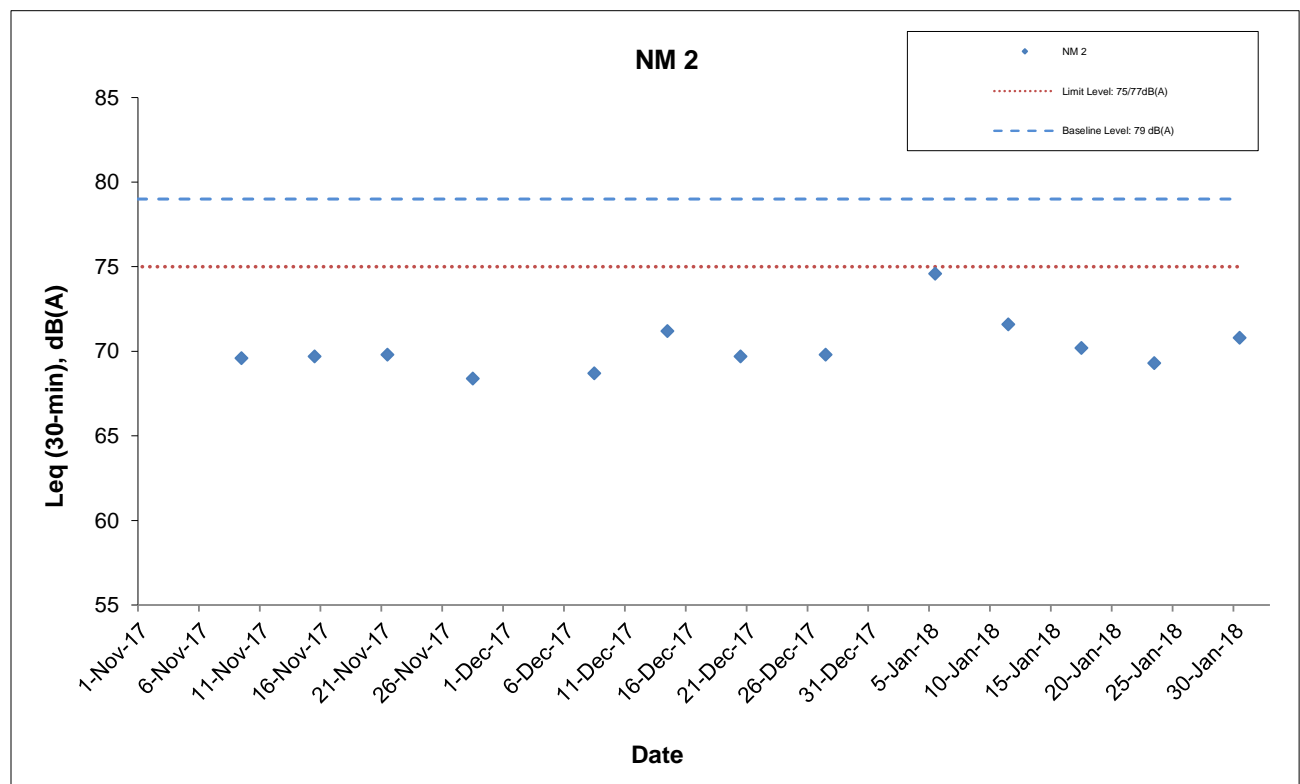
## Appendix H Regular Construction Noise Monitoring Results

\* - The noise monitoring results of the measurements are higher than the daytime construction noise criterion. However, the results are not considered as exceedance if they are either below the baseline level or below the limit level after deducting the baseline noise level.

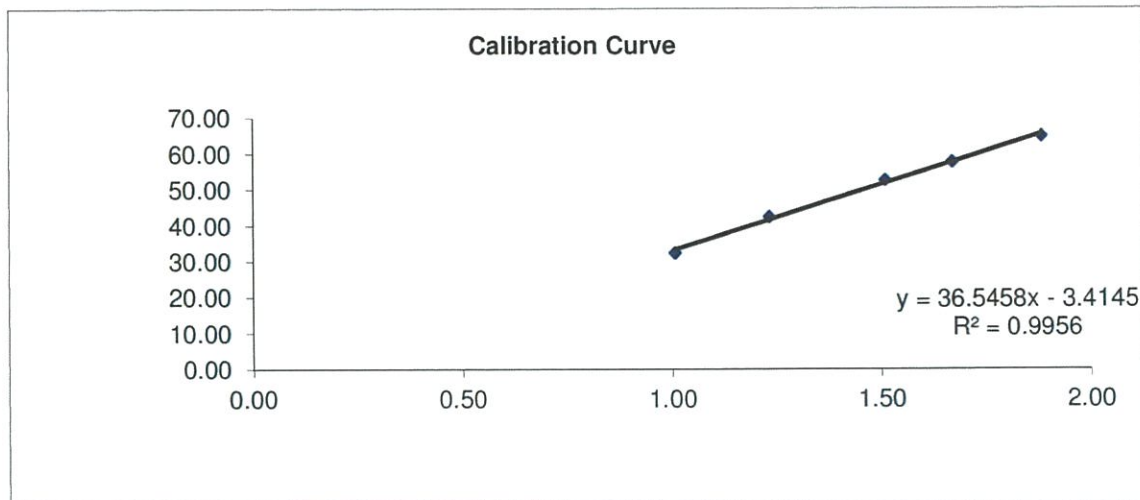
Calibration date	28-Dec-17	Barometric pressure	760 mm Hg
Next Calibration date	26-Feb-18	Temperature (°C)	18 °C
Sampler location	DMS2 - Price Memorial Catholic Pri	Temperature (K)	291 K
Sampler model	TE-5170	P <sub>std</sub>	760 mm Hg
Sampler serial number	3761	T <sub>std</sub>	298 K
Calibrator model	TE-5025A		
Calibrator serial number	2421		
Slope of the standard curve, m <sub>s</sub>	2.00576		
Intercept of the standard curve, b <sub>s</sub>	0.00519

Resistance Plate No.	Manometer Reading (inch H <sub>2</sub> O)	Flow Recorder Reading (CFM)	Calculated Q <sub>std</sub> (m <sup>3</sup> /min)	Continuous Flow Recorder Reading IC (CFM)
5	4.00	32.00	1.01	32.38
7	6.00	42.00	1.23	42.50
10	9.00	52.00	1.51	52.62
13	11.00	57.00	1.67	57.68
18	14.00	64.00	1.89	64.77

Sampler slope (m) : 36.5458  
 Sampler intercept (b) : -3.4145  
 Correlation coefficient (R<sup>2</sup>) : 0.9956
