**Shatin to Central Link –  
Tai Wai to Hung Hom Section and  
Mong Kok East to Hung Hom Section**

Monthly EM&A Report No. 65

[Period from 1 to 31 January 2018]

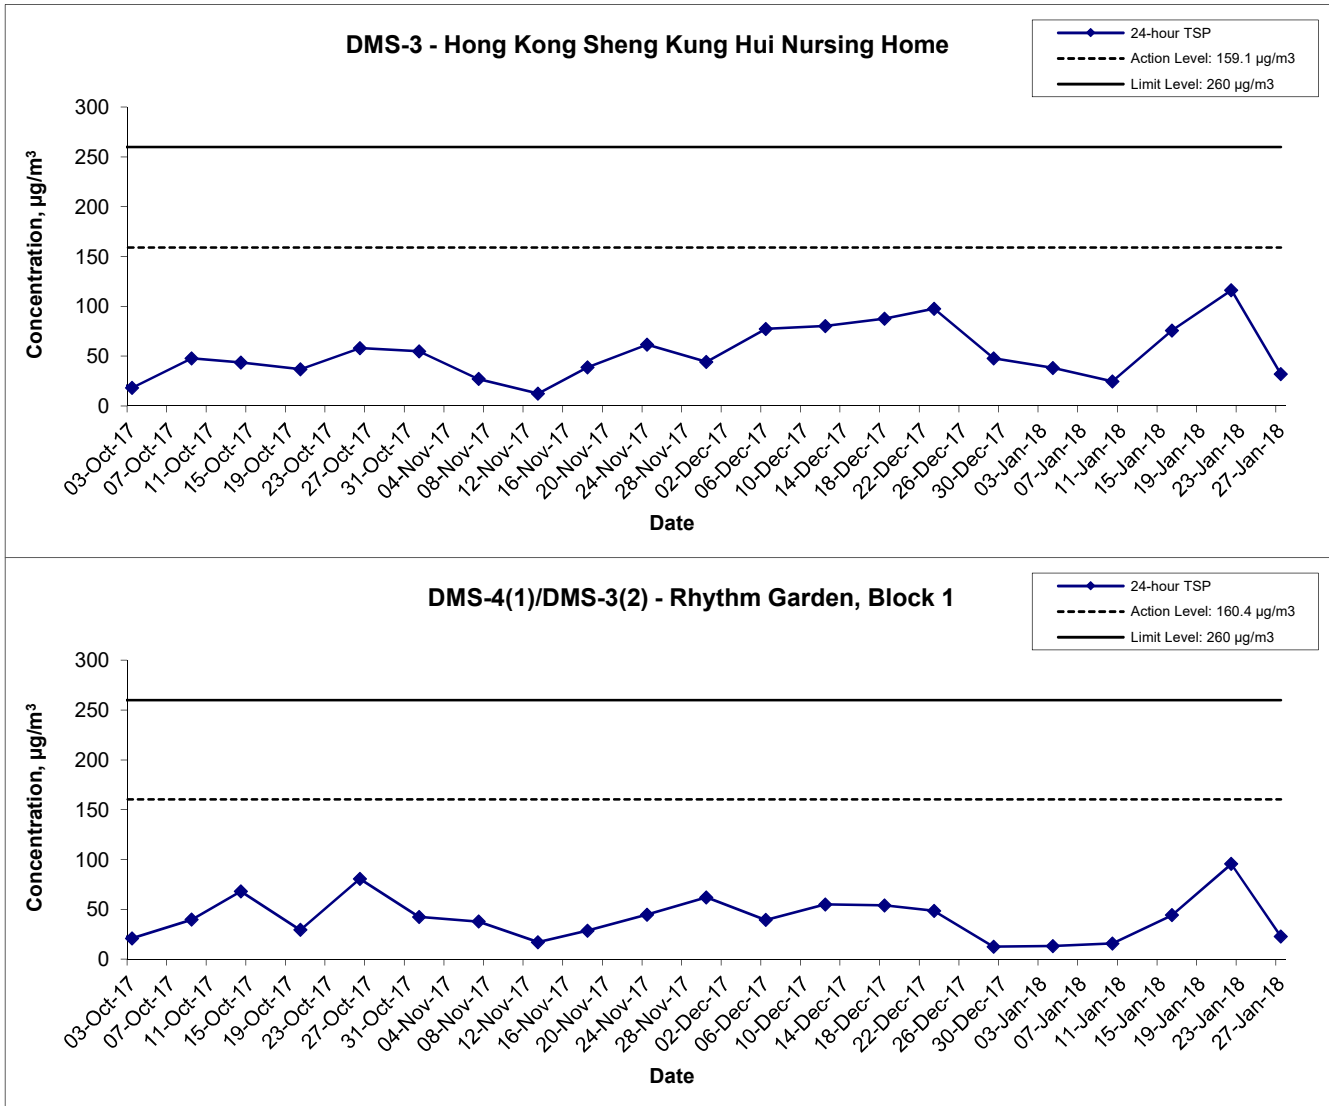
## 24-hour TSP Concentration Levels

- (1) ASR ID as identified in approved EM&A Manual / EIA Report for SCL(TAW-HUH).
- (2) ASR ID as identified in approved EM&A Manual / EIA Report for SCL(HHS).
- (3) 24 hours TSP concentration level of DMS-3 from July to September 2016 were extracted from the Project 1103.

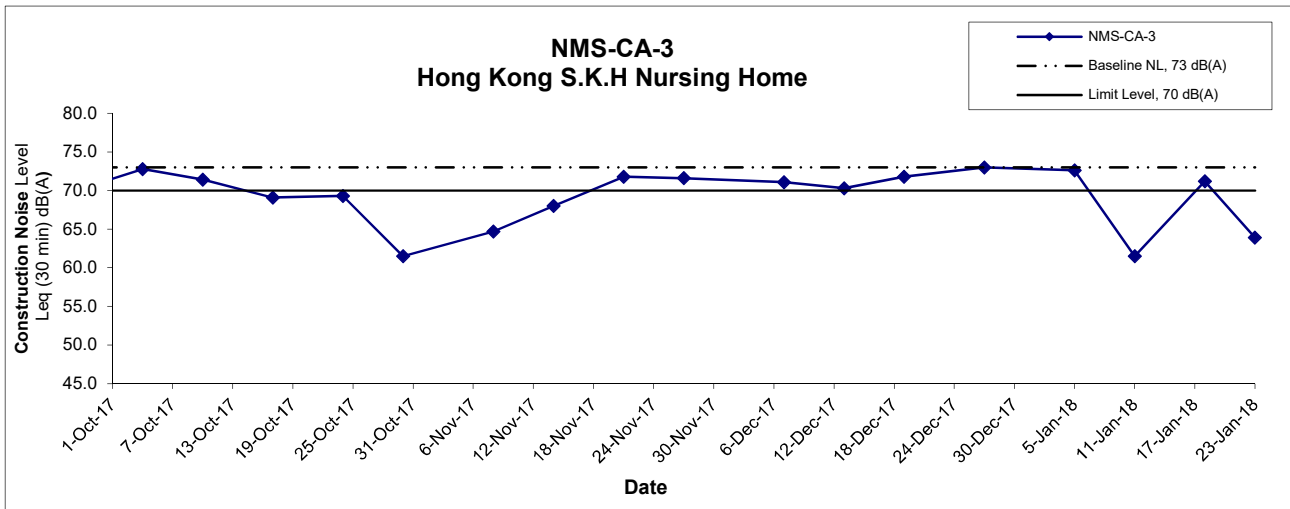
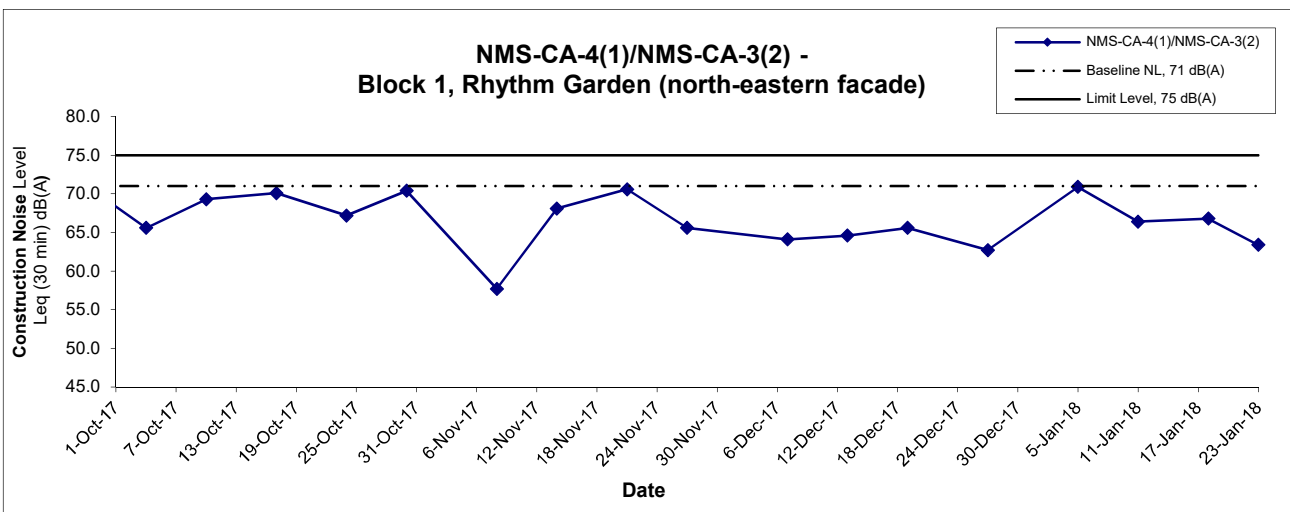
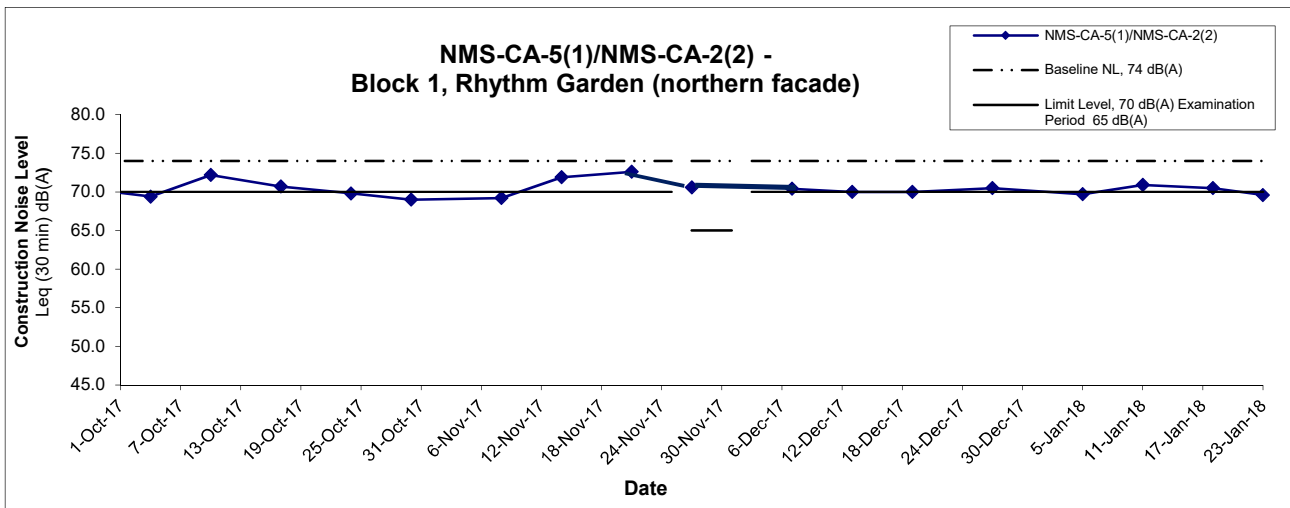
## Noise Levels

- (1) Station ID as identified in approved EM&A Manual / EIA Report for SCL(TAW-HUH).
- (2) Station ID as identified in approved EM&A Manual / EIA Report for SCL(HHS).
- (3) In case of Measured Level  $\leq$  Baseline Level, only Measured Level is presented on the graphical presentation.
- (4) Location NMS-CA-3

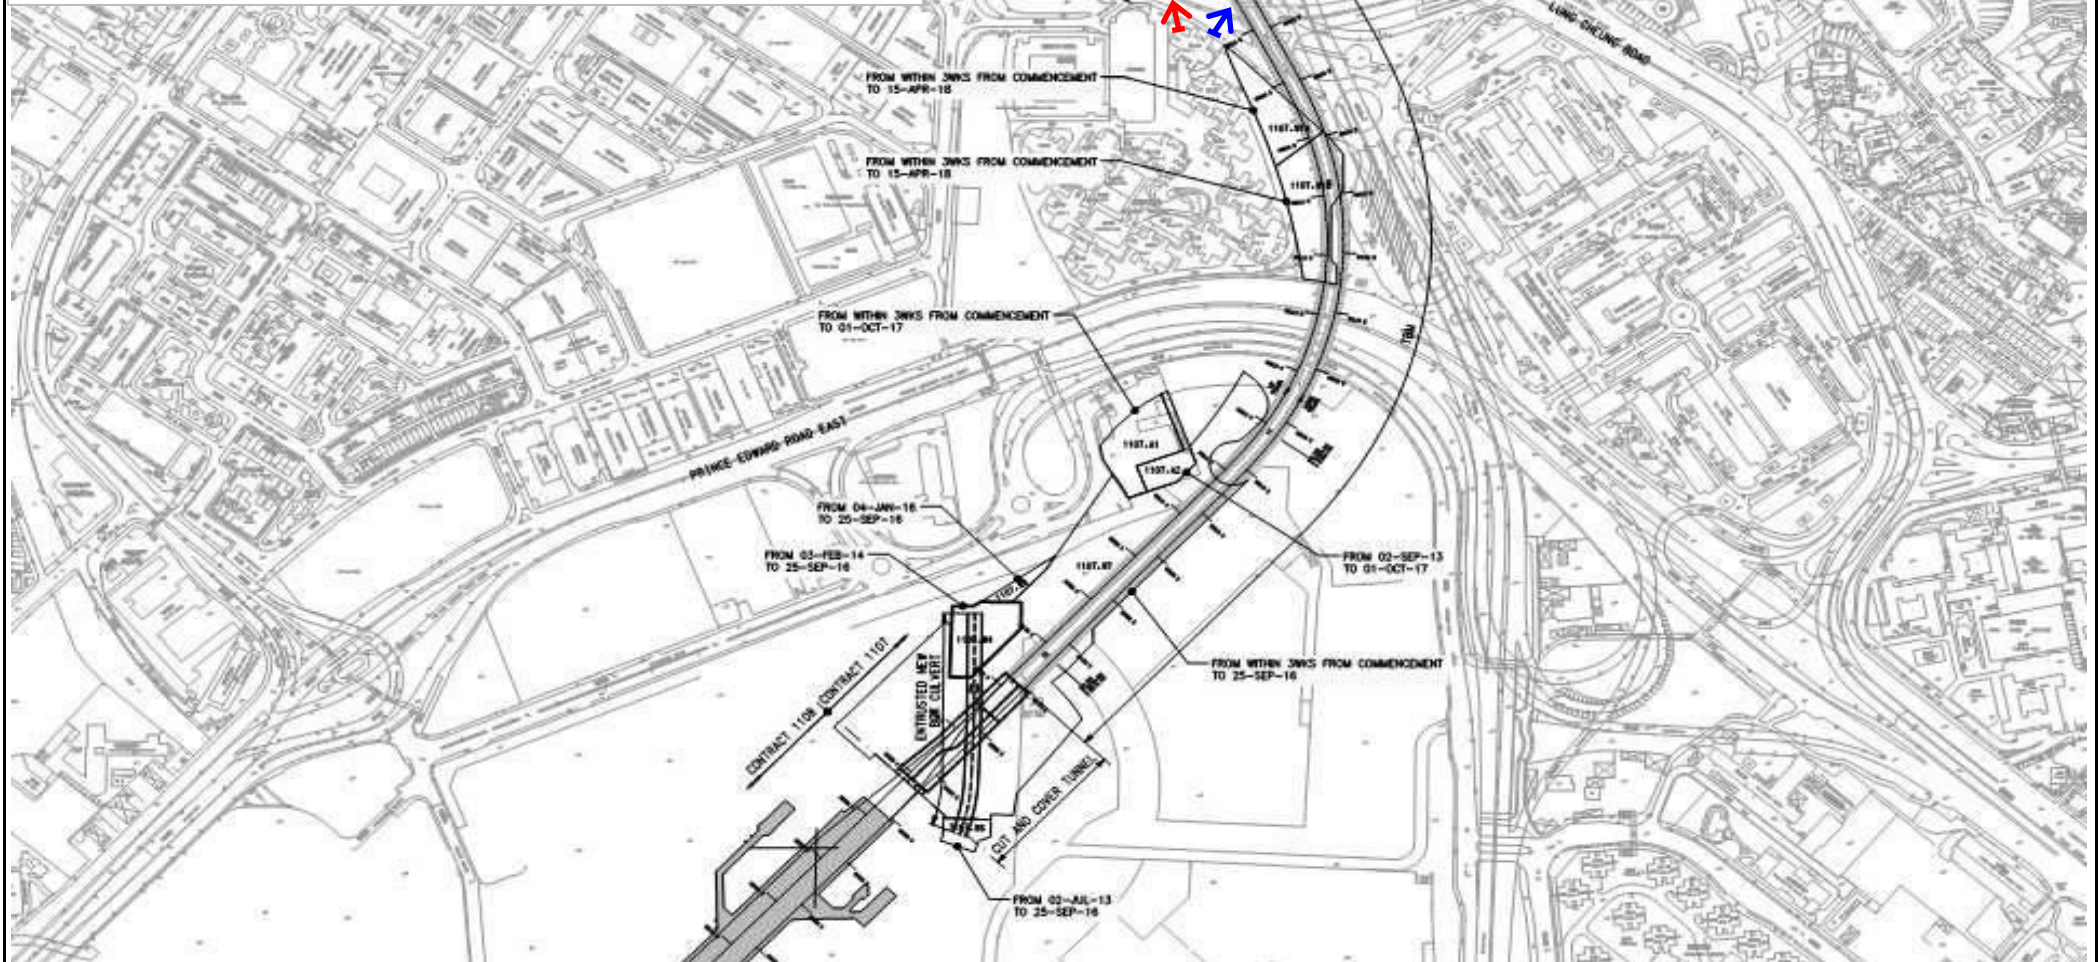
Title	MTR SCL Works Contract 1107 Diamond Hill to Kai Tak Tunnels Locations of Construction Noise Monitoring		Scale	N.T.S	Project No.	MA13018	CINOTECH
			Date	May-13	Figure	2

- 3.1 In accordance with the EM&A Manual, monitoring of construction noise impact should be conducted at the designated monitoring stations. Since access to some of the proposed monitoring locations stated in the EM&A Manual was rejected; alternative locations were proposed and agreed by the ER (Engineer's Representative), IEC (Independent Environmental Checker) and EPD (Environmental Protection Department). The construction noise monitoring locations are listed in **Table 3.1** and shown in **Figure 2**.

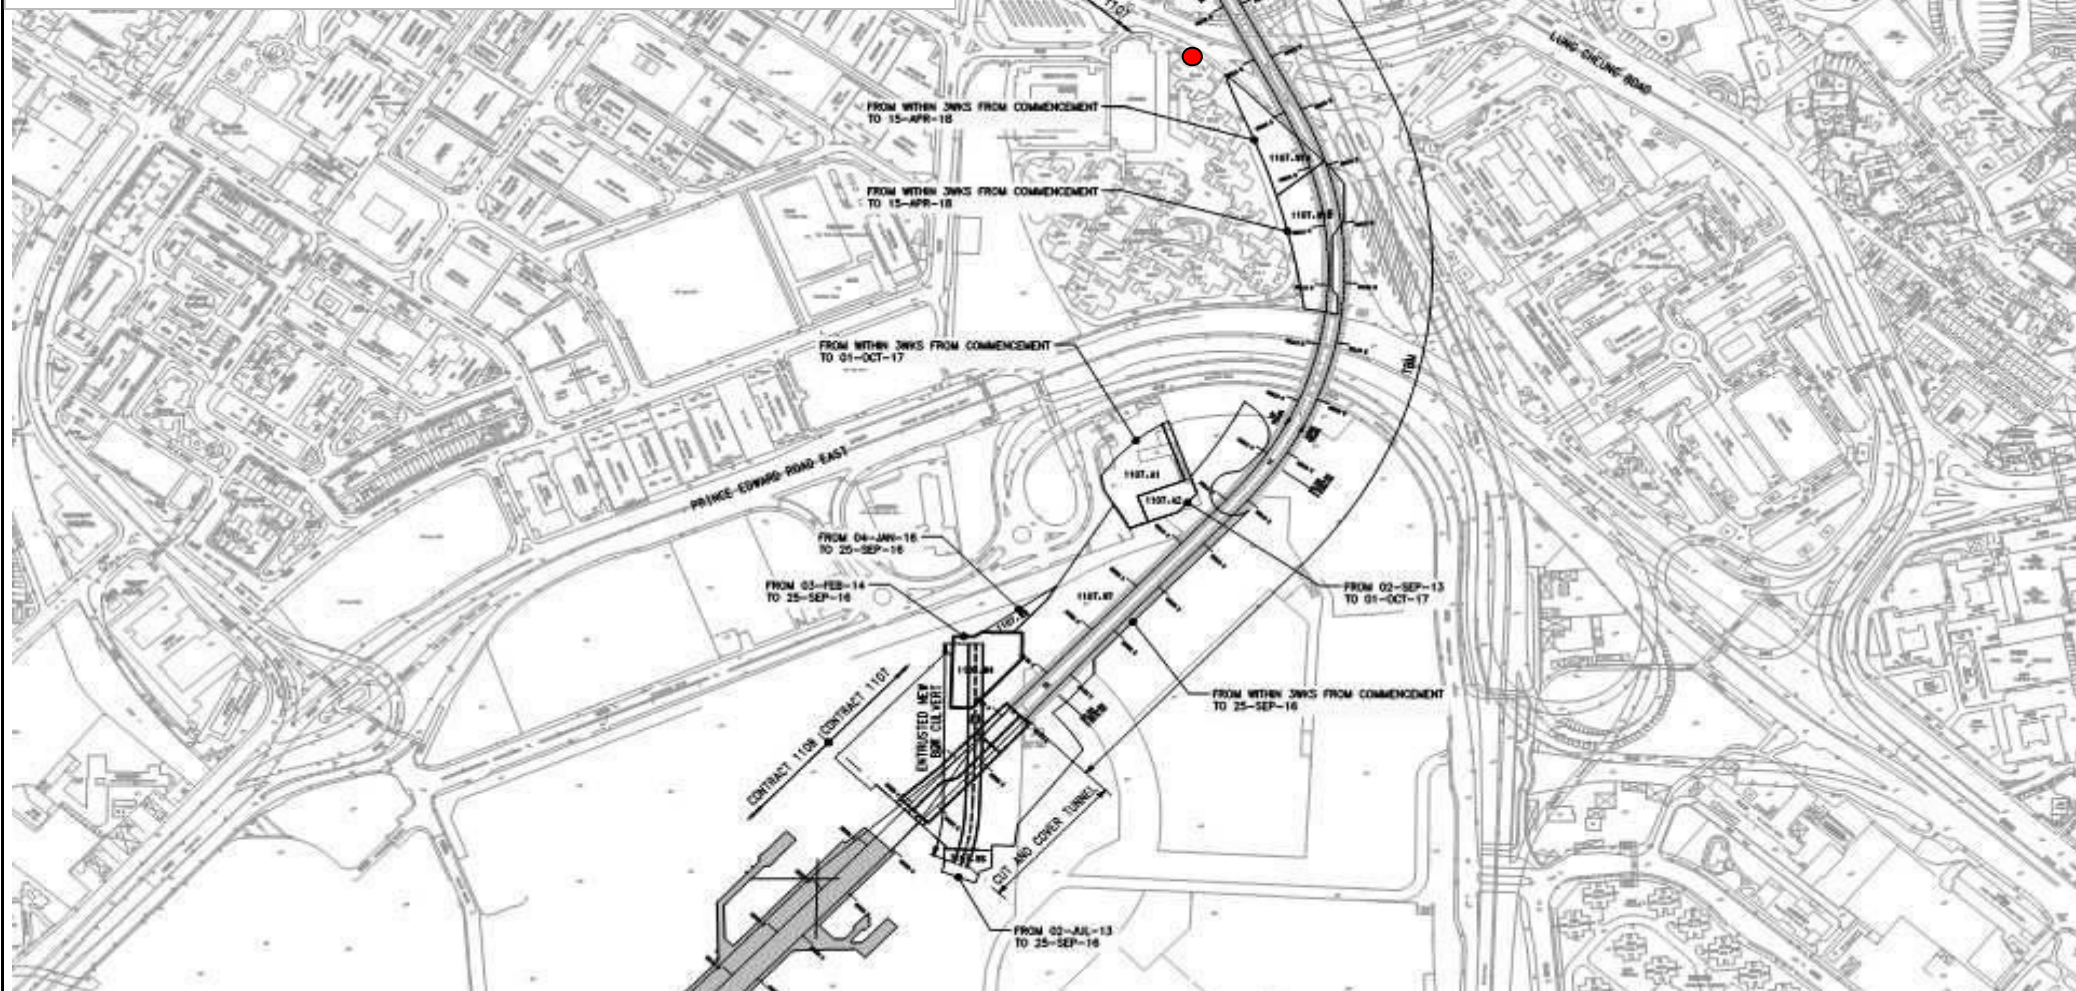
Title	MTR SCL Works Contract 1107 Diamond Hill to Kai Tak Tunnels Location of Dust Monitoring		Scale	N.T.S	Project No.	MA13018	CINOTECH
			Date	May-13	Figure	3

3.9 The proposed dust monitoring stations for the construction phase of the Project, as recommended in the approved EM&A Manual, are listed in **Table 3.3** and shown in **Figure 3**. The proposed locations have been agreed with the ER, EPD and IEC.

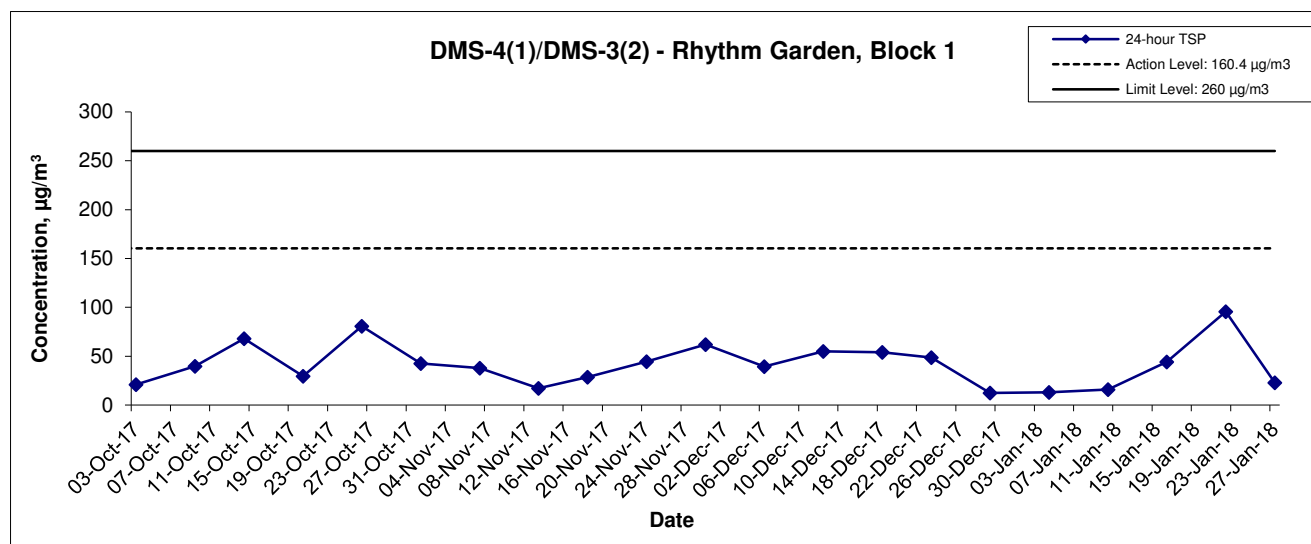
## 24-hour TSP Concentration Levels

- (1) ASR ID as identified in approved EM&A Manual / EIA Report for SCL(TAW-HUH).
- (2) ASR ID as identified in approved EM&A Manual / EIA Report for SCL(HHS).

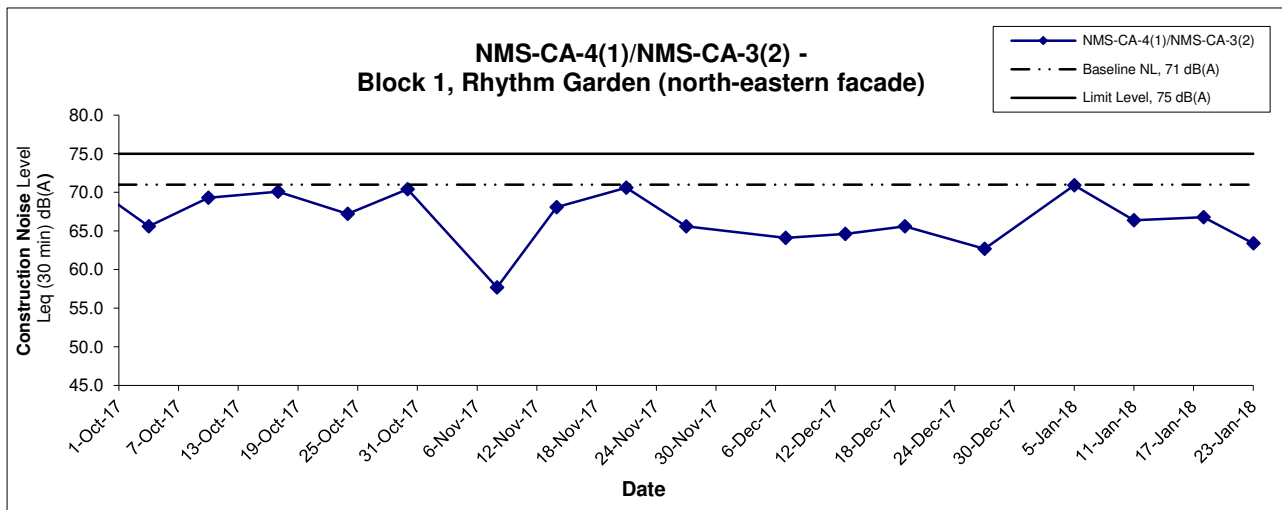
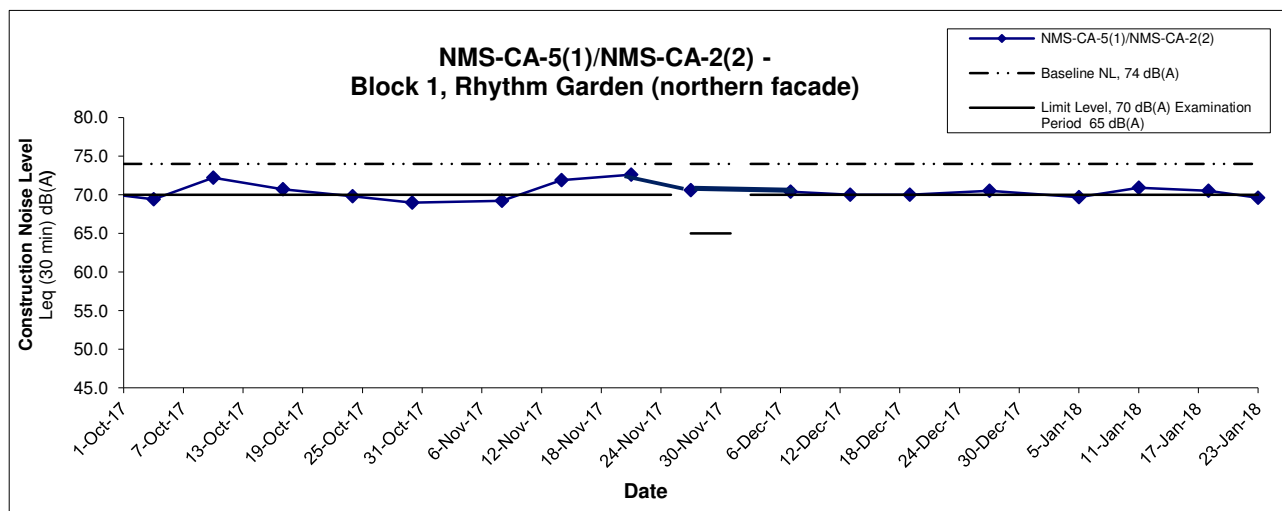
## Noise Levels

- (1) Station ID as identified in approved EM&A Manual / EIA Report for SCL(TAW-HUH).
- (2) Station ID as identified in approved EM&A Manual / EIA Report for SCL(HHS).
- (3) In case of Measured Level  $\leq$  Baseline Level, only Measured Level is presented on the graphical presentation.
- (4) Location NMS-CA-3
