**Shatin to Central Link –  
Tai Wai to Hung Hom Section and  
Mong Kok East to Hung Hom Section**

Monthly EM&A Report No. 69

[Period from 1 to 31 May 2018]

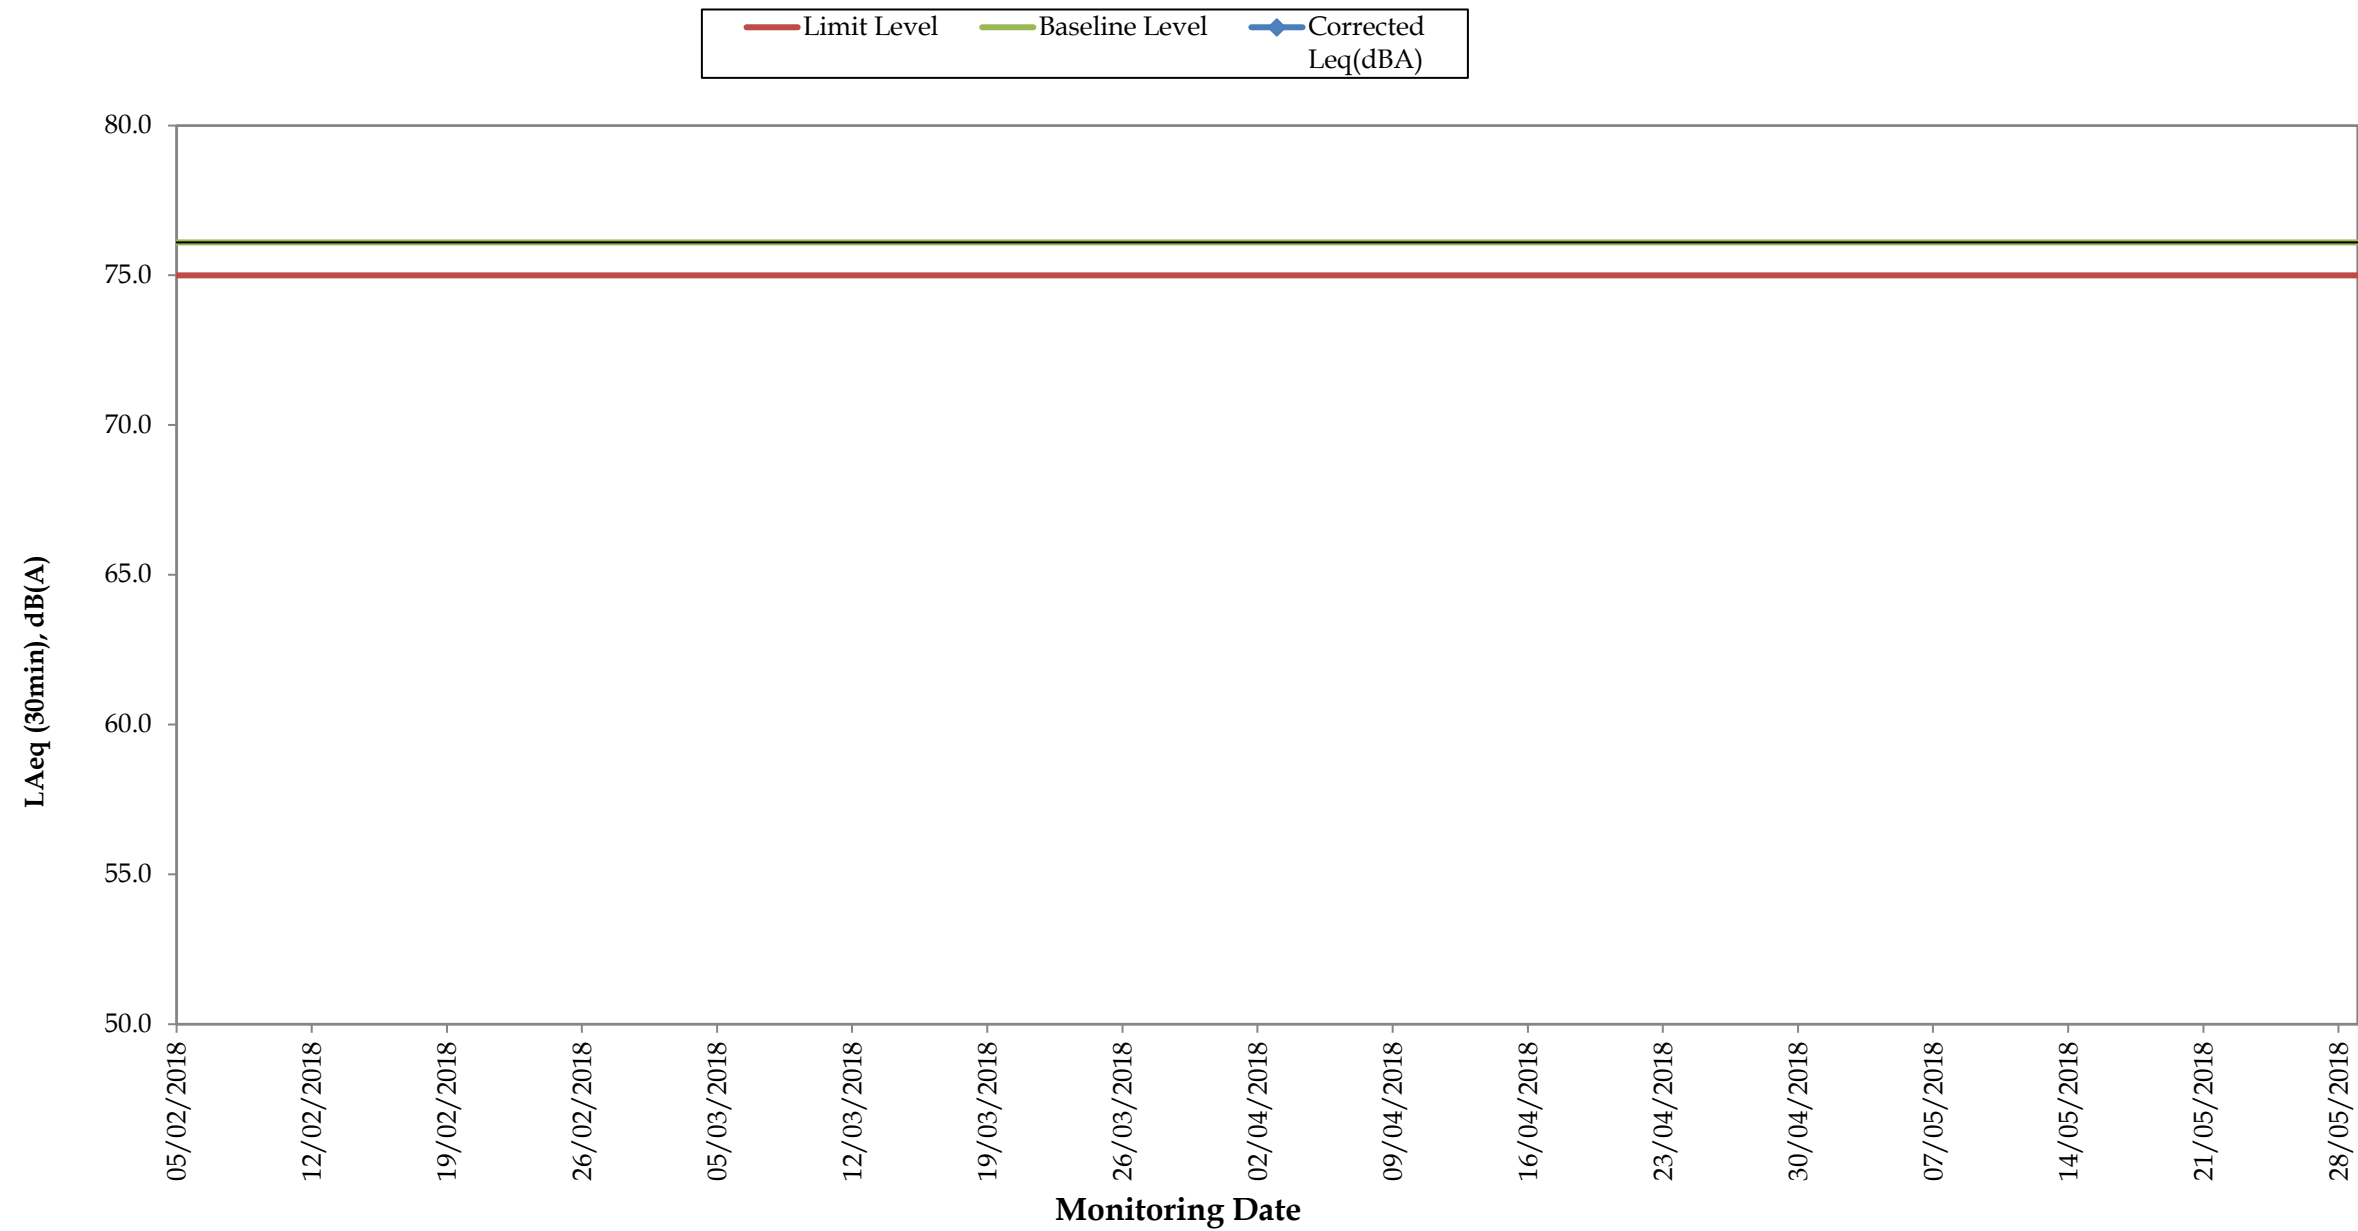
### Regular Noise Monitoring Results at NMS-CA-6 (No. 16-23 Nam Kok Road) (LAeq, 30min) for the Past 4 Months

- For those corrected noise levels that are not shown in this graph, the measured noise levels are equal to or below baseline level.

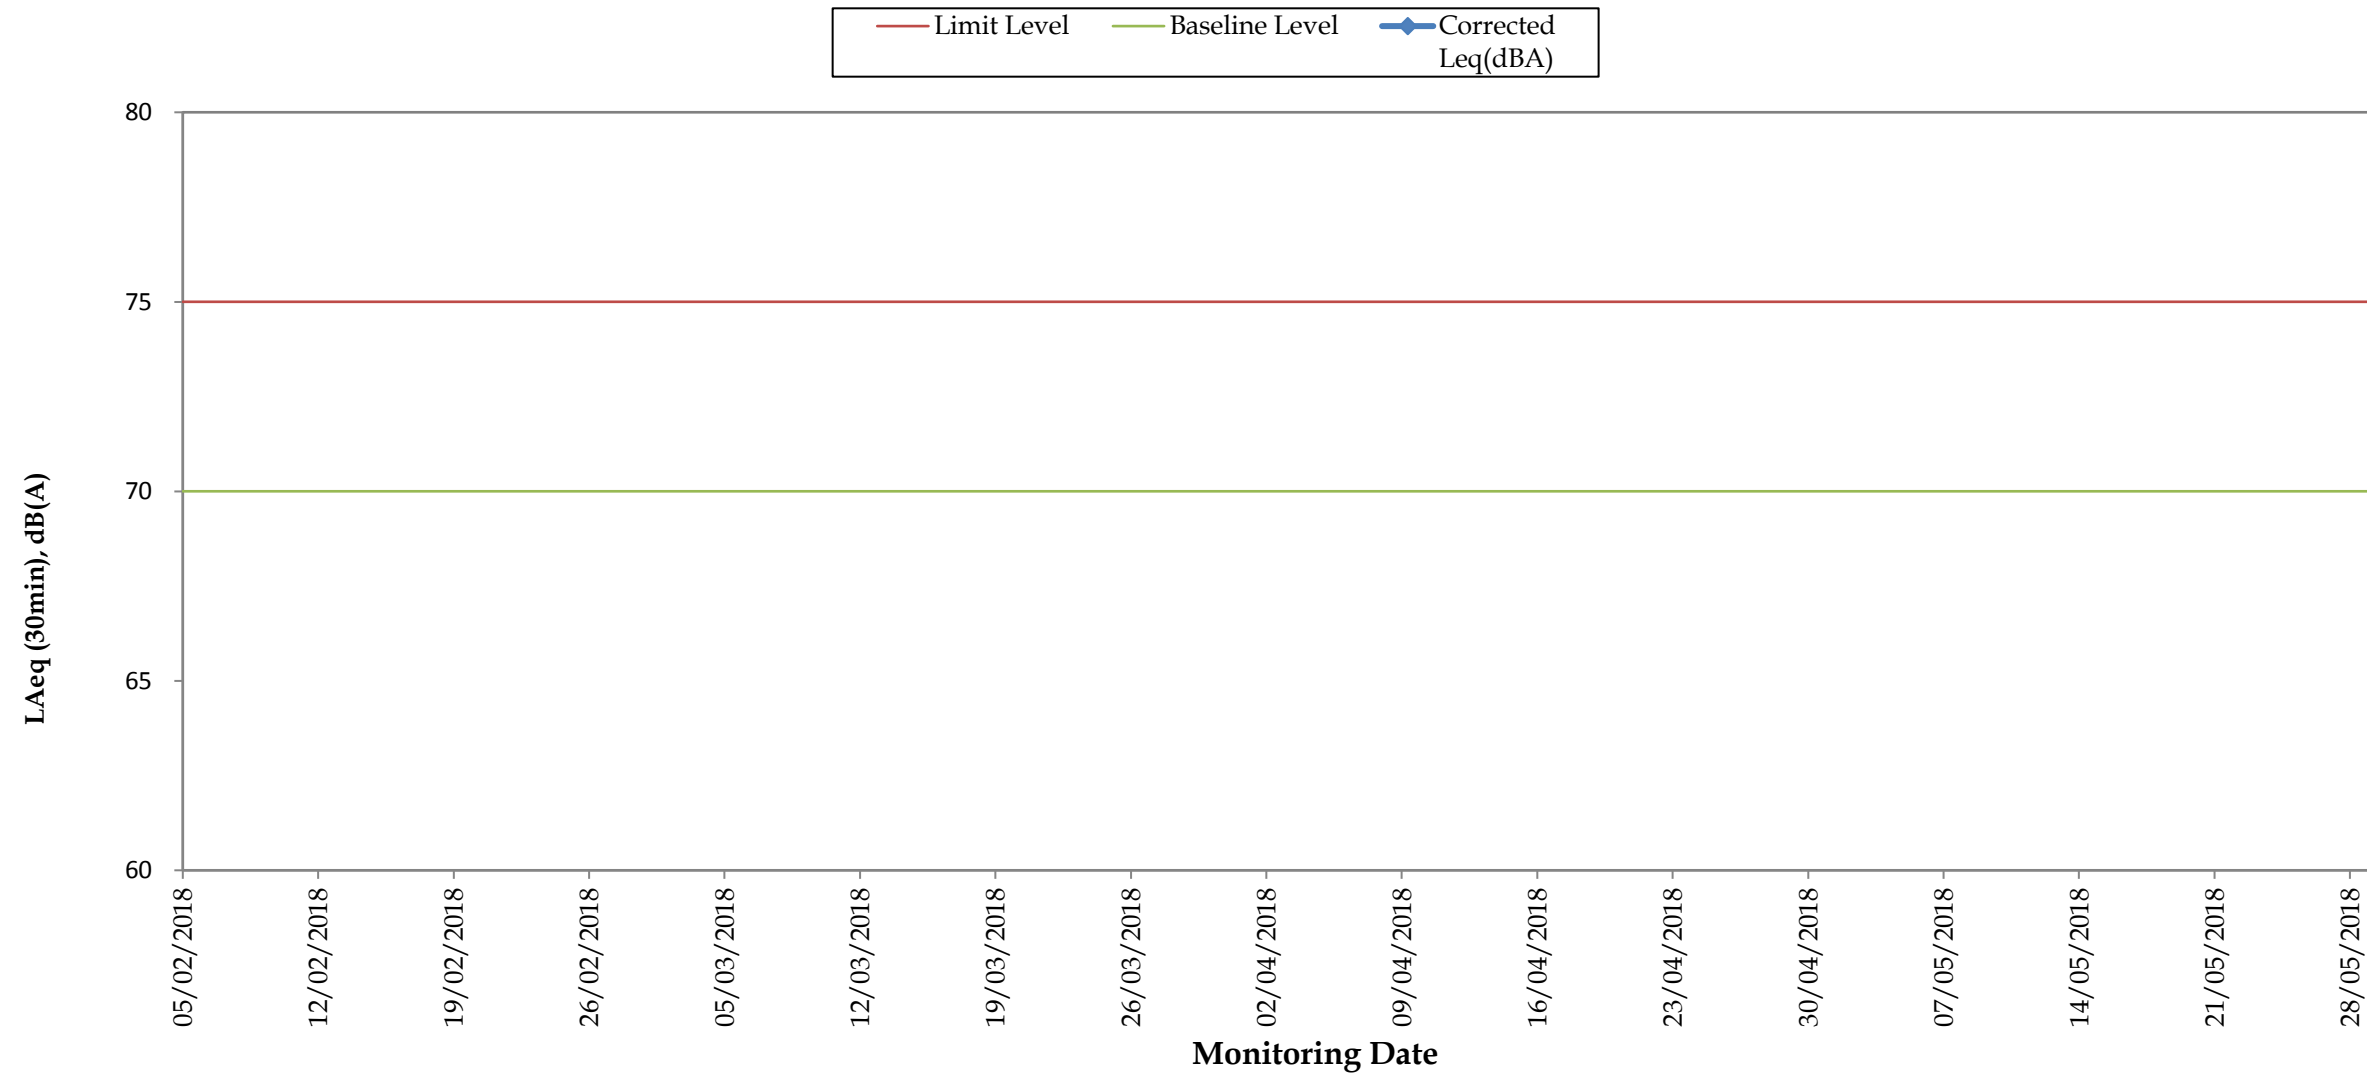
### Regular Noise Monitoring Results at NMS-CA-7 (Skytower Tower 2) (LAeq, 30min) for the Past 4 Months

- For those corrected noise levels that are not shown in this graph, the measured noise levels are equal to or below baseline level.

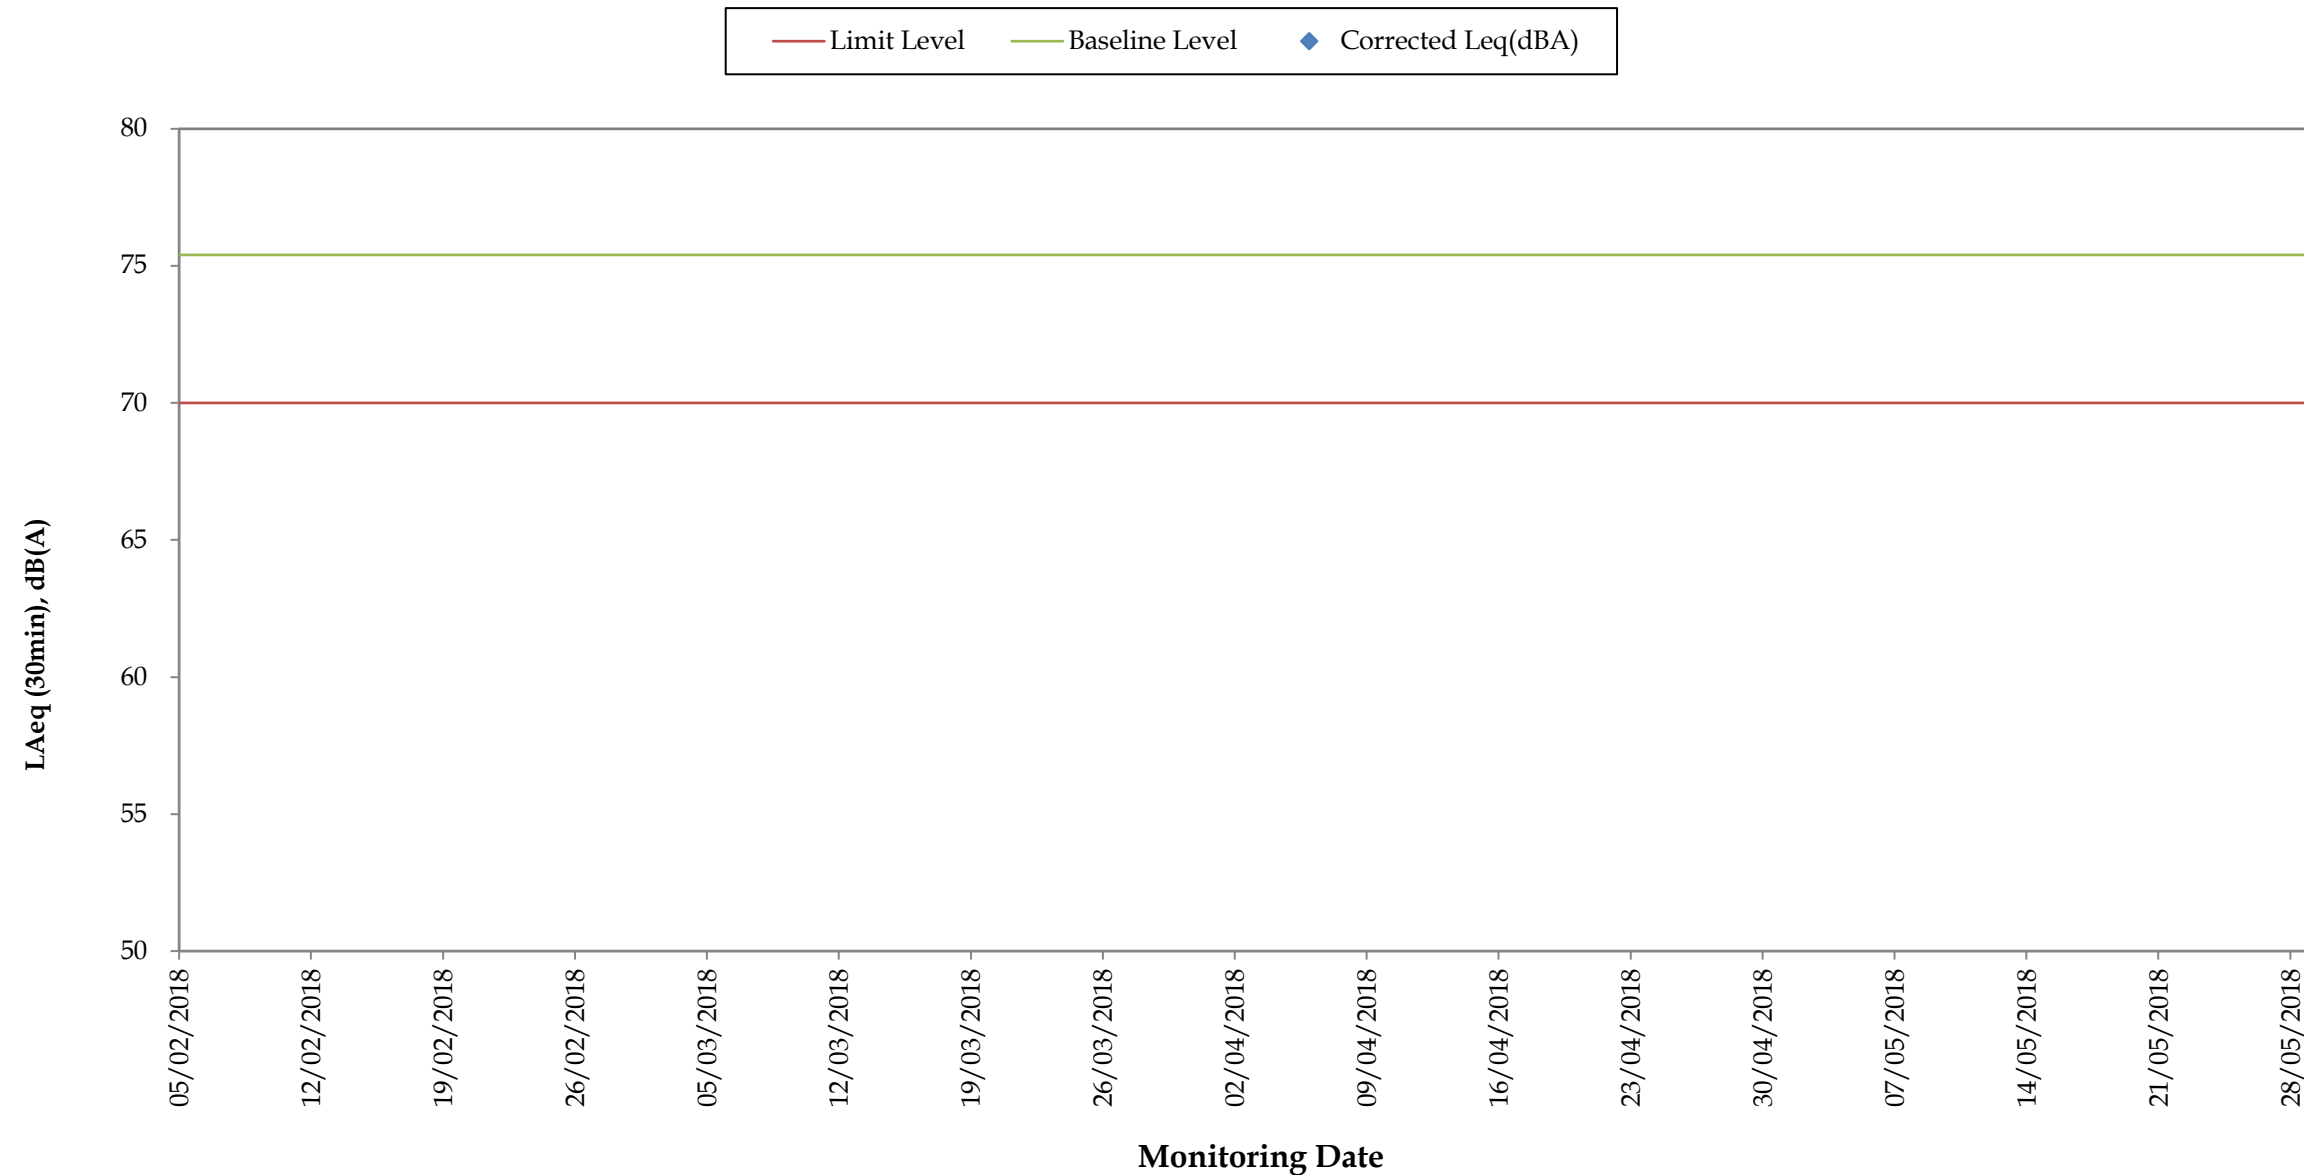
## Regular Noise Monitoring Results at NMS-CA- 8 (SKH Good Shepherd Primary School) (LAeq, 30min) for the Past 4 Months

- For those corrected noise levels that are not shown in this graph, the measured noise levels are equal to or below baseline level.
- The limit level was updated from 78dB(A) to 79 dB(A) on 22 Aug 2013 as per the latest CNMP and CNMMP.
- The limit level was updated from 79dB(A) to 70dB(A)/65dB(A) (during normal/examination period) from April 2016, as the continuous noise monitoring was completed in March 2016 according to the latest CNMP

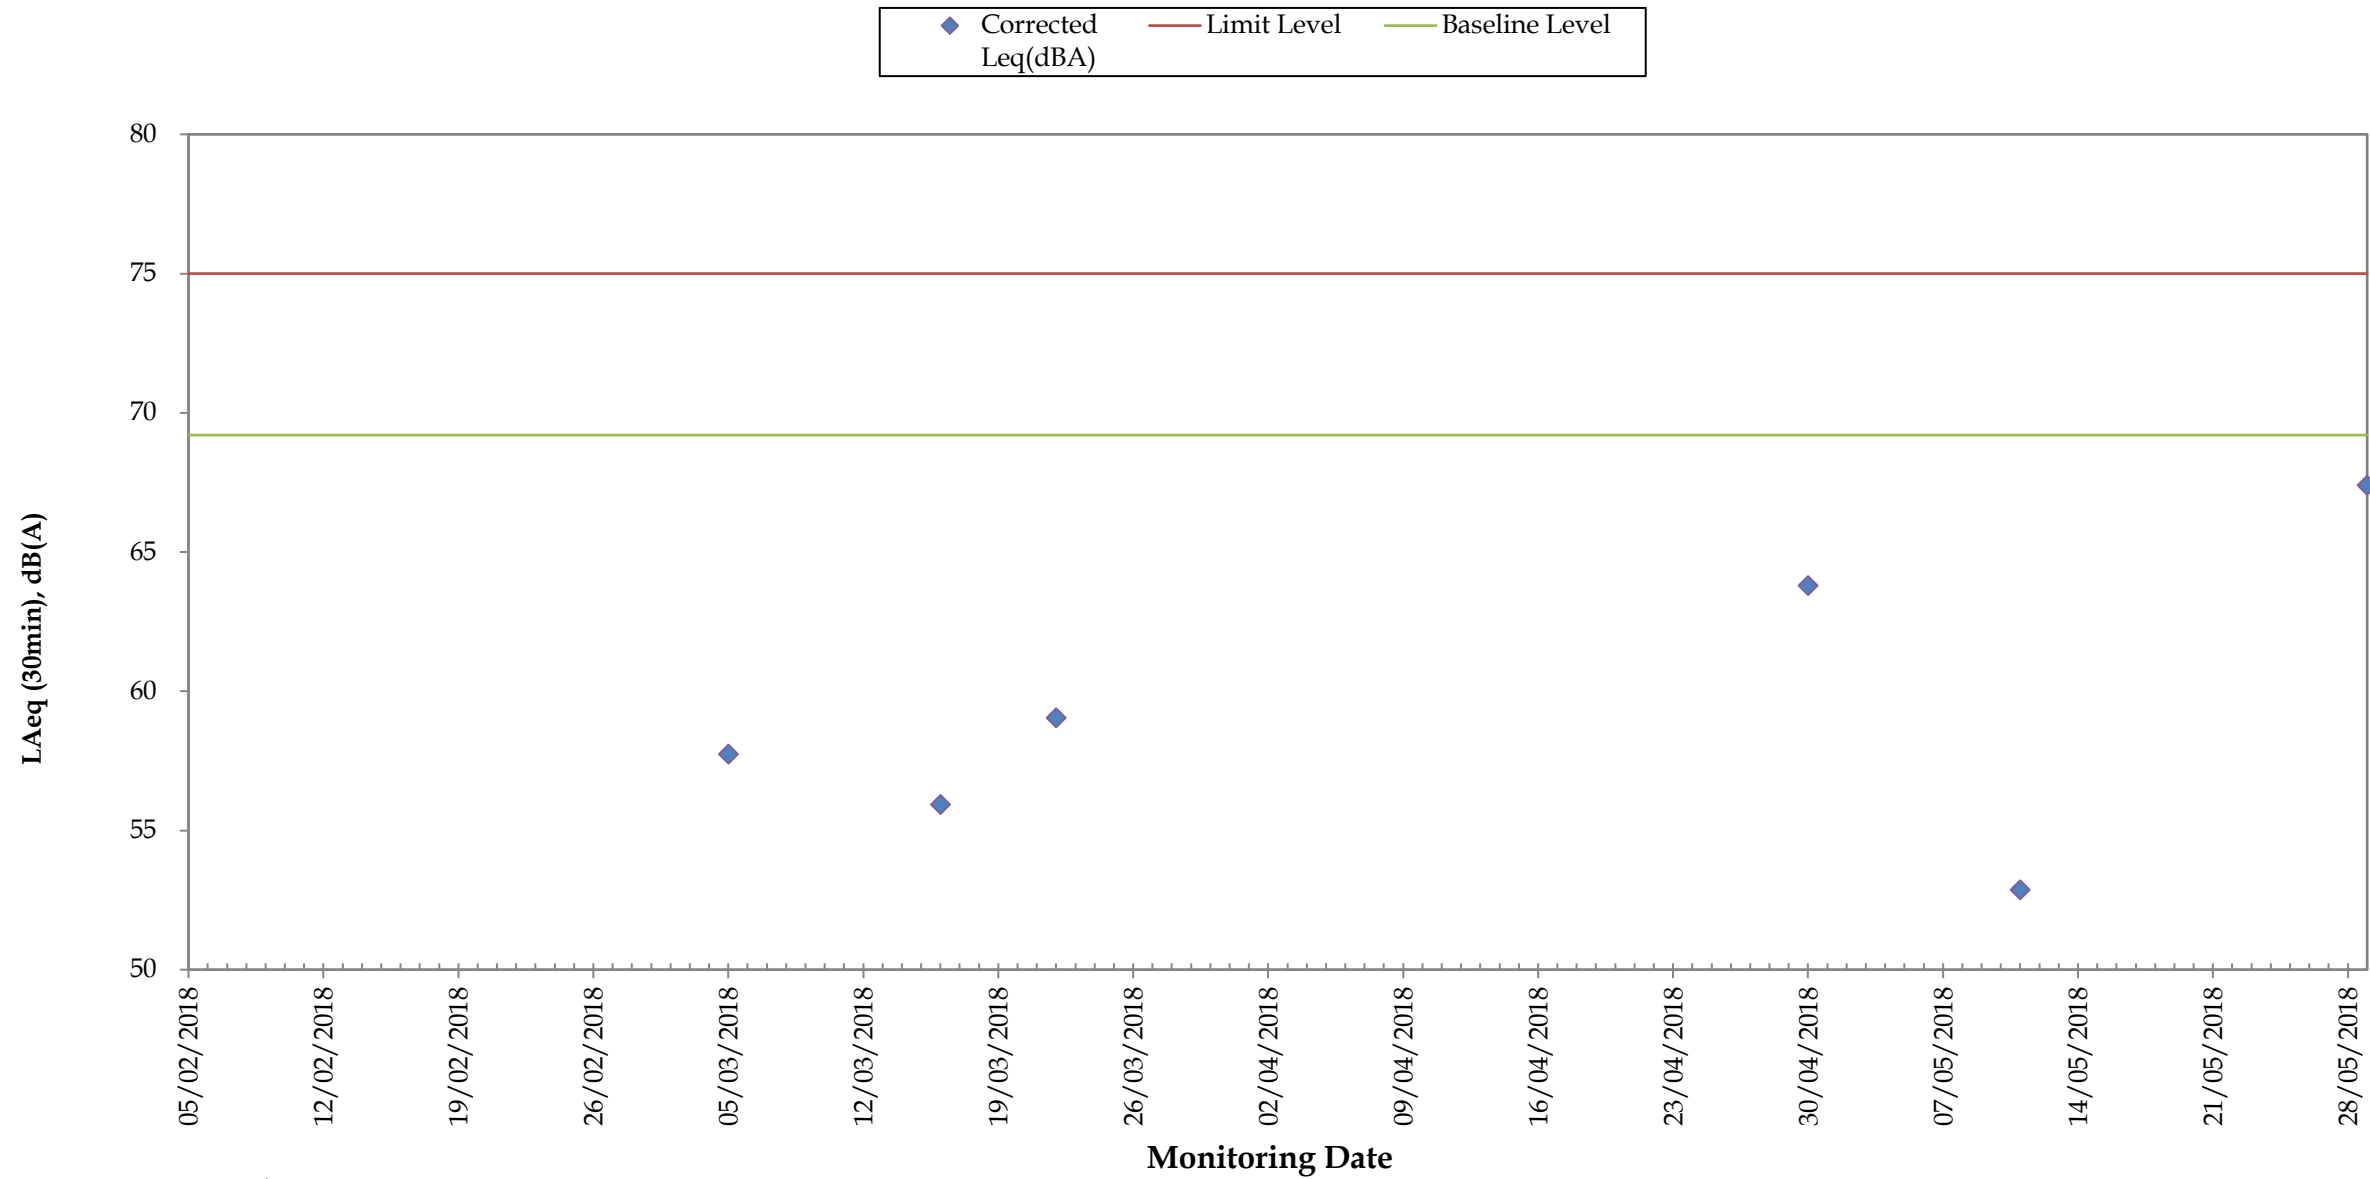
### Regular Noise Monitoring Results at NMS-CA-9 (Kong Yiu Mansion) (LAeq, 30min) ) for the Past 4 Months

- For those corrected noise levels that are not shown in this graph, the measured noise levels are equal to or below baseline level.

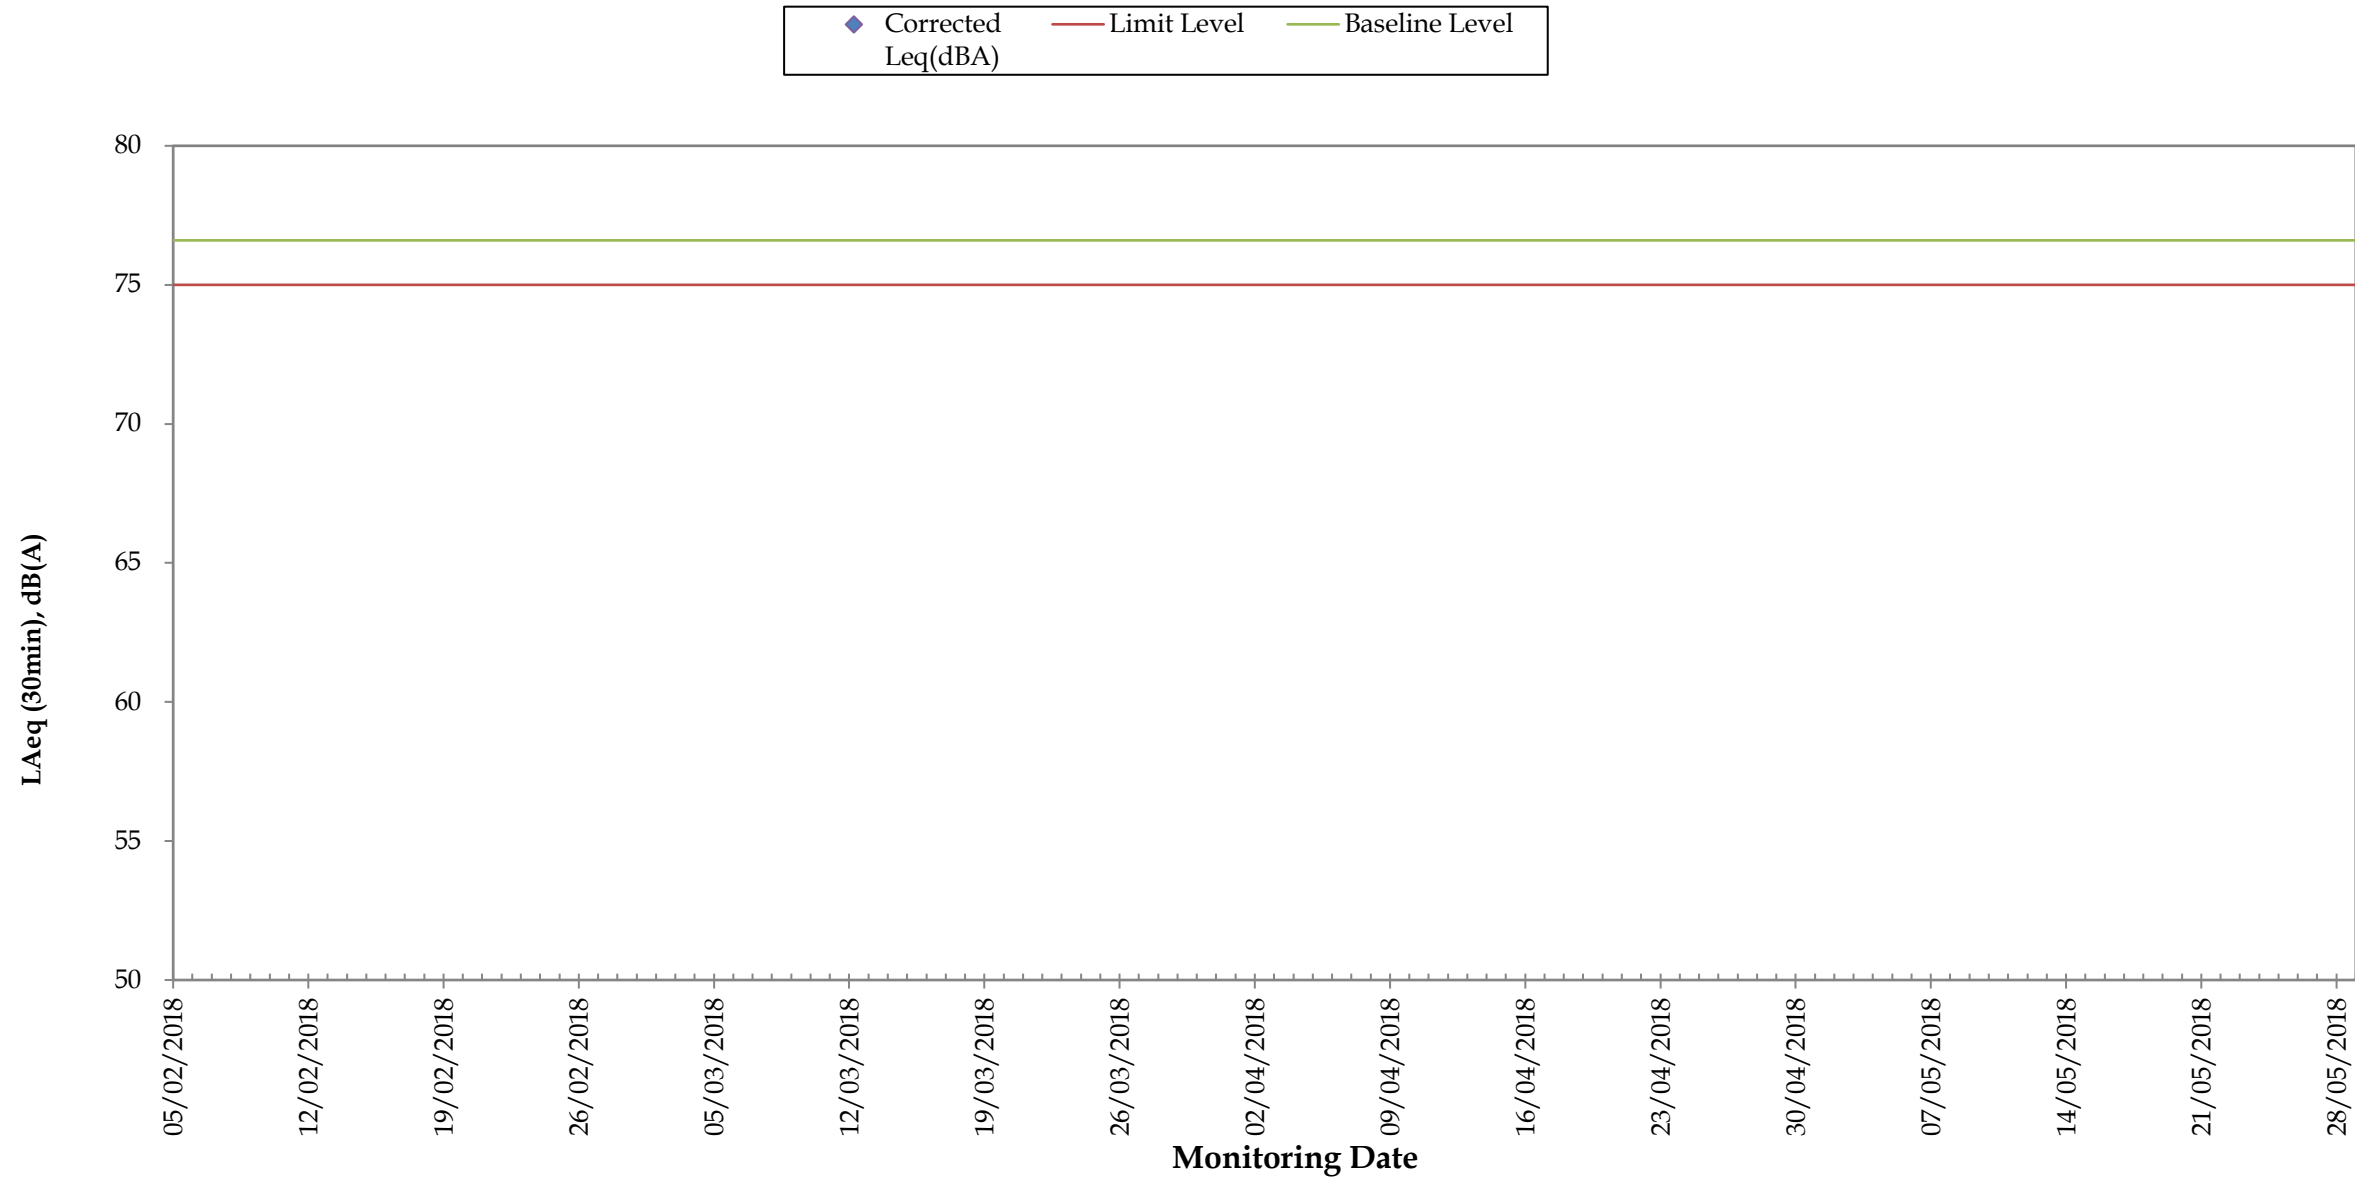
## Regular Noise Monitoring Results at NMS-CA-10 (Chat Ma Mansion) (LAeq, 30min) for the Past 4 Months

- For those corrected noise levels that are not shown in this graph, the measured noise levels are equal to or below baseline level.

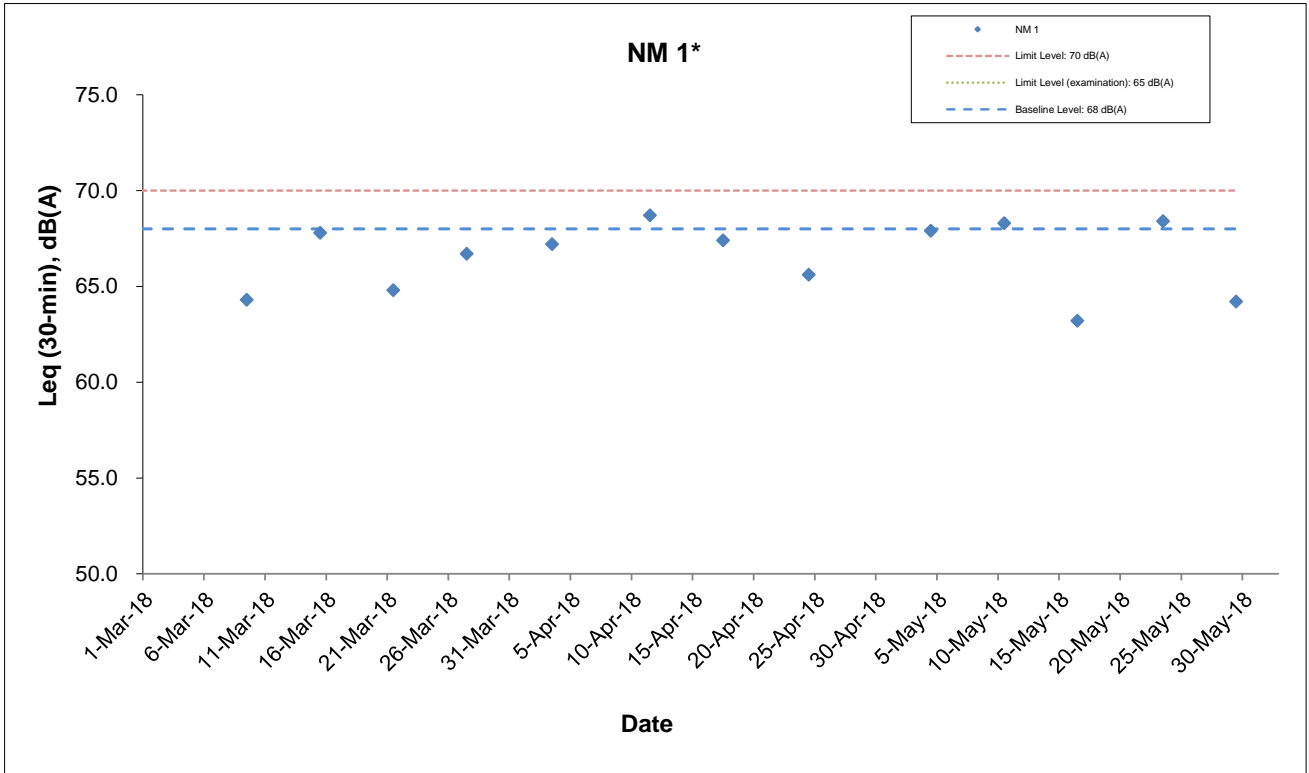
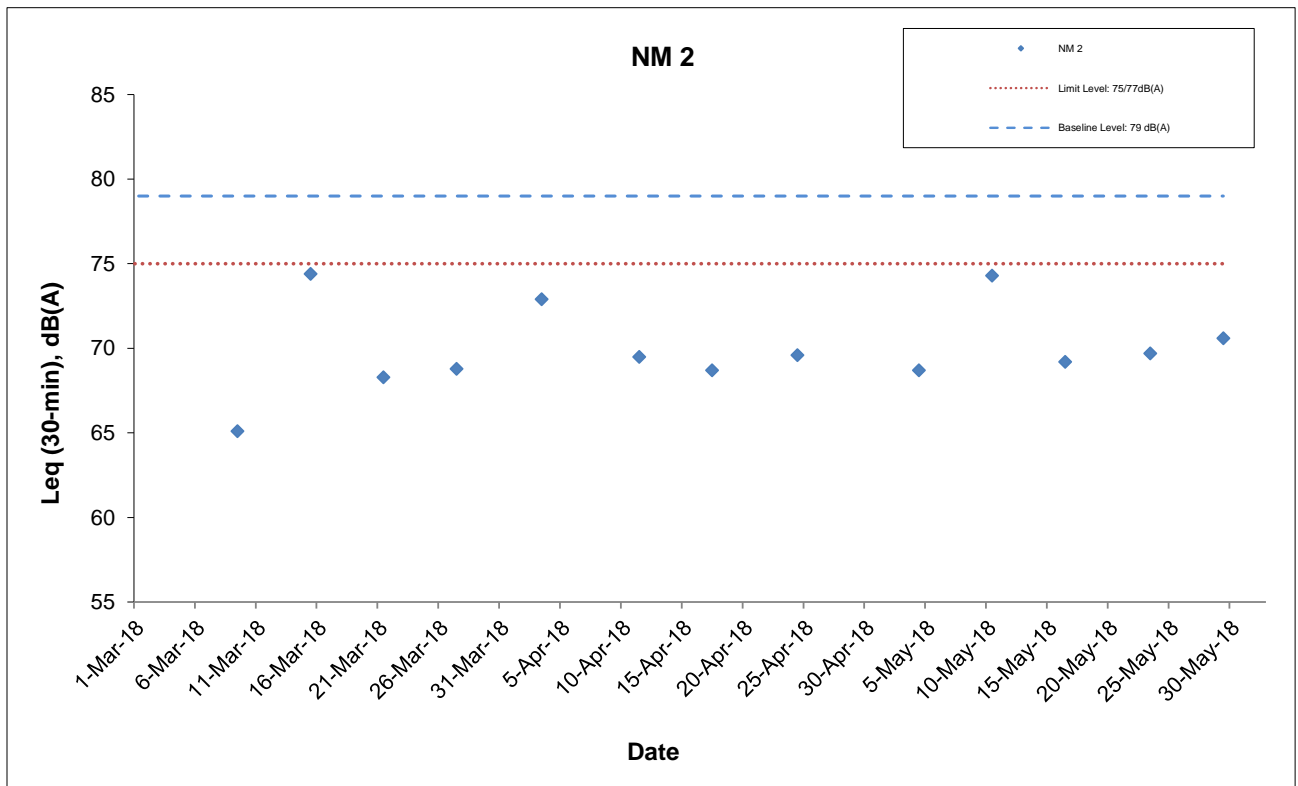
# Appendix H Regular Construction Noise Monitoring Results

\* - The noise monitoring results of the measurements are higher than the daytime construction noise criterion. However, the results are not considered as exceedance if they are either below the baseline level or below the limit level after deducting the baseline noise level.
