**Shatin to Central Link –
Tai Wai to Hung Hom Section and
Mong Kok East to Hung Hom Section**

Monthly EM&A Report No. 80

[Period from 1 to 30 April 2019]

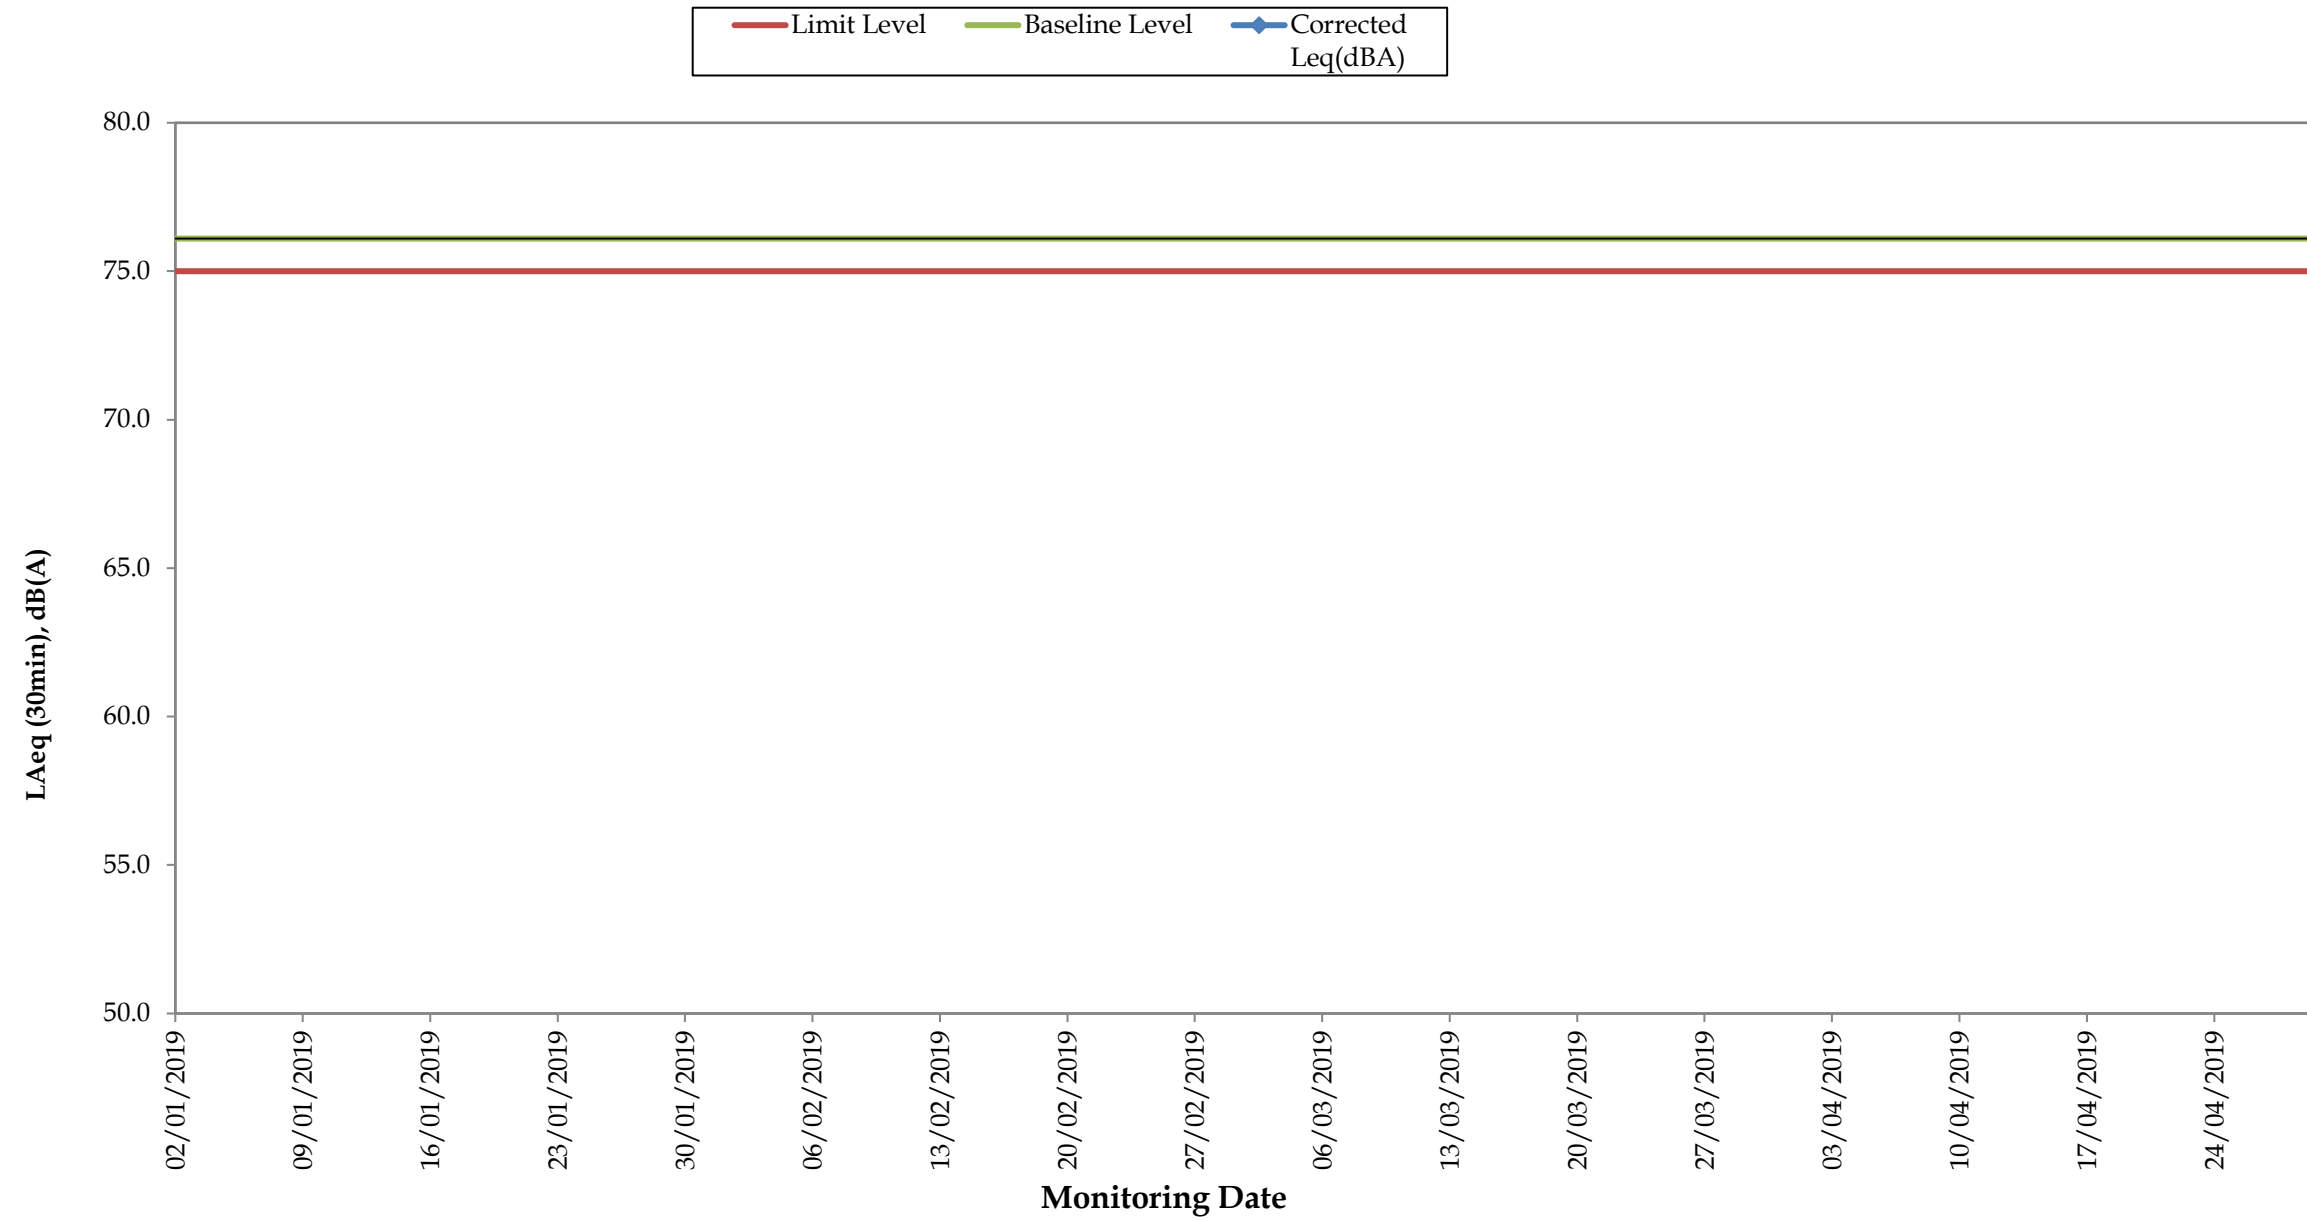
Regular Noise Monitoring Results at NMS-CA-6 (No. 16-23 Nam Kok Road) (LAeq, 30min) for the Past 4 Months

- For those corrected noise levels that are not shown in this graph, the measured noise levels are equal to or below baseline level.

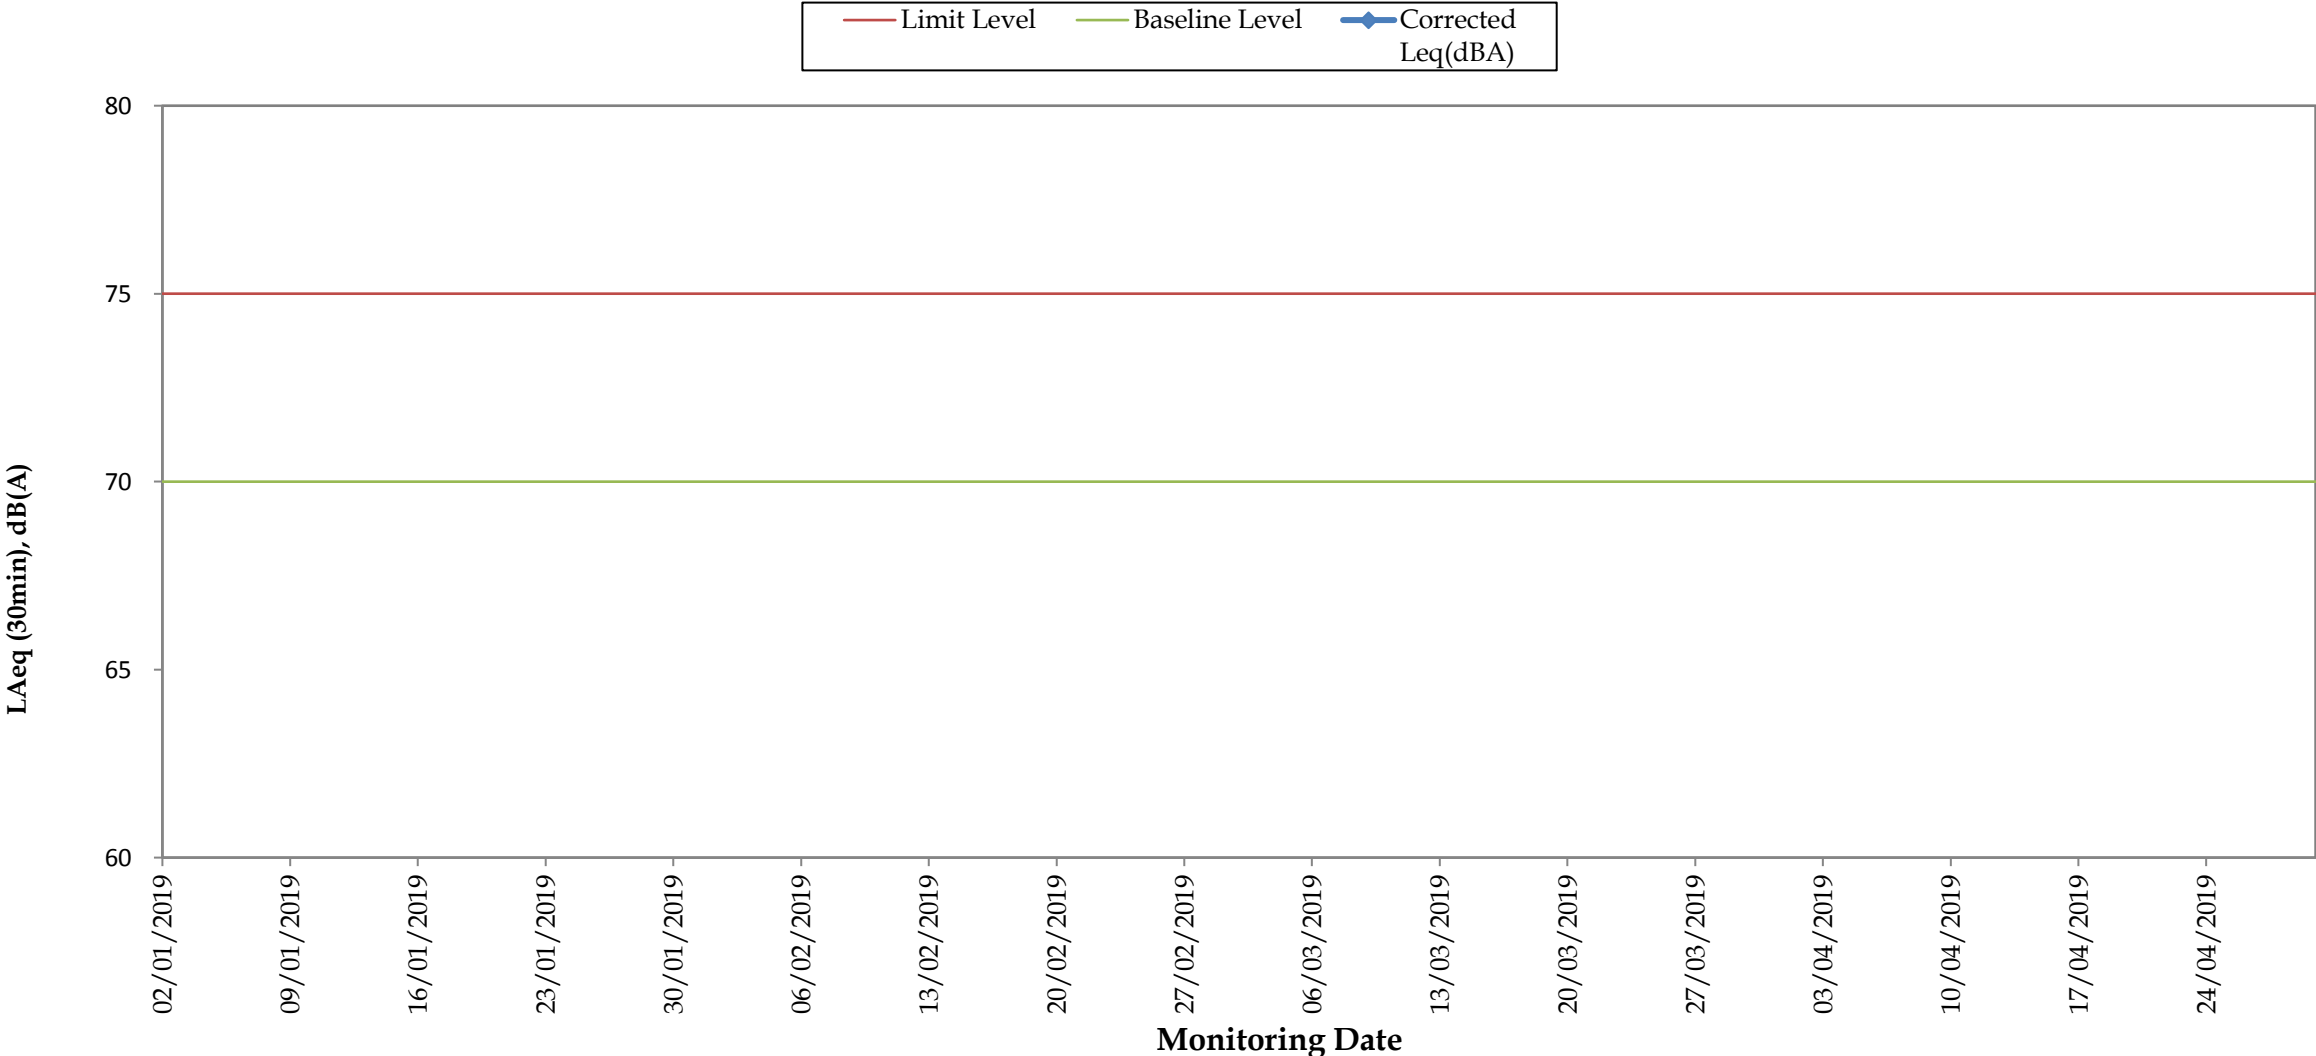
Regular Noise Monitoring Results at NMS-CA-7 (Skytower Tower 2) (LAeq, 30min) for the Past 4 Months

- For those corrected noise levels that are not shown in this graph, the measured noise levels are equal to or below baseline level.

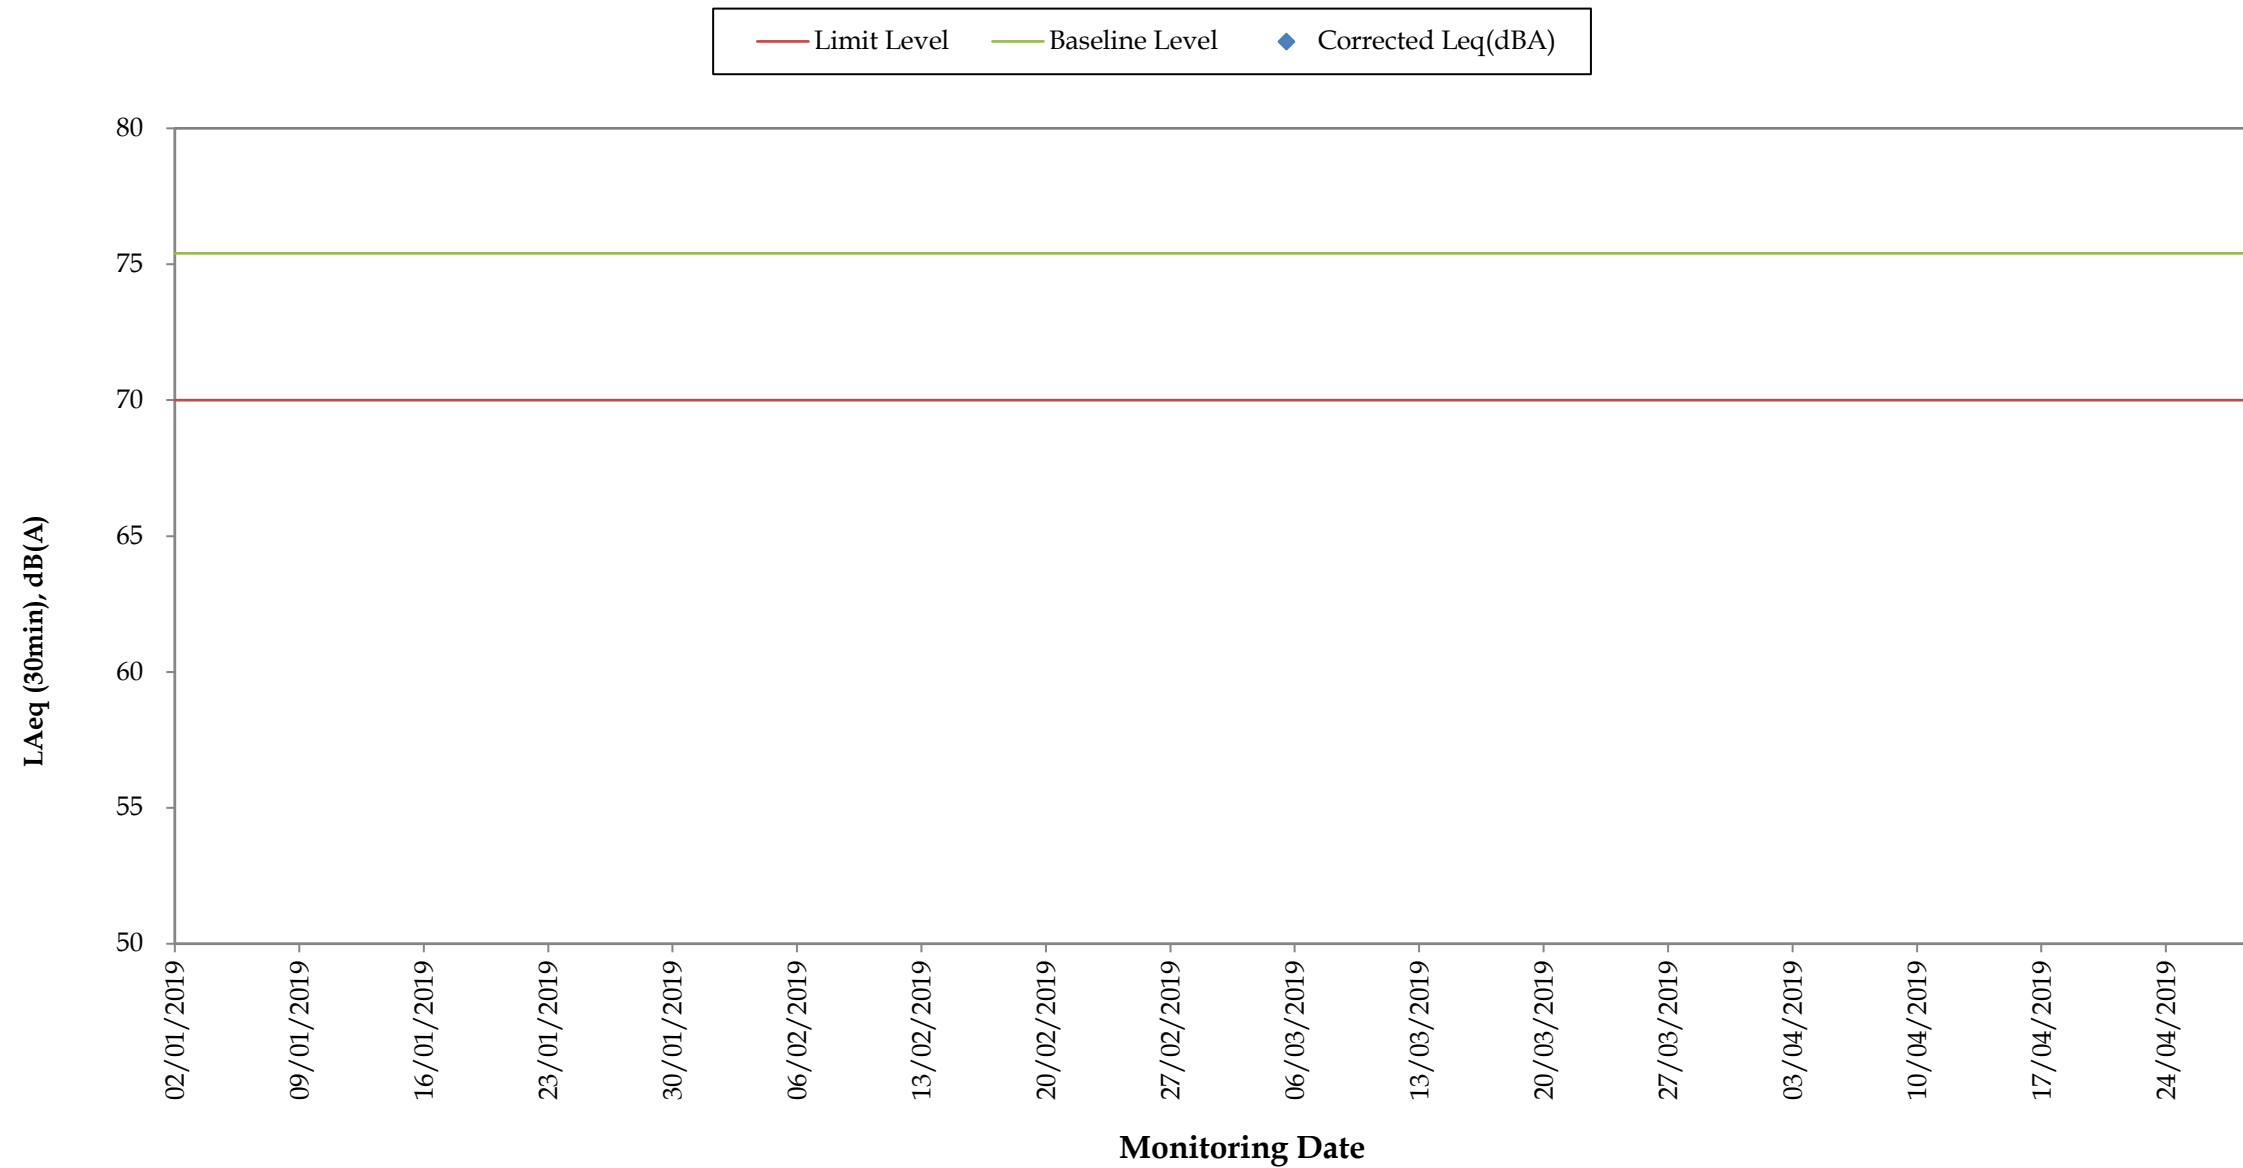
Regular Noise Monitoring Results at NMS-CA- 8 (SKH Good Shepherd Primary School) (LAeq, 30min) for the Past 4 Months

- For those corrected noise levels that are not shown in this graph, the measured noise levels are equal to or below baseline level.
- The limit level was updated from 78dB(A) to 79 dB(A) on 22 Aug 2013 as per the latest CNMP and CNMMP.
- The limit level was updated from 79dB(A) to 70dB(A)/65dB(A) (during normal/ examination period) from April 2016, as the continuous noise monitoring was completed in March 2016 according to the latest CNMP

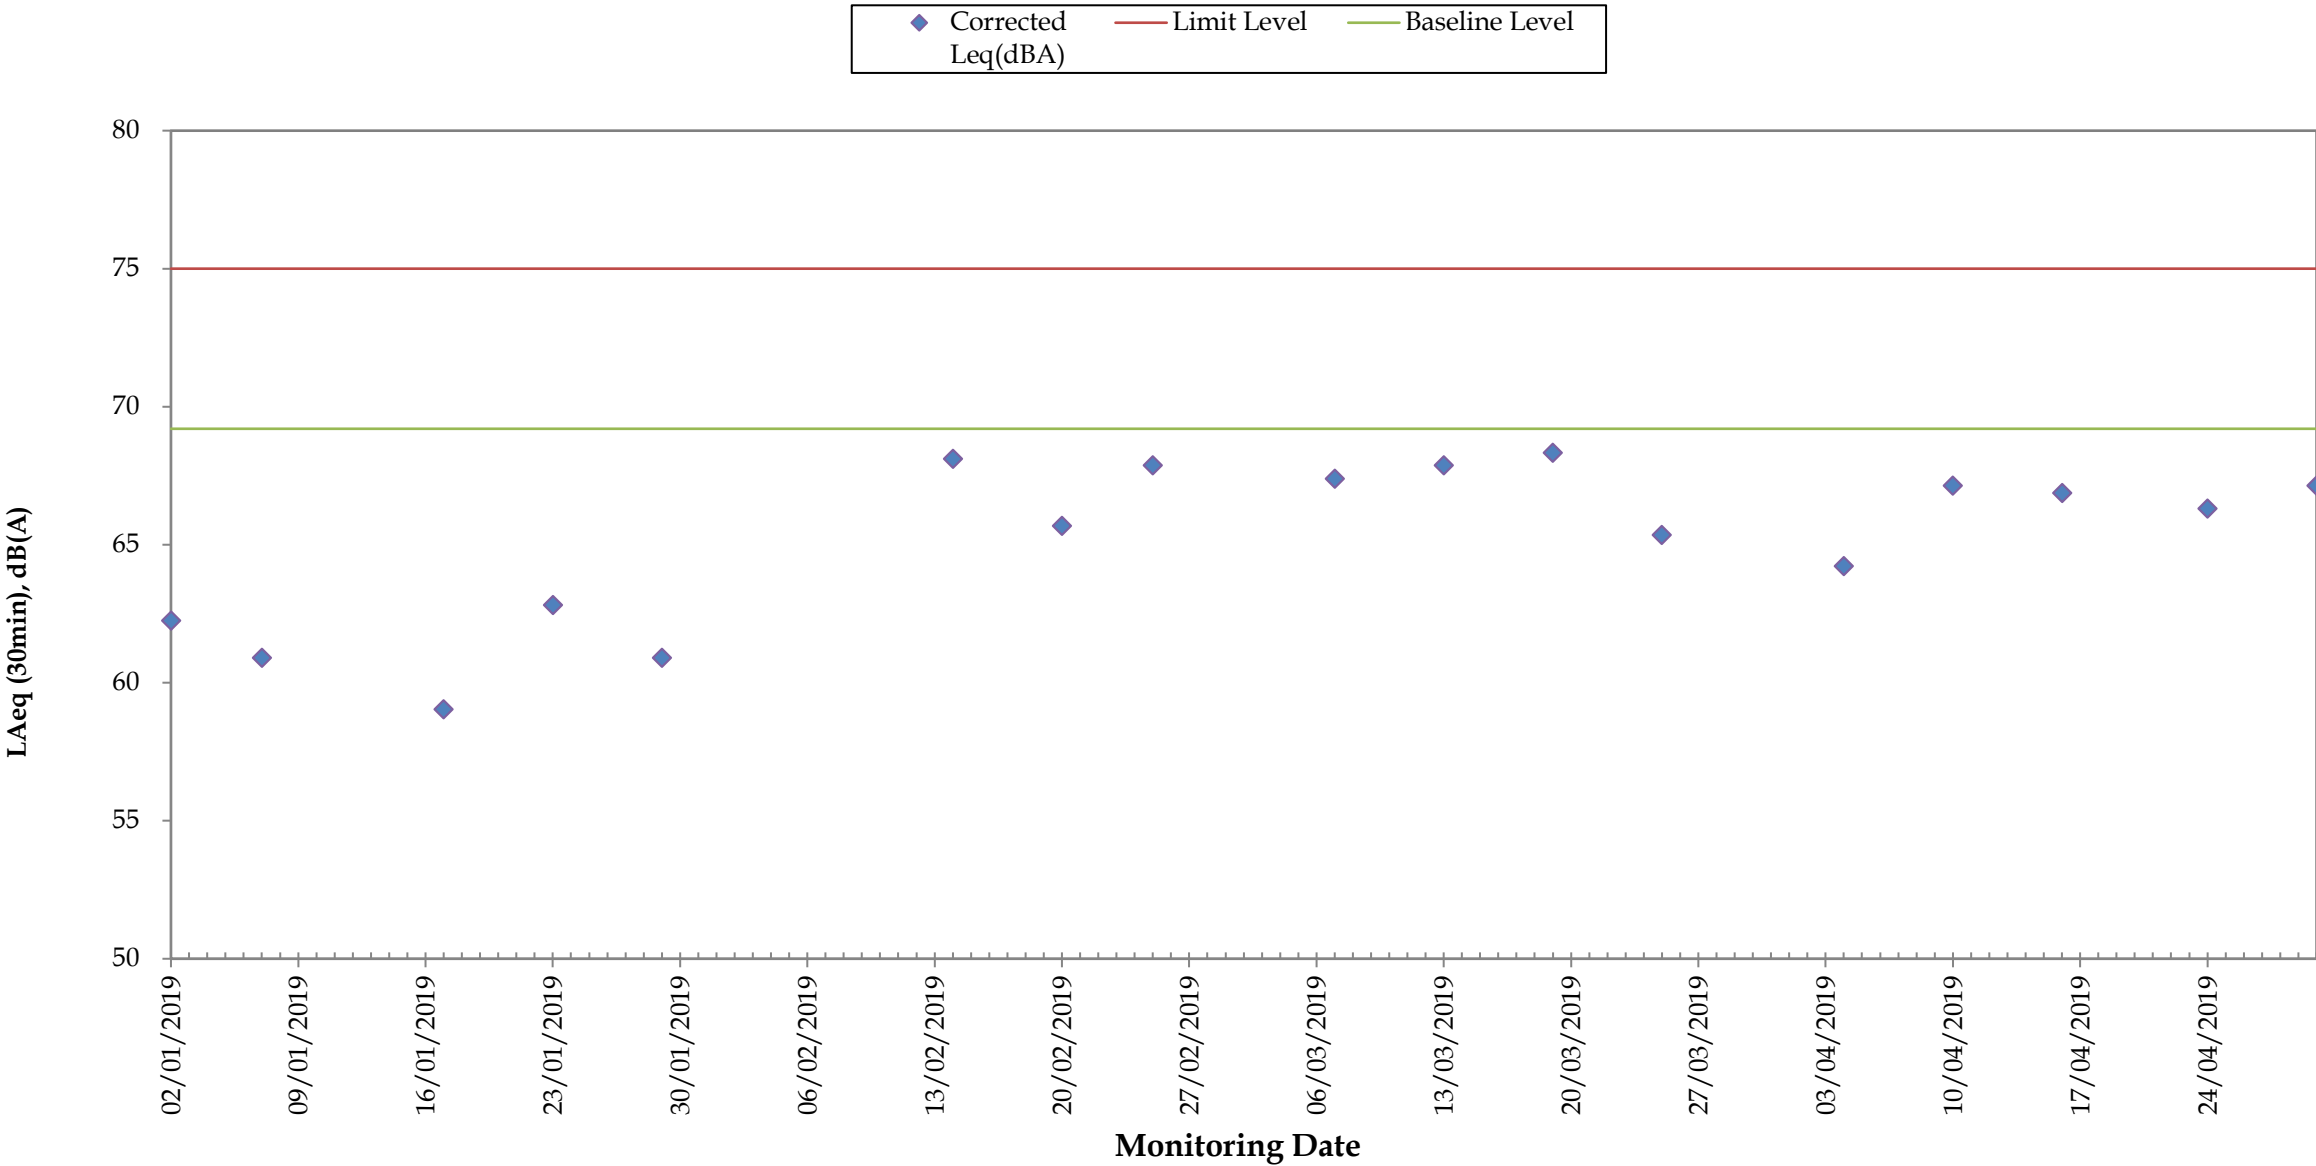
Regular Noise Monitoring Results at NMS-CA-9 (Kong Yiu Mansion) (LAeq, 30min) for the Past 4 Months

- For those corrected noise levels that are not shown in this graph, the measured noise levels are equal to or below baseline level.

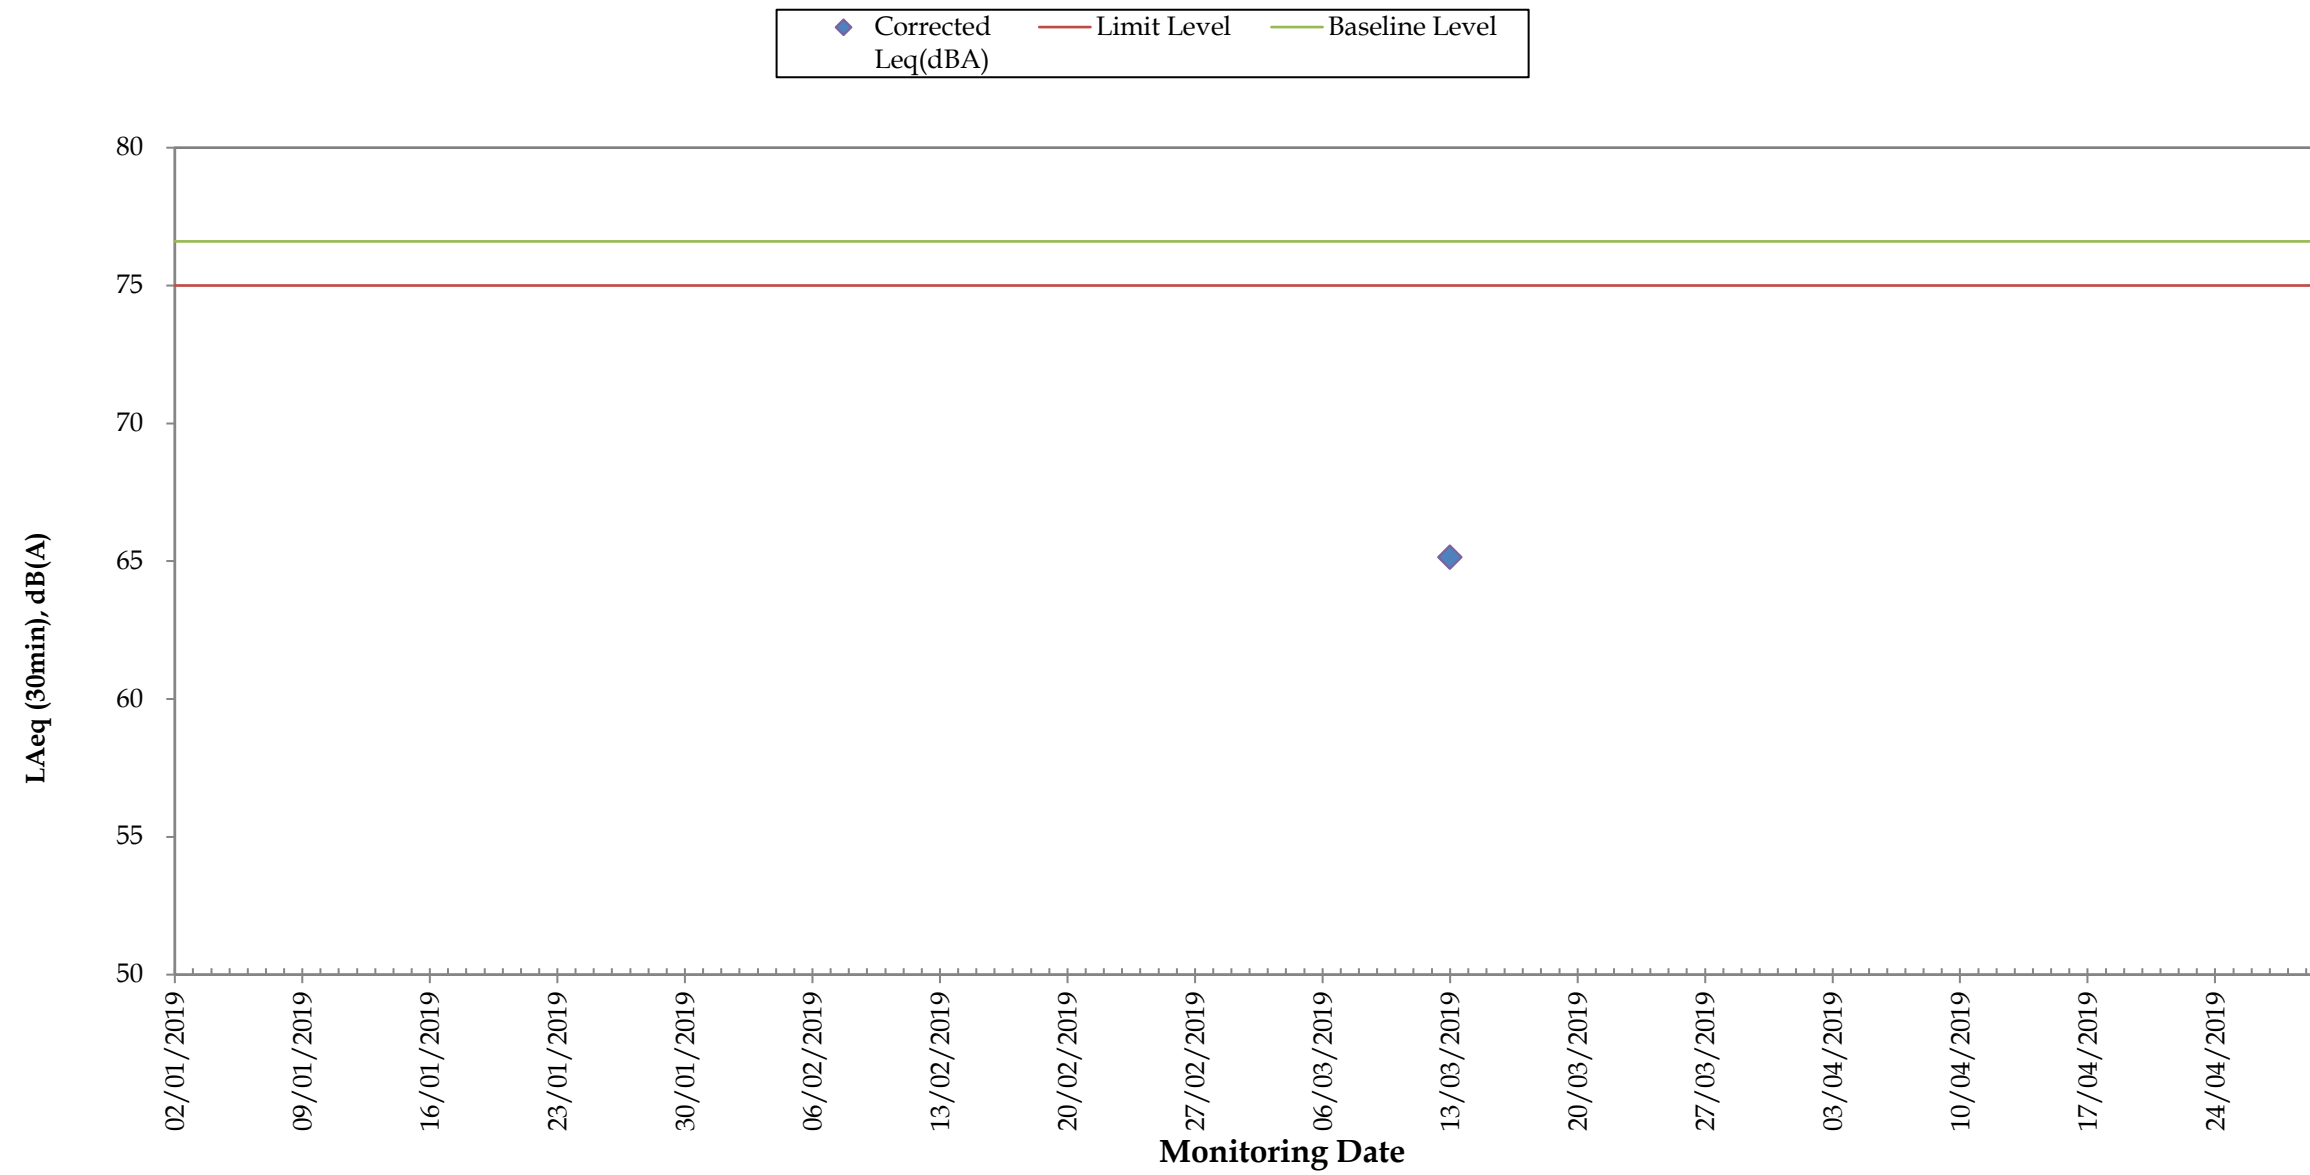
Regular Noise Monitoring Results at NMS-CA-10 (Chat Ma Mansion) (LAeq, 30min) for the Past 4 Months

- For those corrected noise levels that are not shown in this graph, the measured noise levels are equal to or below baseline level.

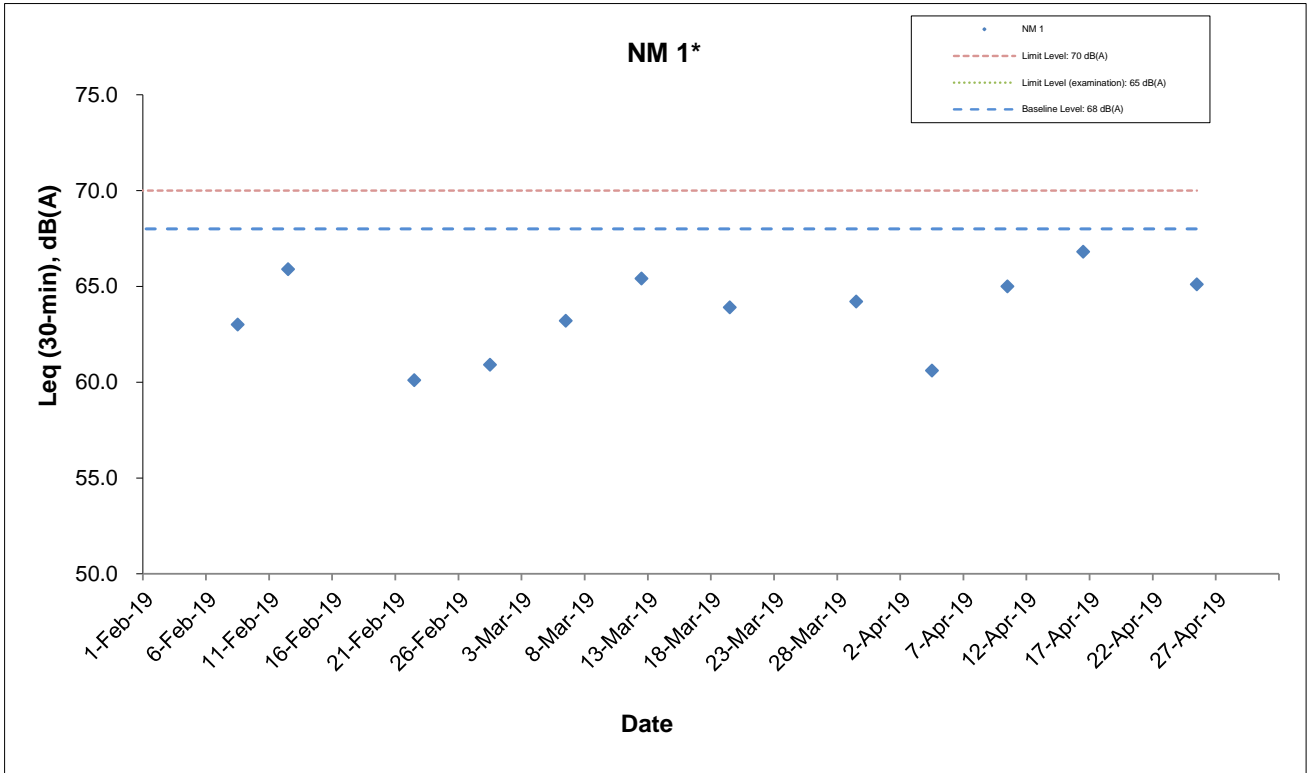
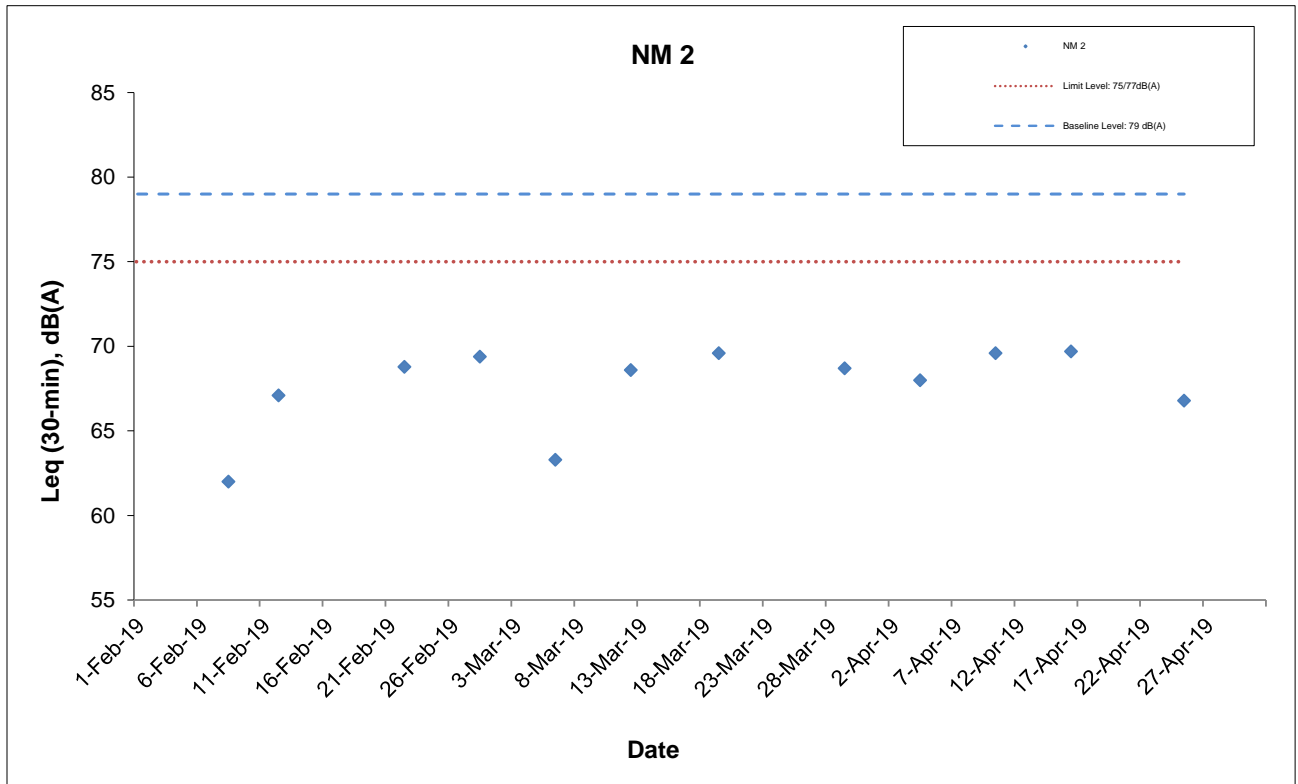
Appendix H Regular Construction Noise Monitoring Results

* - The noise monitoring results of the measurements are higher than the daytime construction noise criterion. However, the results are not considered as exceedance if they are either below the baseline level or below the limit level after deducting the baseline noise level.
