**Shatin to Central Link –
Tai Wai to Hung Hom Section**

Monthly EM&A Report No. 91

[Period from 1 to 31 March 2020]

Works Contract 1109 - Stations and Tunnels of
Kowloon City Section

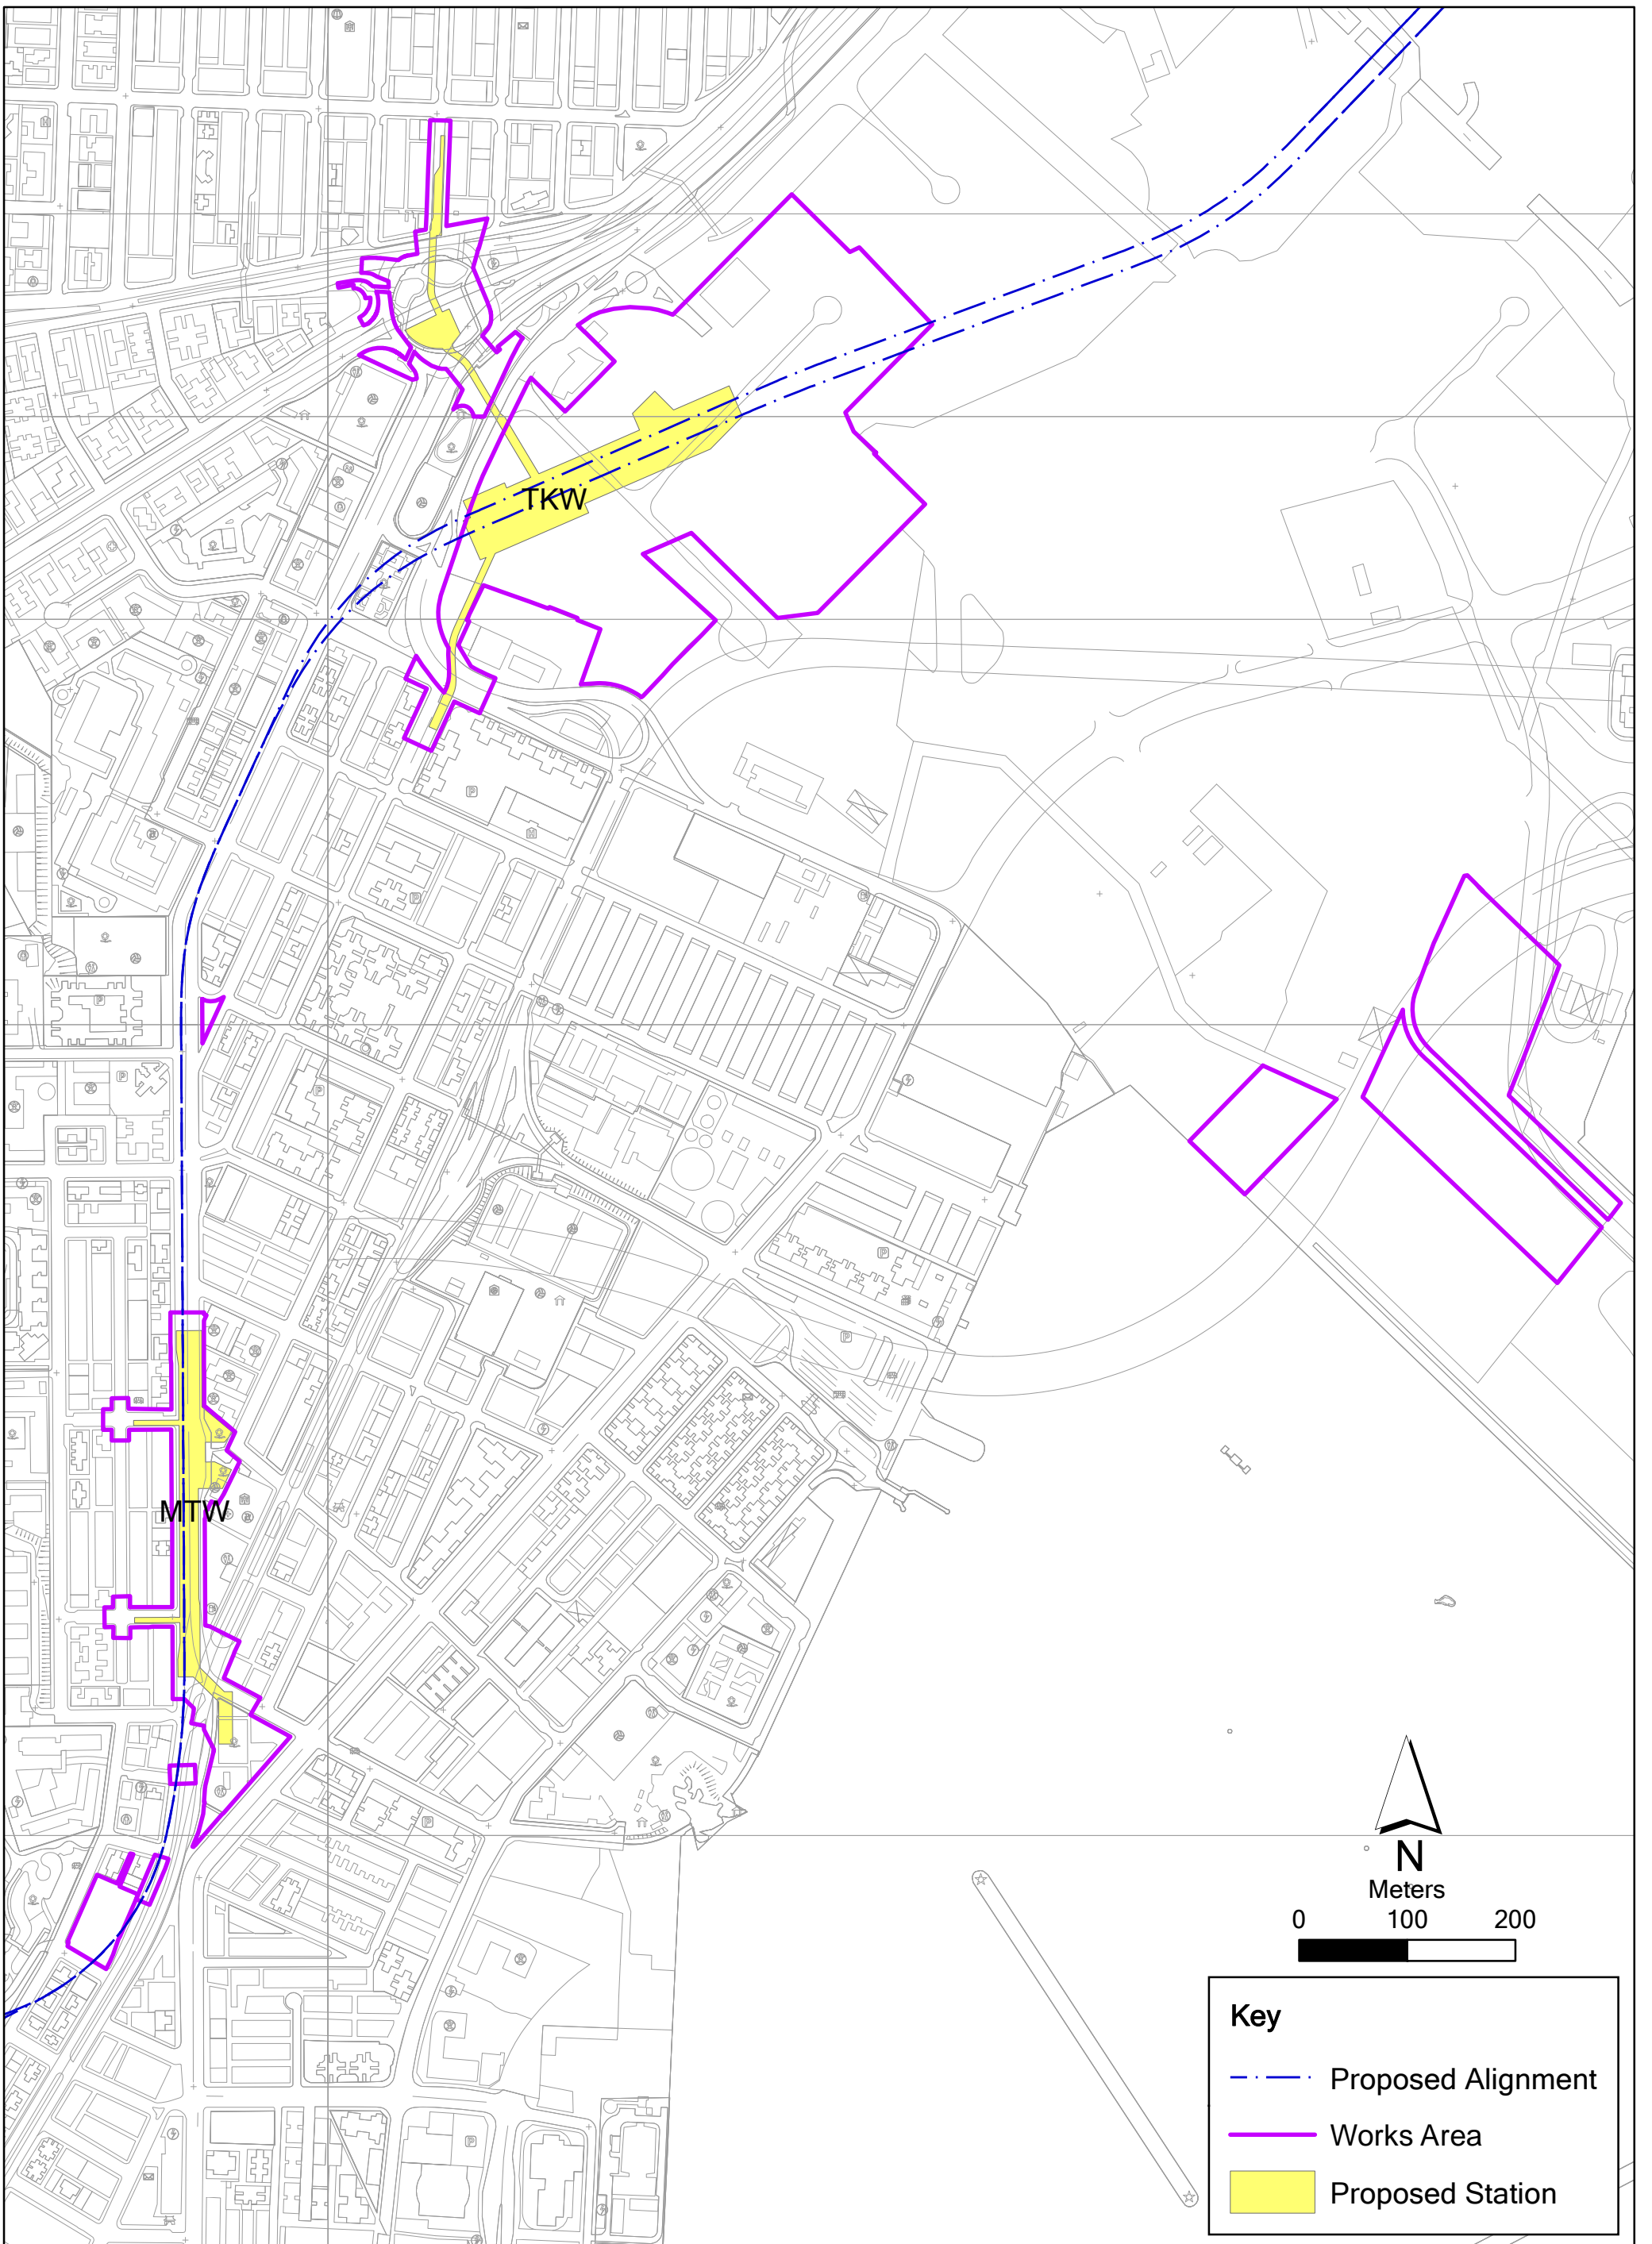
Annex A

Alignment, Stations and Works Area of SCL Works Contract 1109

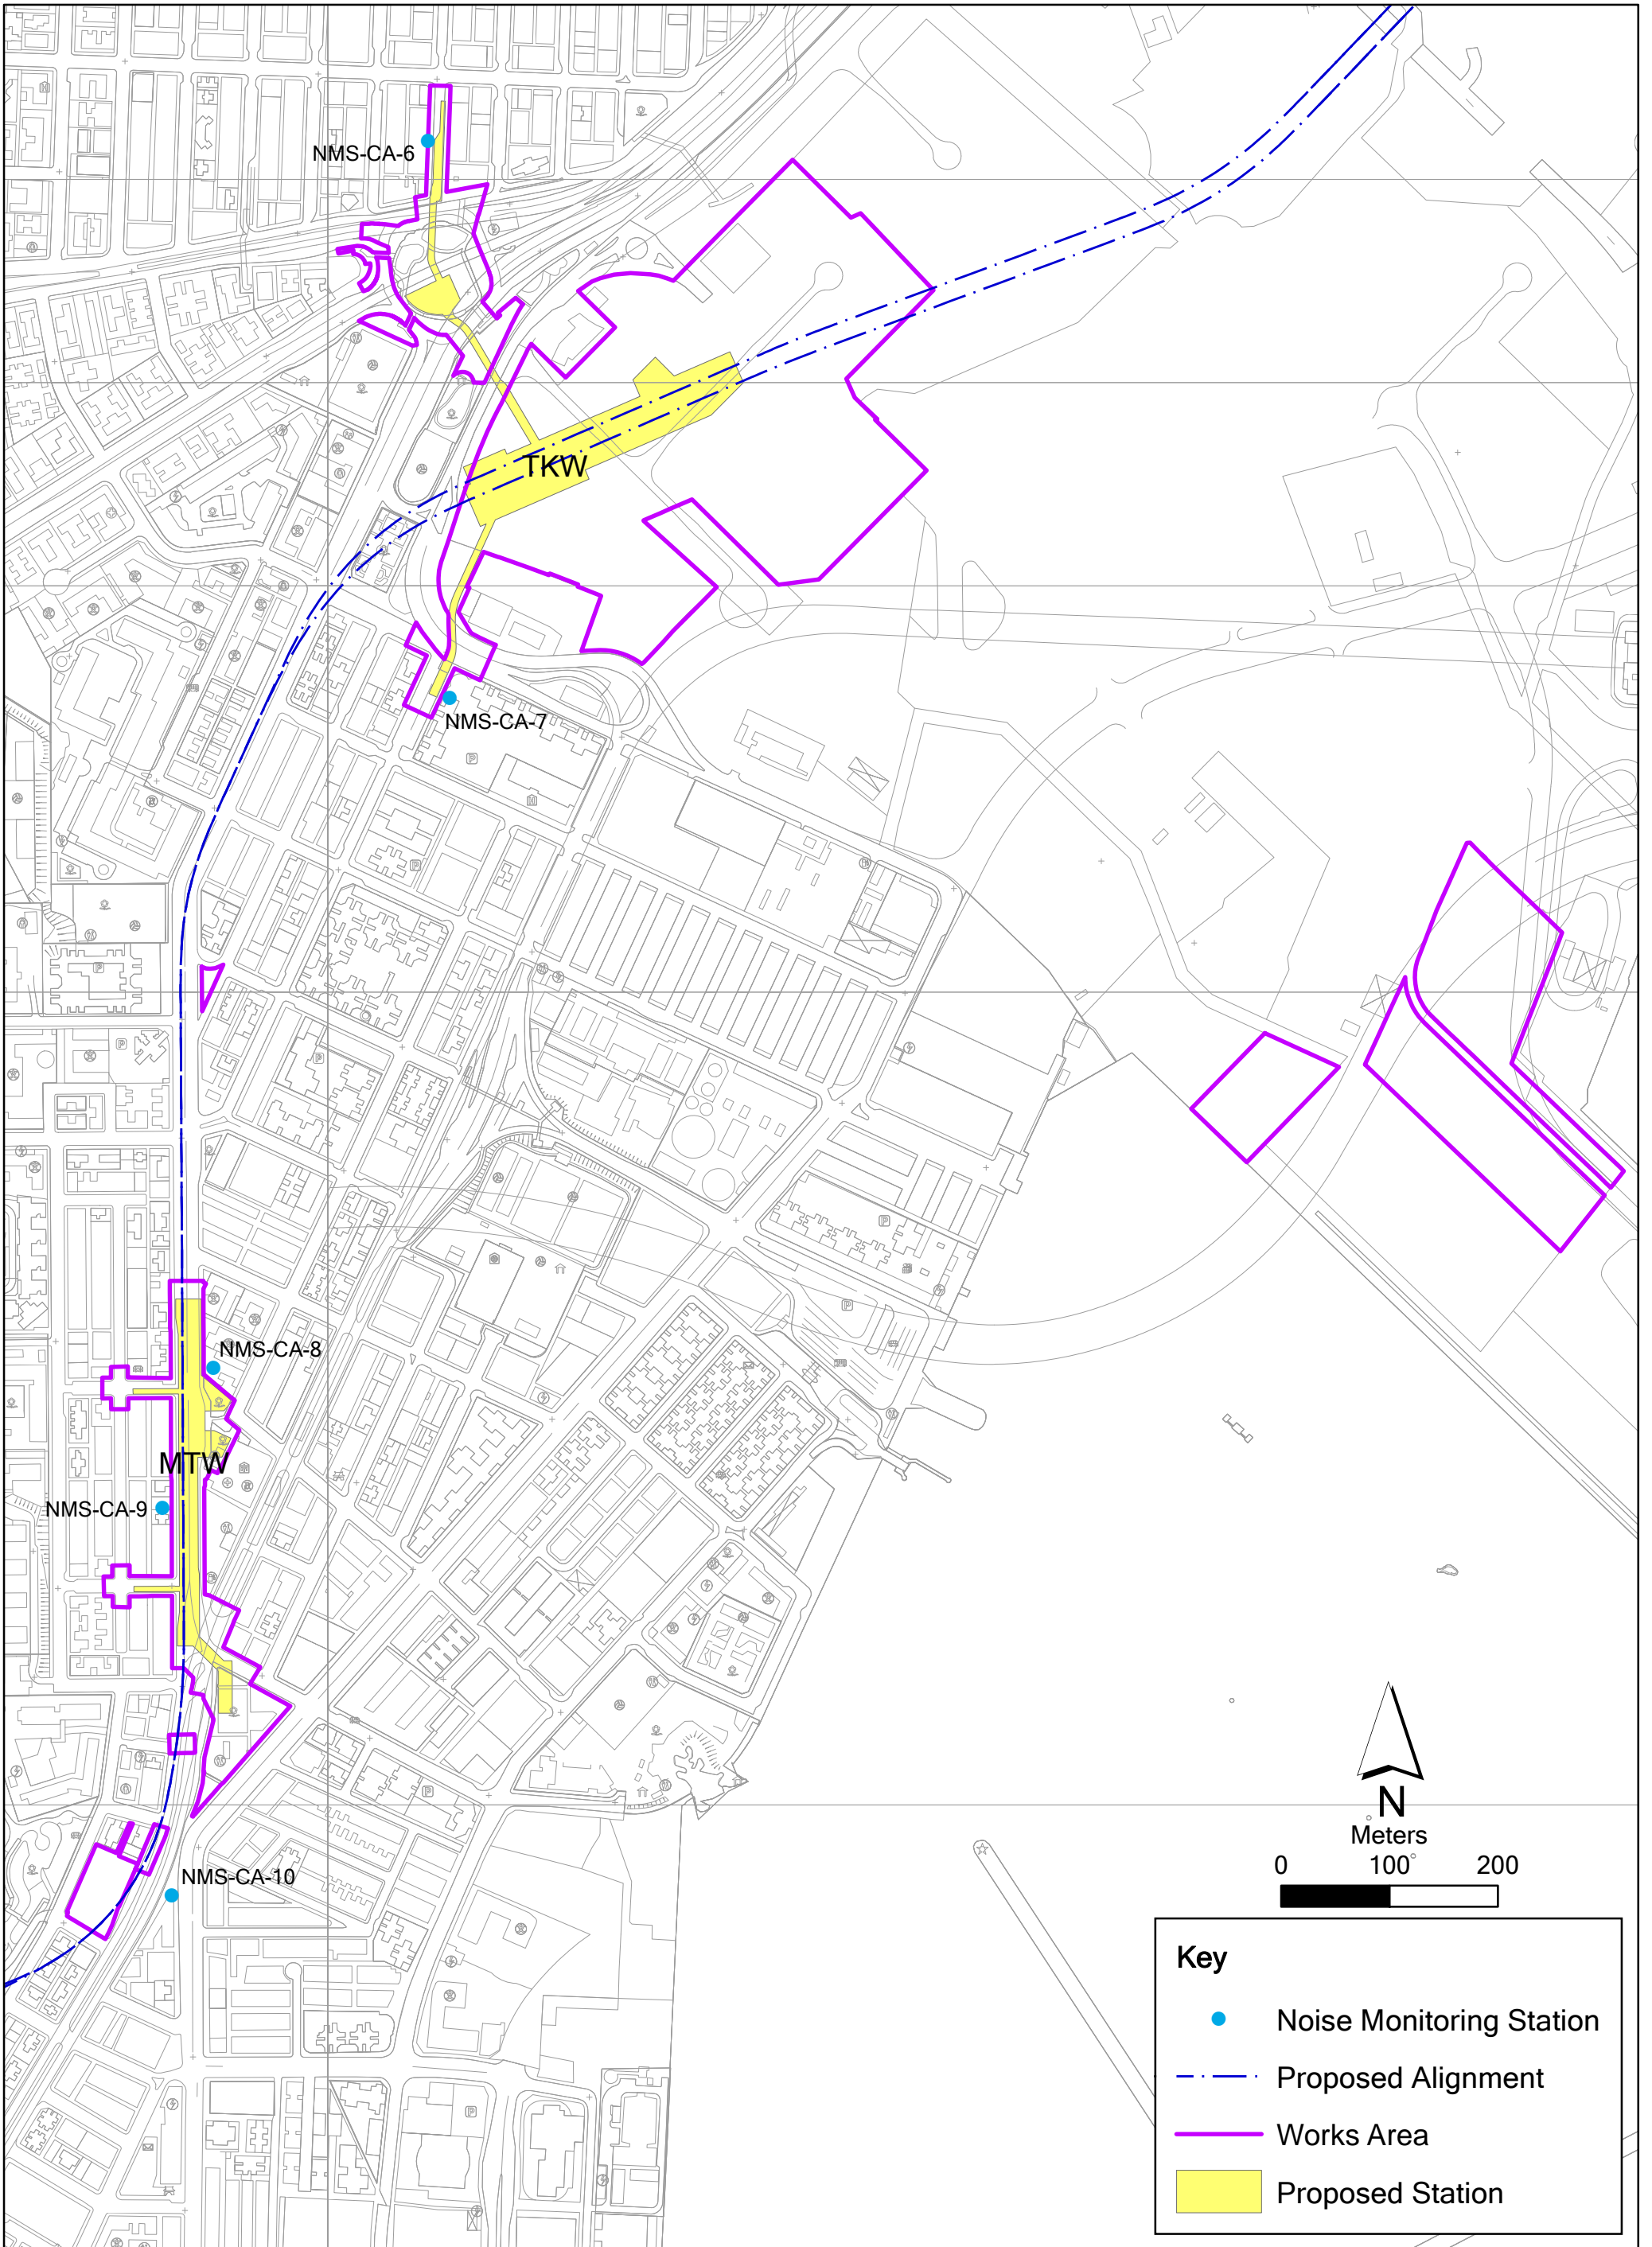
Annex D

Locations of Noise and Dust Monitoring Stations

The proposed dust monitoring stations for the construction phase of the Project, as recommended in the approved EM&A Manual, are listed in *Table 3.7* and shown in *Annex D*. The proposed locations have been agreed with the ER, EPD and IEC.

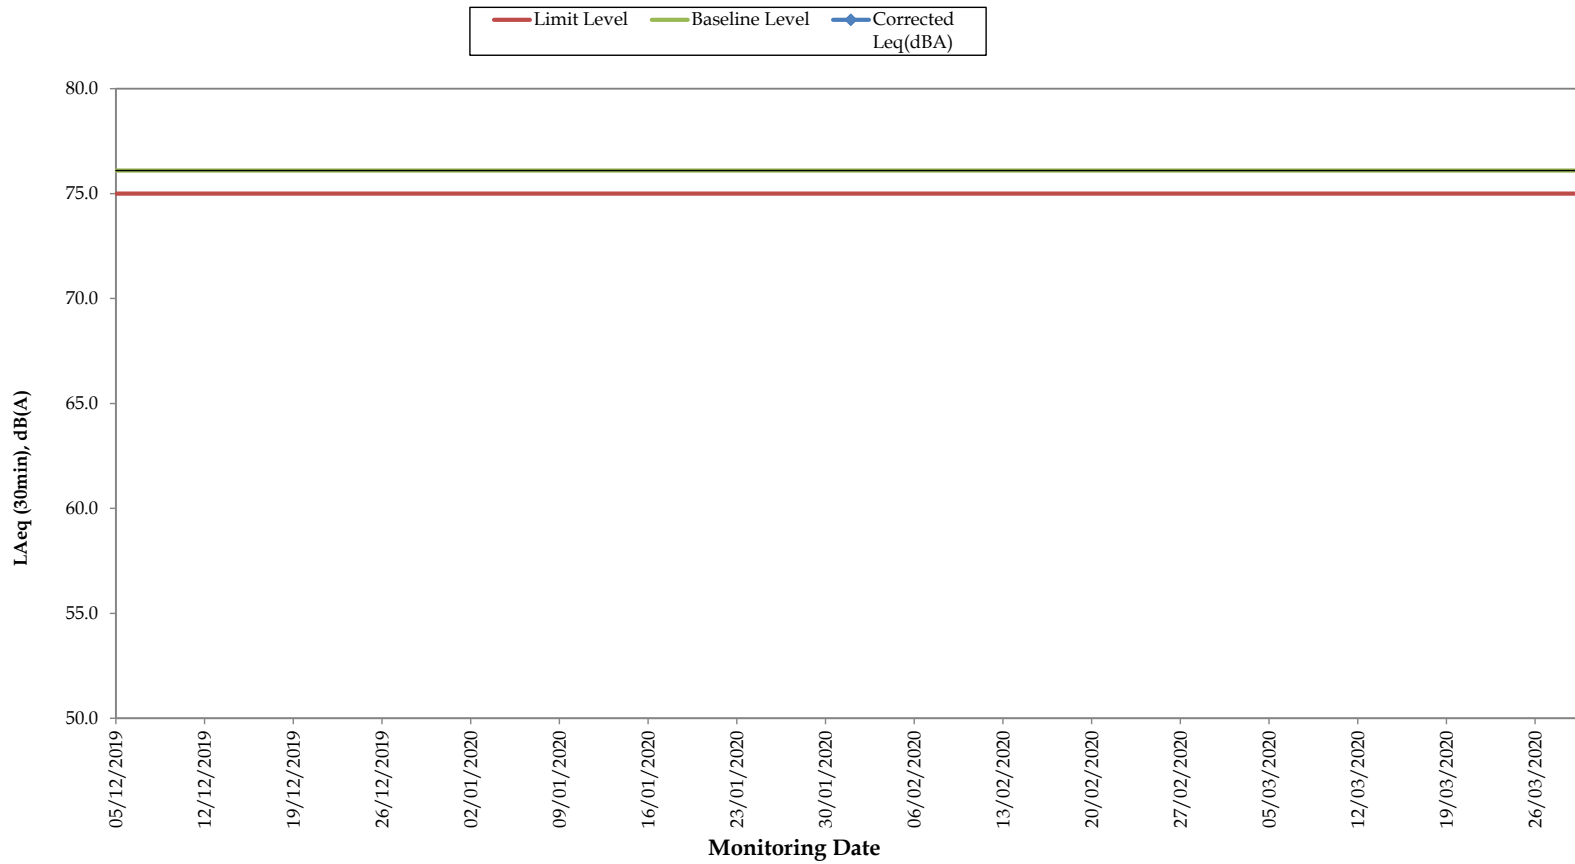
Regular Noise Monitoring Results at NMS-CA-6 (No. 16-23 Nam Kok Road) (LAeq, 30min) for the Past 4 Months

- For those corrected noise levels that are not shown in this graph, the measured noise levels are equal to or below baseline level.

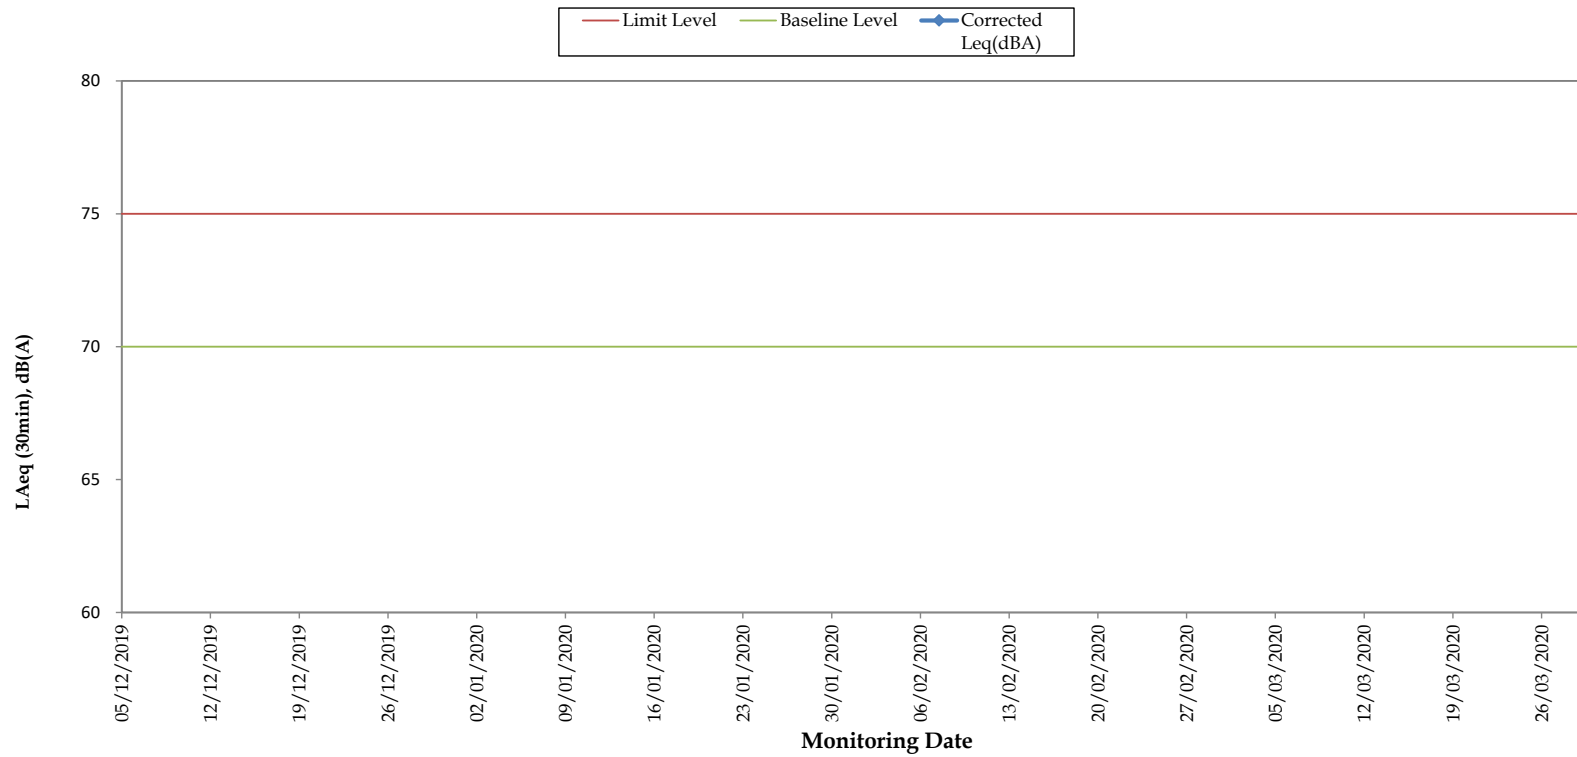
Regular Noise Monitoring Results at NMS-CA-7 (Skytower Tower 2) (LAeq, 30min) for the Past 4 Months

- For those corrected noise levels that are not shown in this graph, the measured noise levels are equal to or below baseline level.

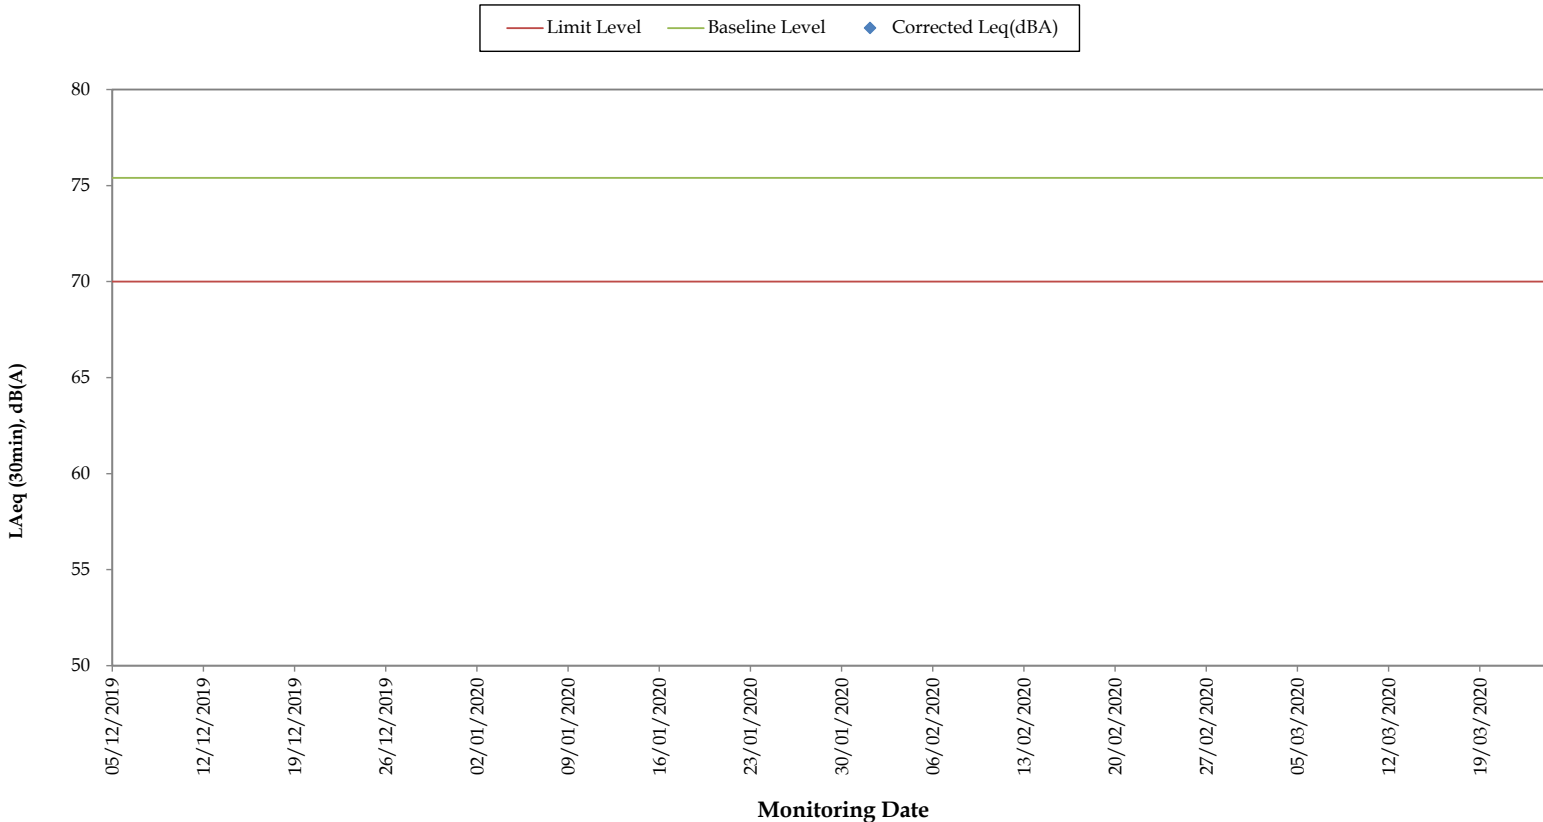
Regular Noise Monitoring Results at NMS-CA- 8 (SKH Good Shepherd Primary School) (LAeq, 30min) for the Past 4 Months

- For those corrected noise levels that are not shown in this graph, the measured noise levels are equal to or below baseline level.
- The limit level was updated from 78dB(A) to 79 dB(A) on 22 Aug 2013 as per the latest CNMP and CNMMP.
- The limit level was updated from 79dB(A) to 70dB(A)/65dB(A) (during normal/examination period) from April 2016, as the continuous noise monitoring was completed in March 2016 according to the latest CNMP

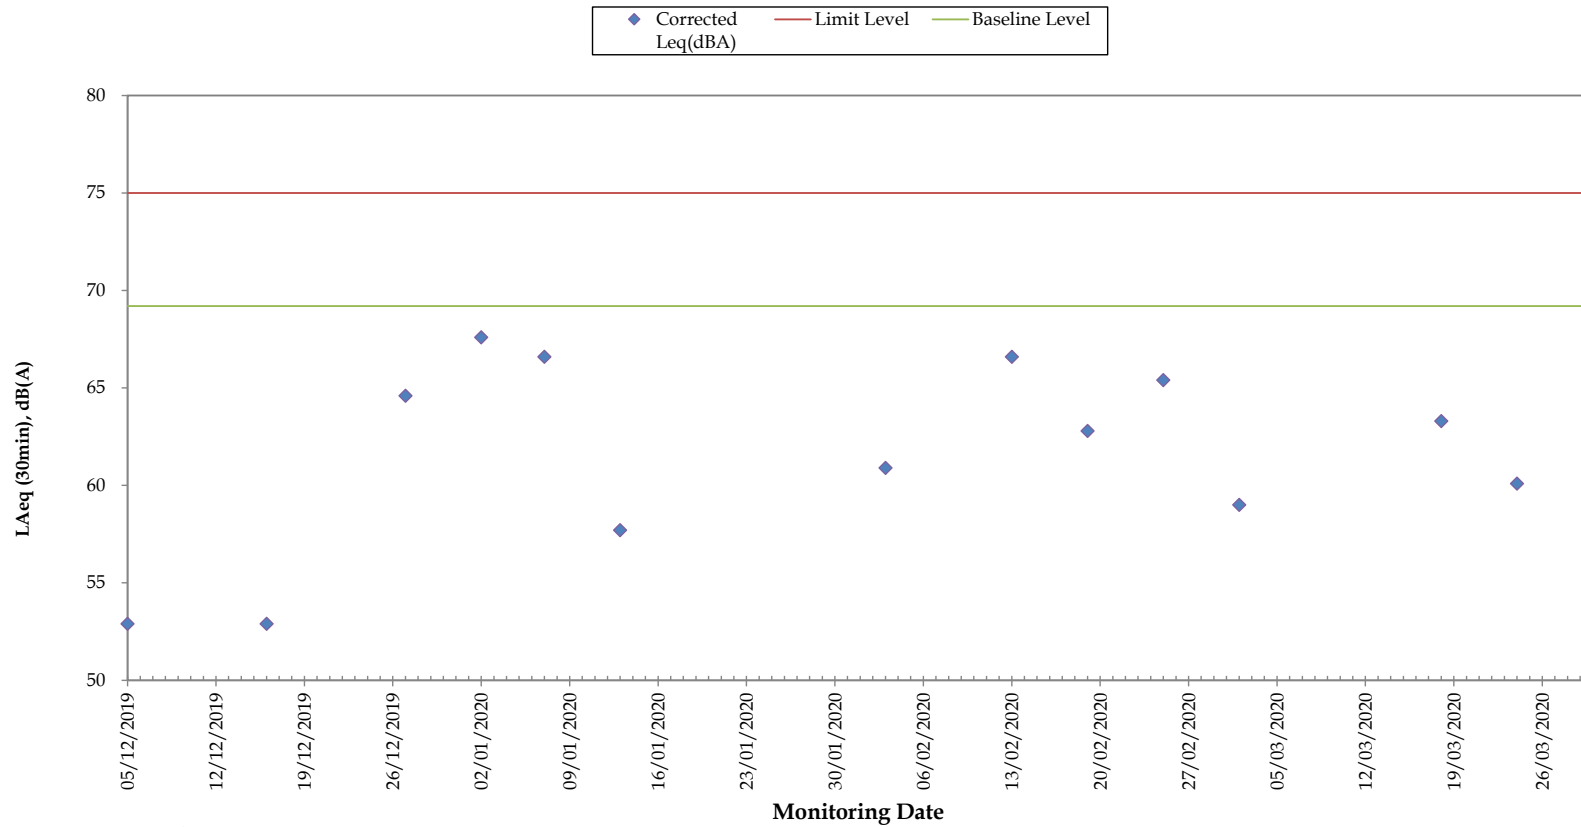
Regular Noise Monitoring Results at NMS-CA-9 (Kong Yiu Mansion) (LAeq, 30min)) for the Past 4 Months

- For those corrected noise levels that are not shown in this graph, the measured noise levels are equal to or below baseline level.

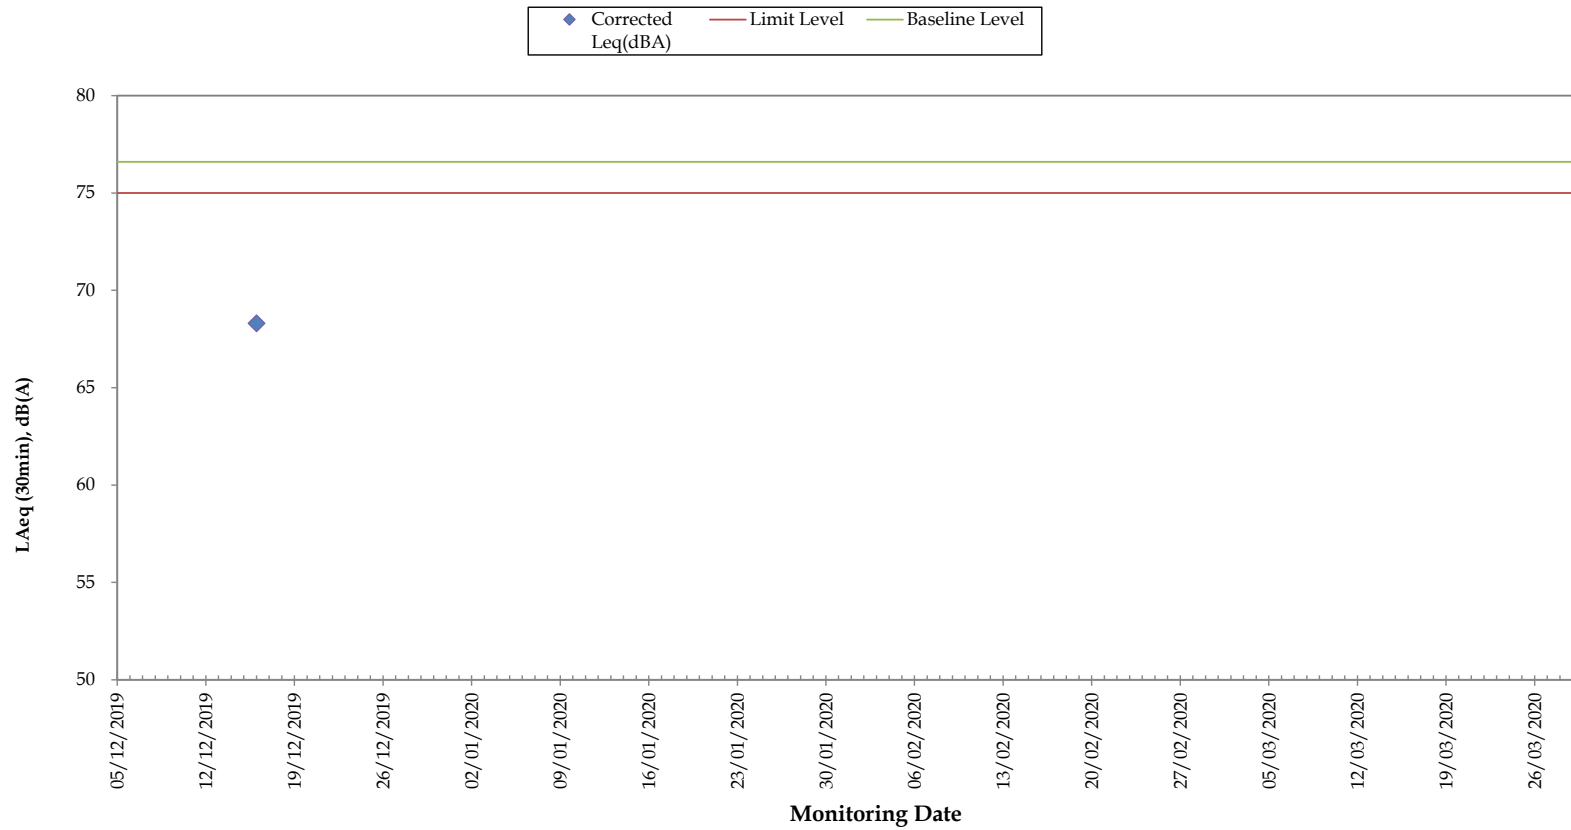
Regular Noise Monitoring Results at NMS-CA-10 (Chat Ma Mansion) (LAeq, 30min) for the Past 4 Months

- For those corrected noise levels that are not shown in this graph, the measured noise levels are equal to or below baseline level.

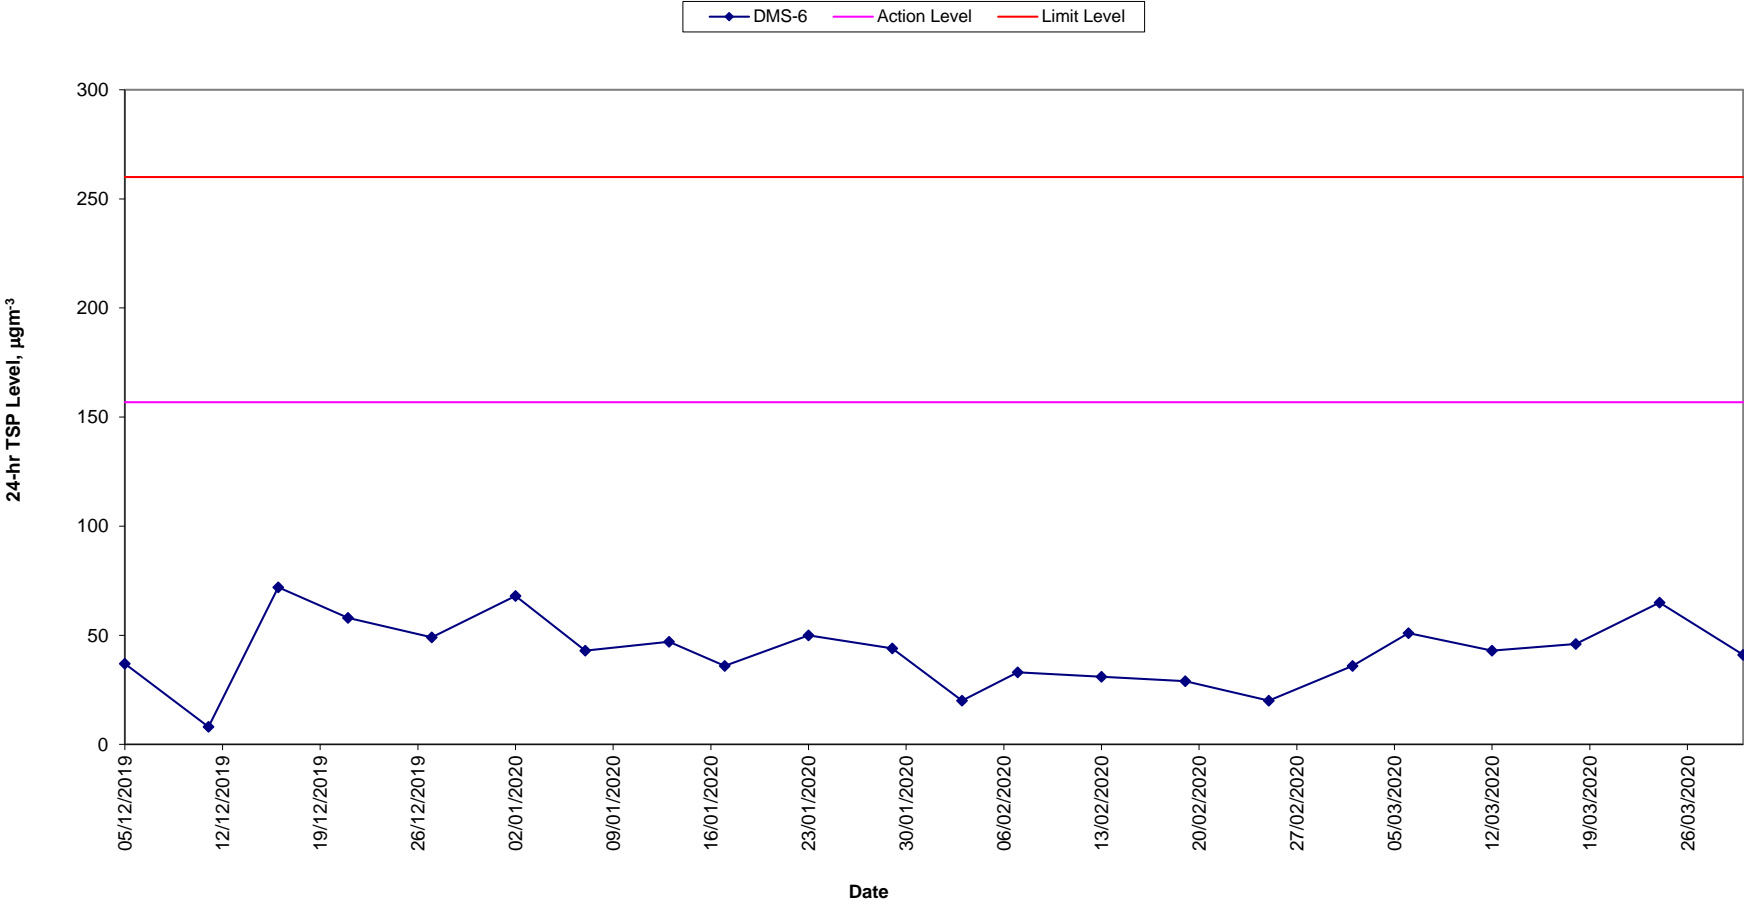
Construction Dust Monitoring Results for the Past 4 Months
DMS-6 (Katherine Building)

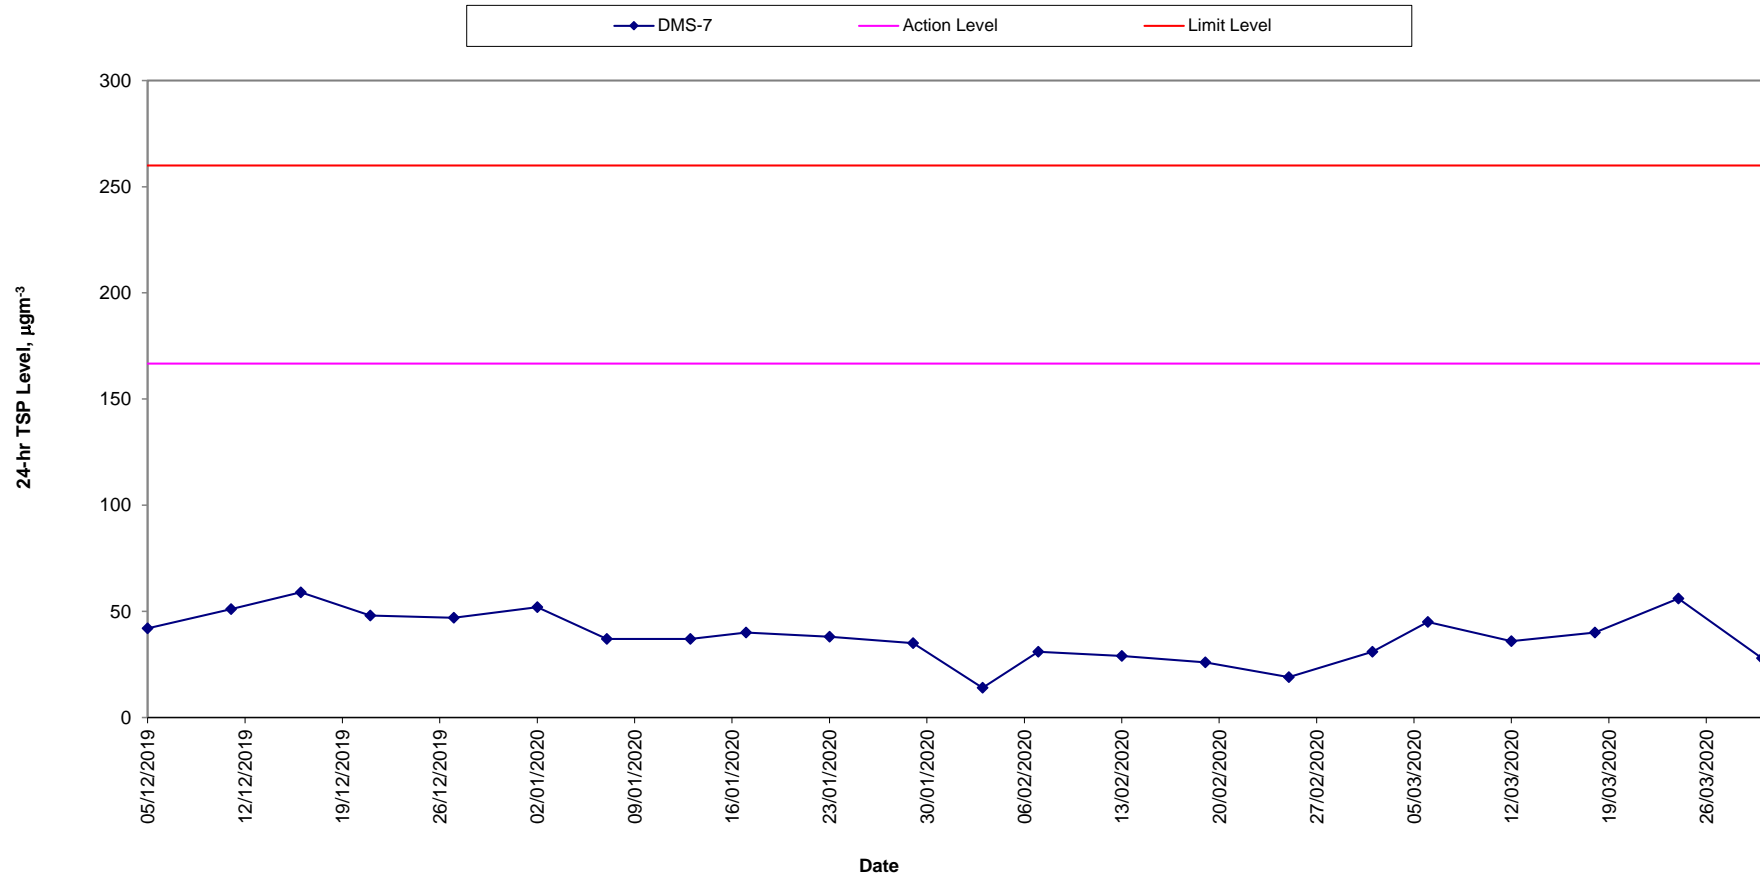
Construction Dust Monitoring Results for the Past 4 Months
DMS- 7 (Parc 22)

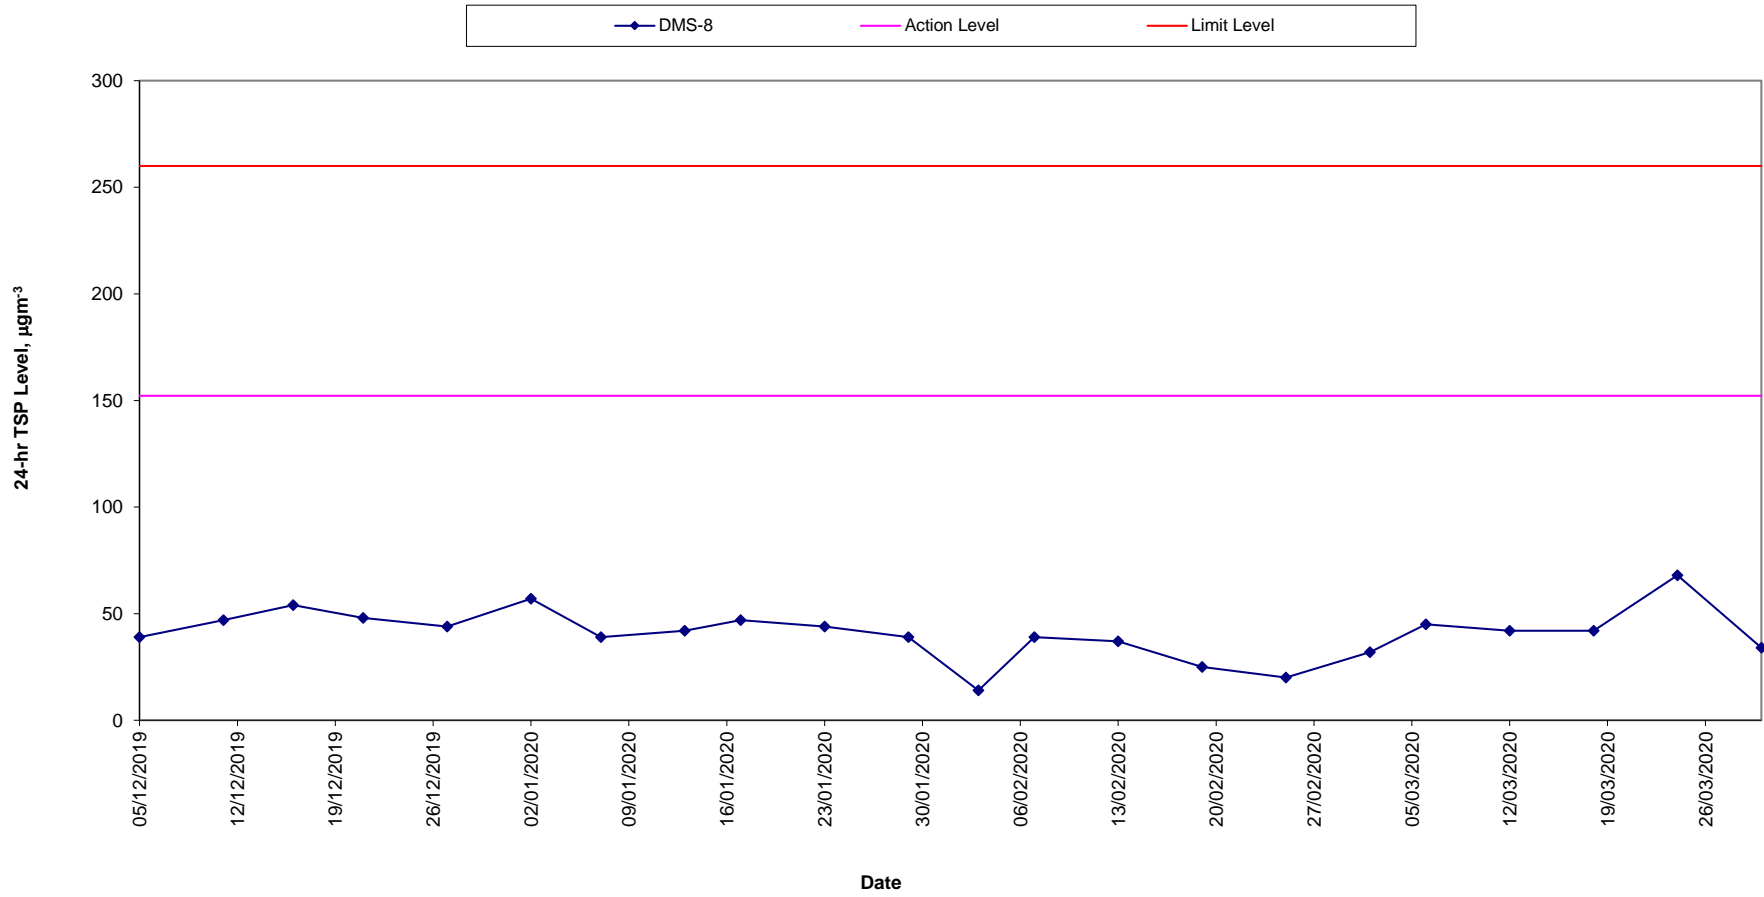
Construction Dust Monitoring Results for the Past 4 Months DMS-8 (SKH Good Shepherd Primary School)

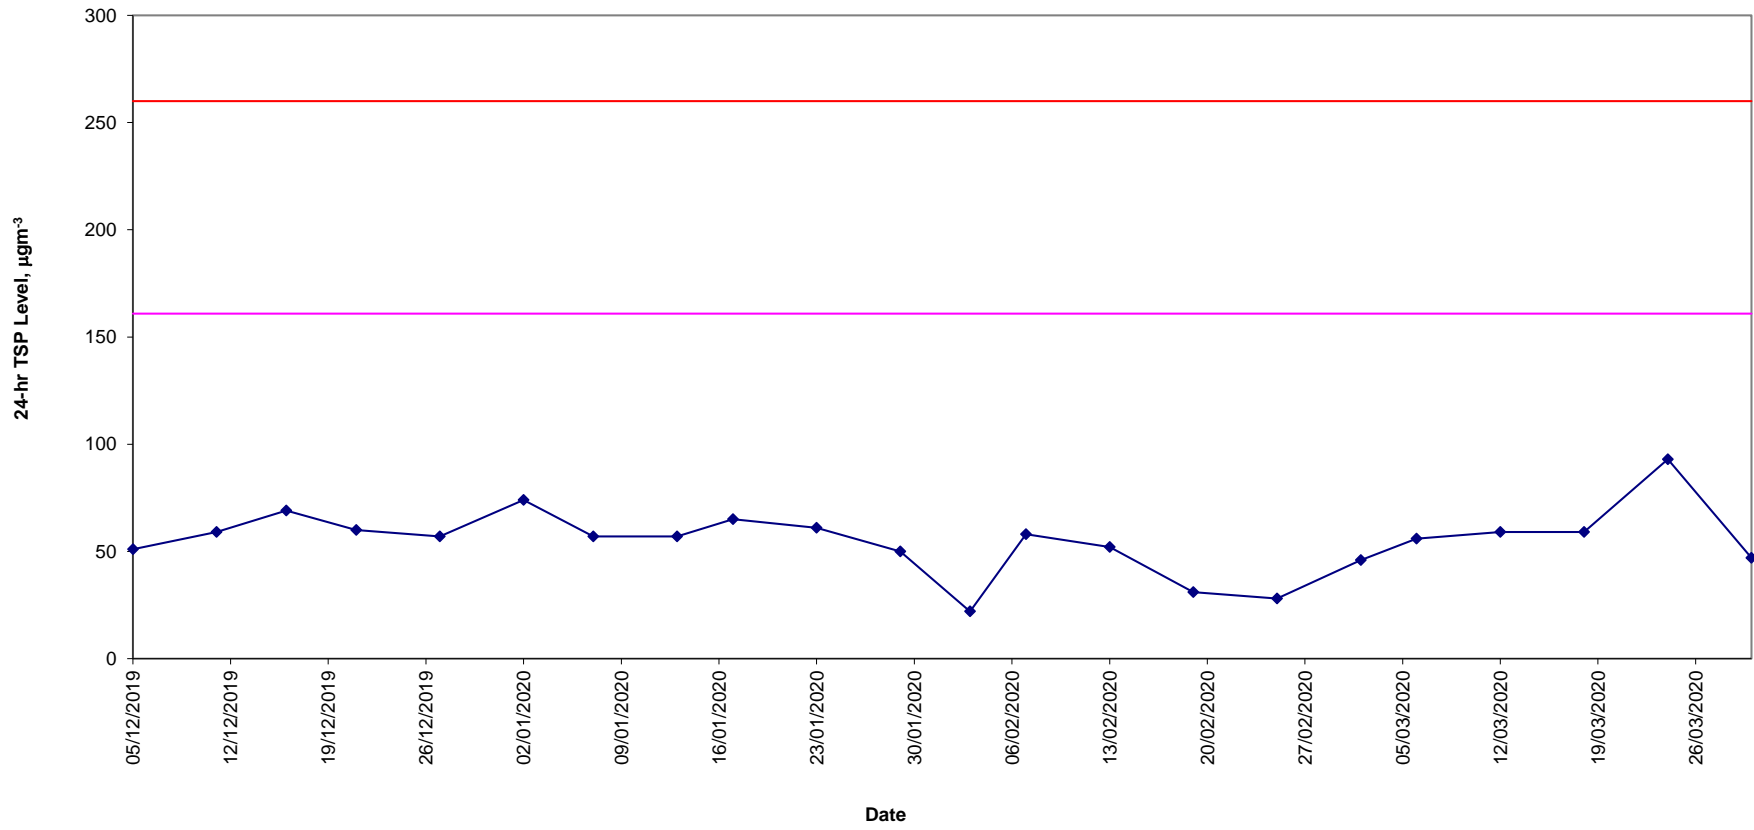
Construction Dust Monitoring Results for the Past 4 Months DMS-9 (No.12 Pau Chung Street)

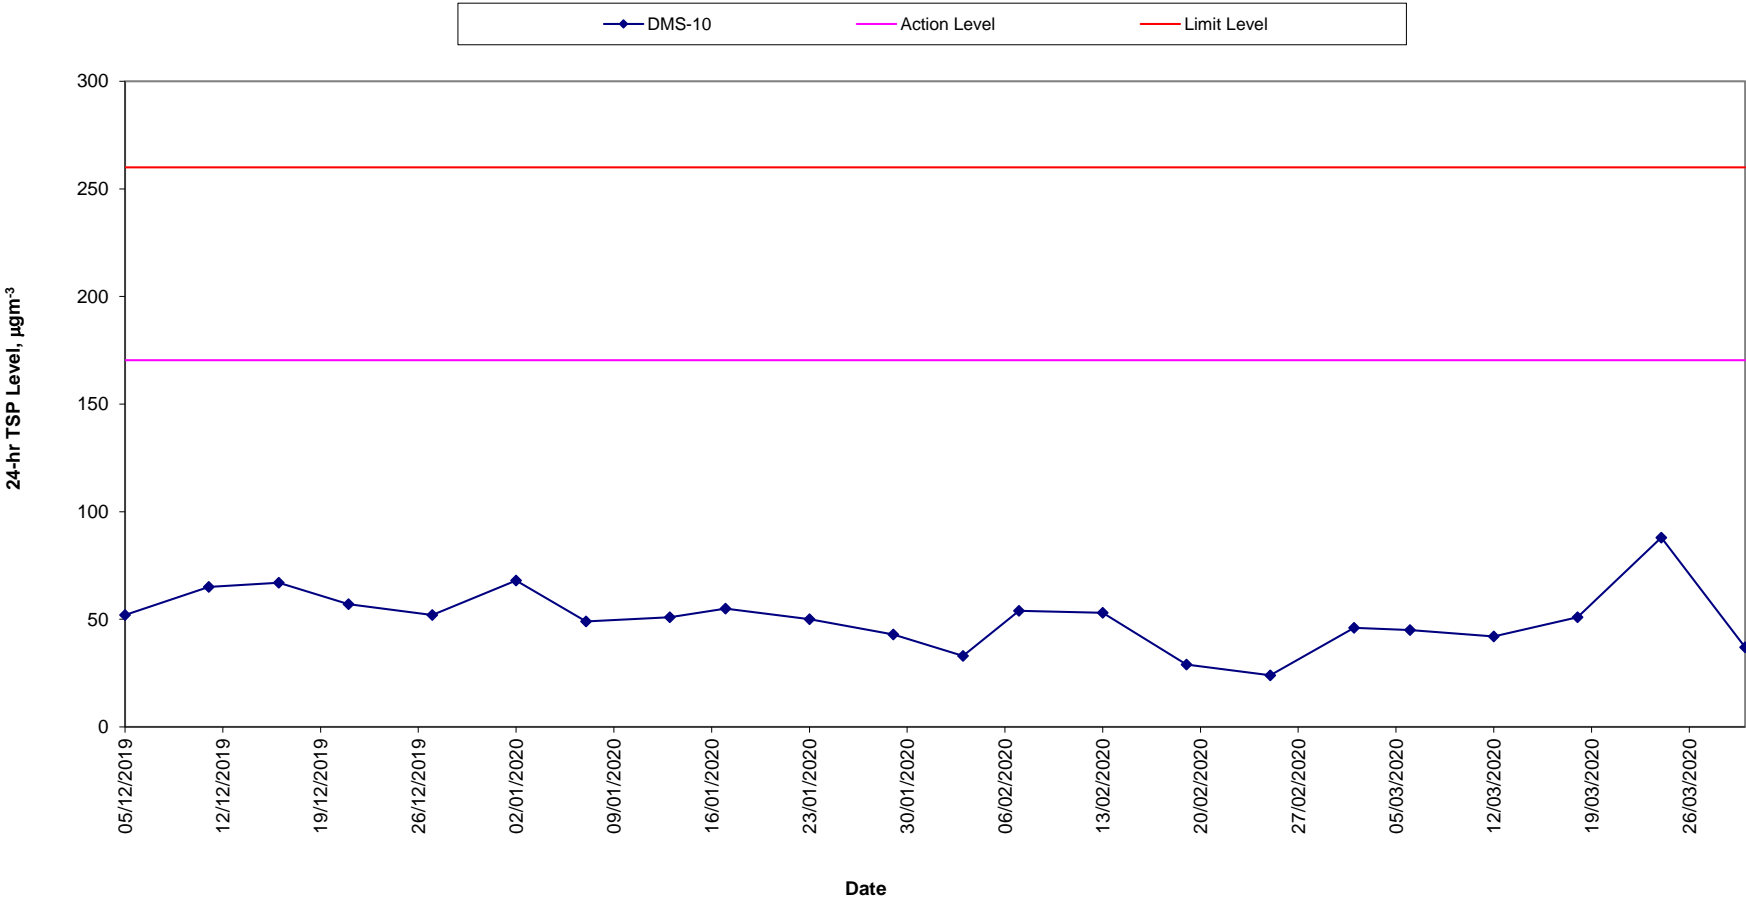
Construction Dust Monitoring Results for the Past 4 Months
DMS-10 (Chat Ma Mansion)
