Shatin to Central Link – Tai Wai to Hung Hom Section

Monthly EM&A Report No. 93

[Period from 1 to 31 May 2020]

Consultancy Agreement No. C11033

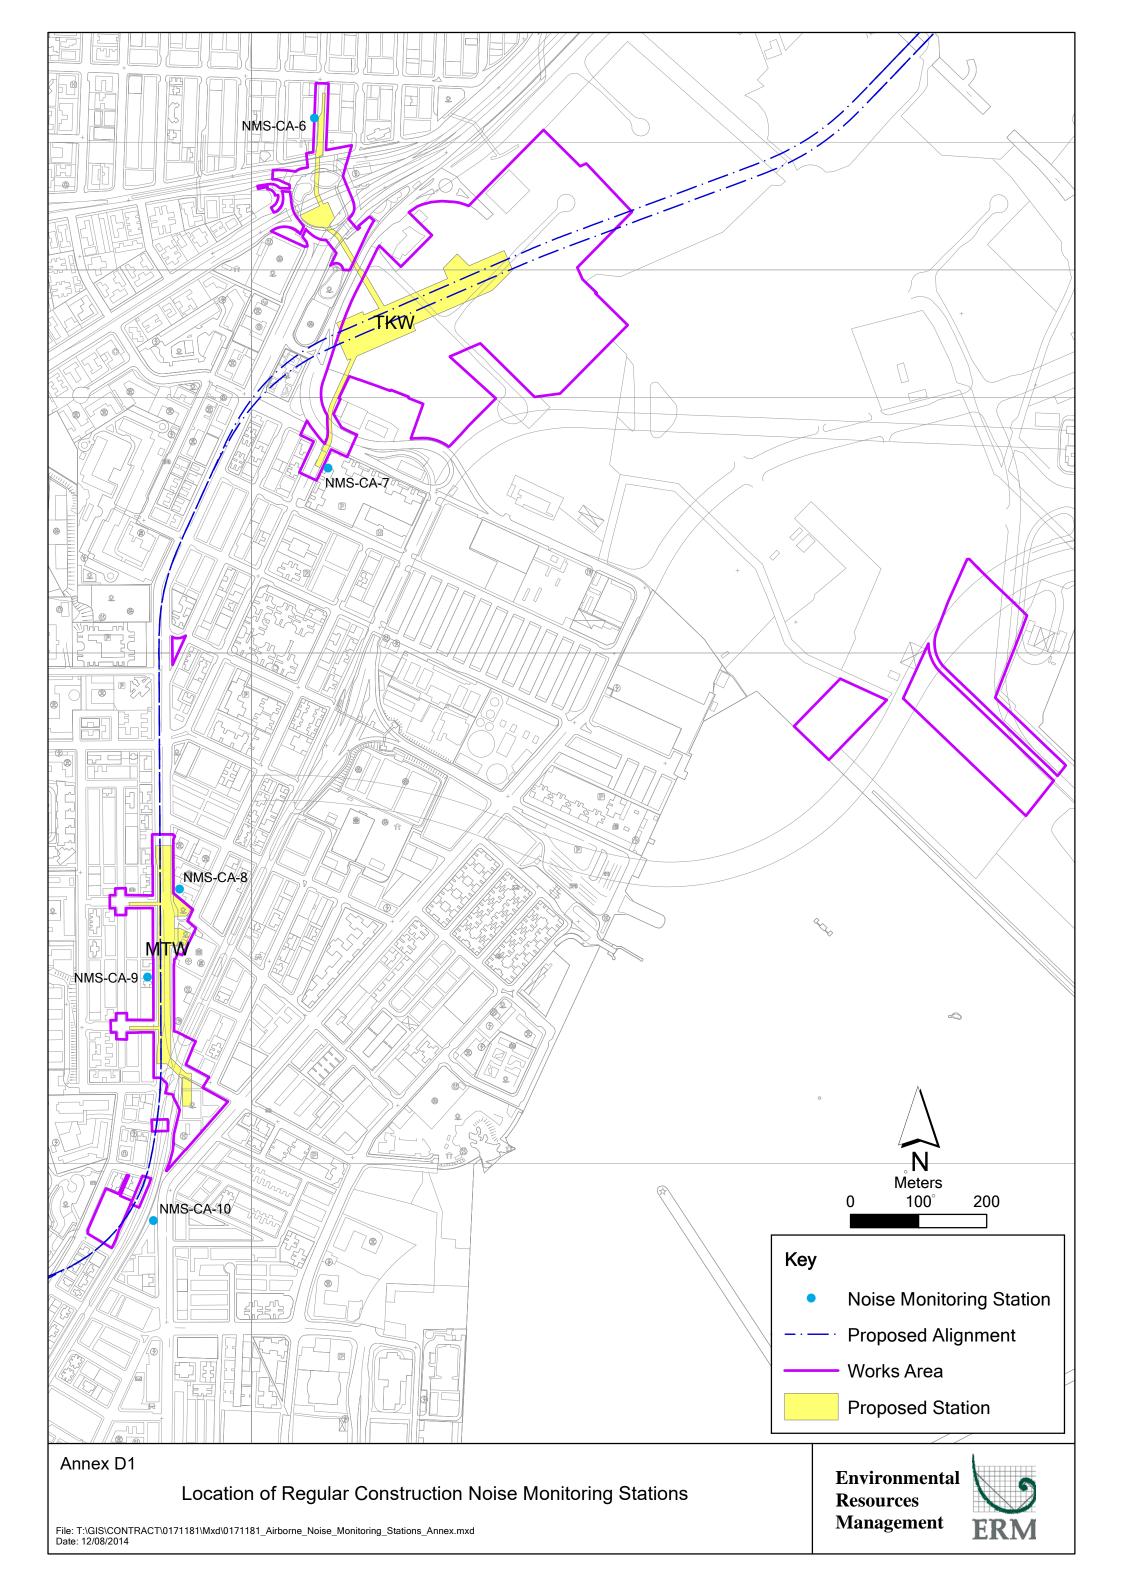
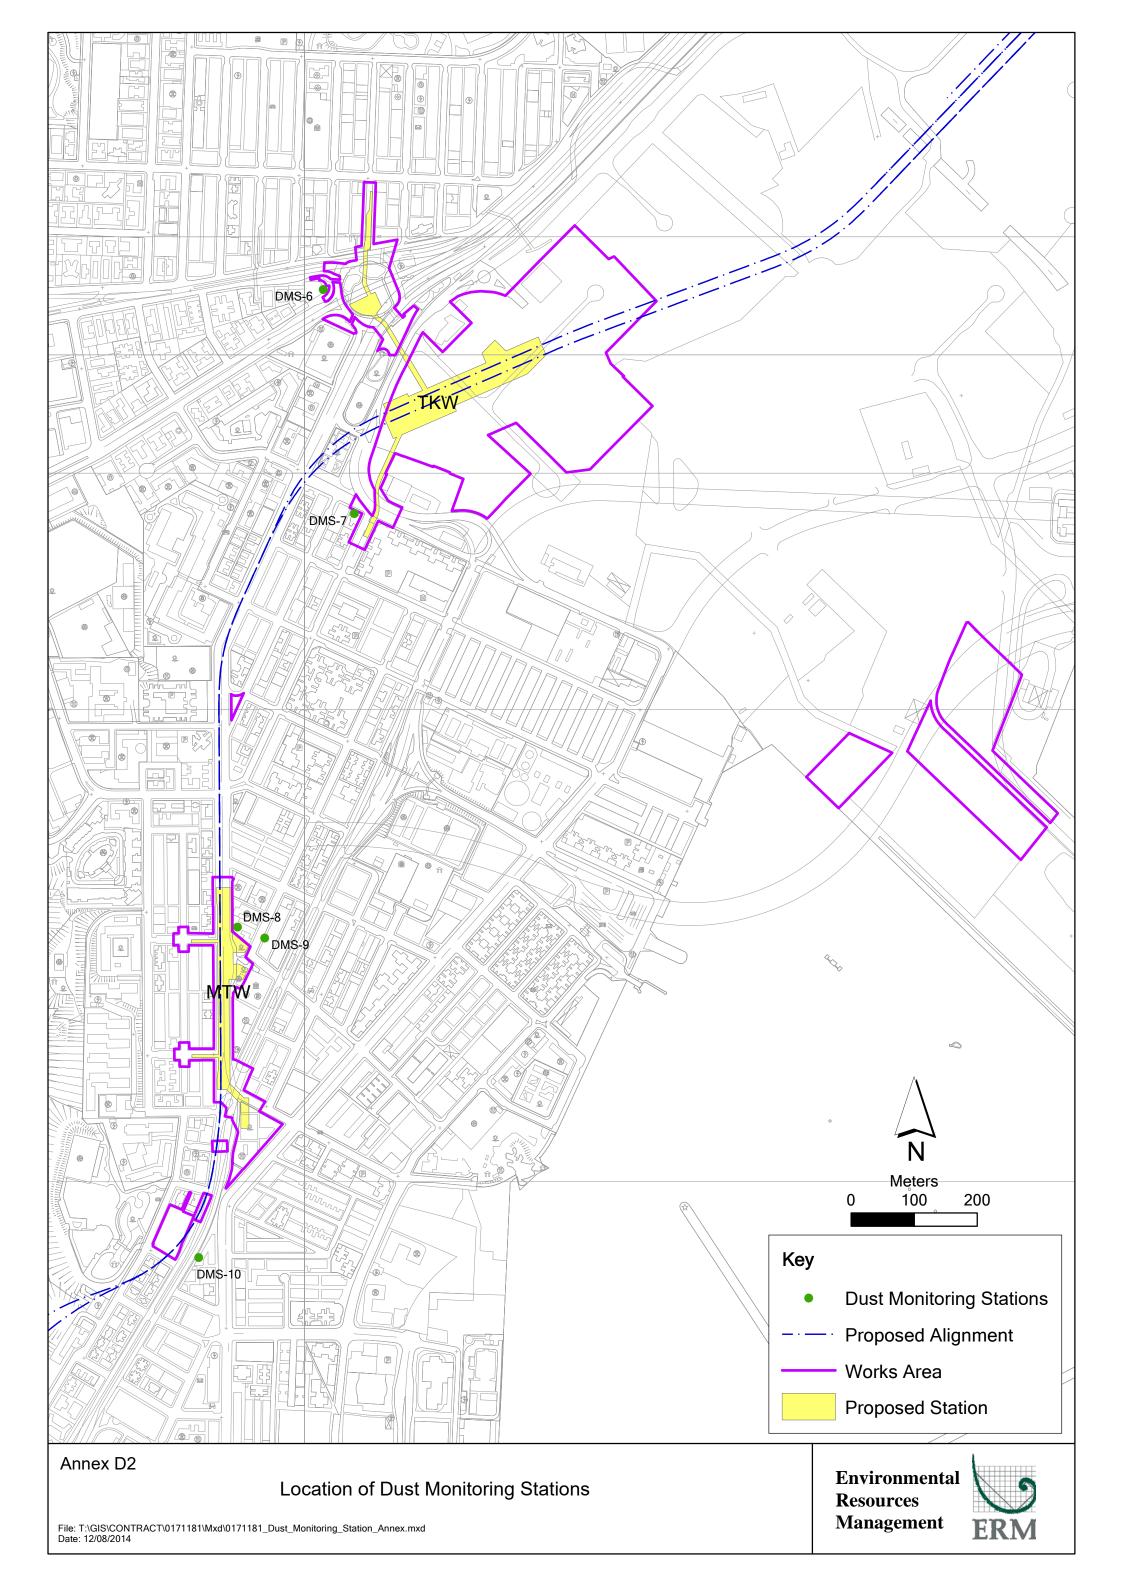
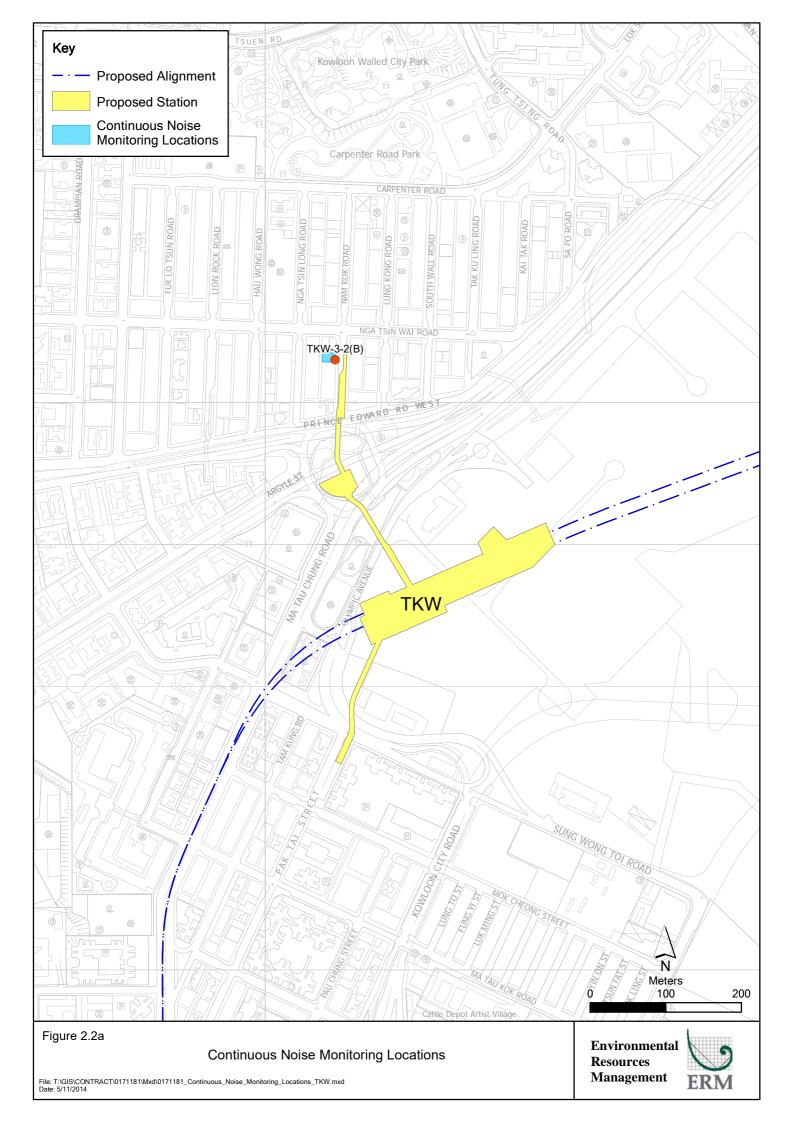
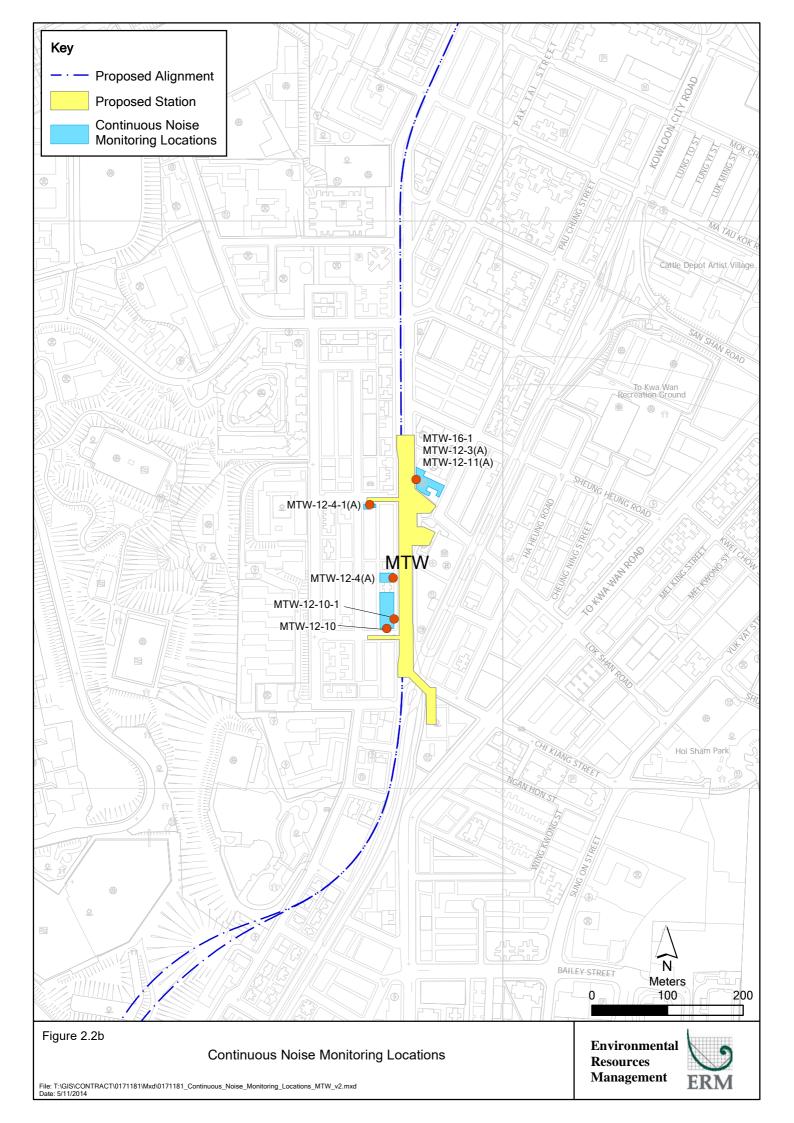
Locations of Noise and Dust Monitoring Stations

The proposed dust monitoring stations for the construction phase of the Project, as recommended in the approved EM&A Manual, are listed in *Table* 3.7 and shown in *Annex D*. The proposed locations have been agreed with the ER, EPD and IEC.

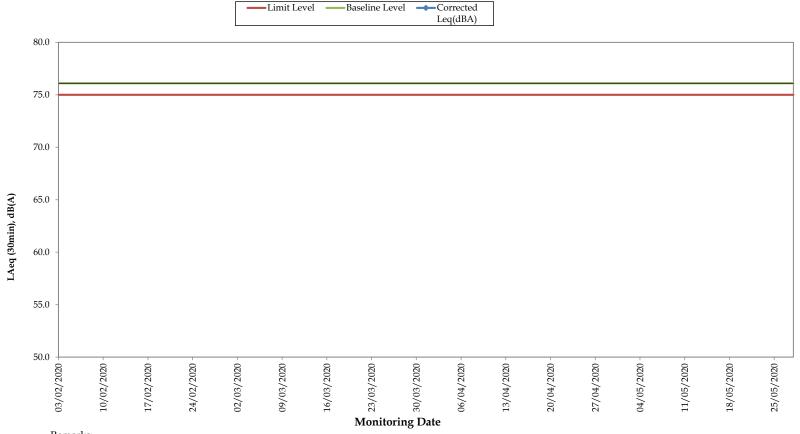
Regular Noise Monitoring Results at NMS-CA-6 (No. 16-23 Nam Kok Road) (LAeq, 30min) for the Past 4 Months

- For those corrected noise levels that are not shown in this graph, the measured noise level s are equal to or below baseline level.

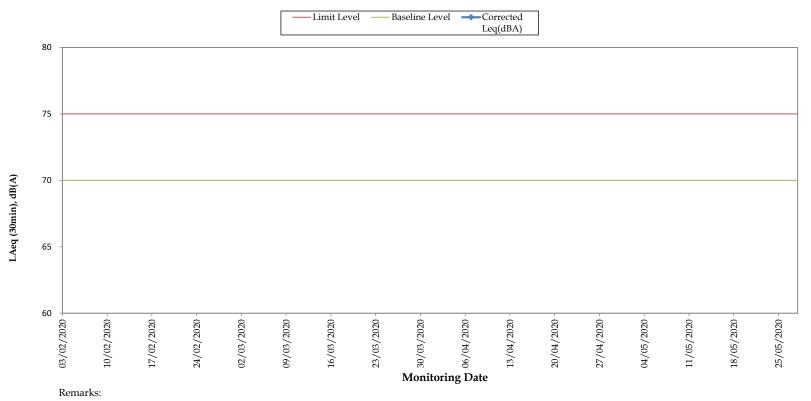
Regular Noise Monitoring Results at NMS-CA-7 (Skytower Tower 2) (LAeq, 30min) for the Past 4 Months

- For those corrected noise levels that are not shown in this graph, the measured noise level s are equal to or below baseline level.

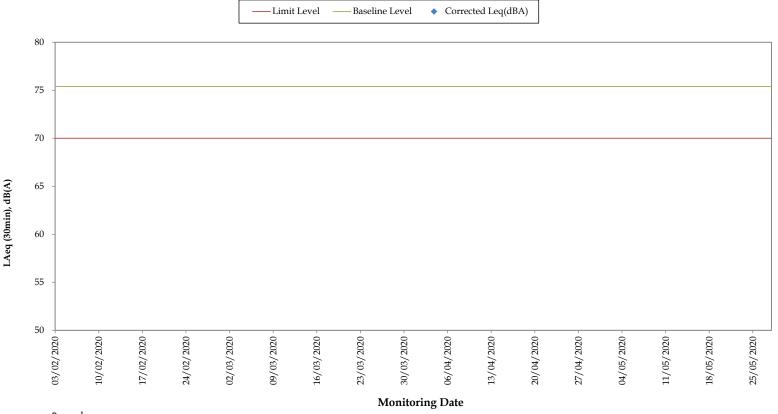
Regular Noise Monitoring Results at NMS-CA- 8 (SKH Good Shepherd Primary School) (LAeq, 30min) for the Past 4 Months

- For those corrected noise levels that are not shown in this graph, the measured noise level s are equal to or below baseline level.
- The limit level was updated from 78dB(A) to 79 dB(A) on 22 Aug 2013 as per the latest CNMP and CNMMP.
- The limit level was updated from 79dB(A) to 70dB(A)/65dB(A) (during normal/examination period) from April 2016, as the continuous noise monitoring was completed in March 2016 according to the latest CNMP

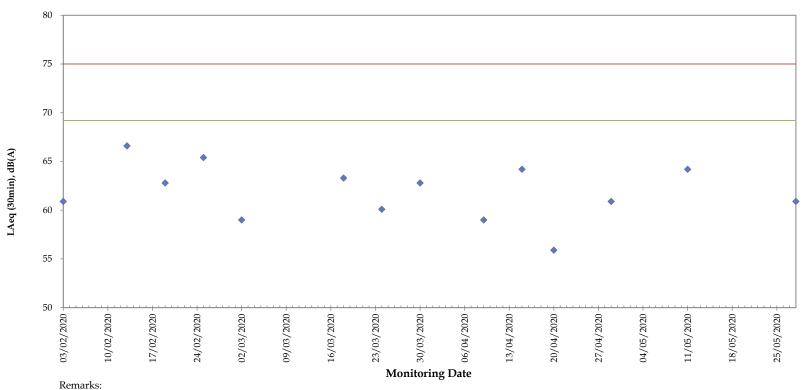
Regular Noise Monitoring Results at NMS-CA-9 (Kong Yiu Mansion) (LAeq, 30min)) for the Past 4 Months

- For those corrected noise levels that are not shown in this graph, the measured noise level s are equal to or below baseline level.

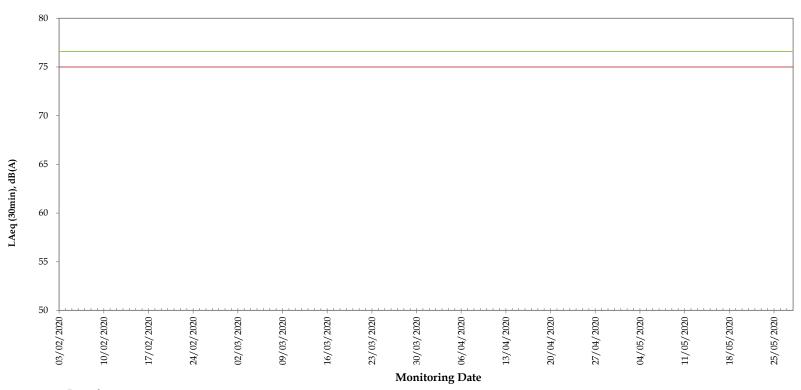
Regular Noise Monitoring Results at NMS-CA-10 (Chat Ma Mansion) (LAeq, 30min) for the Past 4 Months

- For those corrected noise levels that are not shown in this graph, the measured noise level s are equal to or below baseline level.
