**Shatin to Central Link - Tai Wai to Hung
Hom Section [SCL(TAW – HUH)] and
Stabling Sidings at Hung Hom Freight Yard
[SCL(HHS)]**

Monthly Operational Airborne Rail Noise
Monitoring Report (Wing Fung Building) No.2

[Period from 27 July to 26 August 2021]

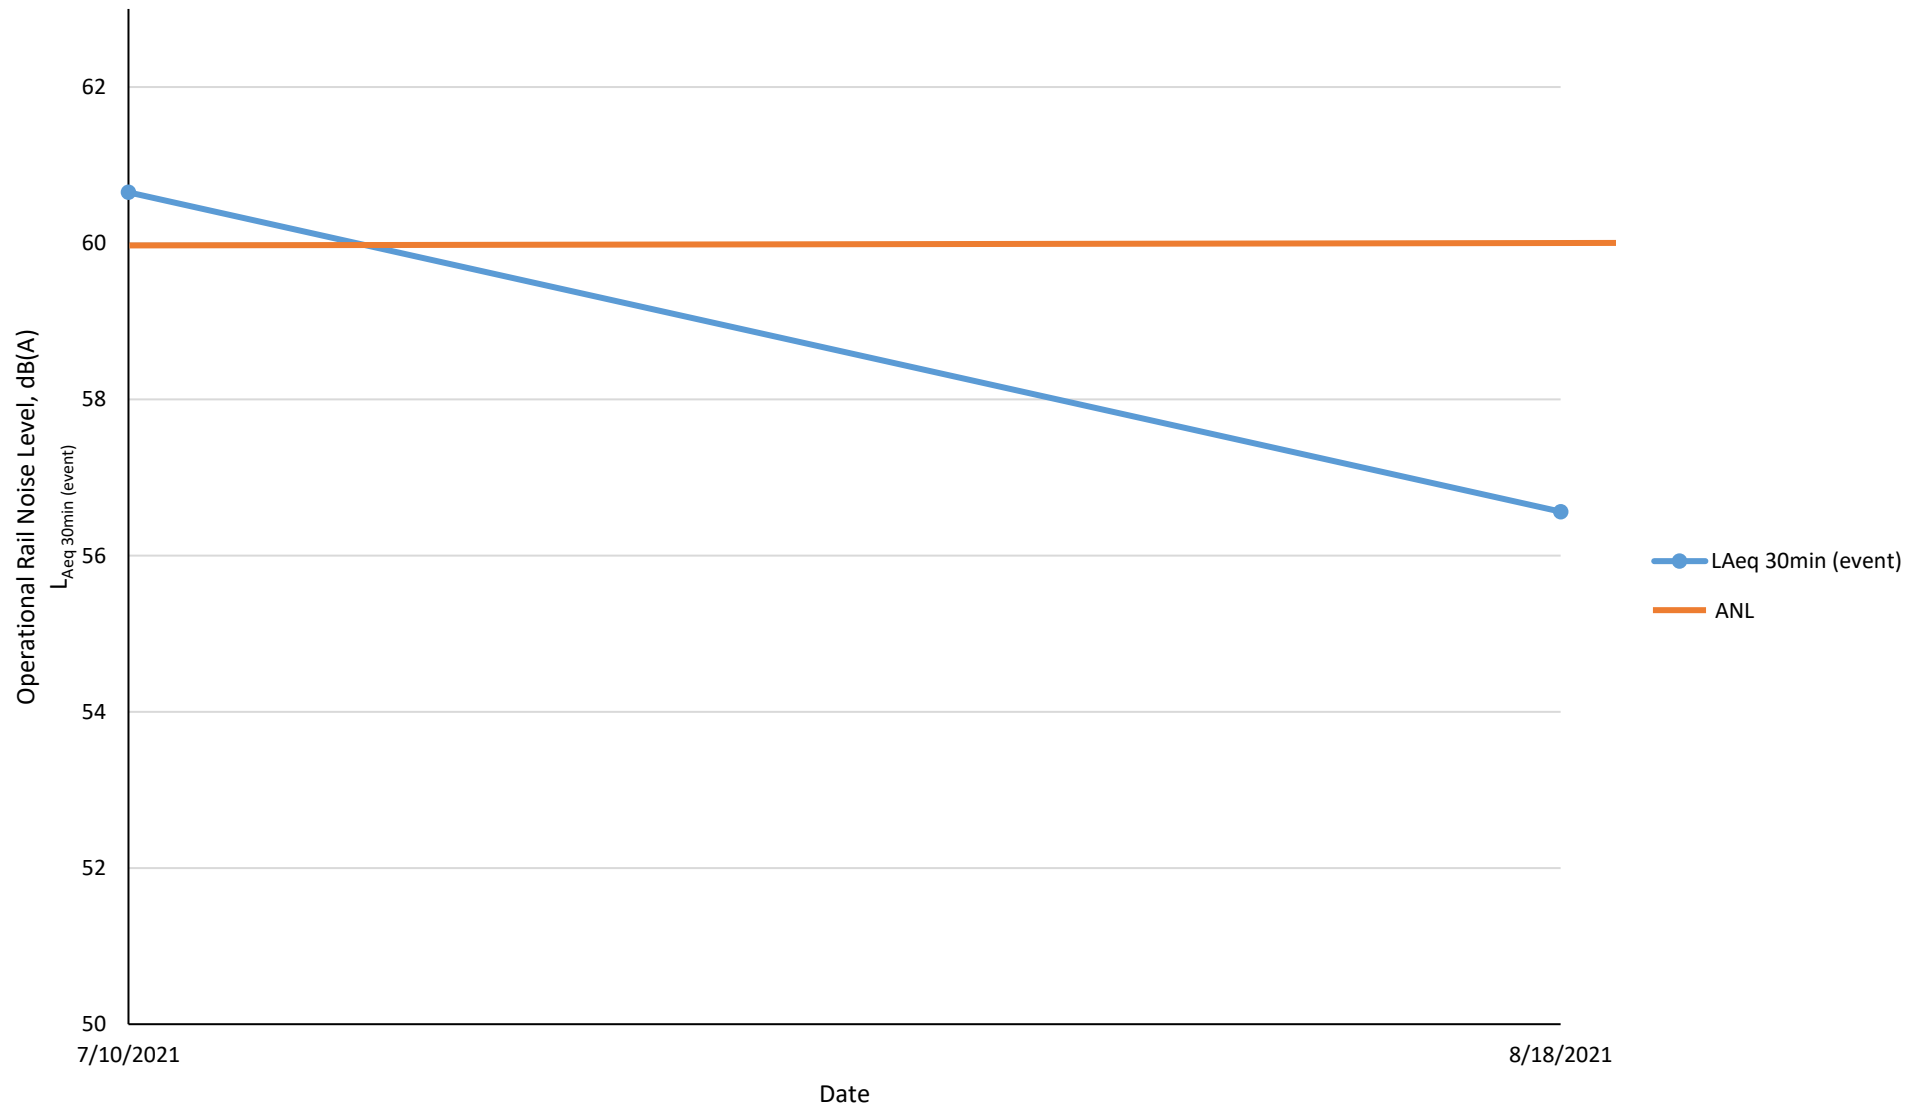
Operation Rail Noise Monitoring at Wing Fung Building

- 2.6.2 According to site observation, train noise from TML was inaudible at the measurement location. The dominant noise sources included road traffic noise from Chatham Road North and EAL.
- 2.6.3 With the satisfaction of either one of conditions set out in **Section 2.5.3**, the monitoring result indicated the compliance of operation rail noise level with NCO noise criteria.

Date	Time	L _{Aeq} 30min (overall)	L _{Aeq} 30min (Background)	Difference	L _{Aeq} 30min (event)	ANL	Compliance (Yes/No)
7/10/2021	06:30 - 07:00	67.6	66.6	1.0	60.7	60	Yes
8/18/2021	06:30 - 07:00	68.2	67.9	0.3	56.6	60	Yes
