MONTHLY EM&A REPORT

March 2019

Contract Name : Road Widening and Retrofitting Noise Barriers
on Tai Po Road (Sha Tin Section)

Report No. : 0064/18/ED/0280A

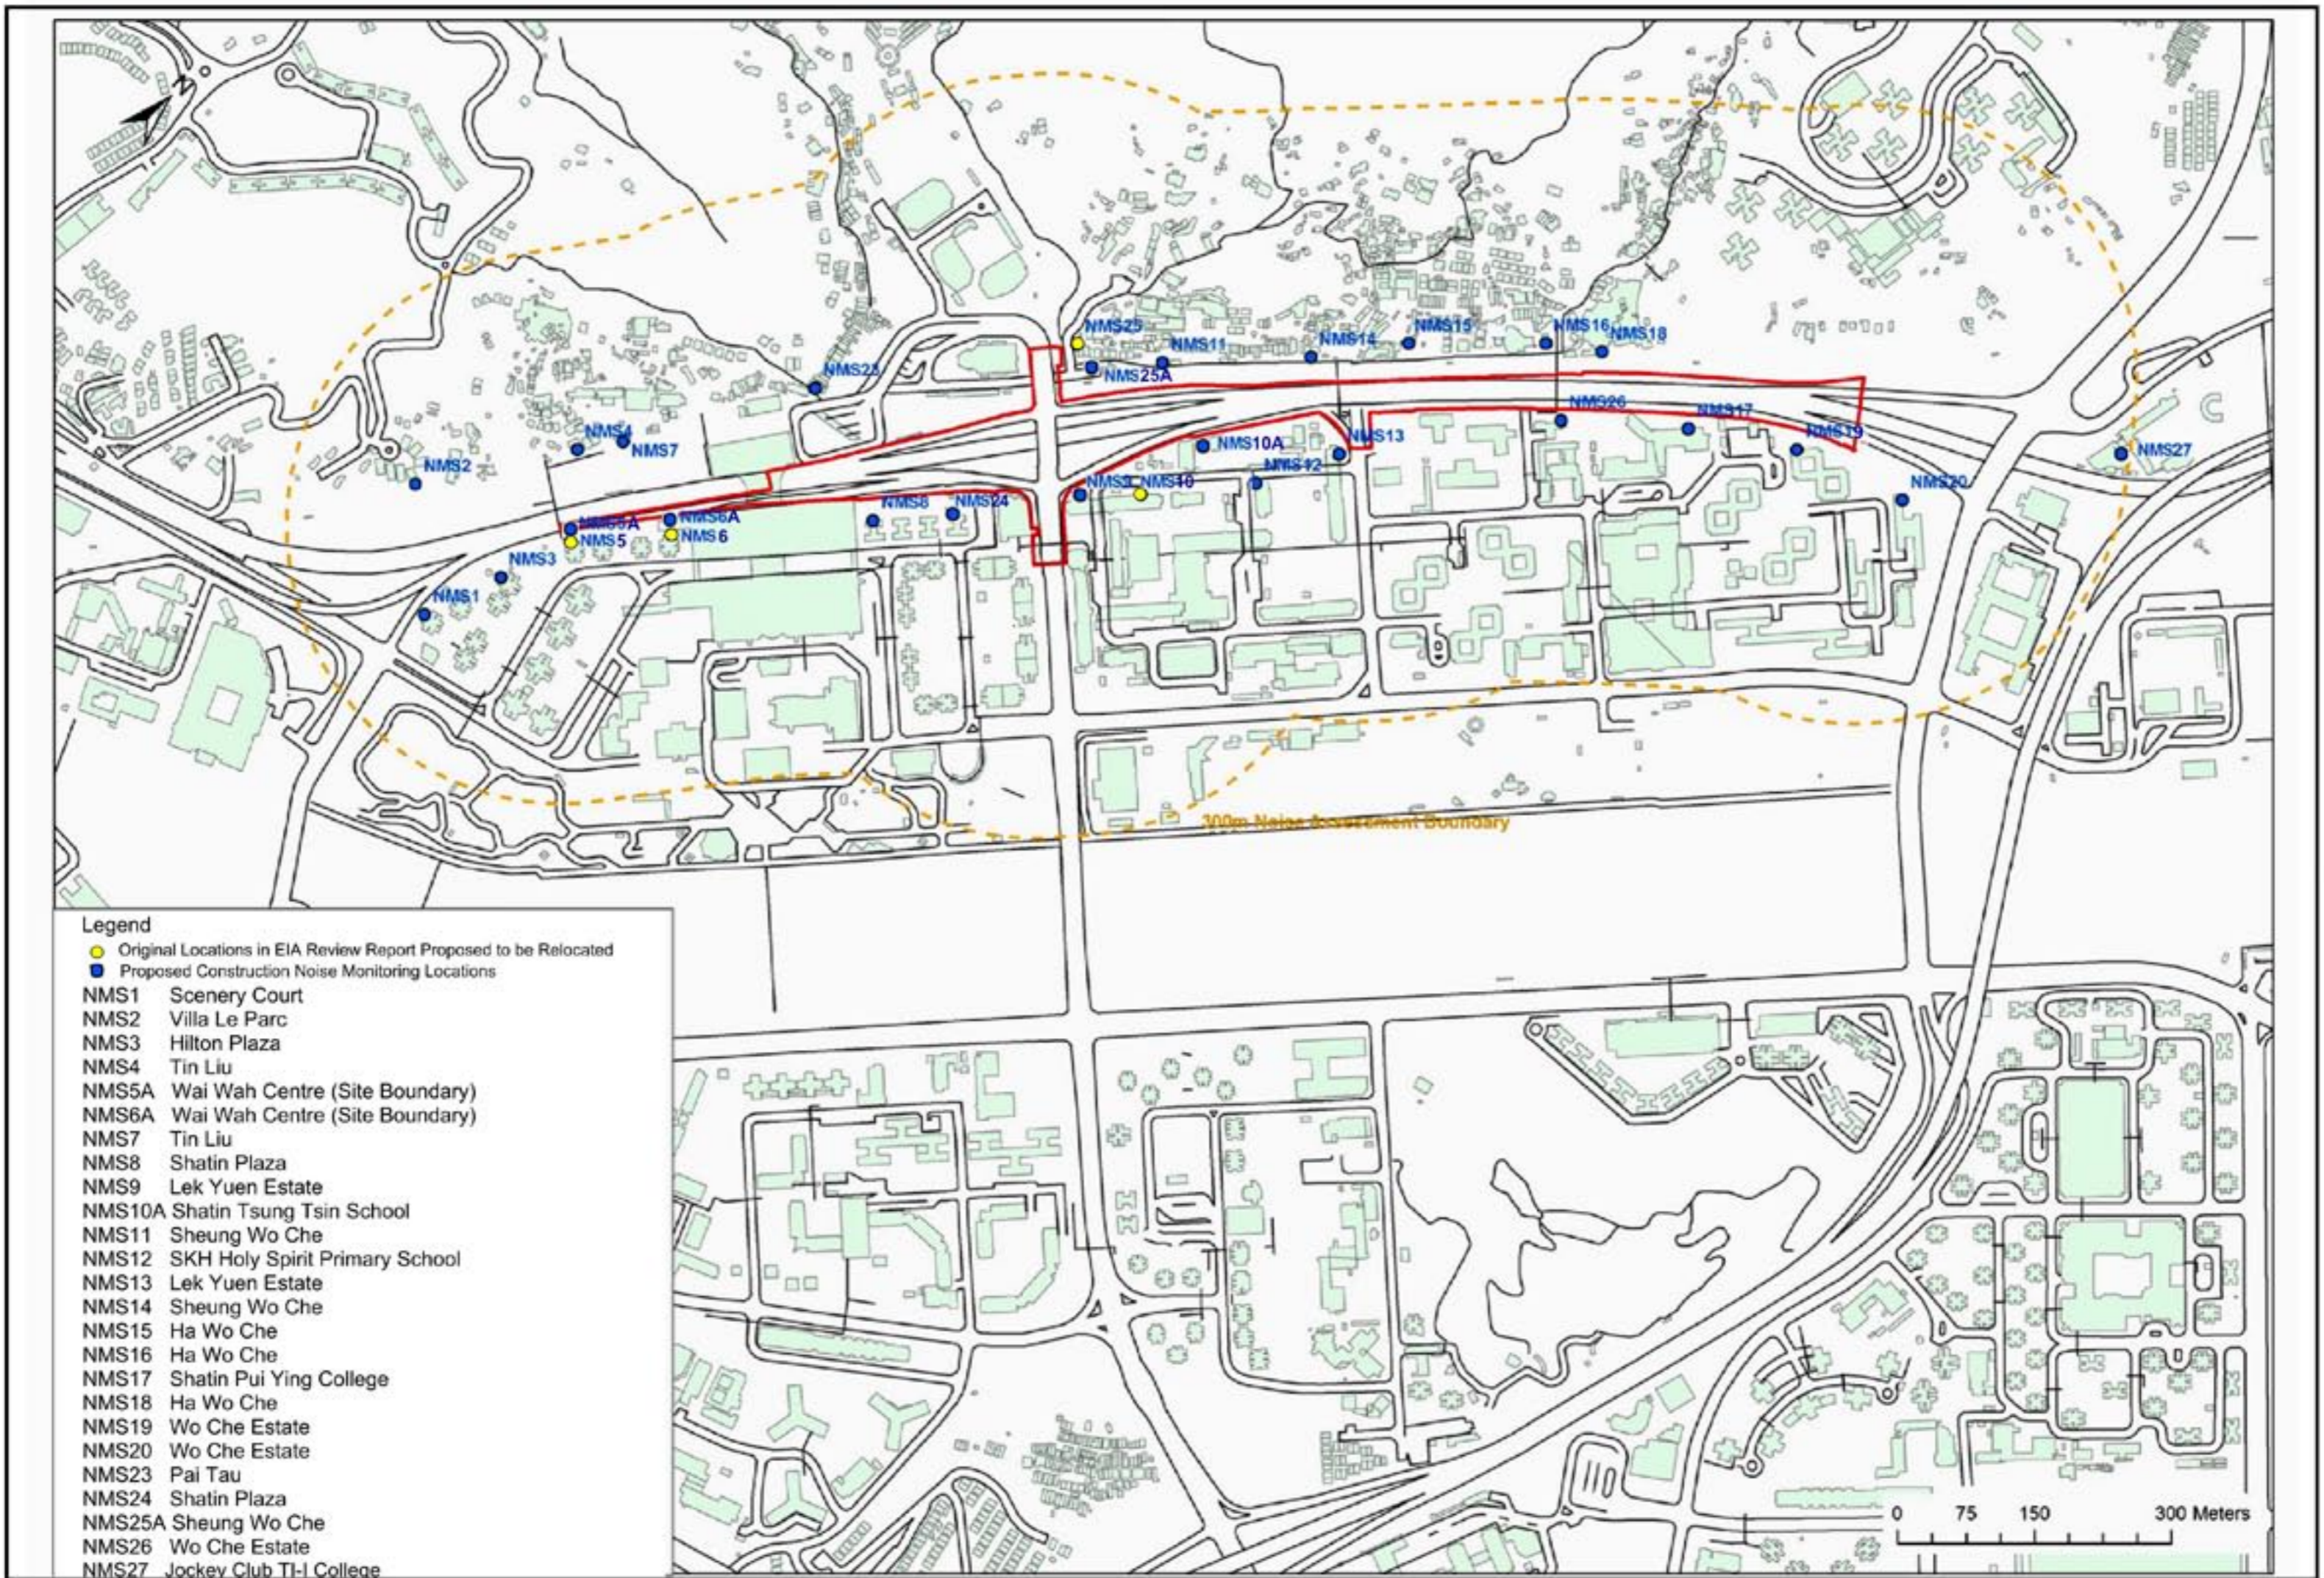
Figure 2b Noise Monitoring Locations

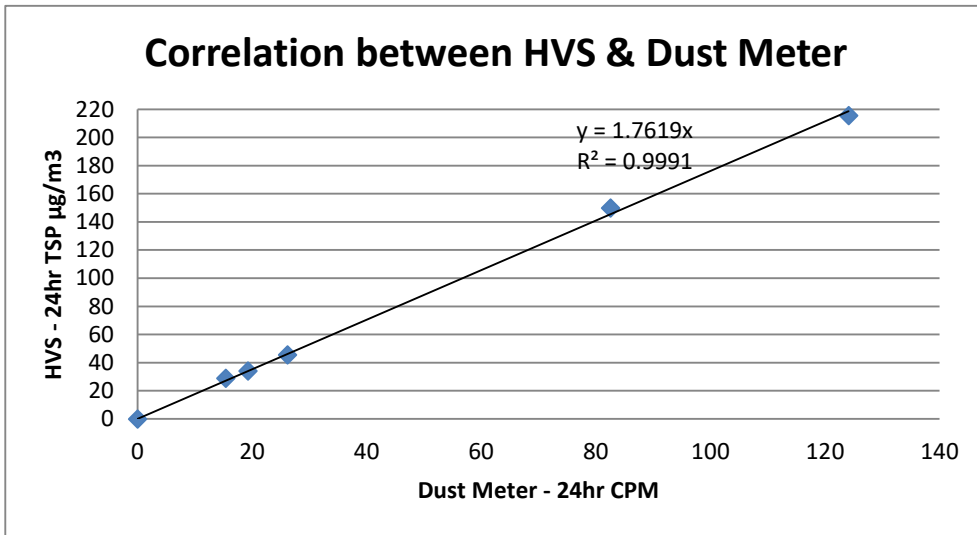
Serial No: 882146

HVS - 24hr TSP $\mu\text{g}/\text{m}^3$	28.99	34.06	45.57	149.88	215.67
Dust Meter - 24hr CPM	15.4	19.3	26.2	82.59	124.12

K factor = 1.762

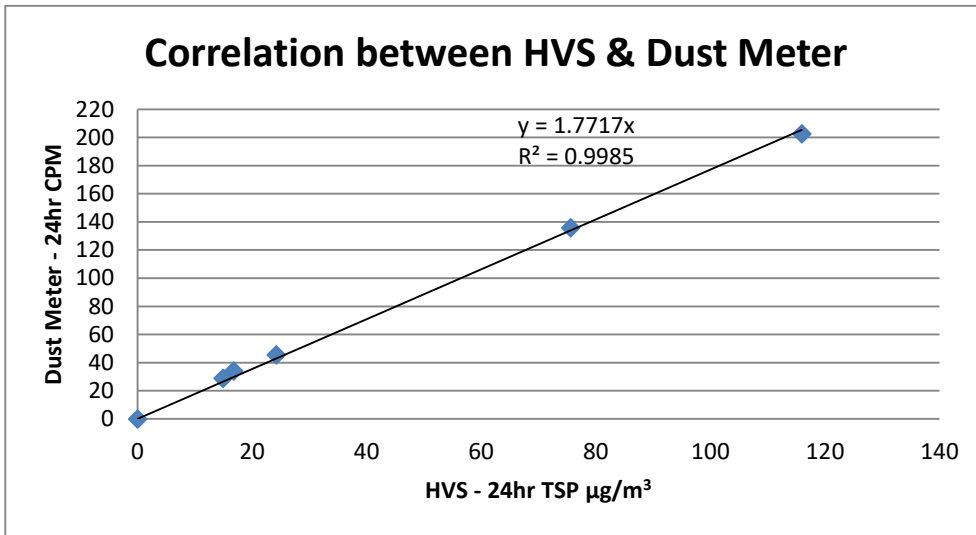
Serial No: 882148

HVS - 24hr TSP $\mu\text{g}/\text{m}^3$	28.99	34.06	45.57	135.96	202.64
Dust Meter - 24hr CPM	14.9	16.8	24.2	75.63	115.96

K factor = 1.772

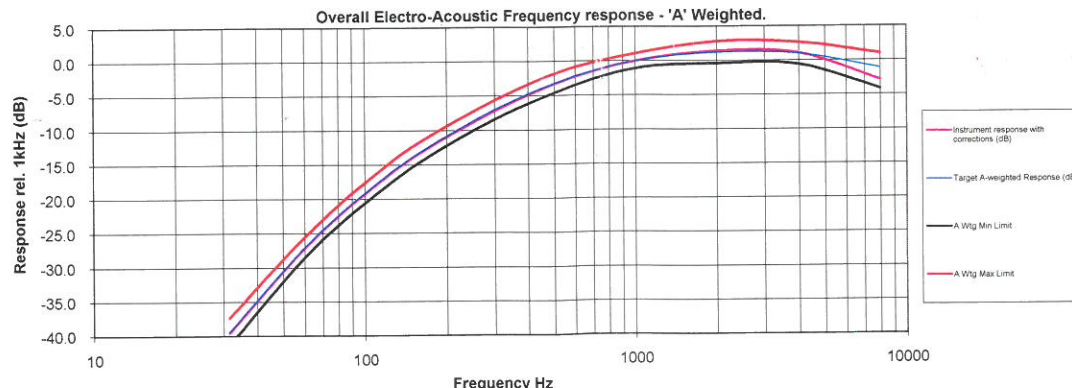
Combined Electro-Acoustic Frequency Response - A Weighted (IEC 61672-3:2006)

The following A-Weighted frequency response graph shows this instruments overall frequency response based upon the application of multi-frequency pressure field calibrations. The microphones Pressure to Free field correction coefficients are applied to pressure response. Reference level taken at 1kHz.

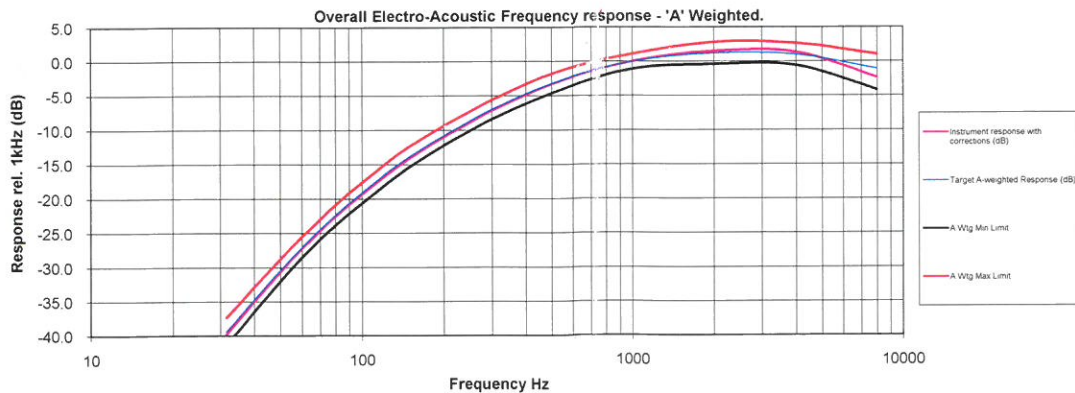
Combined Electro-Acoustic Frequency Response - A Weighted (IEC 61672-3:2006)

The following A-Weighted frequency response graph shows this instrument's overall frequency response based upon the application of multi-frequency pressure field calibrations. The microphones pressure to Free field correction coefficients are applied to pressure response. Reference level taken at 1kHz.
