MONTHLY EM&A REPORT

May 2019

Contract Name : Road Widening and Retrofitting Noise Barriers
on Tai Po Road (Sha Tin Section)

Report No. : 0064/18/ED/0311A

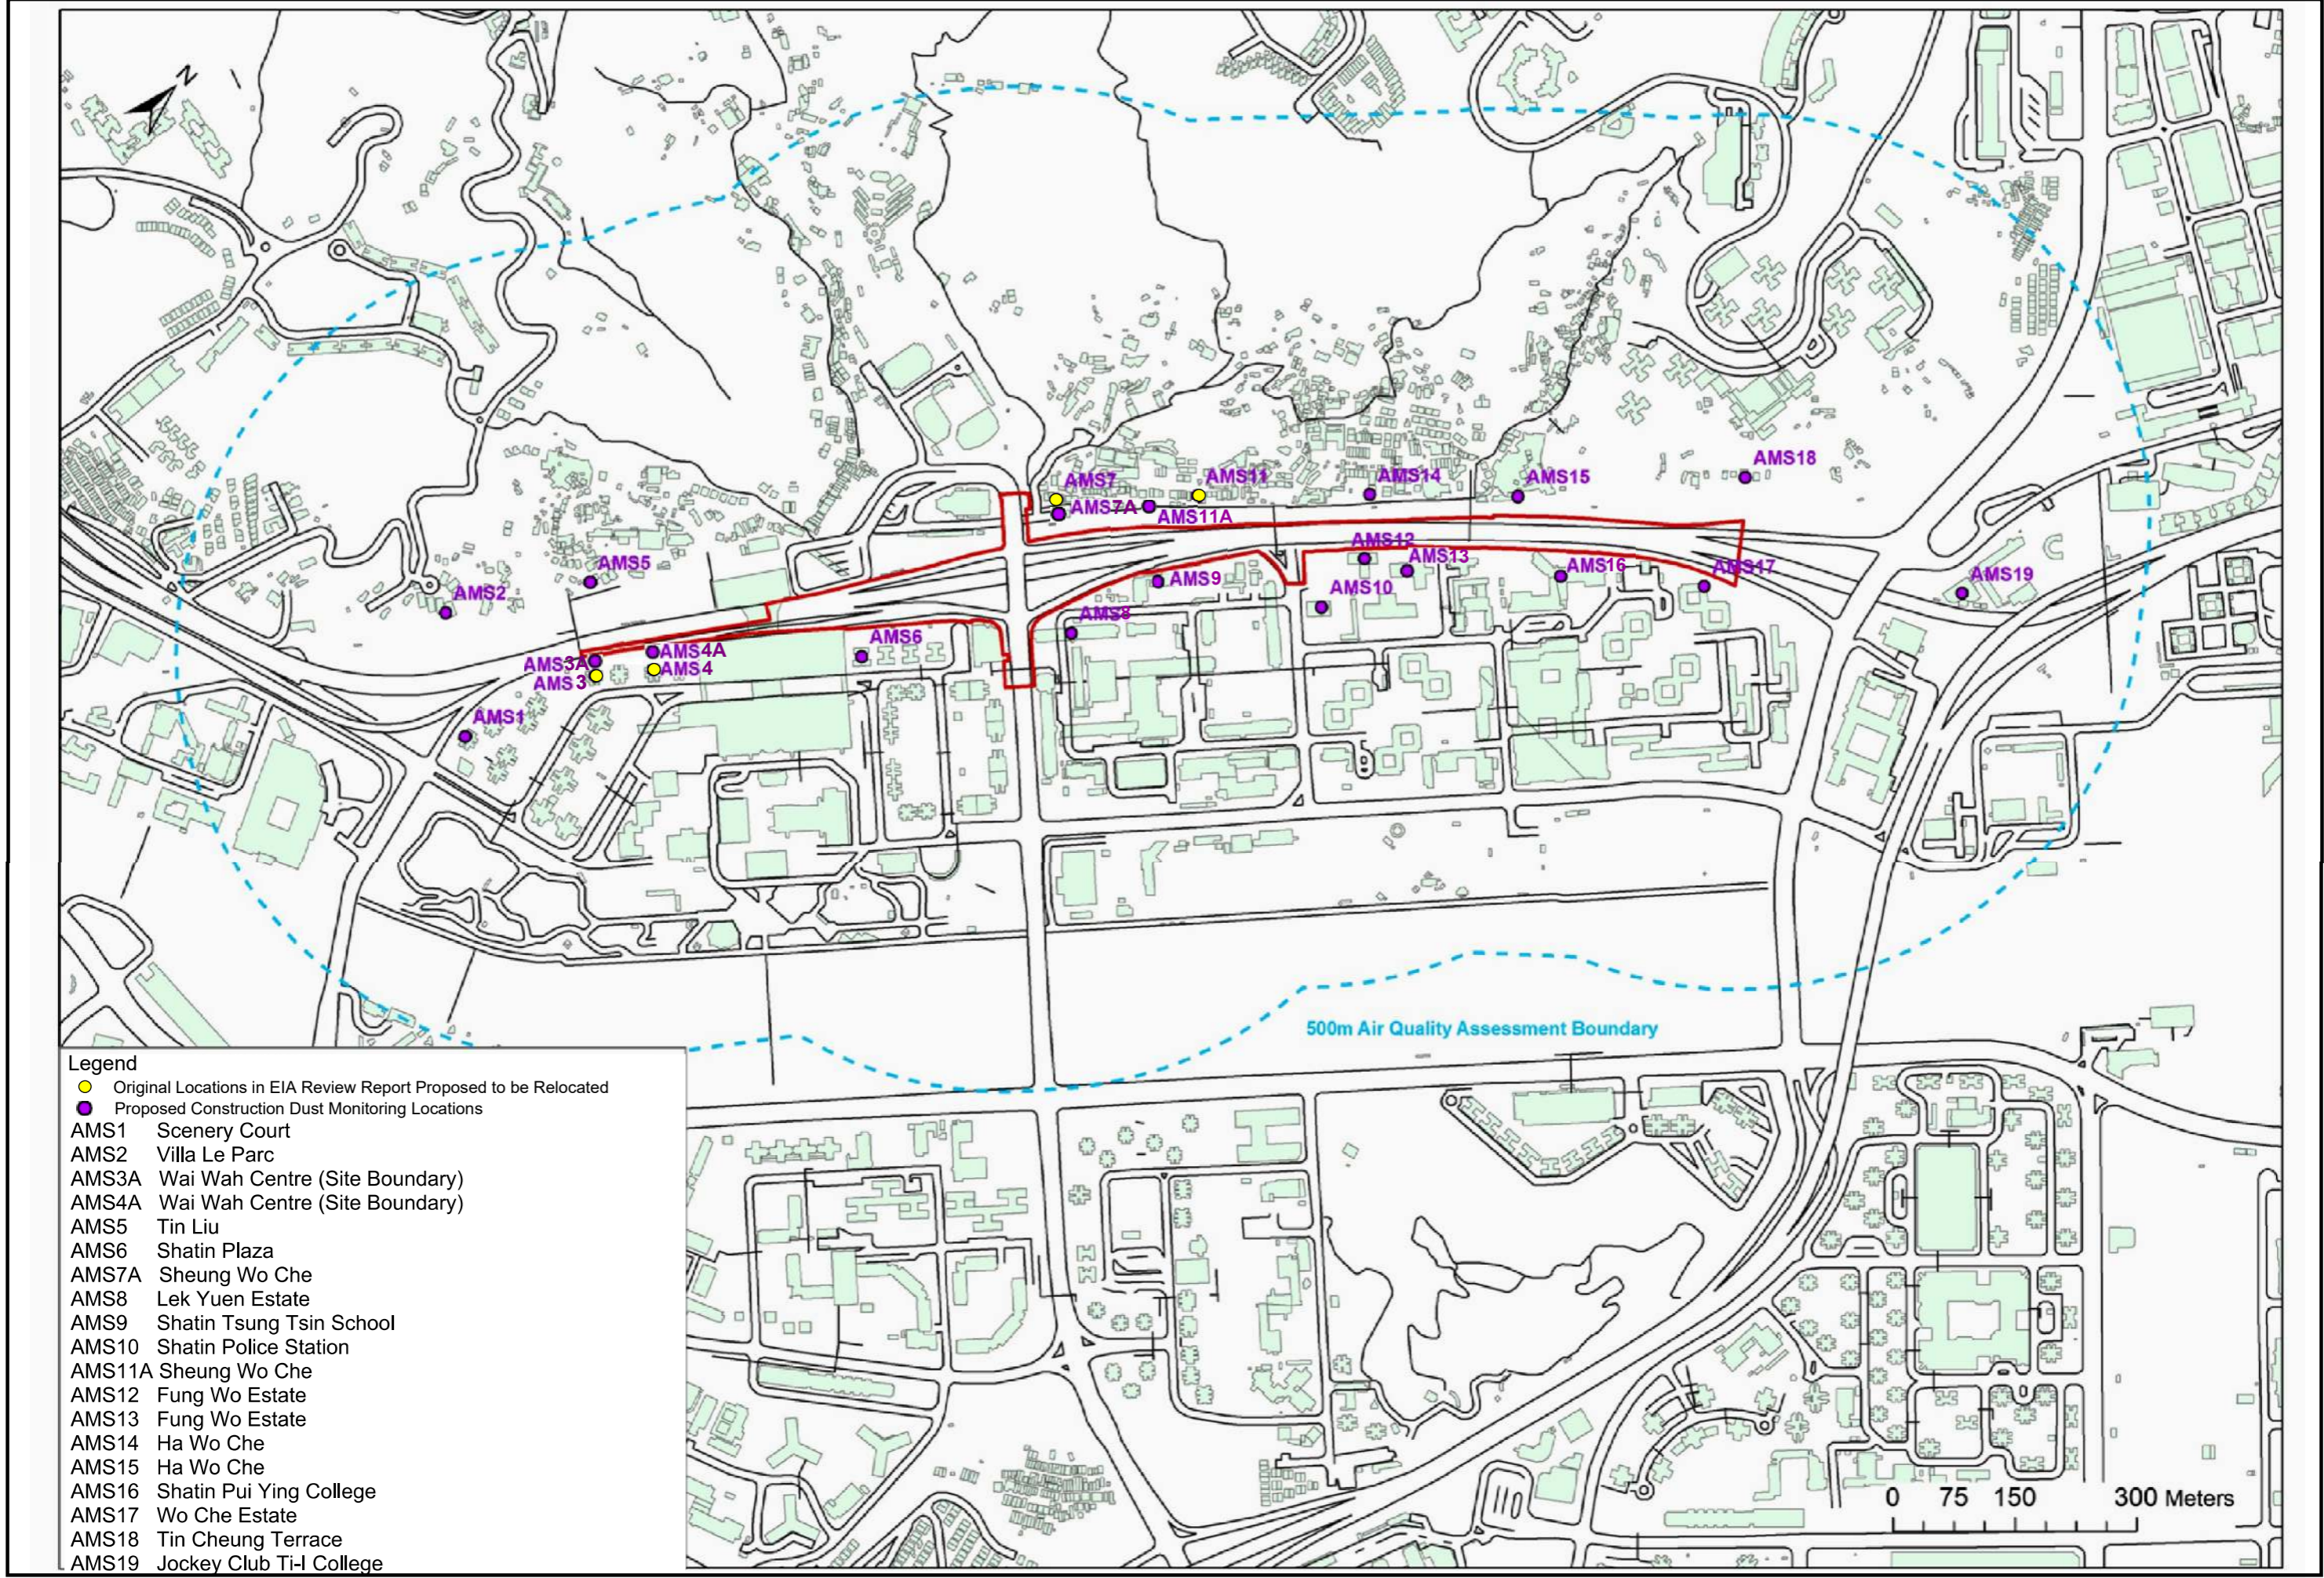
Air Monitoring Locations

Figure 2a Air Quality Monitoring Locations

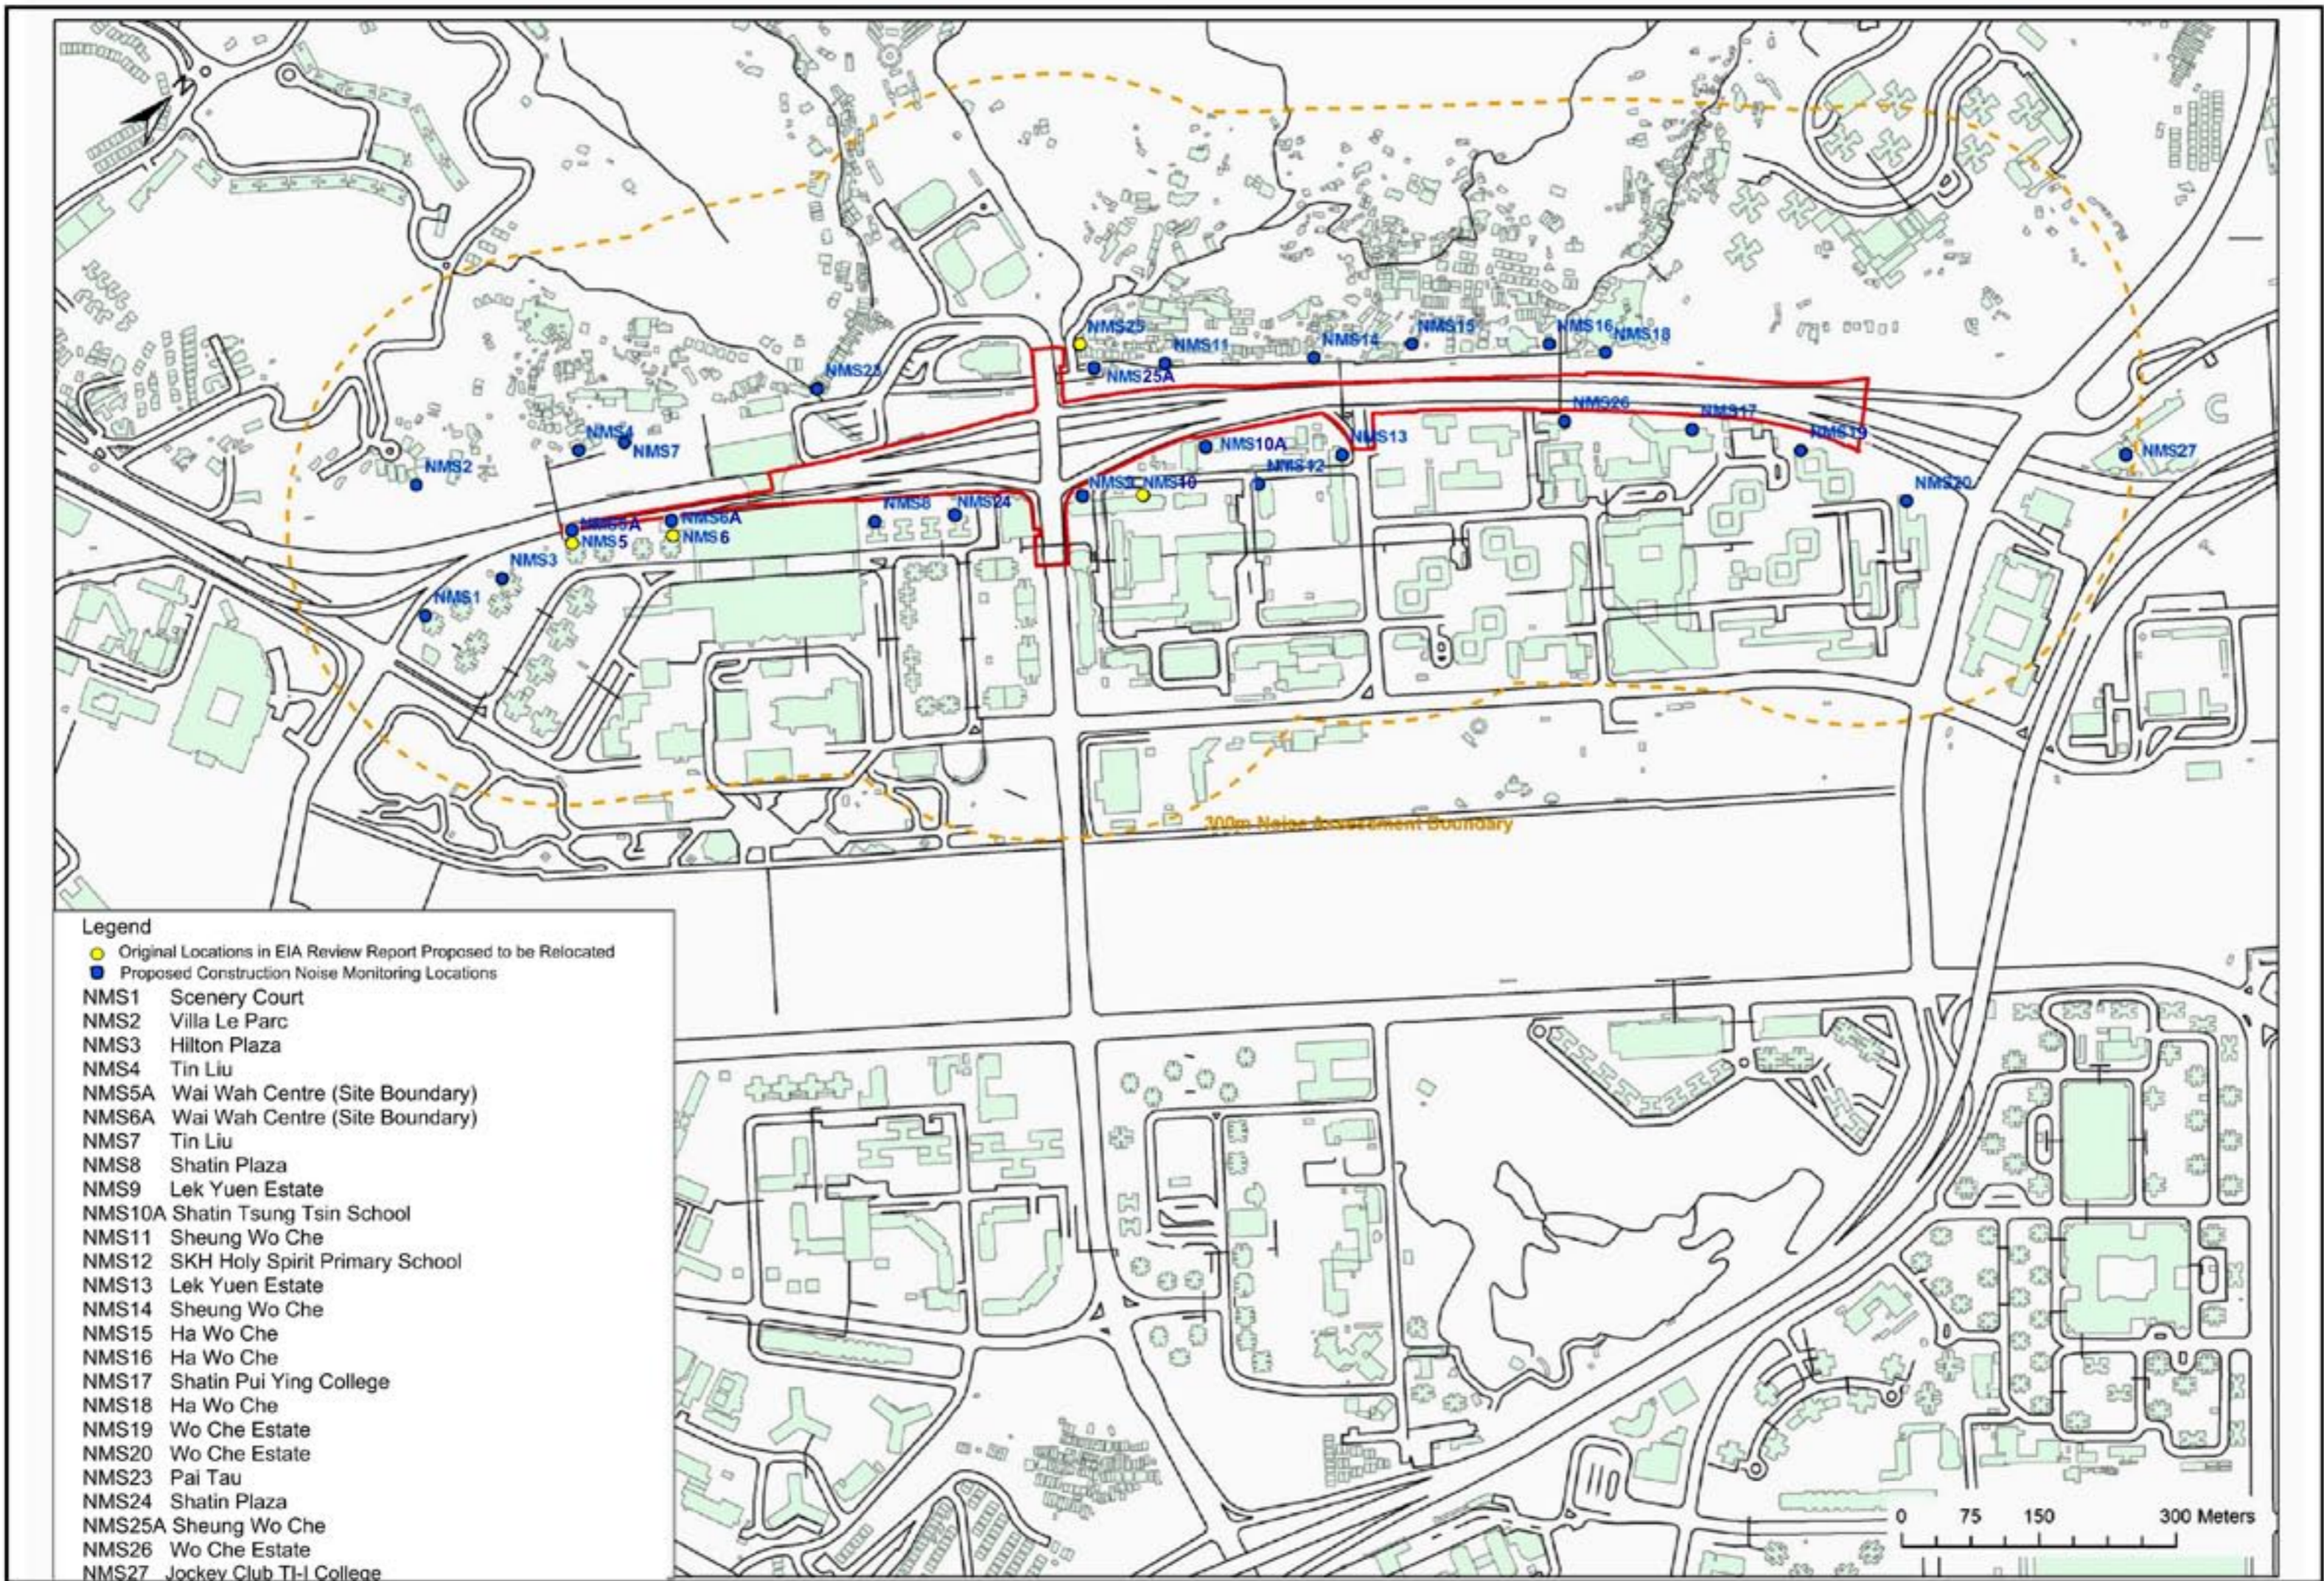
Noise Monitoring Locations

Figure 2b Noise Monitoring Locations

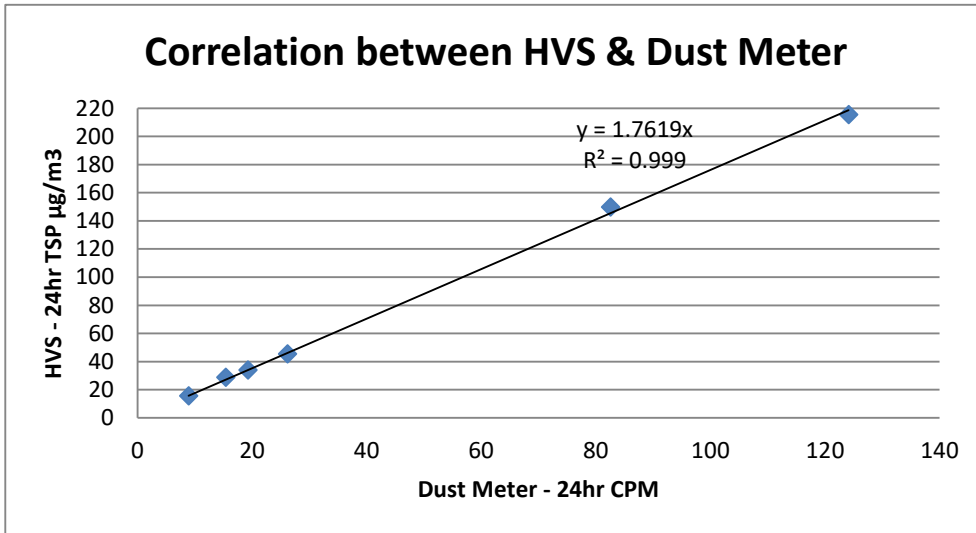
Serial No: 882146

HVS - 24hr TSP $\mu\text{g}/\text{m}^3$	15.62	28.99	34.06	45.57	149.88	215.67
Dust Meter - 24hr CPM	8.9	15.4	19.3	26.2	82.59	124.12

K factor = 1.762

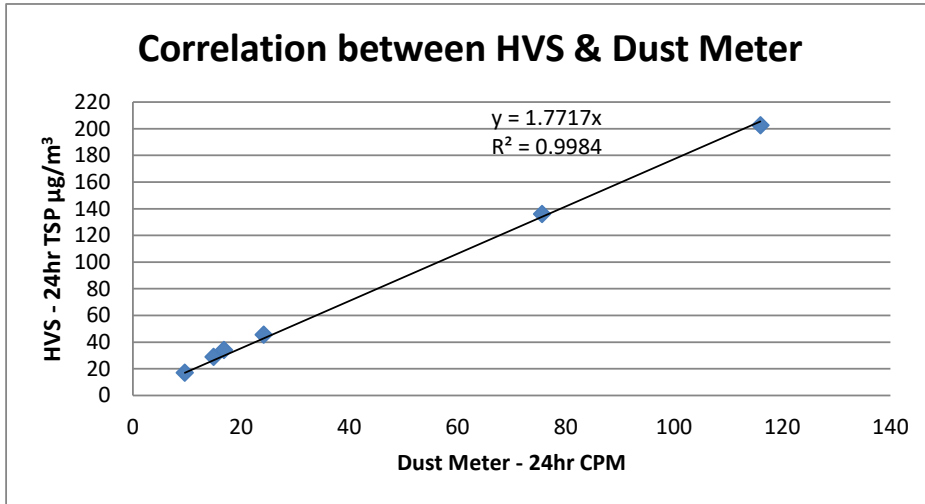
Serial No: 882148

HVS - 24hr TSP $\mu\text{g}/\text{m}^3$	16.99	28.99	34.06	45.57	135.96	202.64
Dust Meter - 24hr CPM	9.6	14.9	16.8	24.2	75.63	115.96

K factor = 1.772

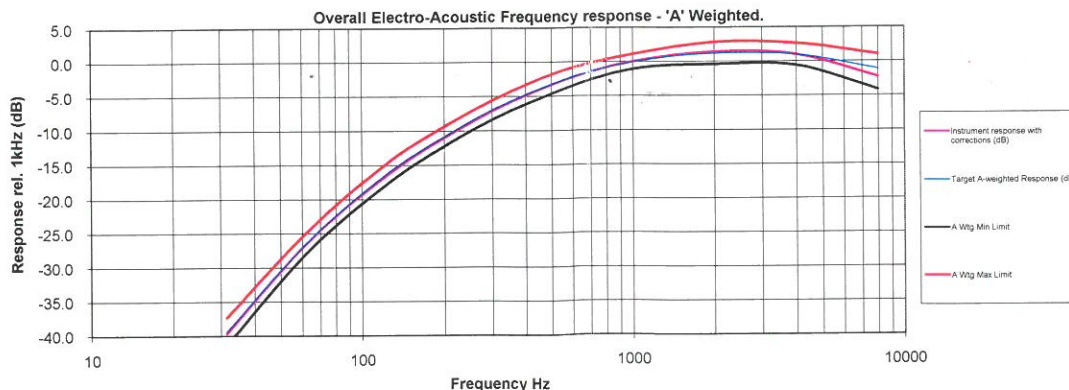
Combined Electro-Acoustic Frequency Response - A Weighted (IEC 61672-3:2006)

The following A-Weighted frequency response graph shows this instruments overall frequency response based upon the application of multi-frequency pressure field calibrations. The microphones Pressure to Free field correction coefficients are applied to pressure response. Reference level taken at 1kHz.

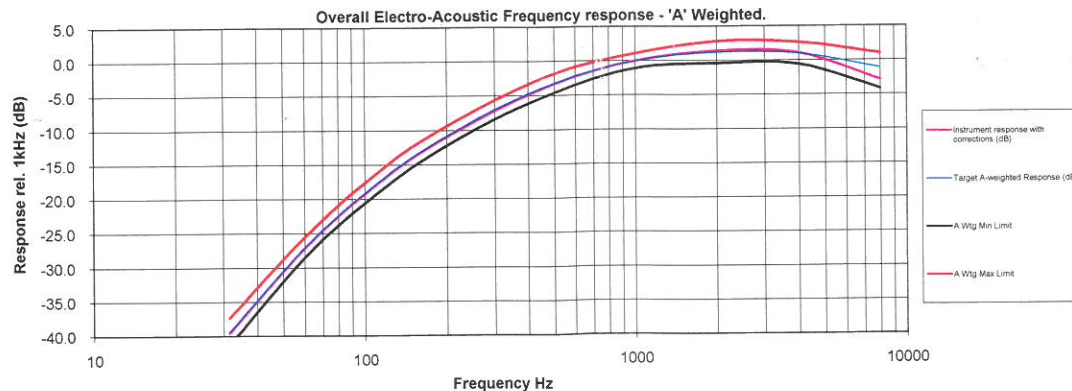
Combined Electro-Acoustic Frequency Response - A Weighted (IEC 61672-3:2006)

The following A-Weighted frequency response graph shows this instruments overall frequency response based upon the application of multi-frequency pressure field calibrations. The microphones Pressure to Free field correction coefficients are applied to pressure response. Reference level taken at 1kHz.

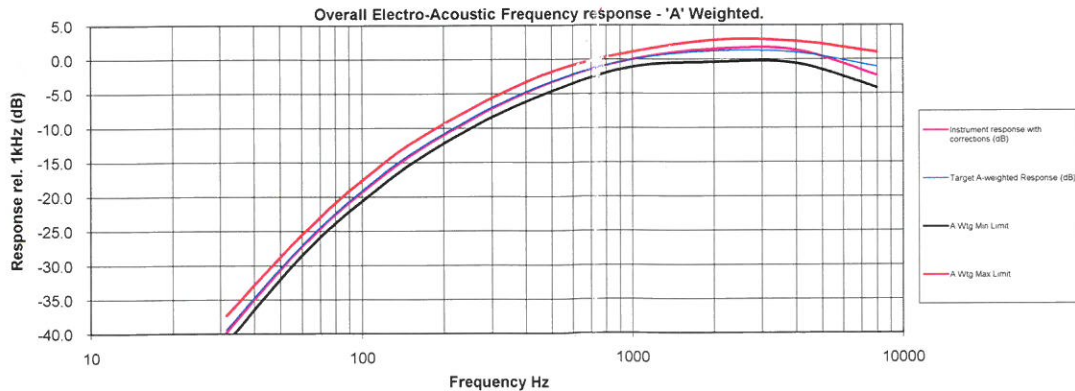
Combined Electro-Acoustic Frequency Response - A Weighted (IEC 61672-3:2006)

The following A-Weighted frequency response graph shows this instrument's overall frequency response based upon the application of multi-frequency pressure field calibrations. The microphones pressure to Free field correction coefficients are applied to pressure response. Reference level taken at 1kHz.
