Central Kowloon Route

Kai Tak West

Contract No. HY/2014/07

Independent Environmental Checker Verification

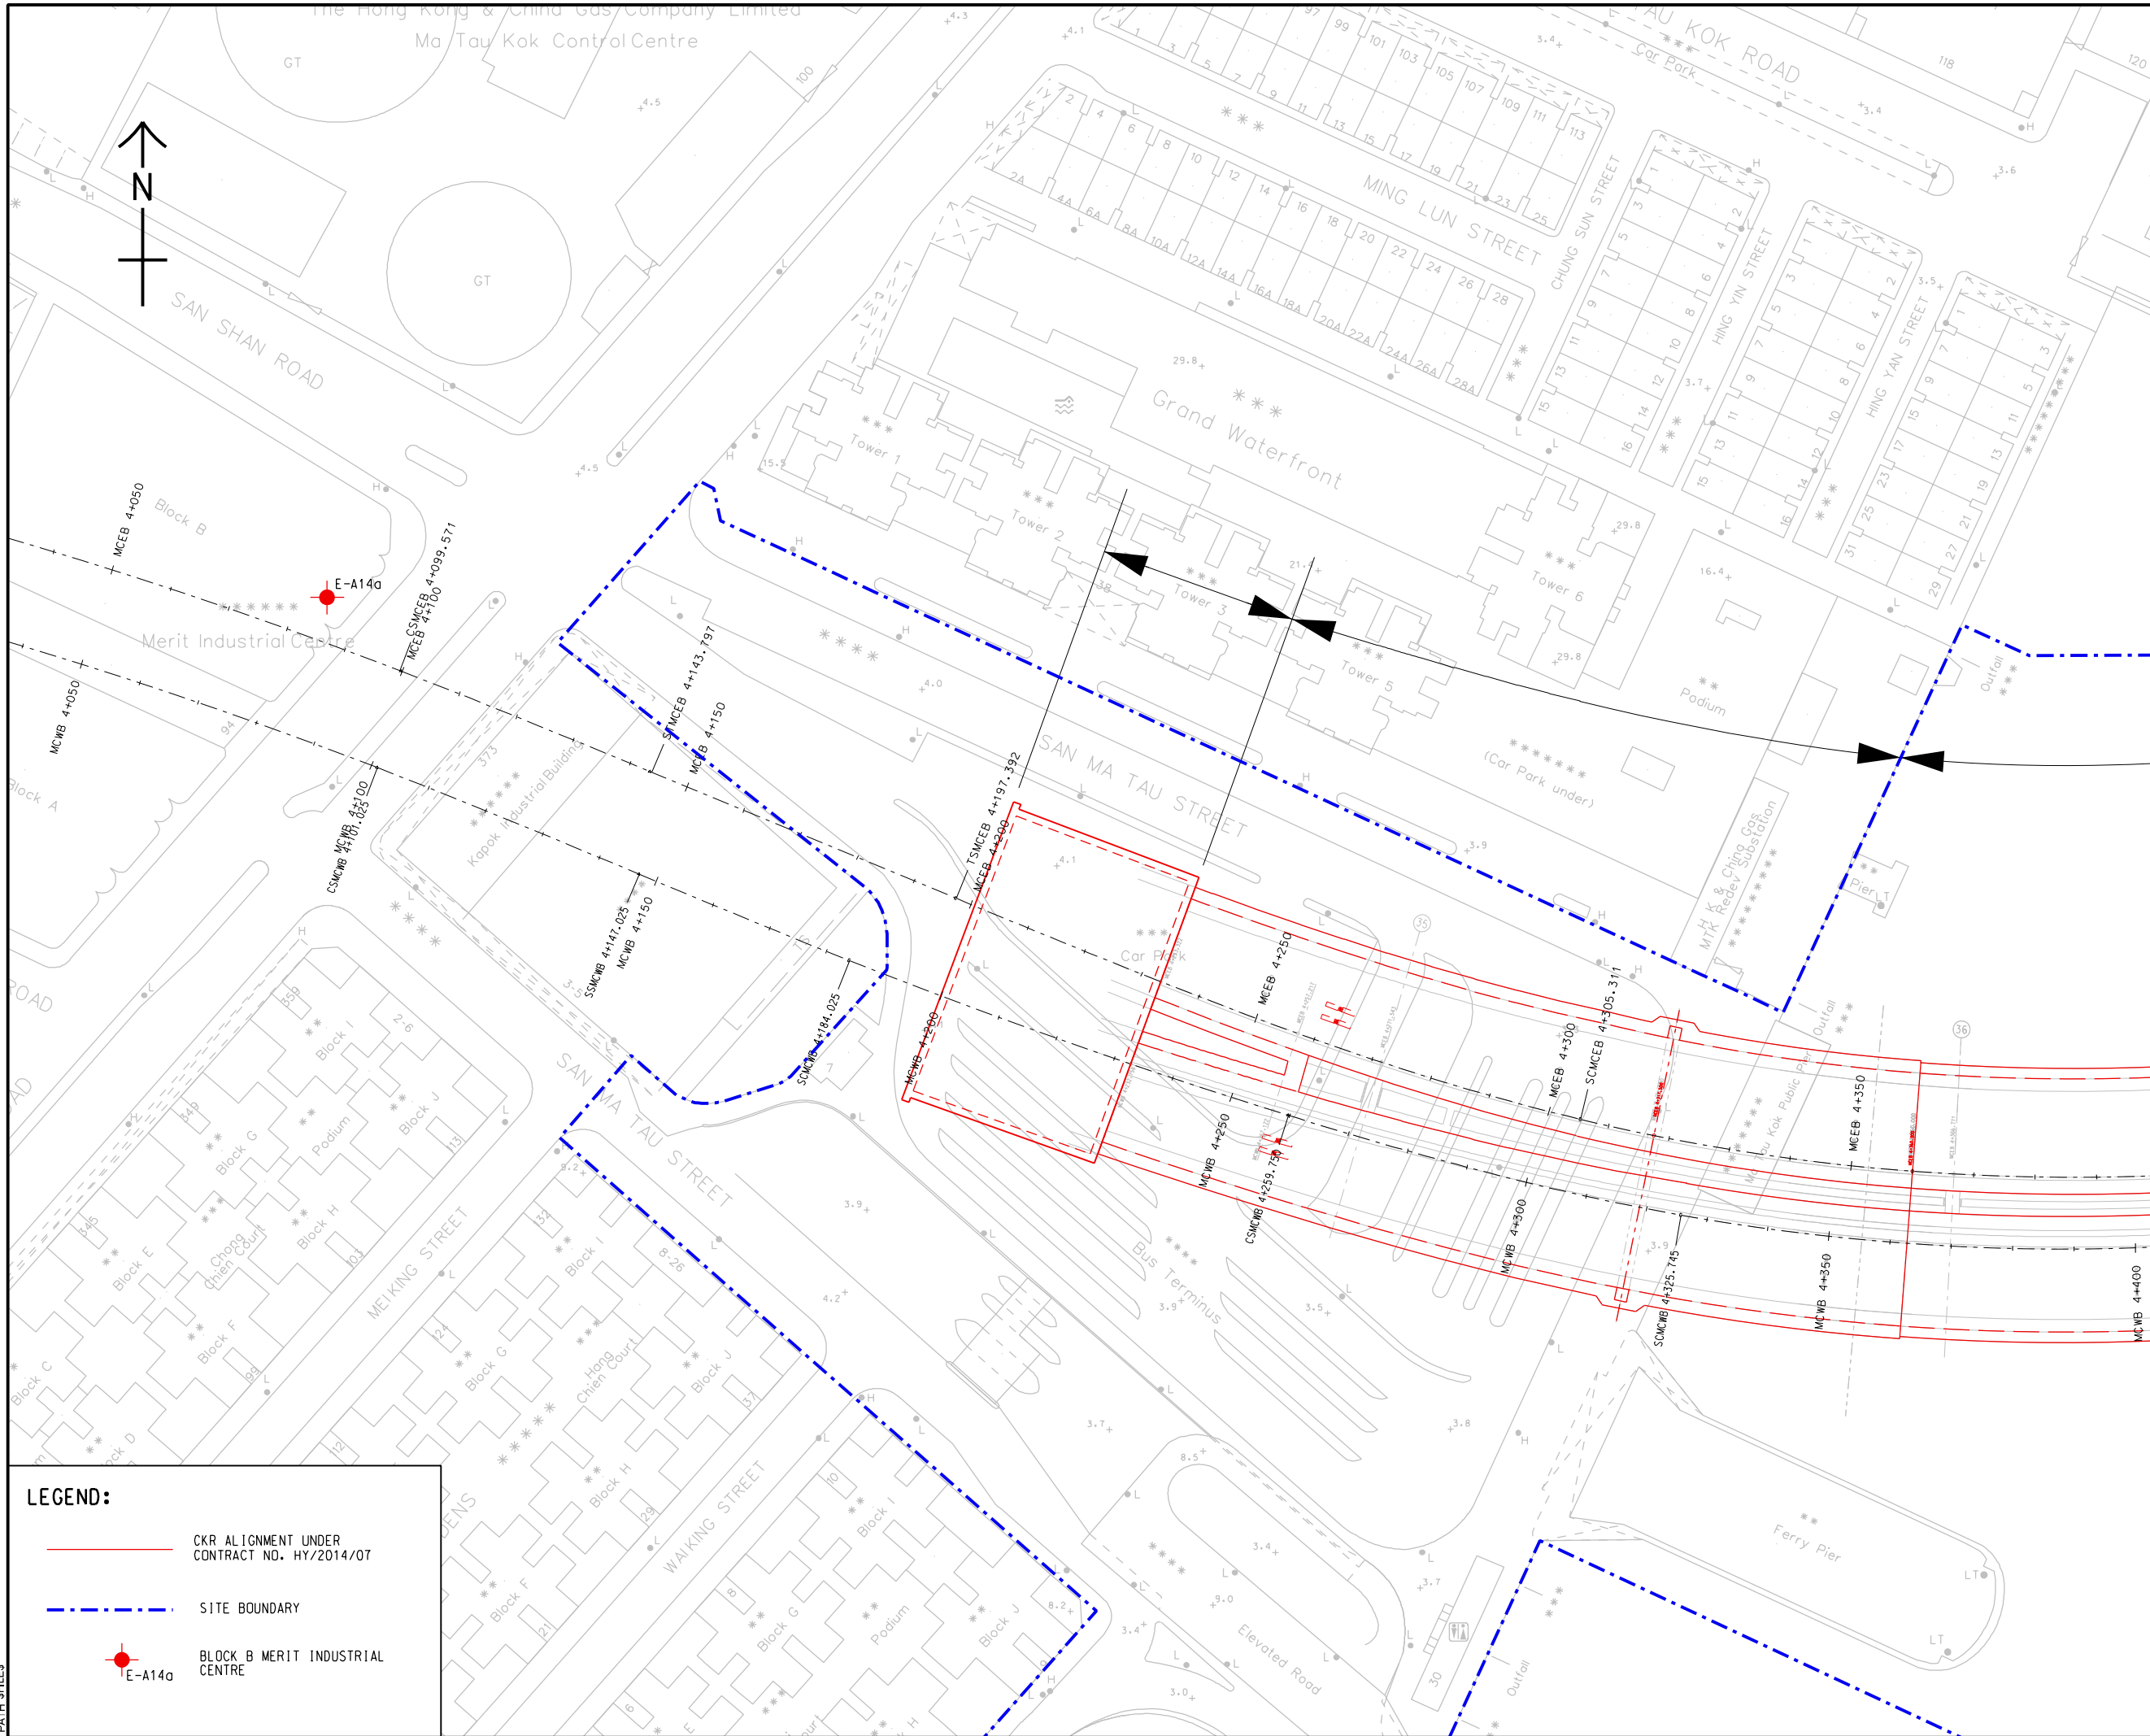
SHEET TITLE
LOCATION OF AIR QUALITY MONITORING STATION

- CKR ALIGNMENT UNDER CONTRACT NO. HY/2014/07
- - - SITE BOUNDARY
- BLOCK B MERIT INDUSTRIAL CENTRE

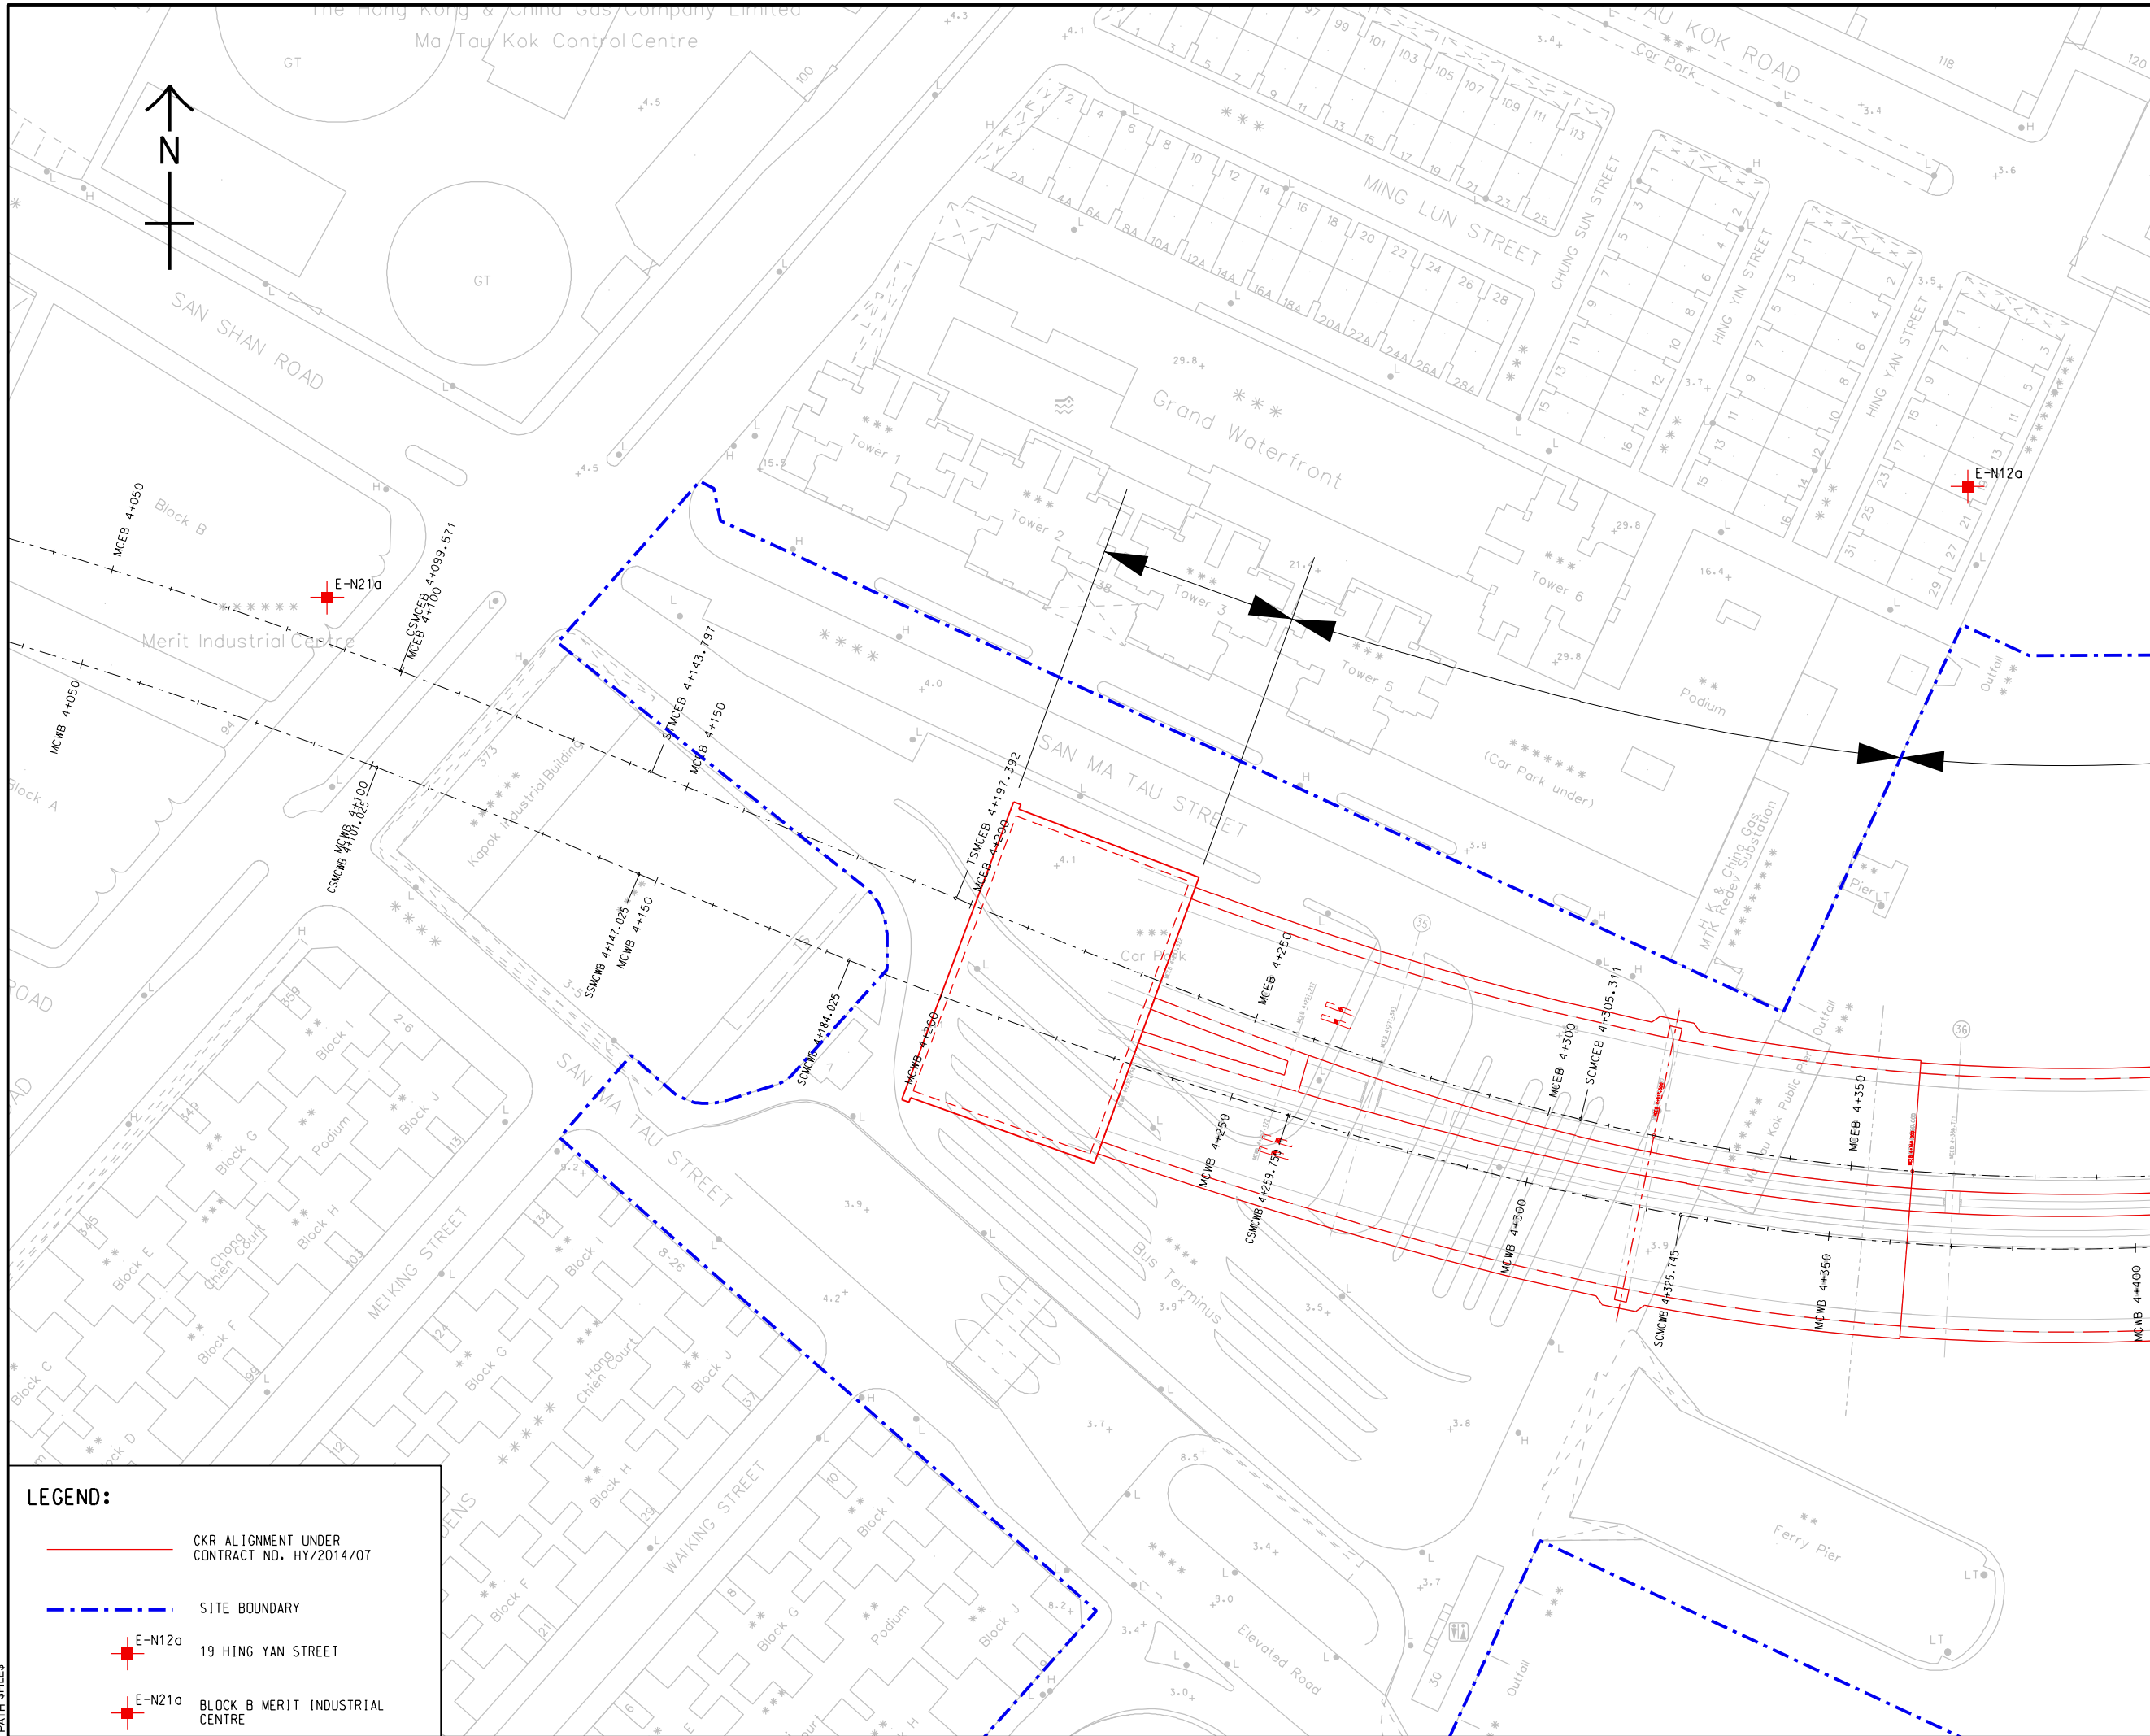
CKR ALIGNMENT UNDER CONTRACT NO. HY/2014/07
	SITE BOUNDARY
	E-N12a 19 HING YAN STREET
	E-N21a BLOCK B MERIT INDUSTRIAL CENTRE

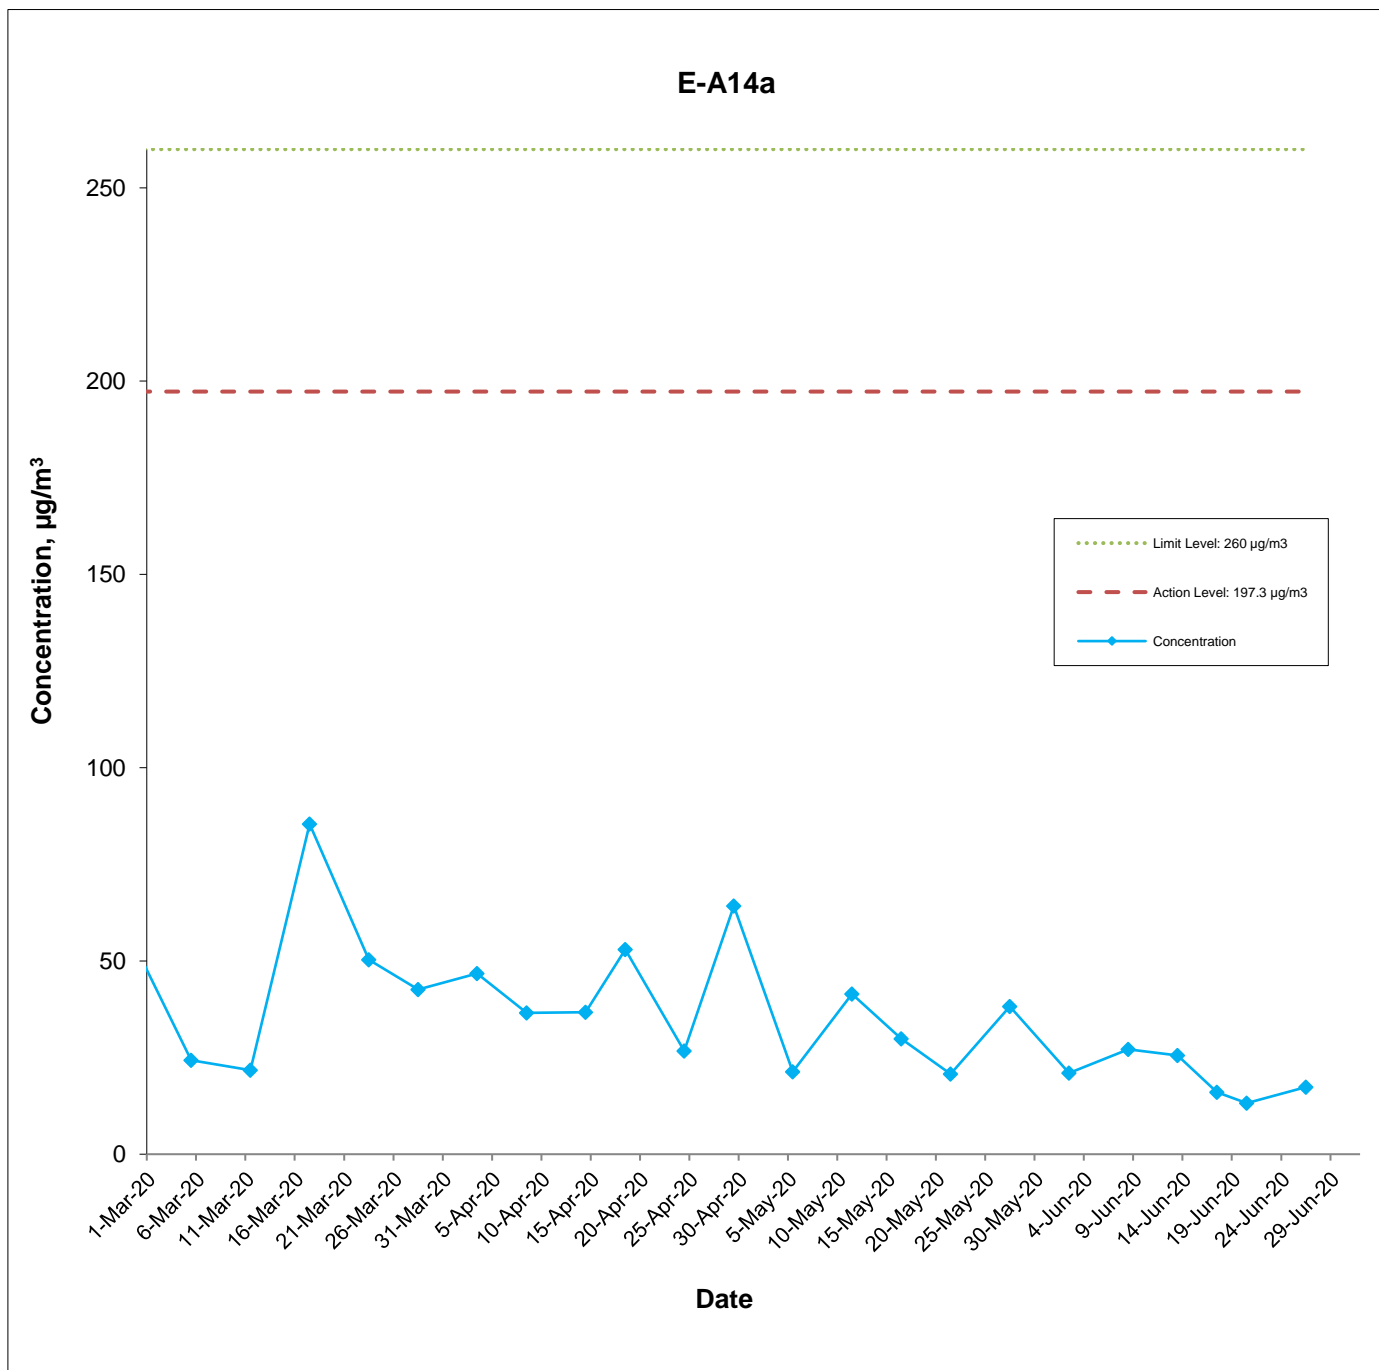
E-A14a

Date	Start Time (hh:mm)	Weather Condition	1st Hour	2nd Hour	3rd Hour
			Conc. ($\mu\text{g}/\text{m}^3$)	Conc. ($\mu\text{g}/\text{m}^3$)	Conc. ($\mu\text{g}/\text{m}^3$)
2-Jun-20	13:05	Fine	58.8	61.7	62.0
8-Jun-20	14:10	Rainy	58.8	60.4	62.2
13-Jun-20	13:30	Fine	60.7	59.5	61.6
17-Jun-20	10:00	Sunny	61.2	60.3	62.1
20-Jun-20	13:30	Sunny	58.8	59.4	60.8
26-Jun-20	13:00	Fine	57.4	59.2	58.8
Average					60.2
Min					57.4
Max					62.2

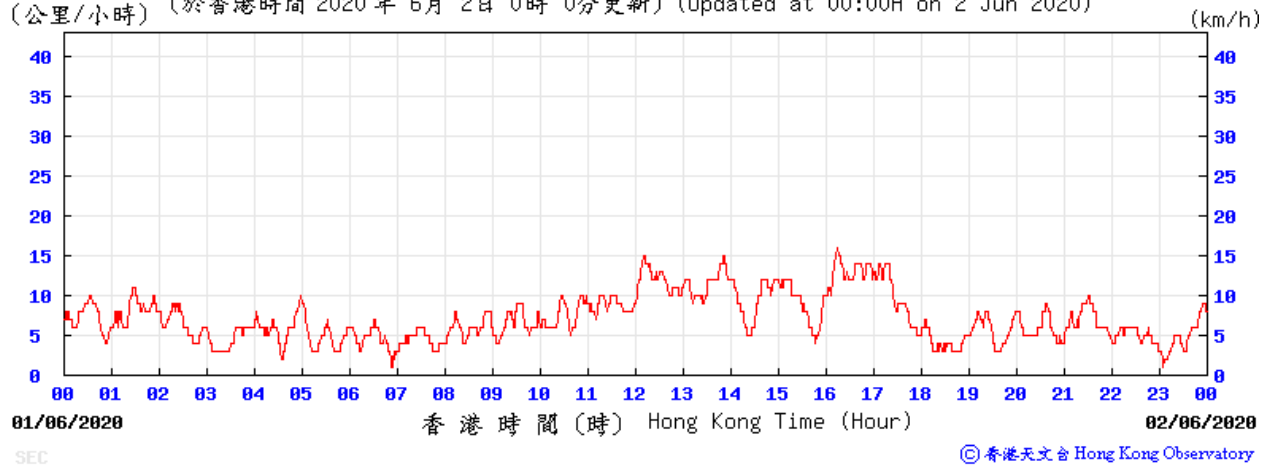
(公里/小時) (於香港時間 2020 年 6 月 2 日 0 時 0 分更新) (Updated at 00:00H on 2 Jun 2020)

Data of Wind Speed Extracted from Kai Tak Wind Station of the Hong Kong Observatory

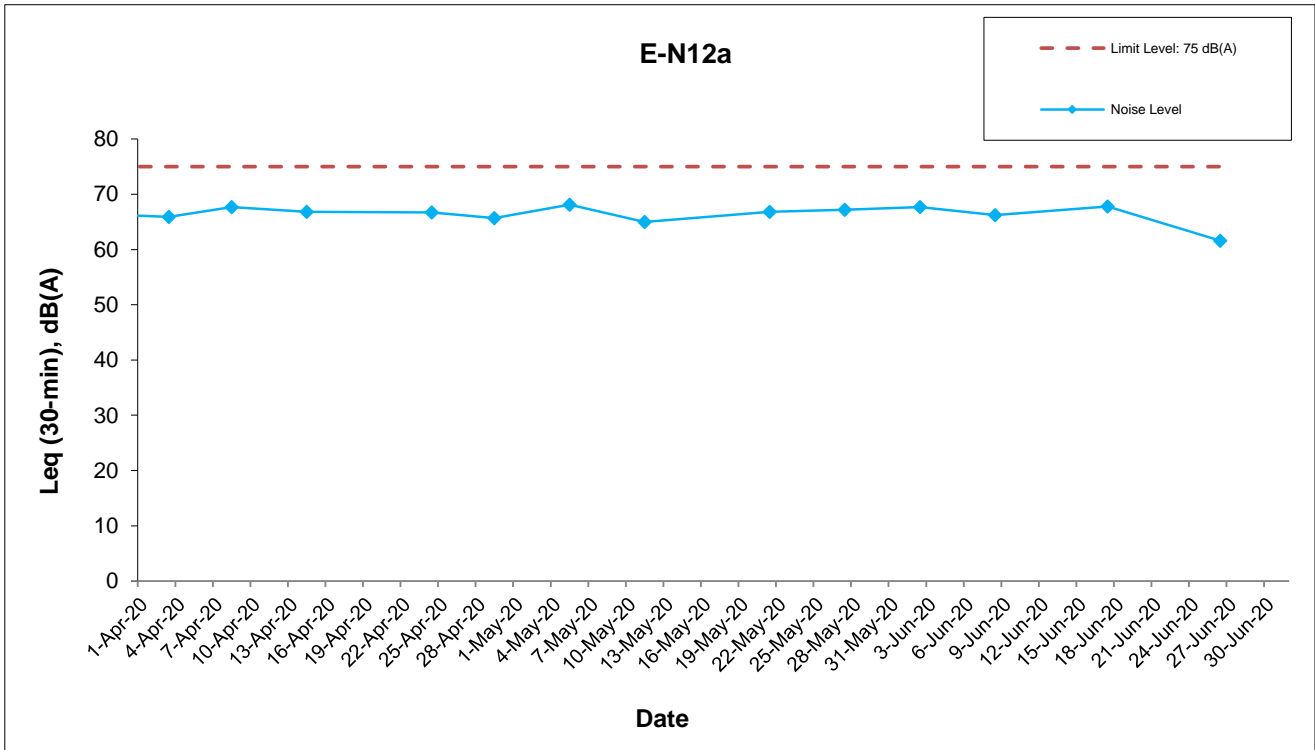
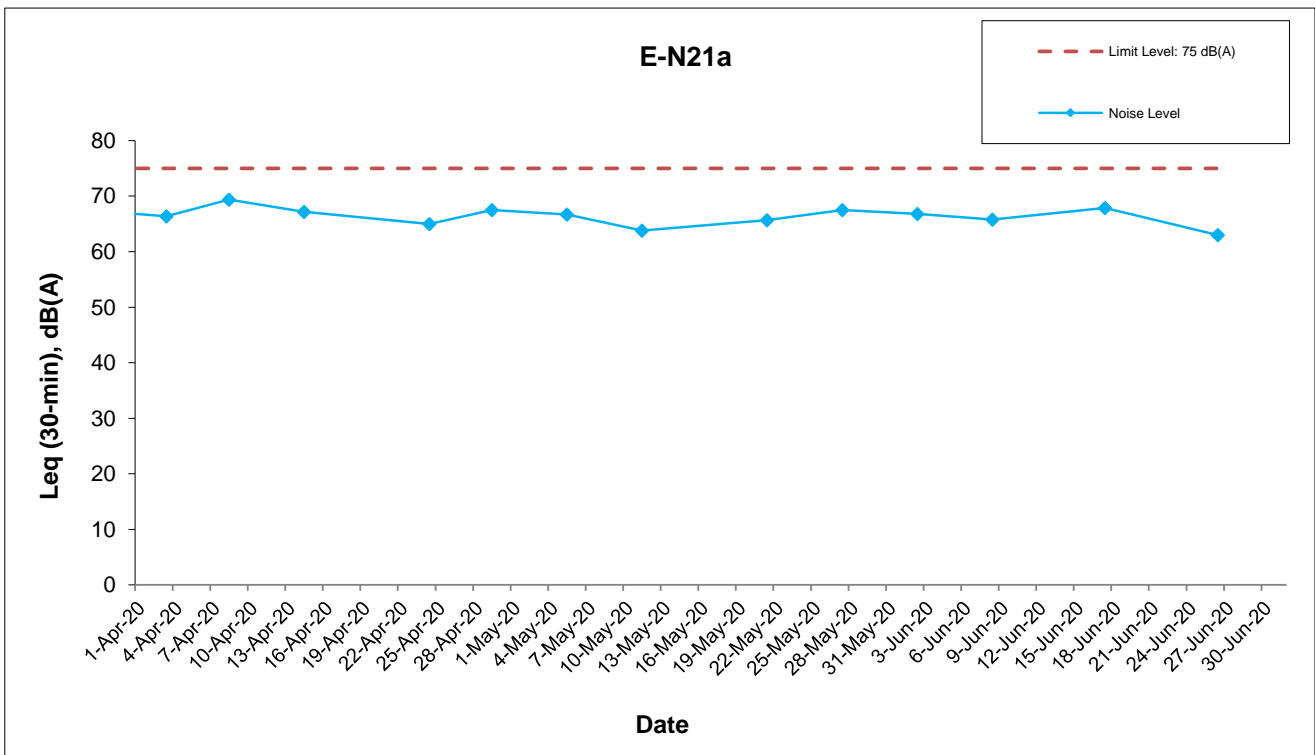
**Noise Monitoring Results and
their Graphical Presentations**

[#] - A correction of +3dB(A) was made to the free field measurement.

^{*} - Limit Level of 70dB(A) applies to education institutes while 65dB(A) applies during school
