**Agreement No. CE 59/2015 (EP)
Environmental Team for
Tseung Kwan O – Lam Tin Tunnel
Design and Construction**

**Monthly Environmental Monitoring and
Audit Report for April 2017**

(version 2.0)

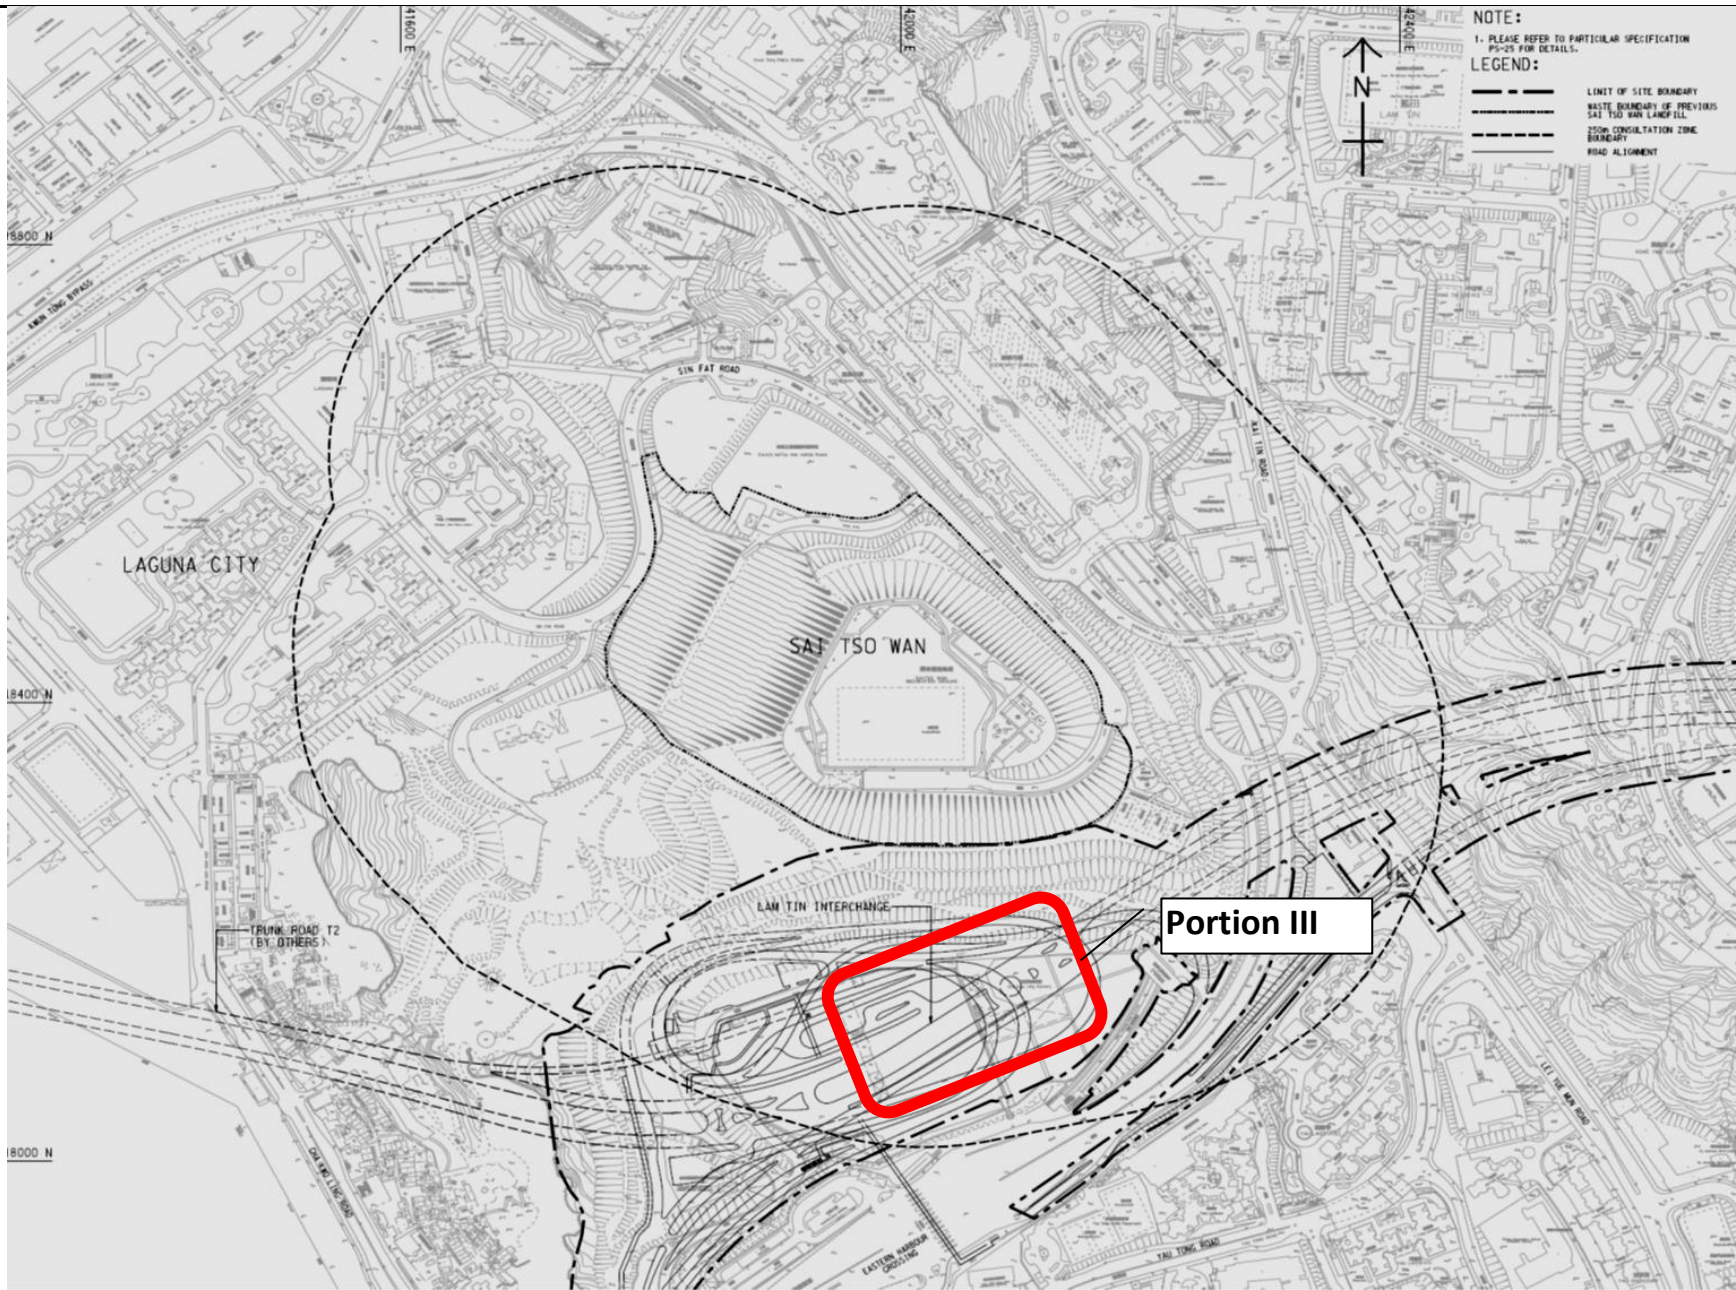
Title Agreement No. CE/59/2015 (EP)
 Environmental Team for Tseung Kwan O - Lam Tin Tunnel - Design and Construction
 Locations of Landfill Gas Monitoring
