**Agreement No. CE 59/2015 (EP)
Environmental Team for
Tseung Kwan O – Lam Tin Tunnel
Design and Construction**

**Monthly Environmental Monitoring and
Audit Report for August 2017**

(version 1.0)

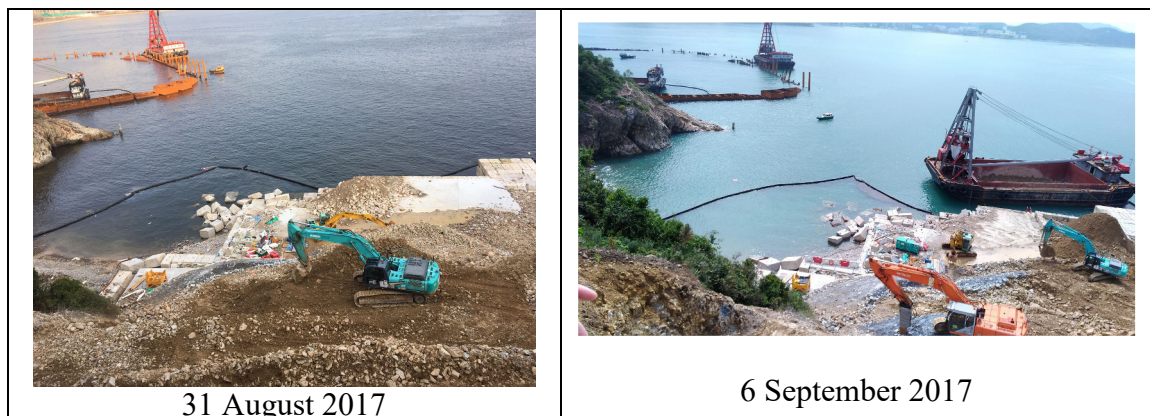
- 10.5 The Contractor has taken the initiative to improve/rectify the non-compliance as soon as possible. Leaks and damaged positions of the silt curtain has been repaired promptly by the Contractor on 31 August 2017. Further, during the following ET inspection on 6 September 2017, it is observed that the silt curtain is in generally good condition. No effluent discharge outside of silt curtain is observed on 6 September 2017
