**Agreement No. CE 59/2015 (EP)
Environmental Team for
Tseung Kwan O – Lam Tin Tunnel
Design and Construction**

**Monthly Environmental Monitoring and
Audit Report for September 2017
(version 1.0)**

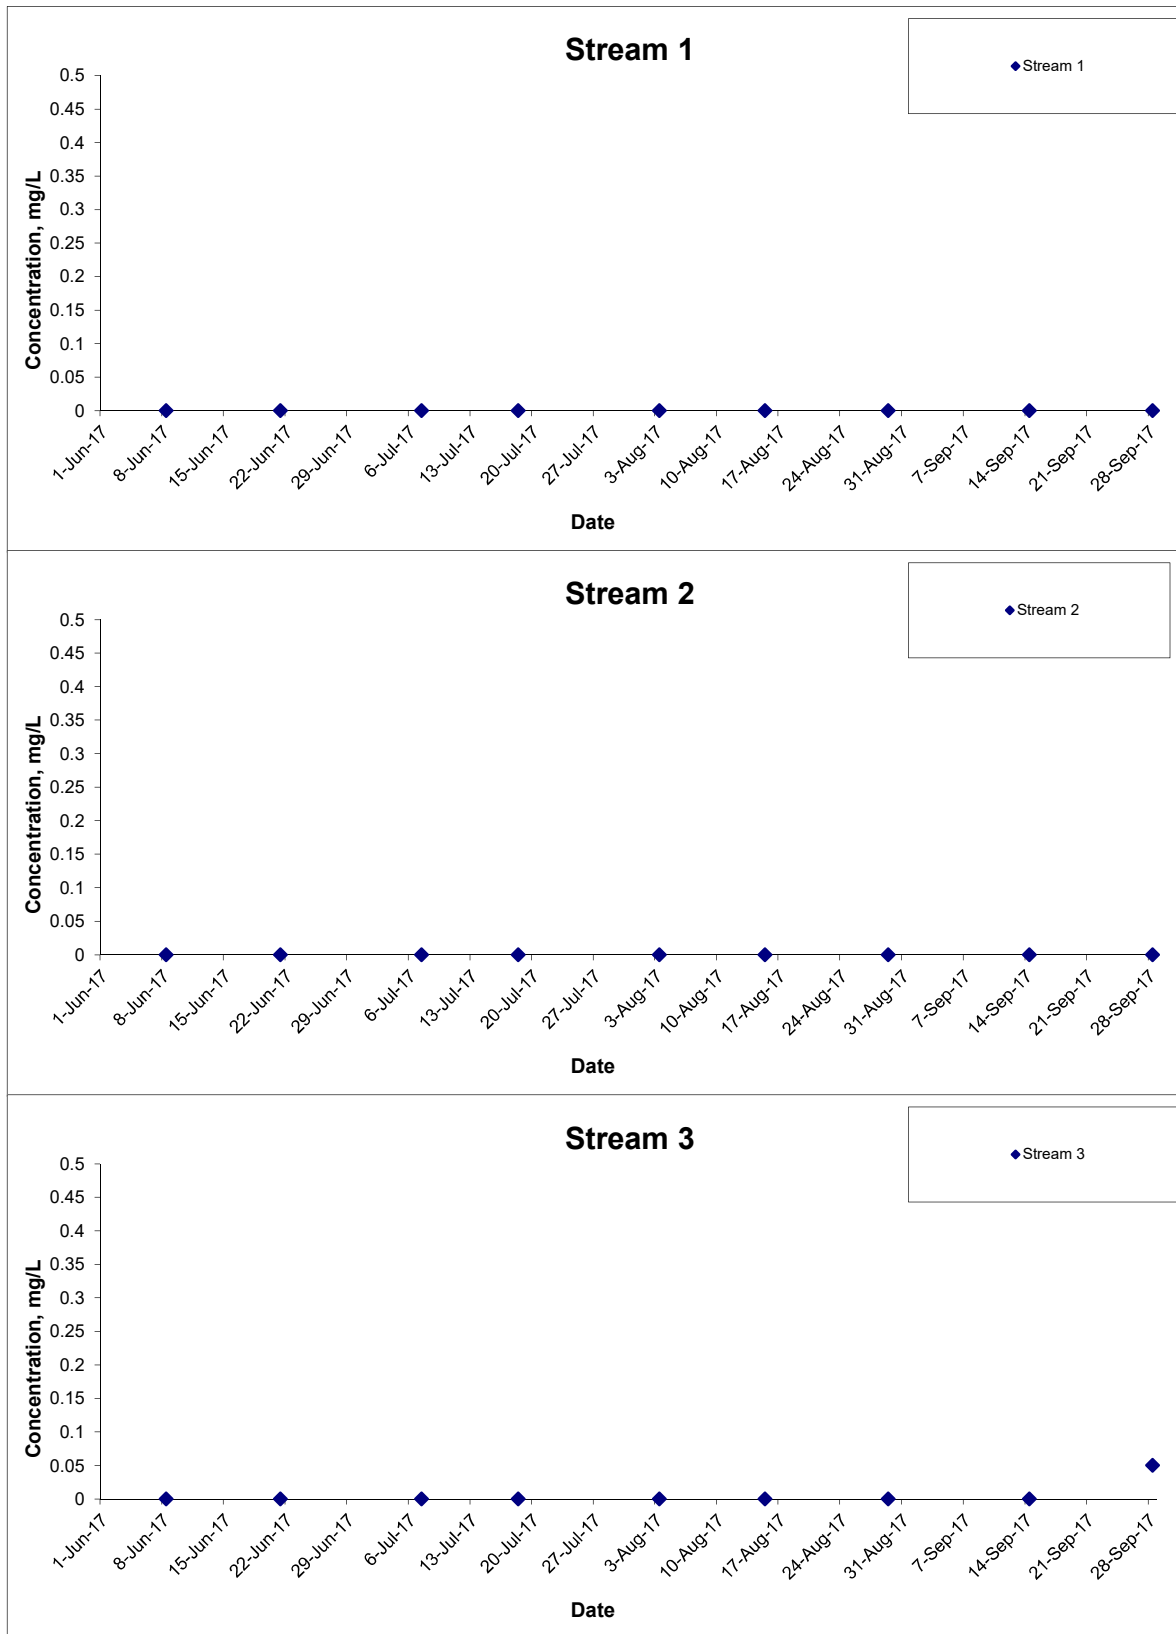
Total Phosphate

Remarks: The graphical point at zero concentration is presented as <0.05 mg/L
