Civil Engineering and Development Department

**Agreement No. CE 59/2015 (EP)
Environmental Team for
Tseung Kwan O – Lam Tin Tunnel
Design and Construction**

**Monthly Environmental Monitoring and
Audit Report for December 2017**

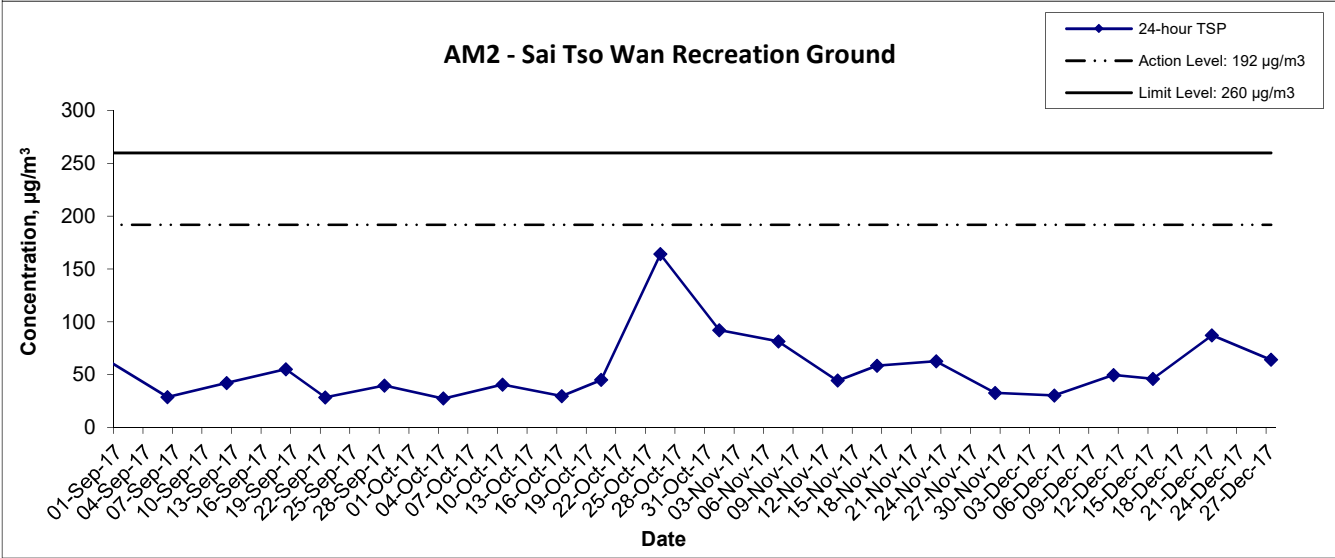
24-hr TSP Concentration Levels

Title Agreement No. CE/59/2015 (EP) Environmental Team for Tseung Kwan O - Lam Tin Tunnel - Design and Construction Graphical Presentation of 24-hour TSP Monitoring Results	Scale N.T.S	Project No. MA16034	
	Date Dec 17	Appendix F
