Agreement No. CE 59/2015 (EP) Environmental Team for Tseung Kwan O – Lam Tin Tunnel Design and Construction

Monthly Environmental Monitoring and Audit Report for March 2018

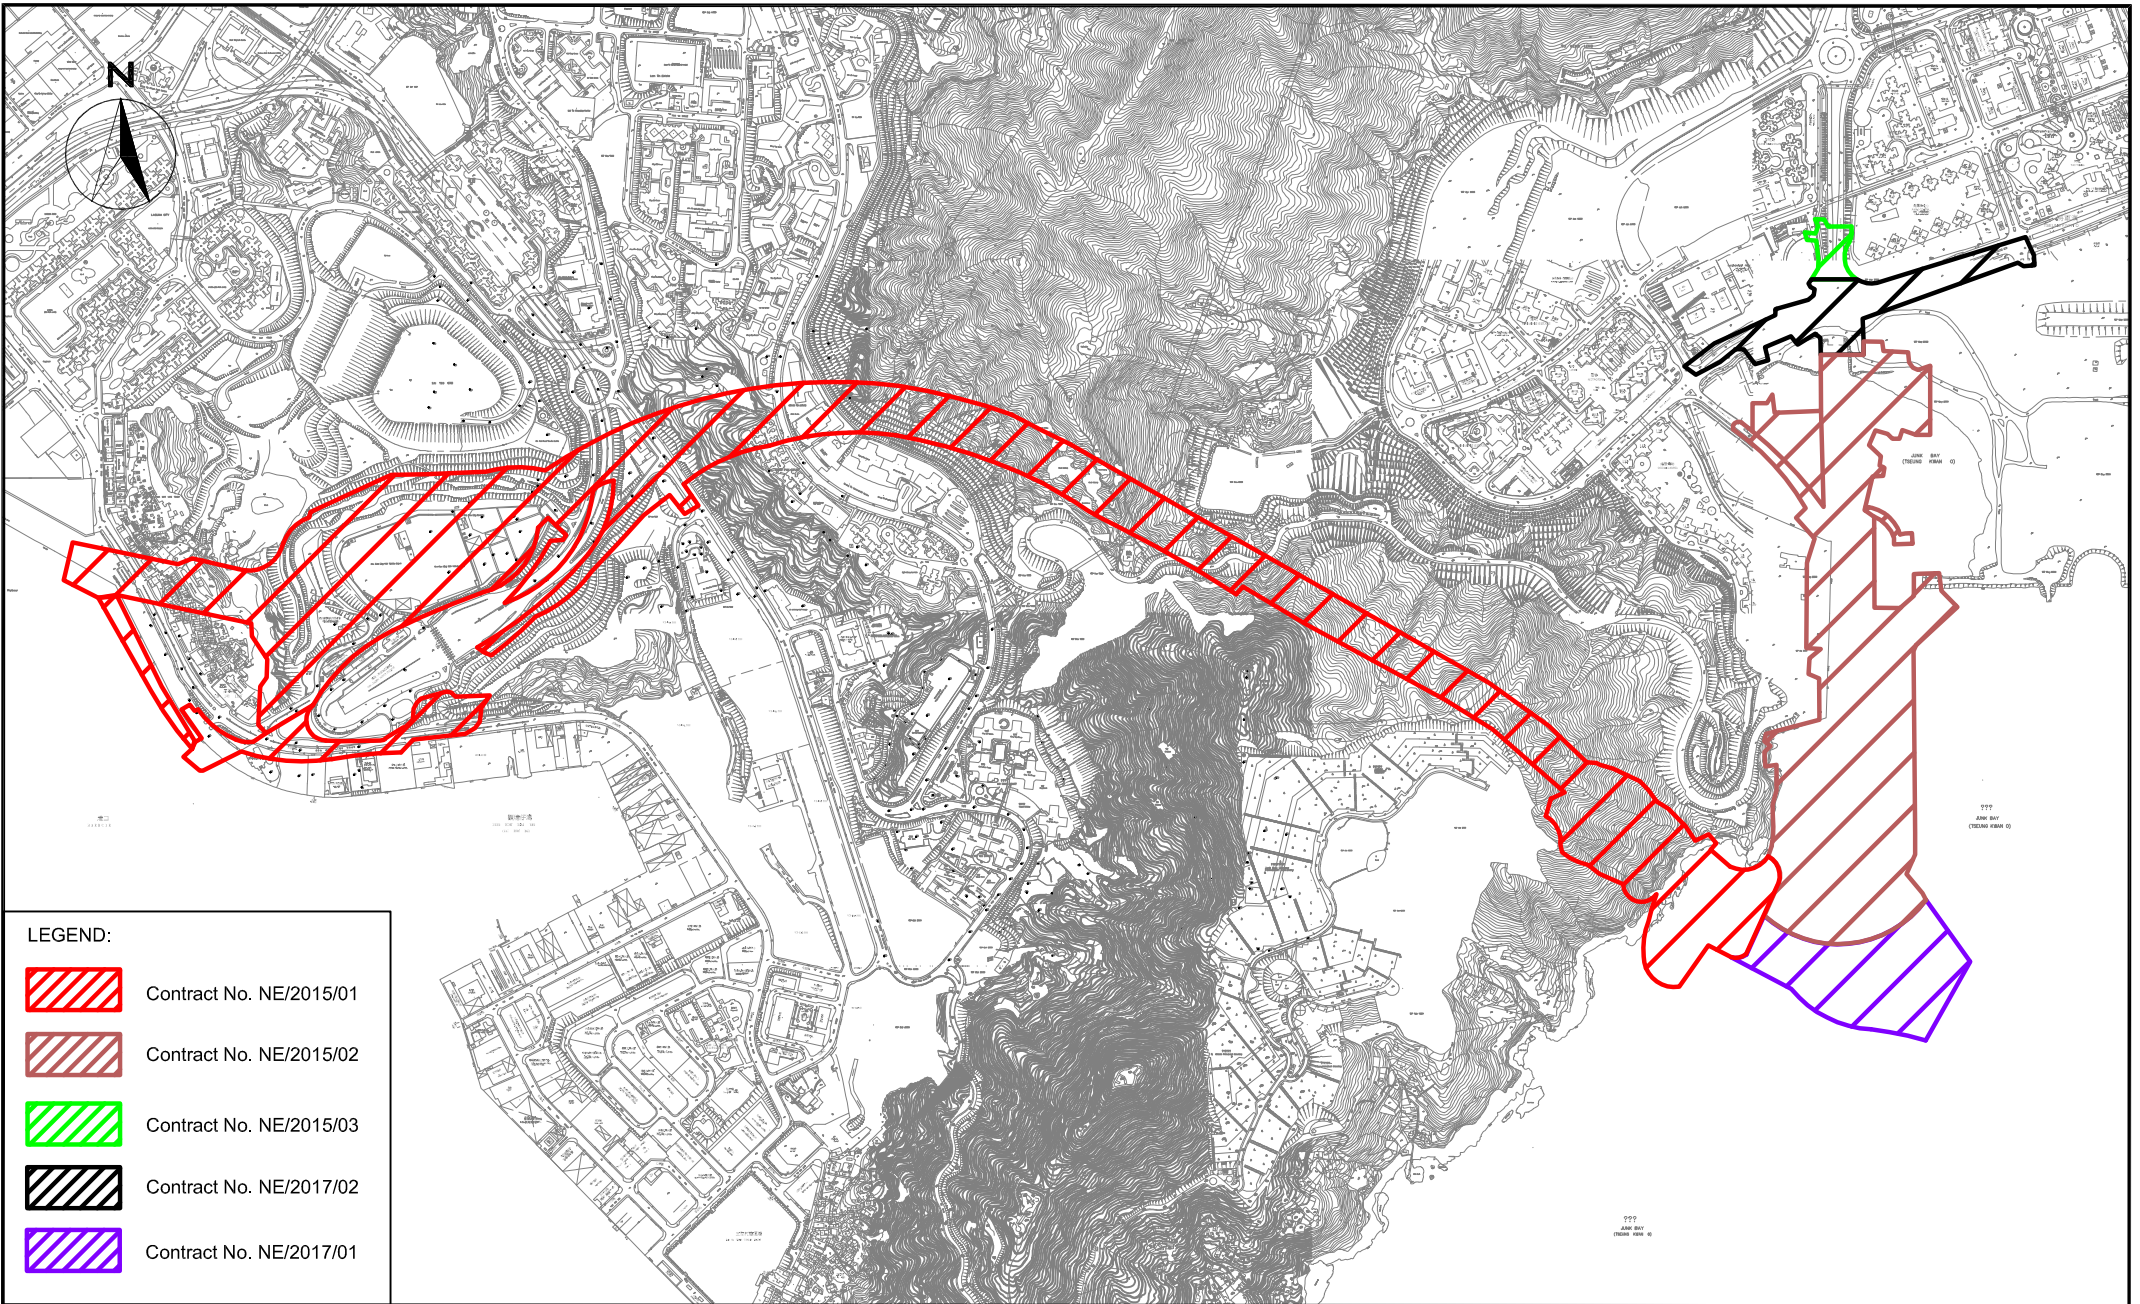
SCALE	1:15000 @ A4	DATE	APR 2018
CHECK	JF	DRAWN	AC
JOB No.	MA16034	FIGURE NO.	1
		REV	-

- 2.2 At present, the Tseung Kwan O Tunnel is the main connection between Tseung Kwan O (TKO) and other areas in the territory. To cope with the anticipated transport need, the TKO Study recommended the provision of Tseung Kwan O – Lam Tin Tunnel (TKO-LTT) (hereinafter referred to as “the Project”) and Cross Bay Link (CBL) to meet the long-term traffic demand between TKO and the external areas. The site layout plan for the Project is shown in **Figure 1**.
