Civil Engineering and Development Department

**Agreement No. CE 59/2015 (EP)
Environmental Team for
Tseung Kwan O – Lam Tin Tunnel
Design and Construction**

**Monthly Environmental Monitoring and
Audit Report for July 2018**

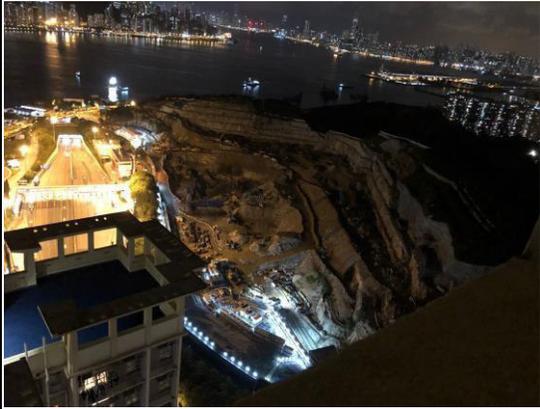
<p>(a) Statement of exceedance(s) Construction noise measured at CM1, CM2 & CM3 exceeded the construction noise (night time) limit level.</p>

<p>(b) Cause of exceedance(s) The exceedance was not considered related to the Project works:</p> <ul style="list-style-type: none"> • According to our field observation, road traffic noise were identified as the dominant noise source. No noticeable noise from blasting / associated works was identified. • No major construction activity was observed in Lam Tin Interchange during monitoring (see photo). • As confirmed by RE, only construction works inside the tunnel were being conducted with the blast door closed.

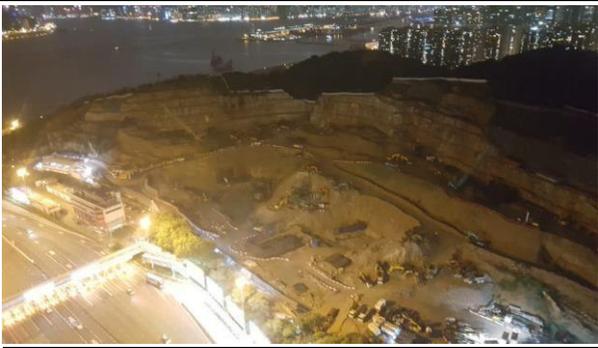
<p>(a) Statement of exceedance(s) Construction noise measured at CM1, CM2 & CM3 exceeded the construction noise (night time) limit level.</p>

<p>(b) Cause of exceedance(s) The exceedance was not considered related to the Project works:</p> <ul style="list-style-type: none"> • According to our field observation, road traffic noise were identified as the dominant noise source. No noticeable noise from blasting / associated works was identified. • No major construction activity was observed in Lam Tin Interchange during monitoring (see photo).

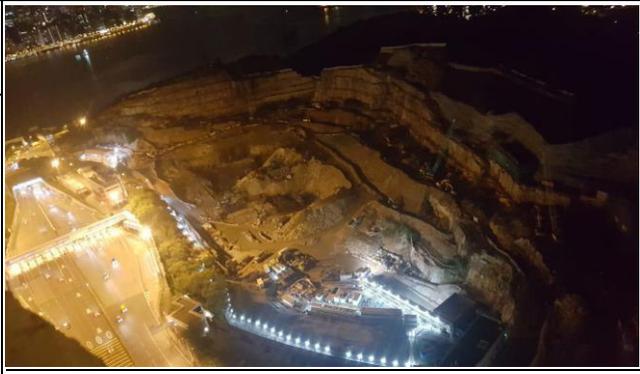
<p>(a) Statement of exceedance(s) Construction noise measured at CM1, CM2 & CM3 exceeded the construction noise (night time) limit level.</p>

<p>(b) Cause of exceedance(s) The exceedance was not considered related to the Project works:</p> <ul style="list-style-type: none"> • According to our field observation, road traffic noise were identified as the dominant noise source. No noticeable noise from blasting / associated works was identified. • No major construction activity was observed in Lam Tin Interchange during monitoring (see photo).
