**Agreement No. CE 59/2015 (EP)  
Environmental Team for  
Tseung Kwan O – Lam Tin Tunnel  
Design and Construction**

**Monthly Environmental Monitoring and  
Audit Report for Aug 2019**

**(version 1.0)**

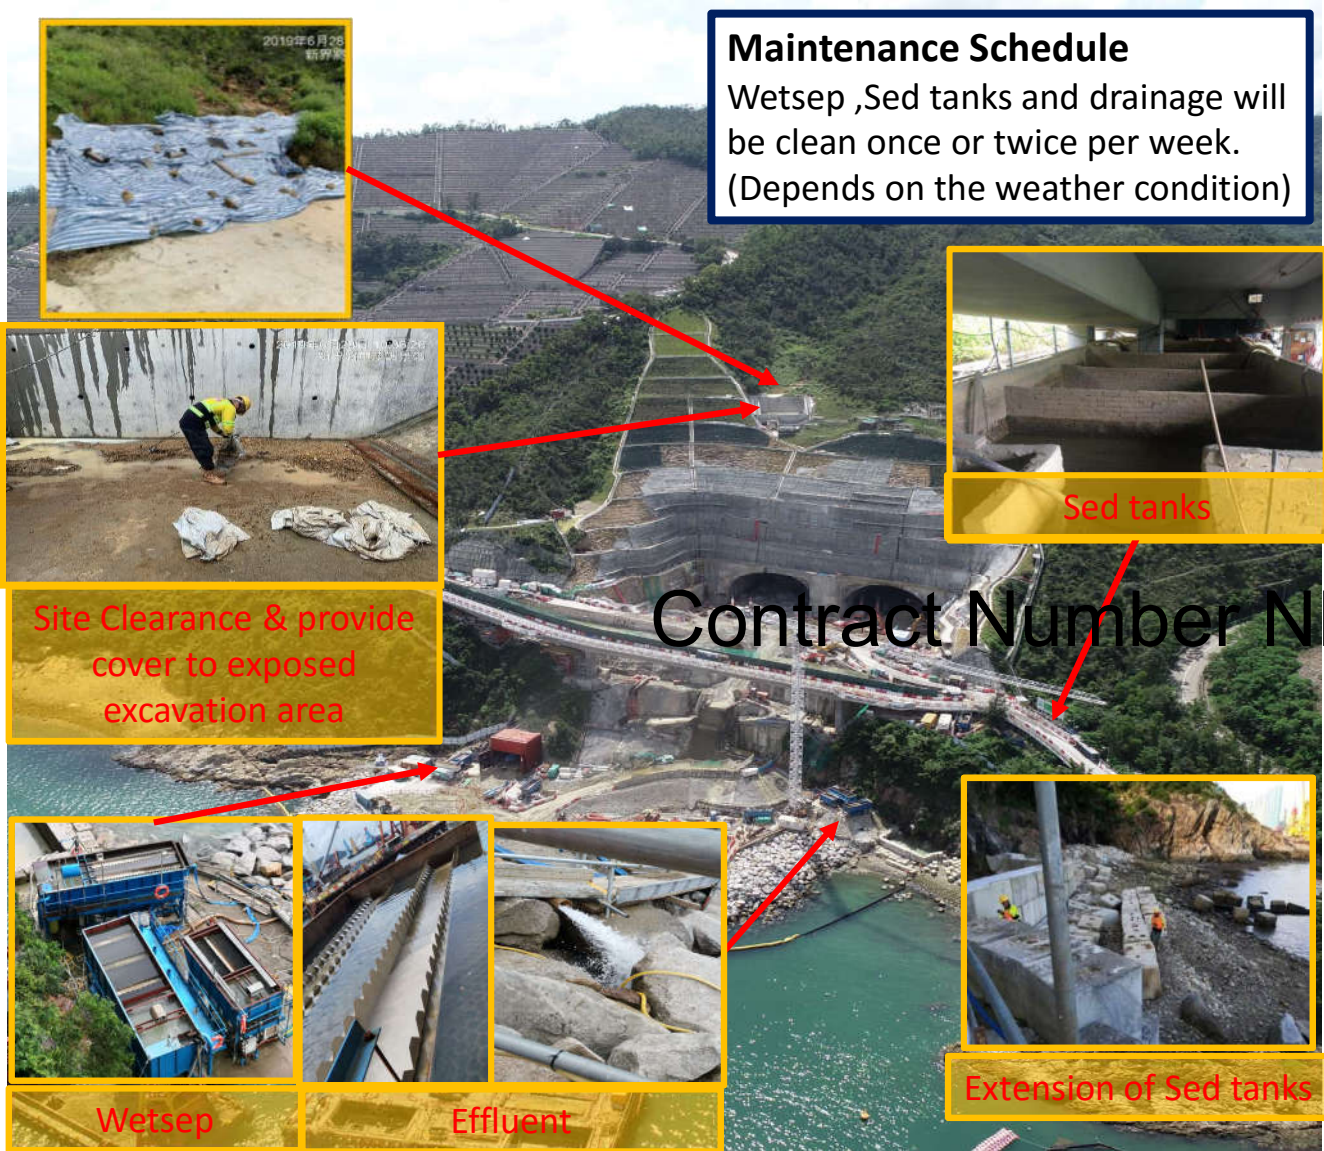
**Maintenance Schedule**  
Wetsep ,Sed tanks and drainage will be clean once or twice per week.  
(Depends on the weather condition)

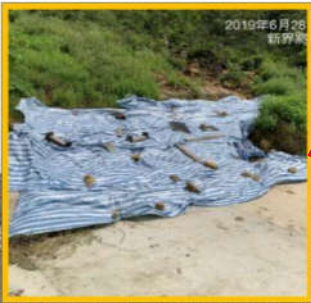
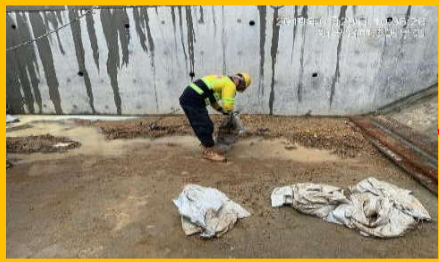
Site Clearance & provide cover to exposed excavation area
