Civil Engineering and Development Department

**Agreement No. CE 59/2015 (EP)
Environmental Team for
Tseung Kwan O – Lam Tin Tunnel
Design and Construction**

**Monthly Environmental Monitoring and
Audit Report for
April 2020
(version 1.0)**

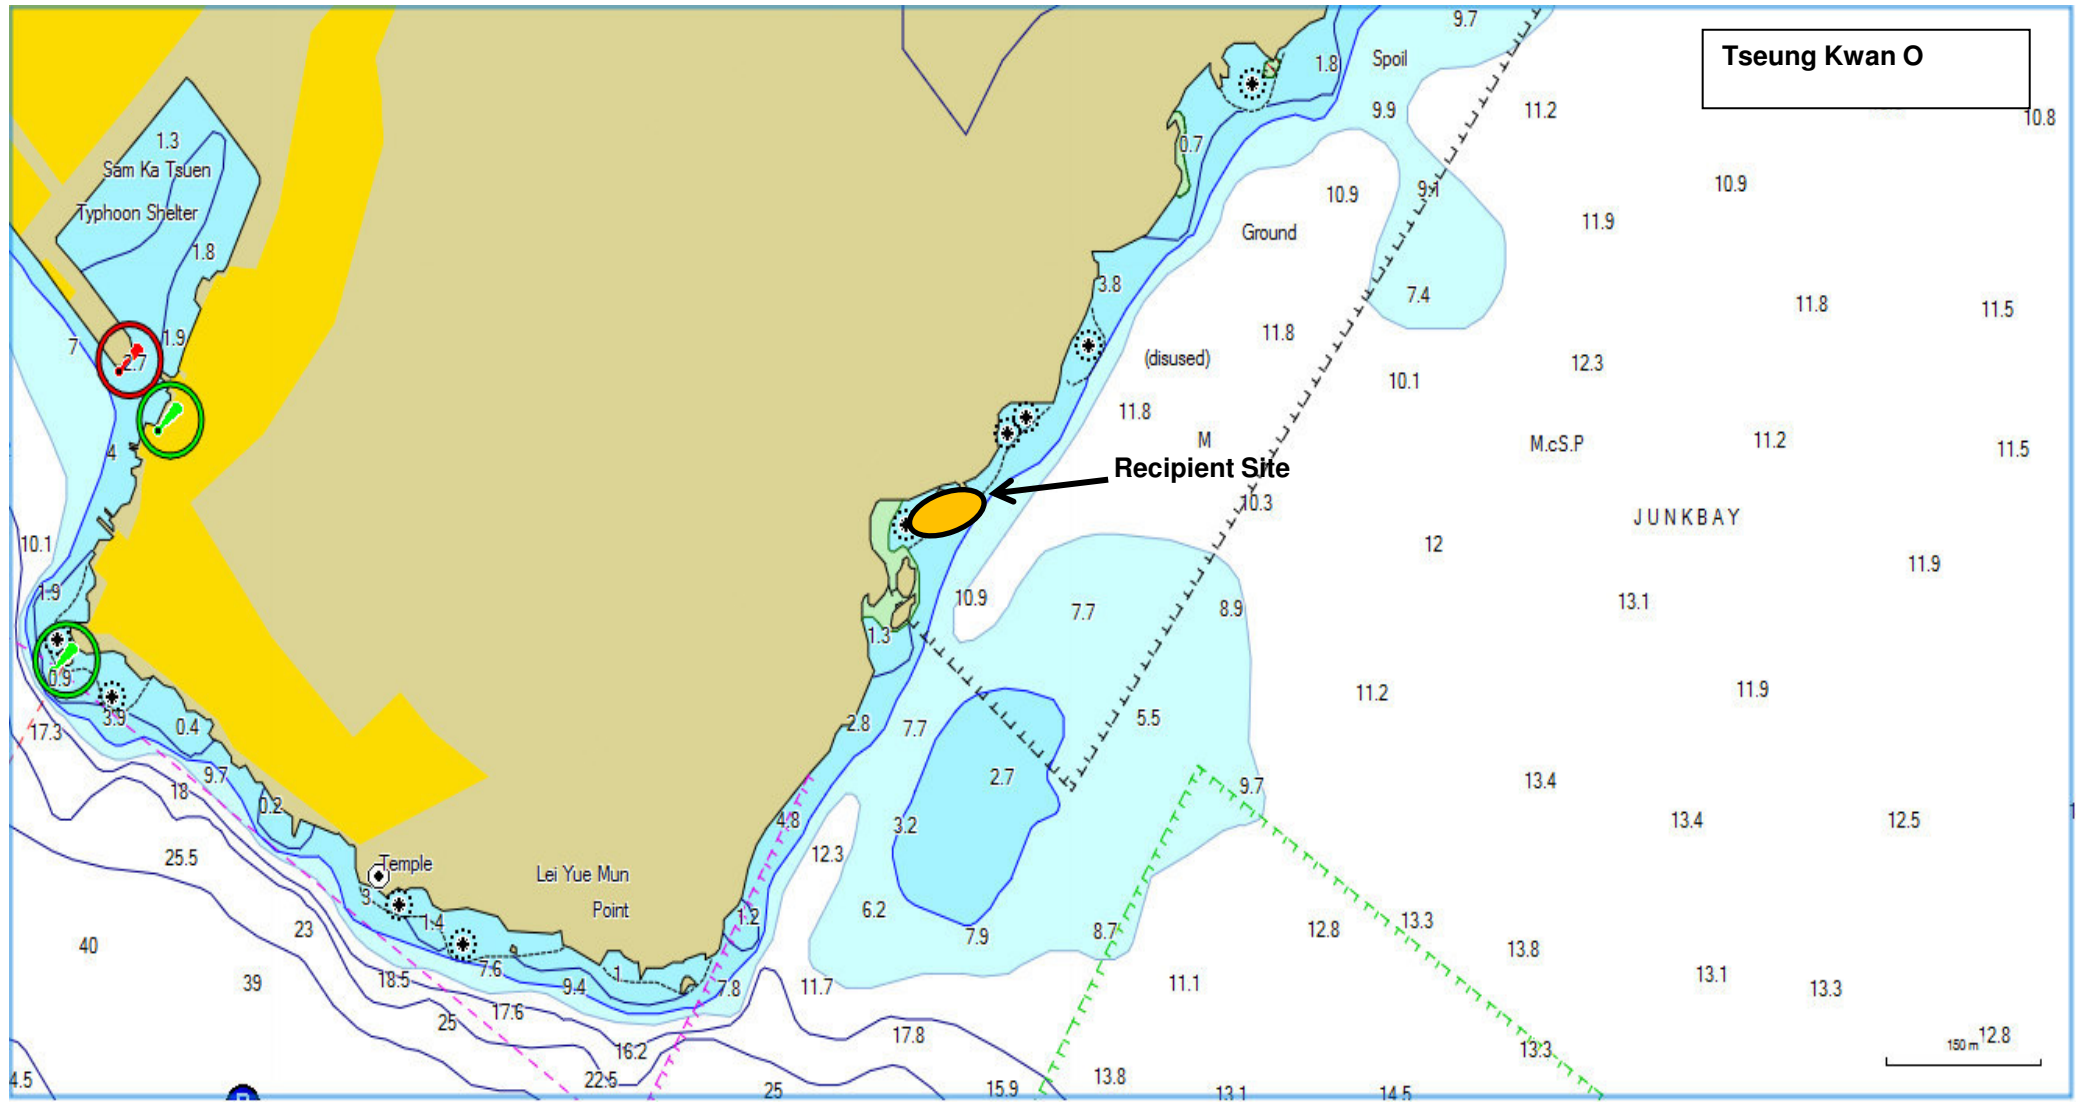
Title Agreement No. CE/59/2015 (EP)
 Environmental Team for Tseung Kwan O - Lam Tin Tunnel - Design and Construction
 Location of Post-translocation Coral Monitoring

- 6.1 Post-translocation monitoring survey is recommended in the EM&A Manual to audit the success of coral translocation. Information gathered during each post-translocation monitoring survey should include observations on the presence, survival, health condition and growth of the translocated coral colonies. These parameters should then be compared with the baseline results collected from the pre-translocation survey.
